Archaeological work during ground-works at Church Farm, Wilkinson Lane, Elmesthorpe, Leicestershire (SP 460 965)

ULAS Report No 2011-096
©2012

Planning Application No. 10/0731/1/PX

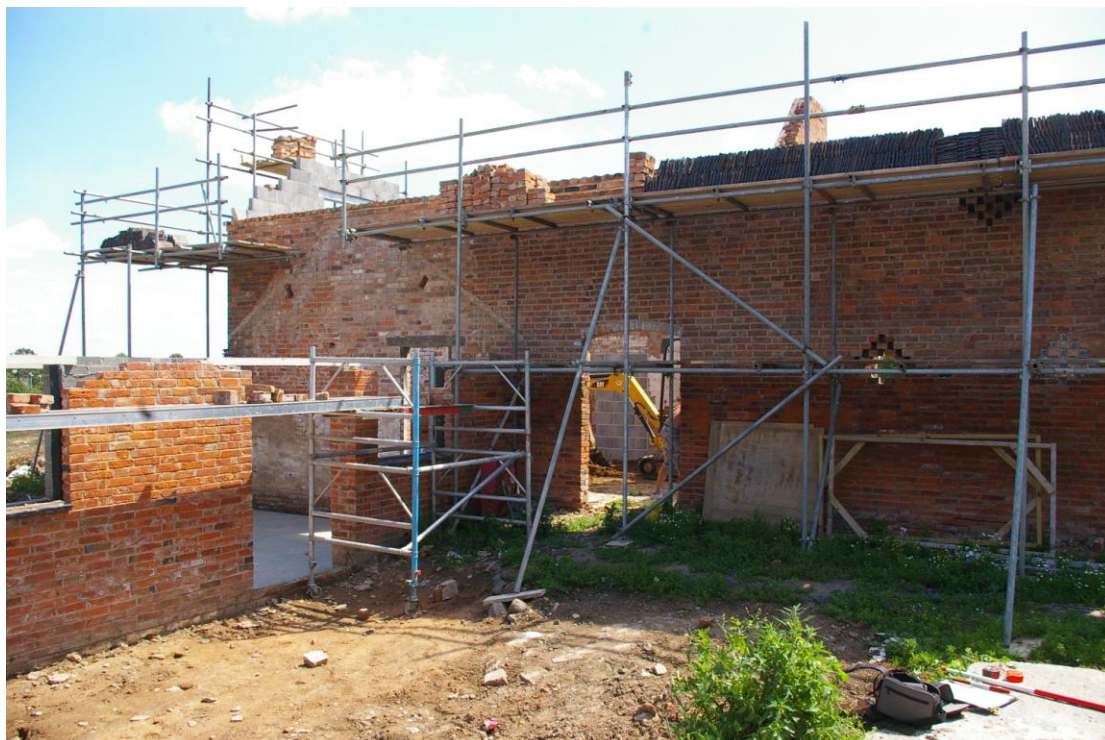
Plate 1: The two storey barn to the north-east, looking north-east

The initial visit to the site on 14th June 2011 was to monitor the removal of a brick and concrete floor within a two storey barn at the north-east corner of the building range (Plate 1) and ground reduction prior to the excavation of foundation trenches between two single storey barns close to the centre of the site (Plate 2).

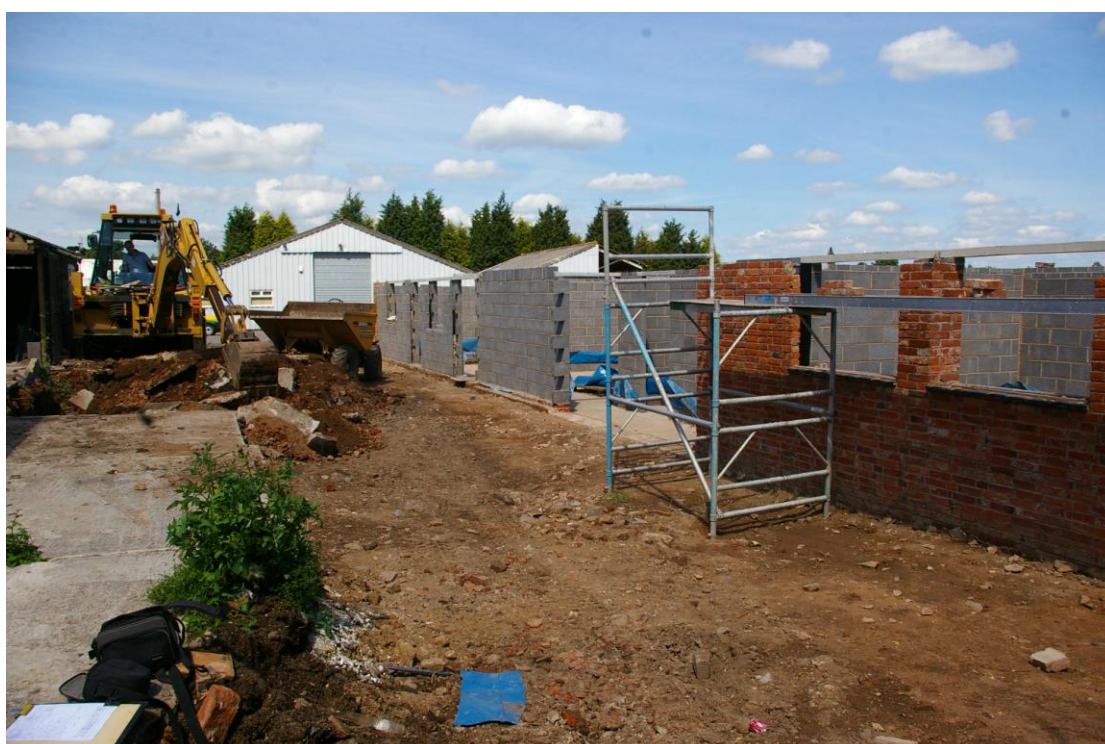
Plate 2: The area between the two single storey barns, looking north-west

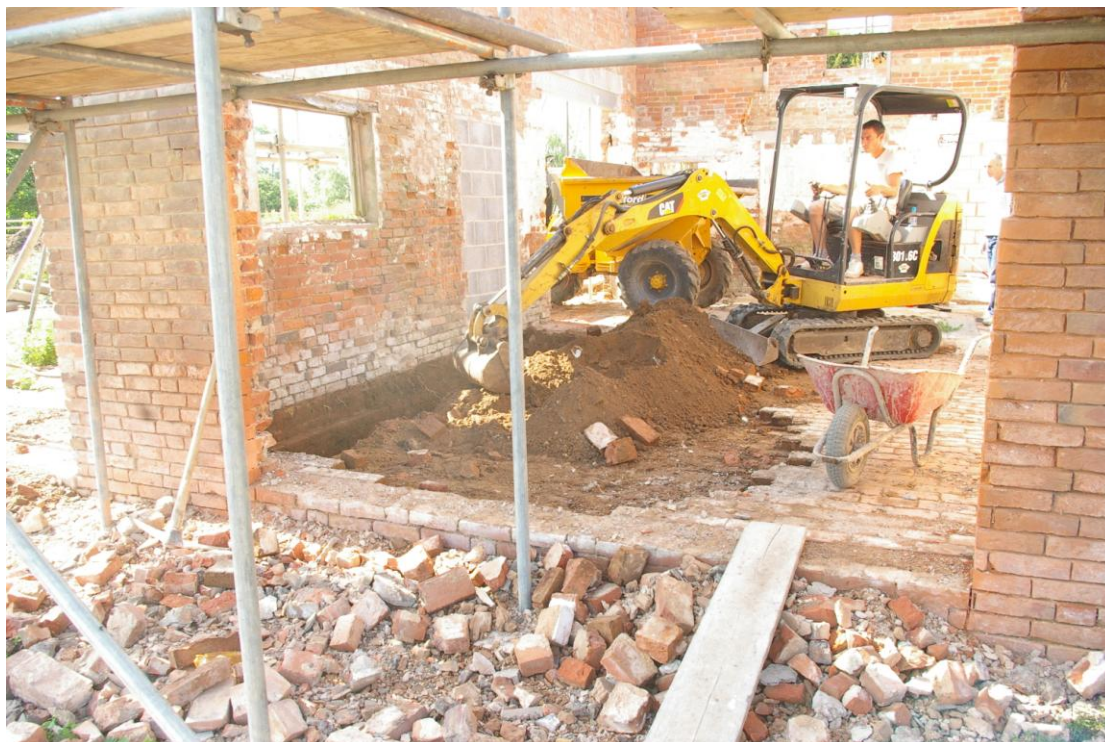
Plate 3: Work in progress inside two storey barn, looking south-east

The two storey block had a floor in the northern part of the building constructed of bricks laid face up. These were removed by a small digger fitted with a toothed bucket and the area then cleaned with a shovel (Plate 3). The bricks were laid in a single course and overlay a layer of yellowish brown silty sand, which was fairly sterile and contained few coarse components, except a few sub-rounded pebbles and some roots. Several sherds of modern pottery and part of a glass bottle were retrieved from the matrix.

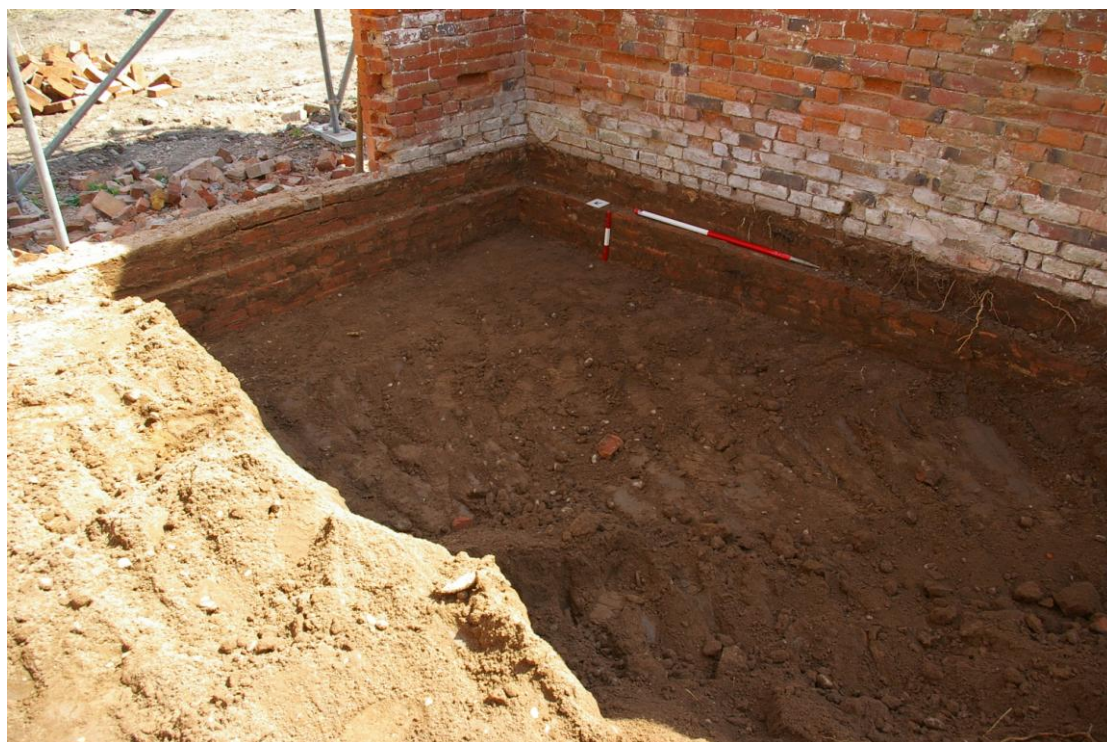
The bricks and soil were fully removed within this area to a depth of around 0.54m below the floor level, exposing more soil (Plates 4 & 5). The southern end of the floor was constructed of thick layers of concrete so that the floor sloped to the west. These were at least 150mm deep and have to be removed with a breaker. The concrete also lay over the silty clay.

The foundations of the barn were exposed along three walls. The foundations consisted of at least eight courses of bricks with the bottom five courses stepped from

between 60-100mm out from those above. There were no indications of earlier building phases.

Plate 4: Floor partially excavated, showing foundations, looking north-east

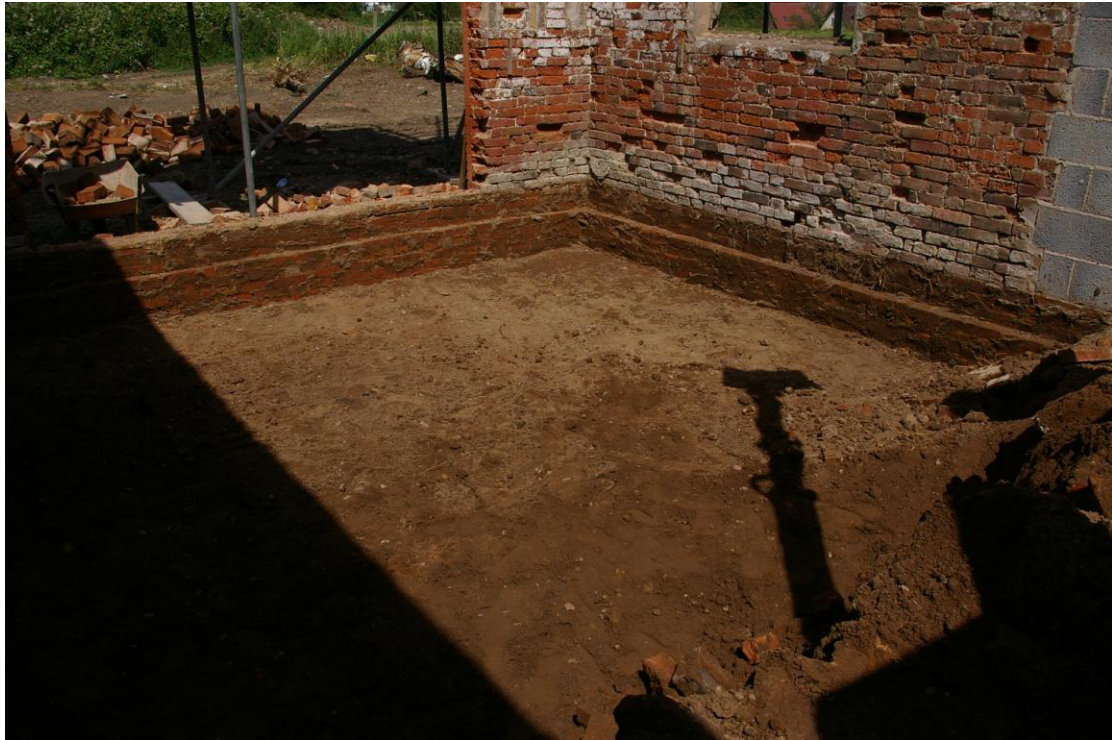
Plate 5: Floor fully excavated, looking north-east

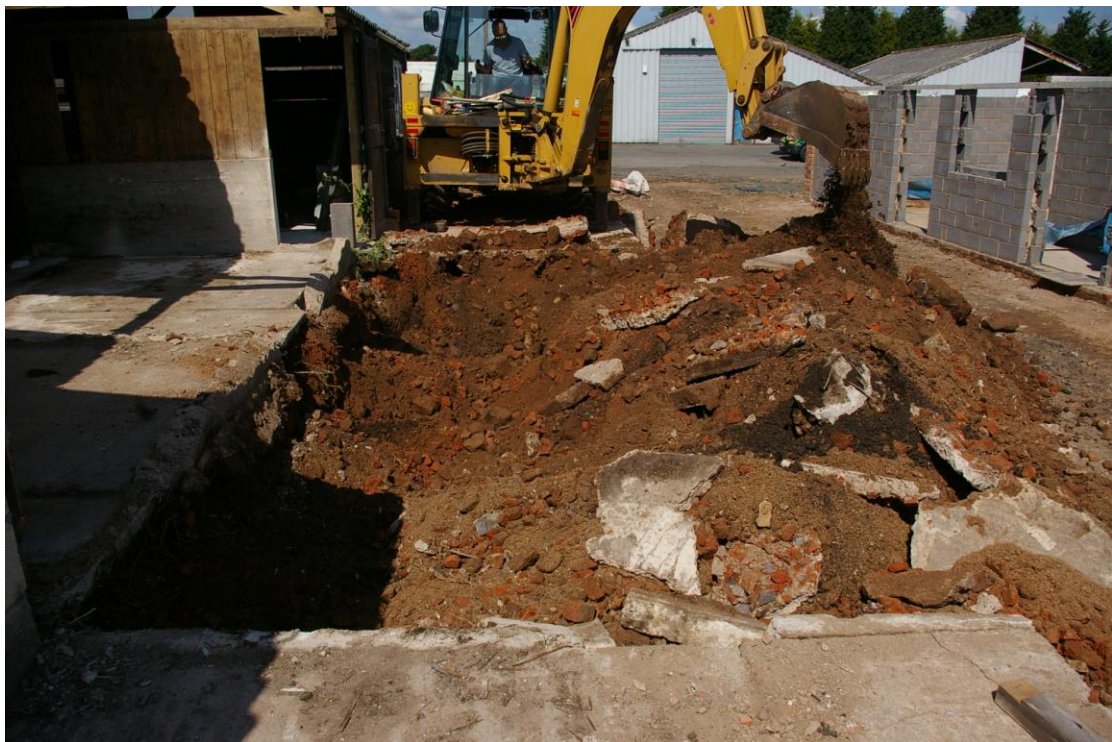
An area to the south of the northern range, partially covered in concrete, was stripped with a JCB with a toothed bucket to a depth of around 1m from the top of the concrete (Plates 6 & 7). A depth of 60mm-0.2m of concrete (at the southern edge of the area close to the building to the south) overlay 0.25m of brick rubble/hardcore. This lay over 0.25m of yellowish brown silty-sand, which lay over 0.25m of ash and clinker (Plate 8). Under this was either the natural substratum of reddish brown sand and gravel or, in places a further 0.20m of silty-sand, over the substratum. The area was cleaned at the appropriate level with a toothless ditching bucket, exposing the sand and gravel across the area. No features were revealed.

Plate 6: Work in progress on centre barns, looking west

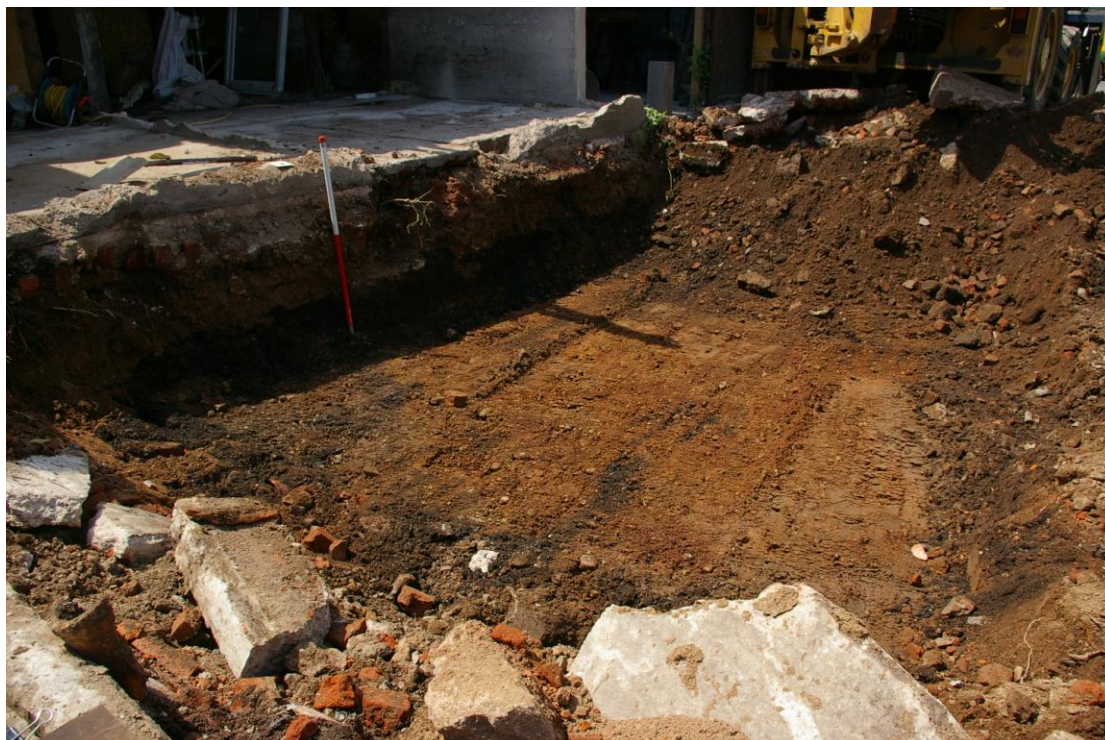
Plate 7: Excavated area at single barns, looking south-west

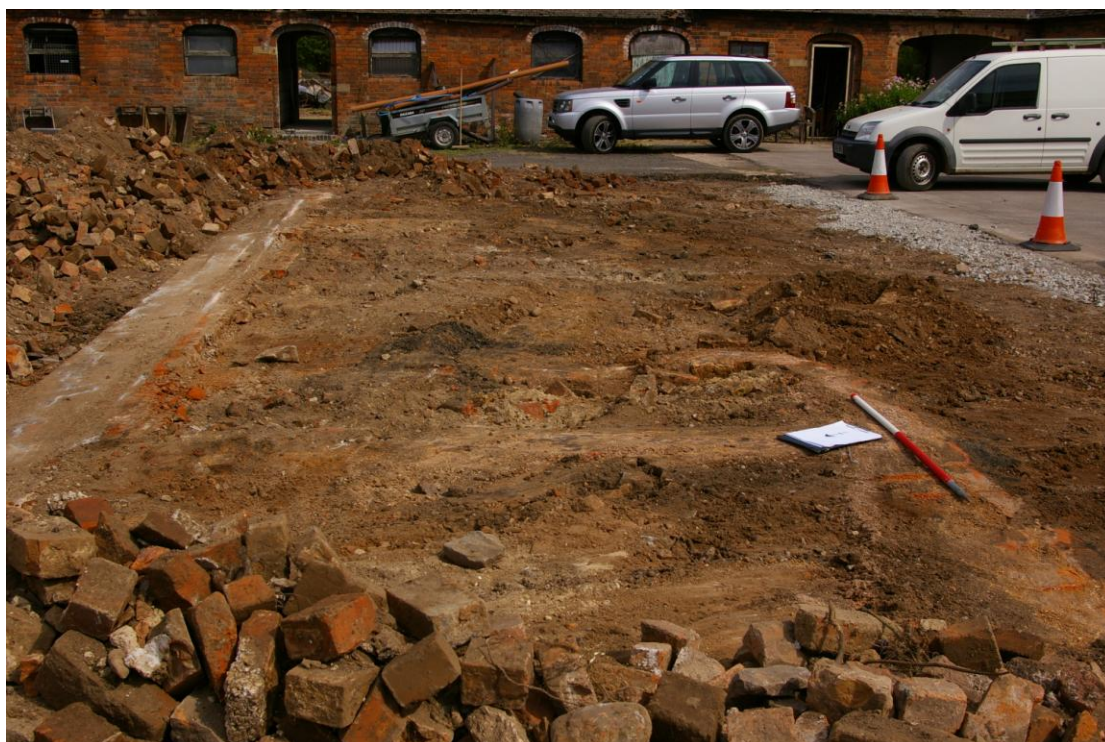
The site was then visited on the 1st August 2011. After removing a concrete raft in the courtyard, the remains of a structure were observed (Plates 9 & 10). Further brick demolition rubble was removed during the visit to partially expose the structure, using a small tracked excavator with a ditching bucket. It was constructed of modern-sized brick and there was evidence for a brick floor. The remains of the brick footings indicated that the building was approximately 18m in length and measured 3.7m in width. There was some evidence that the building was divided into bays (Plate 11). Two narrow bays measuring approximately 1.5m were observed, although it was not possible to obtain a full floor plan. A ceramic drain with a metal grate was present close to the centre of the southern side of the structure. Along the northern wall of the structure, directly behind the brick foundation, was a long concrete 'beam' measuring approximately 13m. Where exposed the natural subsoil consisted of dark red brown sandy-gravel.

Plate 9: Concrete beam and brick foundations, looking east to two story range

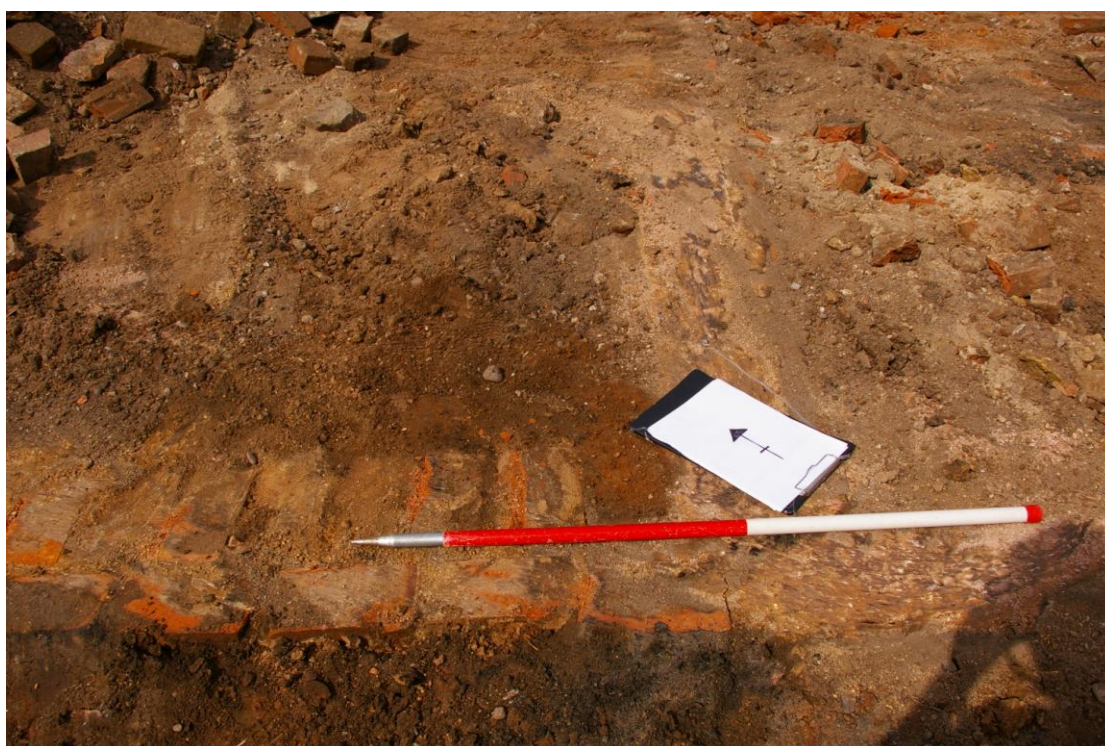
Plate 10: Close-up of brick foundations, looking north-east

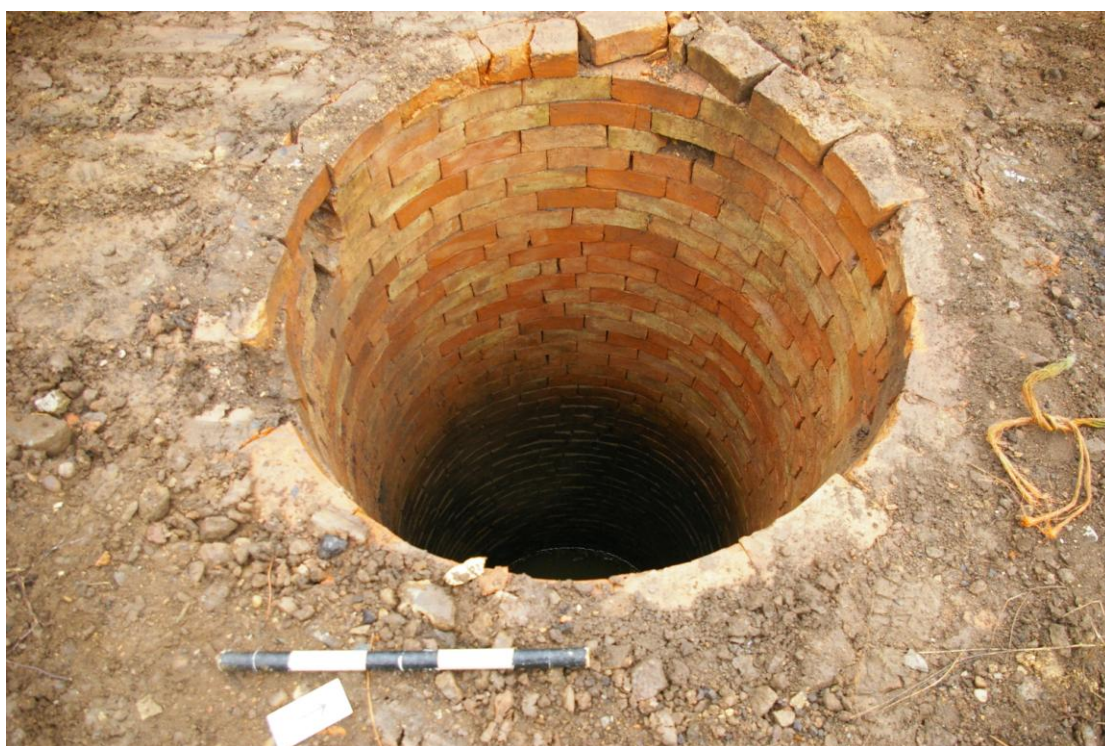
Further clearance of the yard area exposed a well and an area of cobbling. The well was constructed of modern sized curved well bricks and measured approximately 1.4m in diameter (outer measurement) (Plate 14). It was several metres deep and still wet to a depth of 2m (Martyn Bright pers. comm.). The well was roughly located by triangulating off two points on the supplied plan and it is not quite clear how it related to the structure observed on the previous visit, presumably it was outside this building. An area of intact cobbling, indicative of the previous yard surface was observed to the north-west of the well (Plate 15).

Plate 14: Well, looking north-west

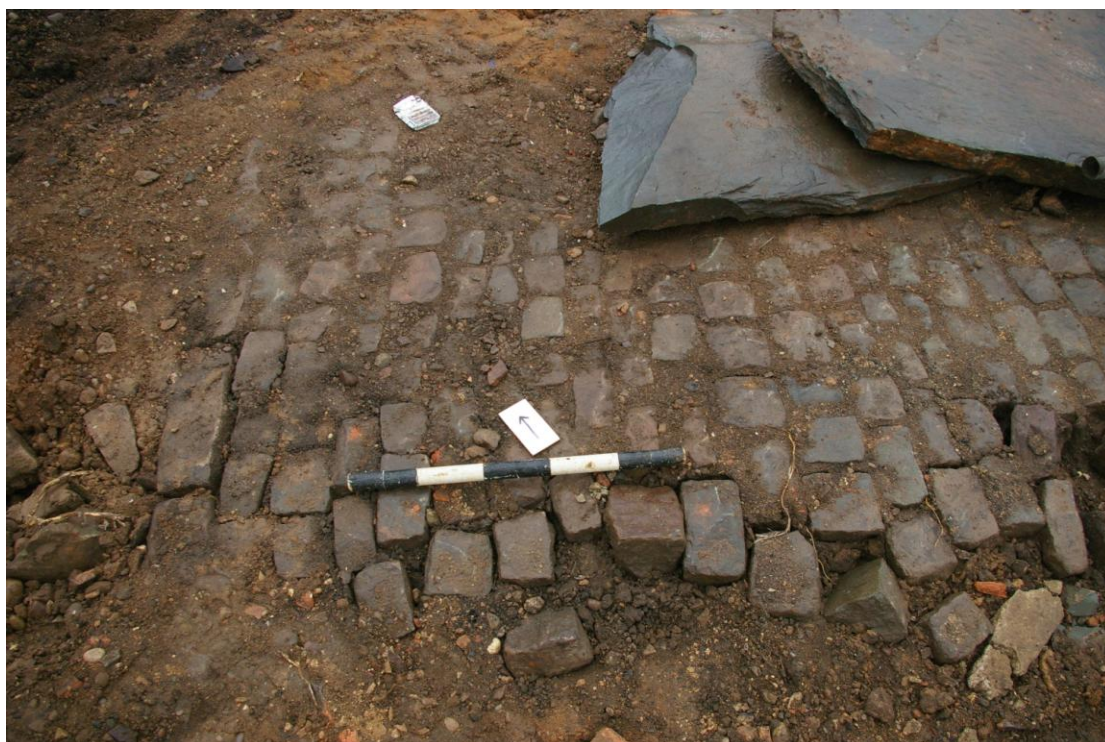
Plate 15: Cobbling, looking north north-east
