**Interim Report for
An Archaeological Watching Brief at
2 Melton Road, Long Clawson,
Leicestershire.
NGR: SK 7182 2690**

ULAS Report No. 2011-195
©2011

**An Interim Report for an
Archaeological Watching Brief at
Culfers Hey,
2 Melton Road, Long Clawson,
Leicestershire.**

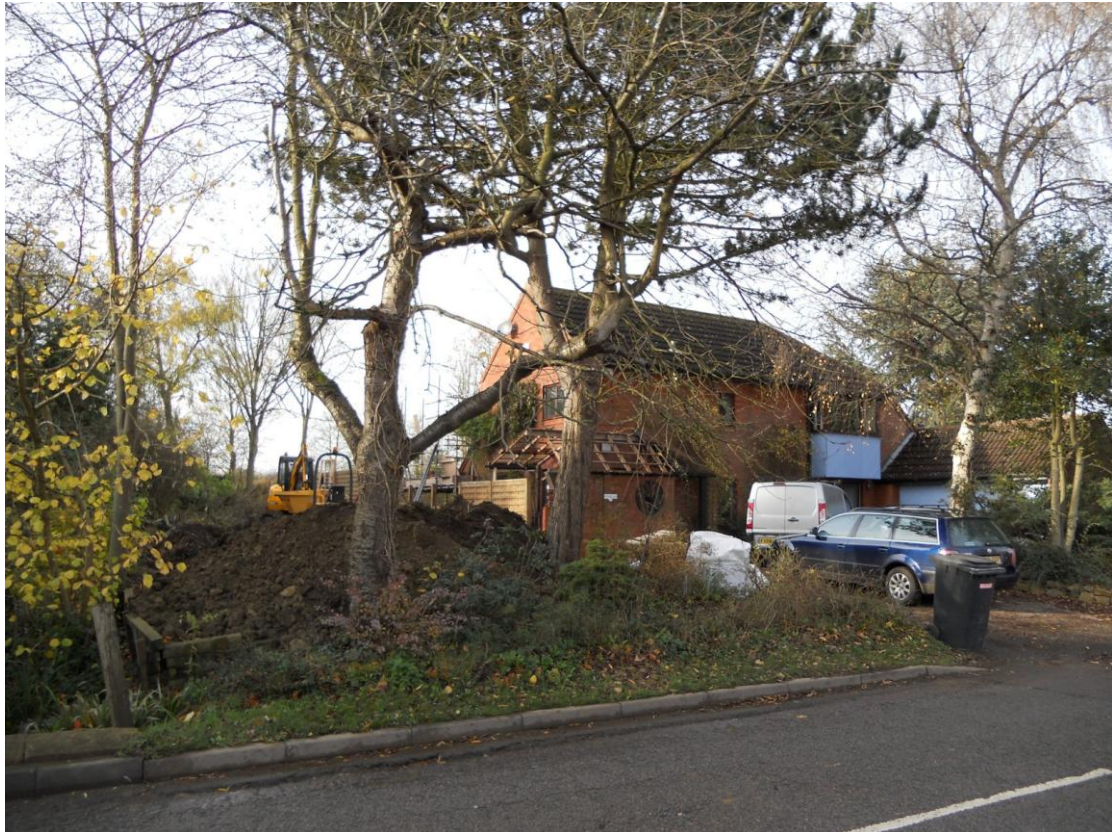
Figure 4. Development site viewed from Melton Road
Looking north-west. Proposed cottage site on left of picture. The house that can be seen is Culfers Hey.

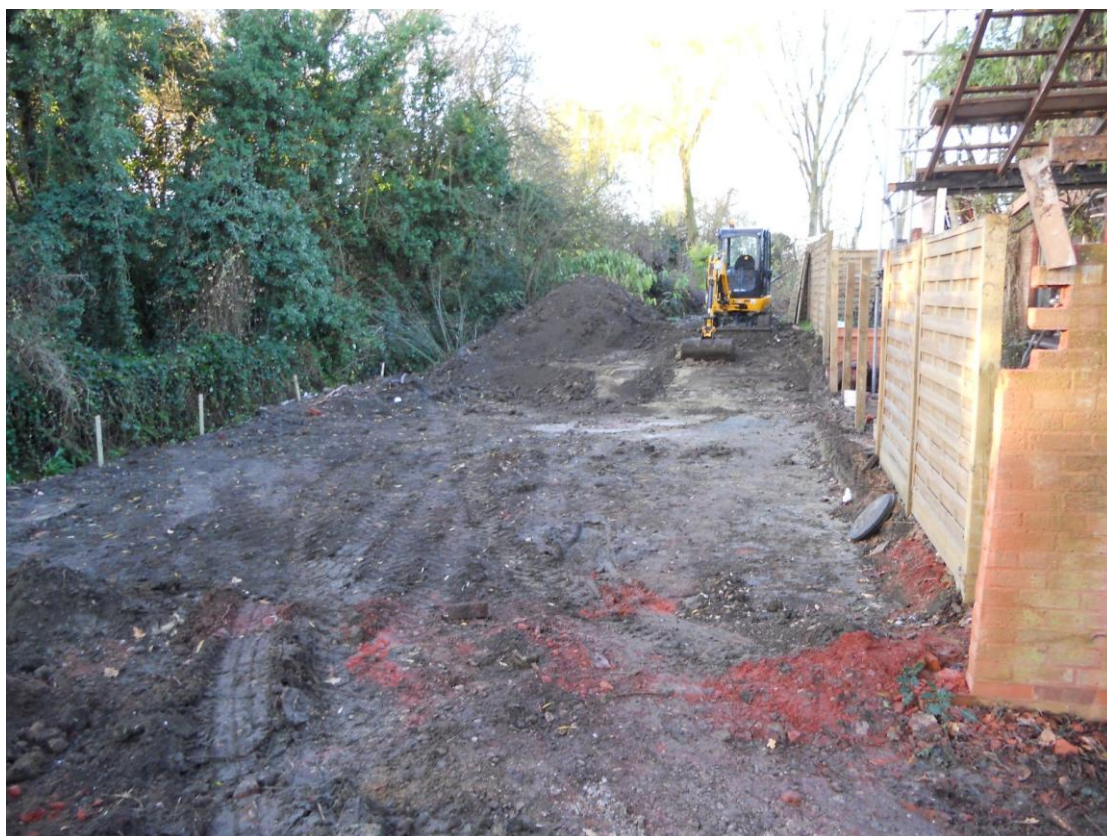
Because of the nature of the sloping site which rose by approximately one metre from Melton Road in the east to the rear of the property it was necessary to remove the topsoil and some subsoil to create a level terrace (Fig. 5). Although quite heavily disturbed by the removal of the shrubbery and undergrowth the topsoil consisted of a dark-brown clay silt with an average depth of around 0.2m. Removal of this revealed a subsoil of mid yellowish-brown silty clay with occasional patches of lighter sandy gravel. The levelling operation removed only part of the subsoil layer on the lower, eastern, area of the cottage footprint but the westernmost 2 metres partially exposed the natural substratum of light yellowish-brown clay. No archaeological features or deposits could be seen in this exposed area except for a horseshoe-profile field drain running from beneath the existing Culfers Hey house south-eastwards to the shallow ditch running down the southern property boundary.

Figure 5. Levelled site
Looking west. Note exposed natural at far end of terrace near excavator

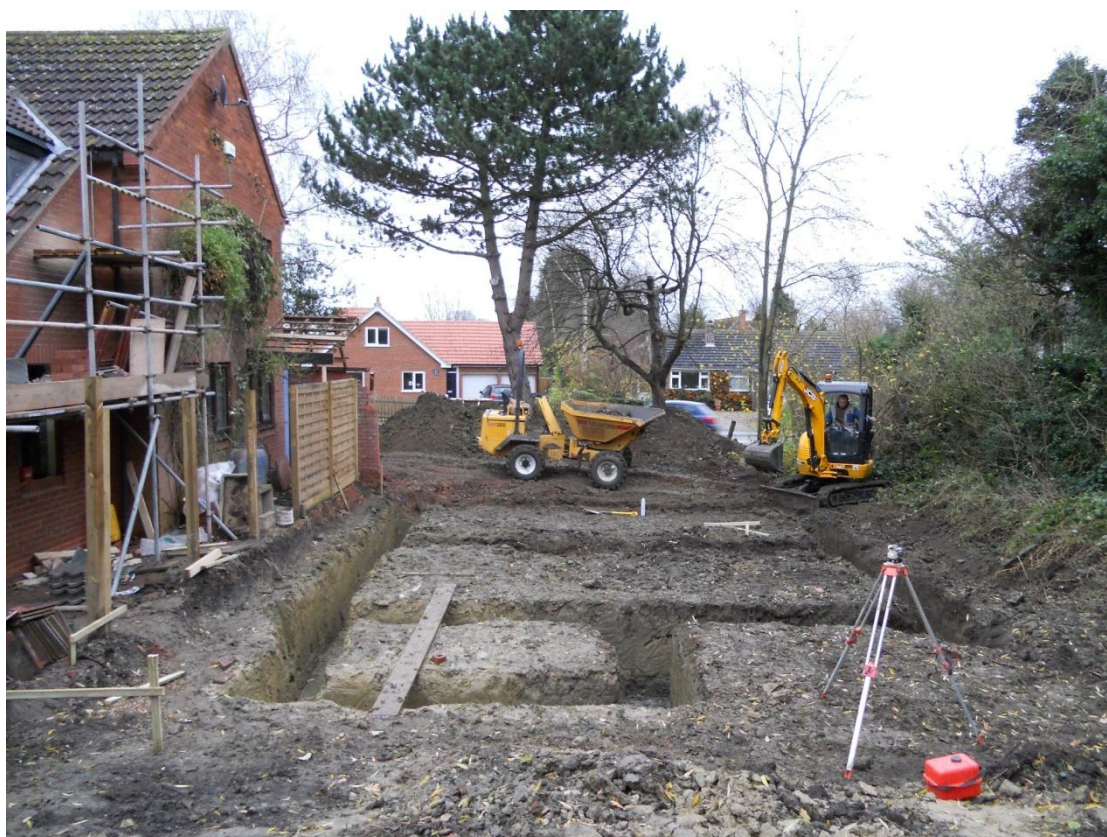
The foundation trenches measured 0.65m wide and 1.2m deep in the western half of the footprint. Due to the proximity of the surrounding trees the trenches had to be stepped down to a depth of 1.6m in the east. The light yellowish-brown clay substratum changed to a slightly darker bluish-grey towards the base of the trenches and some root disturbance could be seen especially towards the south-east corner (Fig. 6).

All faces of the trenches were examined for earthfast archaeological features and the spoil scanned for finds but, with the exception of the horseshoe drain seen during the levelling phase, no features were found.

Figure 6. Excavated foundation trenches
Looking east
