**An Archaeological Strip, Map and  
Sample Investigation at White Barn,  
45 Cressingham Road,  
Reading, Berkshire.  
NGR: SU 7275 7089 centre**

ULAS Report No. 2012-063  
©2012

**For: The Kingwood Trust**

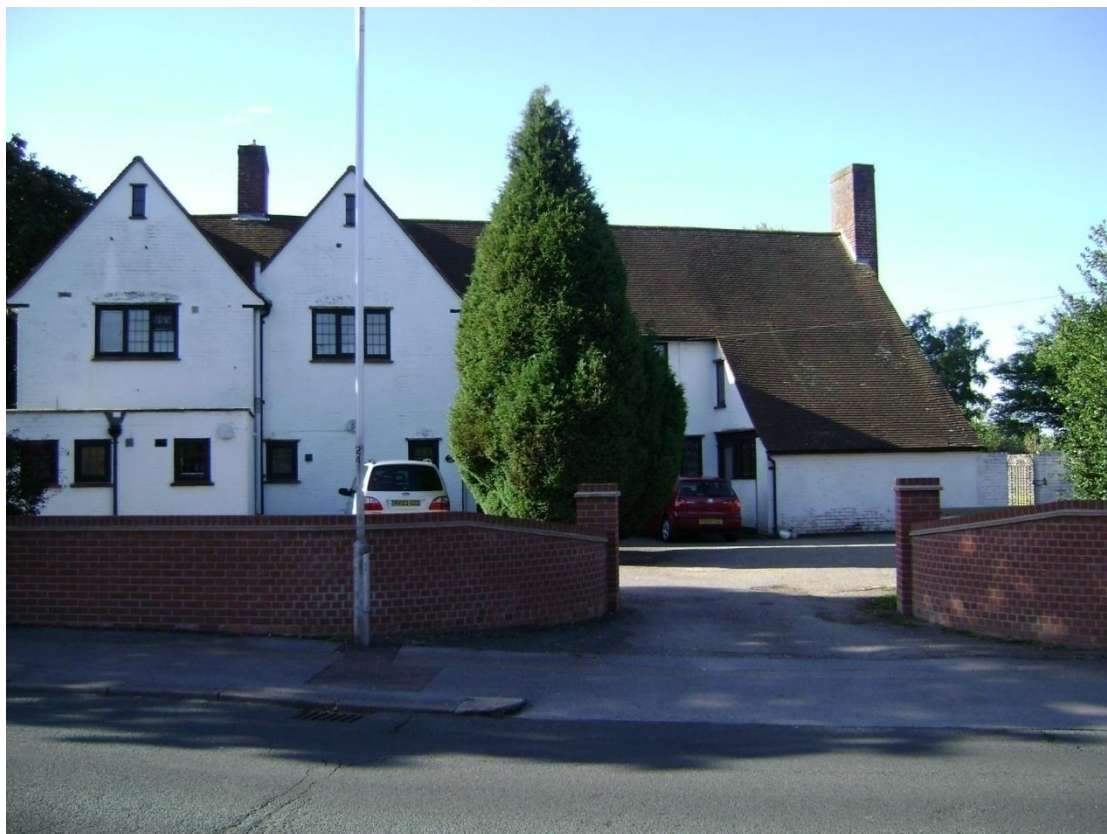
Figure 3. White Barn, 45 Cressingham Road  
Looking south. Photograph taken before commencement of work.

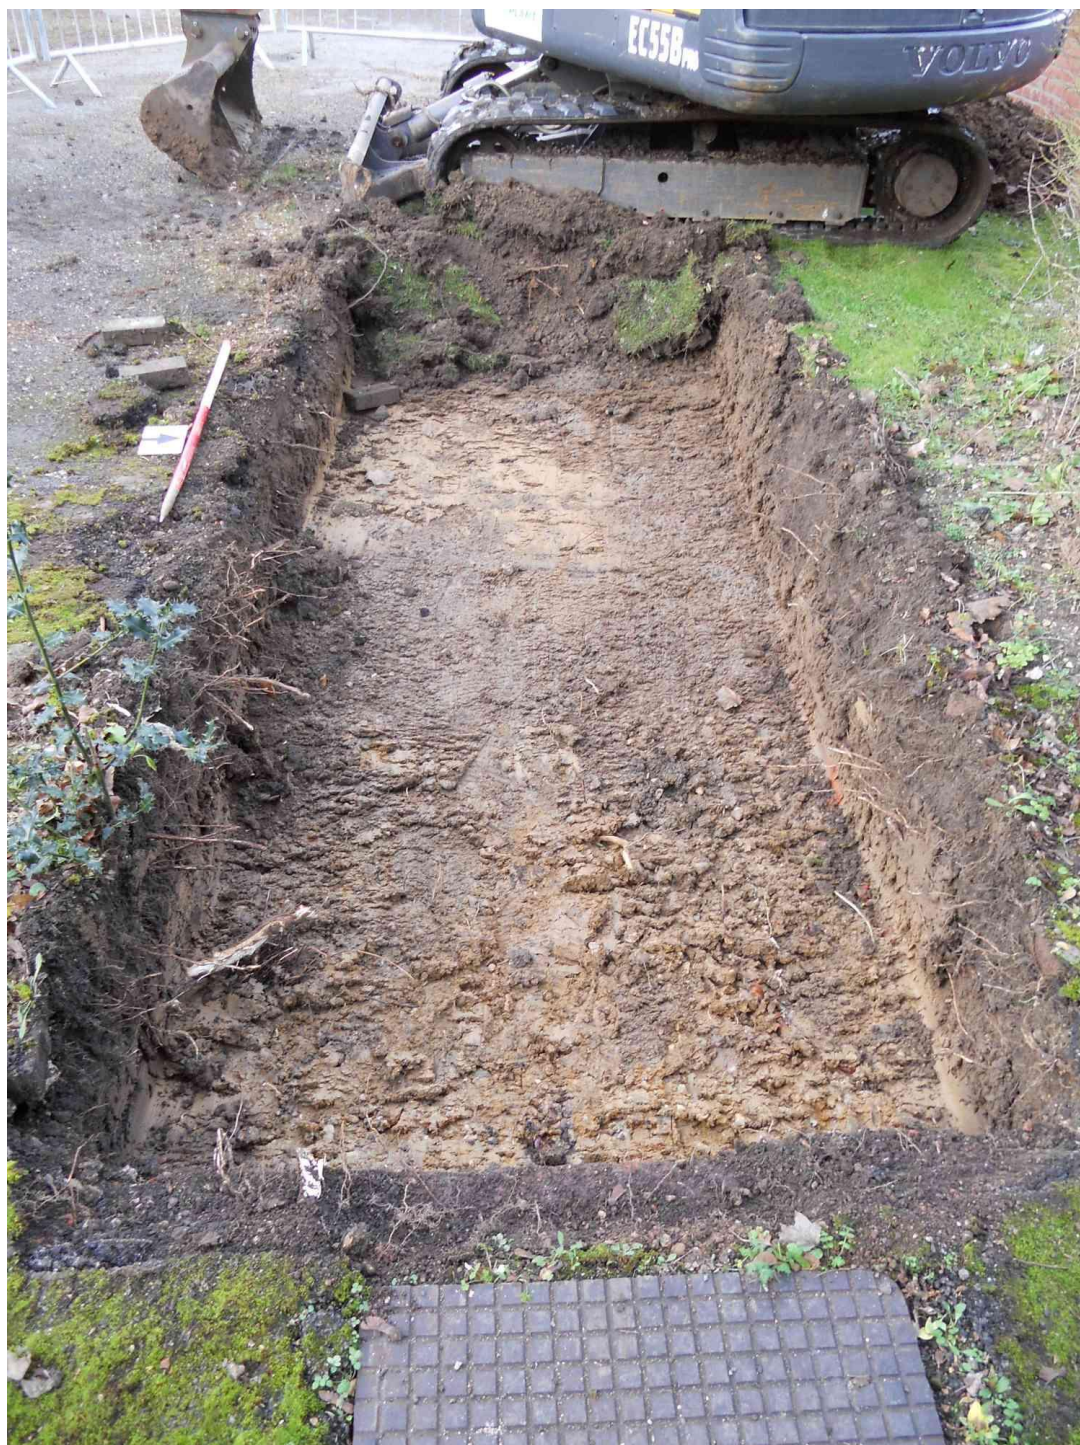
Figure 6. Slot 1

Slot 1 measured 1.55m wide by 4m long and was located in the front western corner of the driveway adjacent to a manhole cover. After removal of approximately 0.45m of mixed topsoil and subsoil a disturbed area of dirty yellow brown sandy clay and disturbed yellow brown clay was seen extending for 2.3m west of the manhole cover. Hand excavation showed this to be the backfilled trench for the existing north to south service pipes supplying the house. Beyond this cut, to the west, was a small triangle of

undisturbed natural yellow-brown clay substratum (Fig. 6). A further area of disturbance cut across the north-western corner of the trench. The fill of this disturbed area contained pieces of plastic sheet and was therefore relatively modern. Partial excavation of this area indicated that it continued downwards for at least 0.2m. No archaeological features or deposits were observed within this slot.

Looking west. 1m scale.

The small area of natural substratum can be seen immediately in front of the north arrow

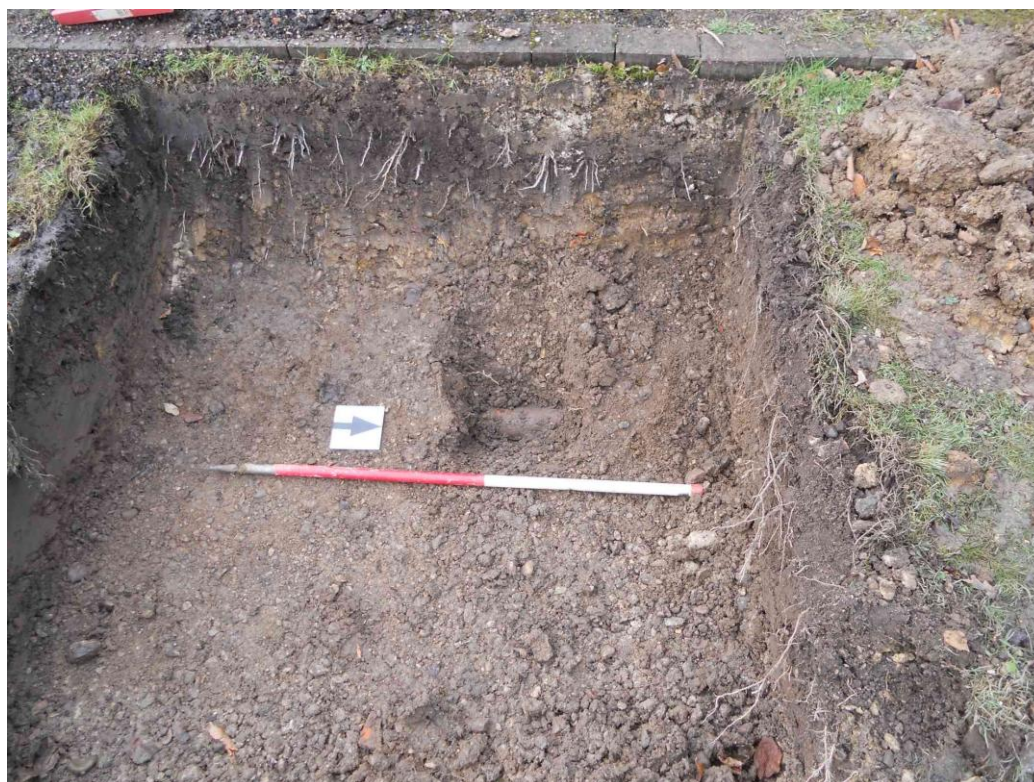
Figure 7. Slot 4

A final test slot was placed approximately 2.6m to the south of Slot 2. A thin layer (0.08m) of tarmac covered 0.41m of disturbed dark grey brown silty clay. Removal of this layer exposed a layer of stone mill-waste with a ceramic land drain running from north to south along the western edge of the excavation (Fig. 7). No archaeological features or deposits were observed within this slot.

Looking west. Land drain partially exposed above 1m scale

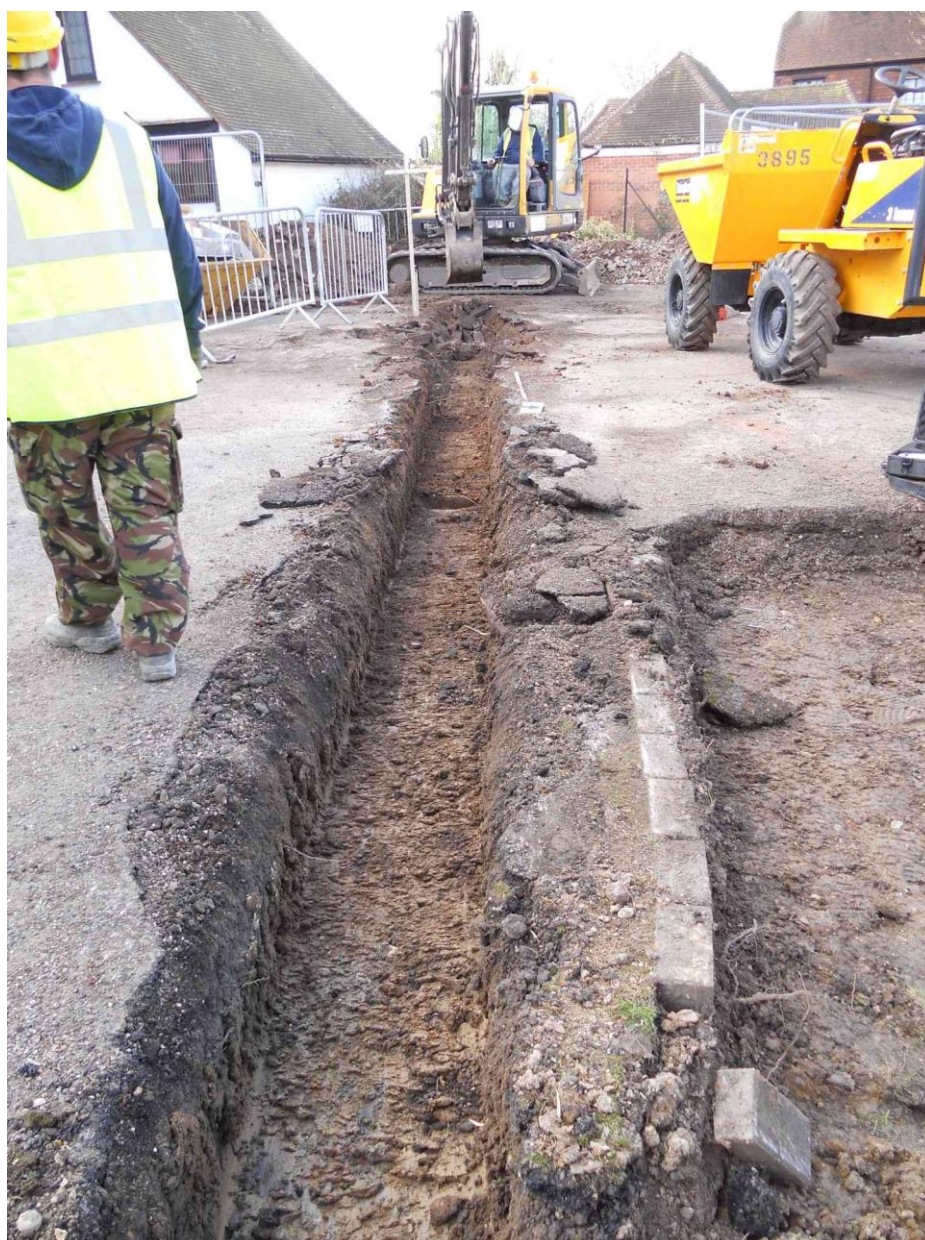
A 0.5m wide service trench was excavated from the manhole adjacent to Slot 1 south-westwards towards the west corner of the house. An average thickness of 0.03m of tarmac was removed to expose a 0.1m thick bedding layer of sandy gravel and ash which was laid on a disturbed grey brown clay silt layer. The silty clay layer varied in thickness from 0.28m to 0.31m (Fig. 8 and cover photograph). At the base of this layer the natural substrate could be seen except where the large conifer tree roots had caused some disturbance. No archaeological features or deposits were observed within this slot.

Figure 8. Service Trench  
Looking south-west. 1m scale
