**An Archaeological Watching Brief at
1/3 Vicarage Lane, Belton
Leicestershire.
NGR: SK 44767 20763**

ULAS Report No. 2012-010
©2012

For: Mr and Mrs Weldon

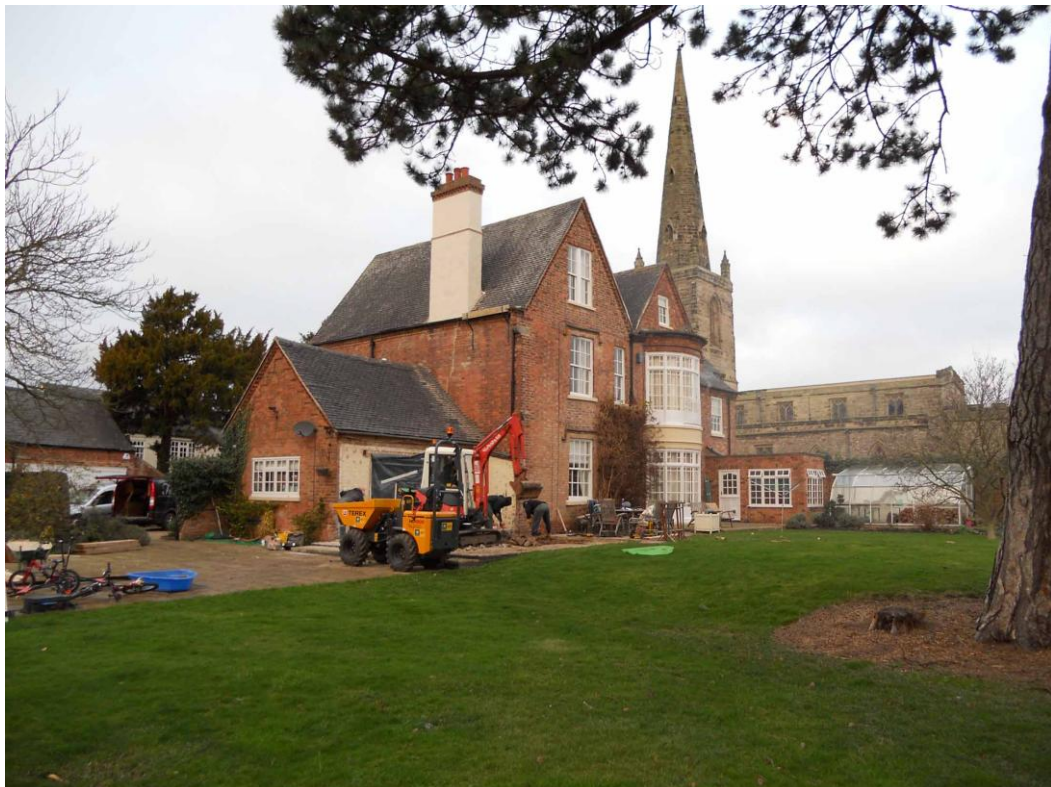
Figure 3. Development site looking north-west

The new orangery is to be constructed into the south-eastern corner created by the main body of the vicarage and a slightly later, 19th century, single-storey extension built onto the south wall of the house (Fig. 3). Although it had been demolished just prior to the watching brief the remains of the conservatory appeared to date for the mid 1970s at the earliest. This had been constructed on a small concrete plinth around which the ground needed to be reduced and new foundations excavated.

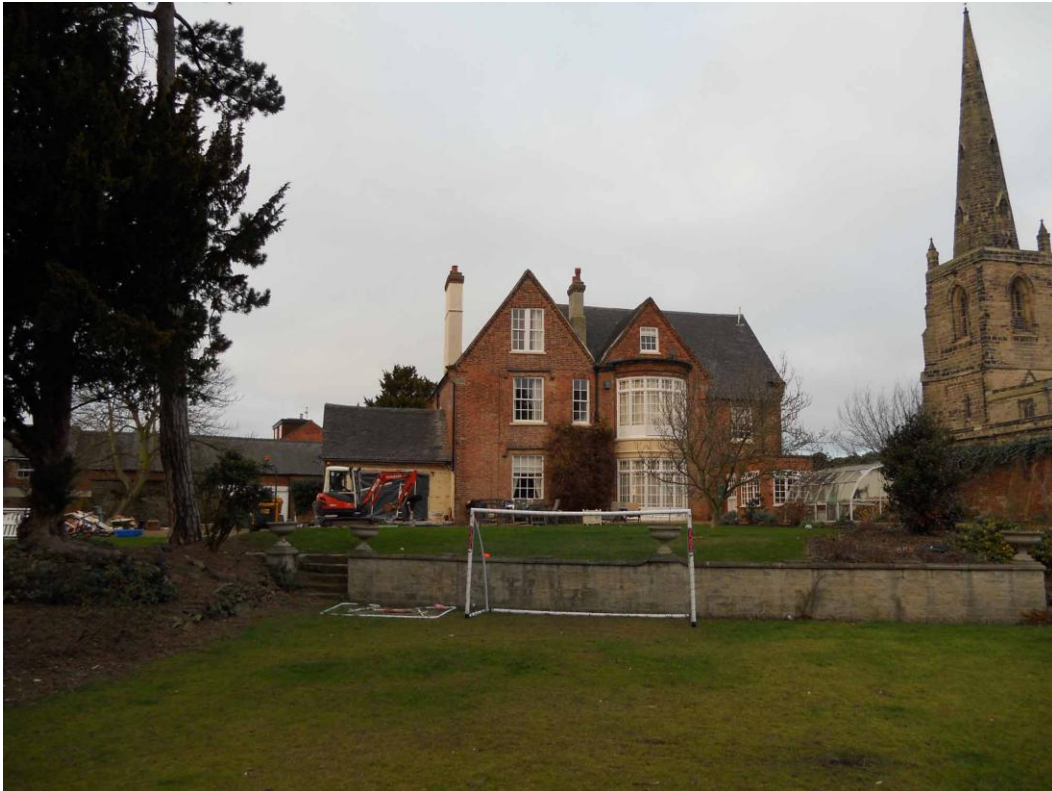
Figure 4. View of the vicarage and landscaped garden
Looking west.

The 1884 first edition Ordnance Survey map of the site shows it much as it remains today but without the conservatory which has recently been demolished. None of the other successive maps up to the 1962 edition show any changes or other development around the site. The rear garden drops down towards the east and south-east of the vicarage and has been partially landscaped to create a retaining wall and a level terrace presently used as a small football pitch (Fig. 4).

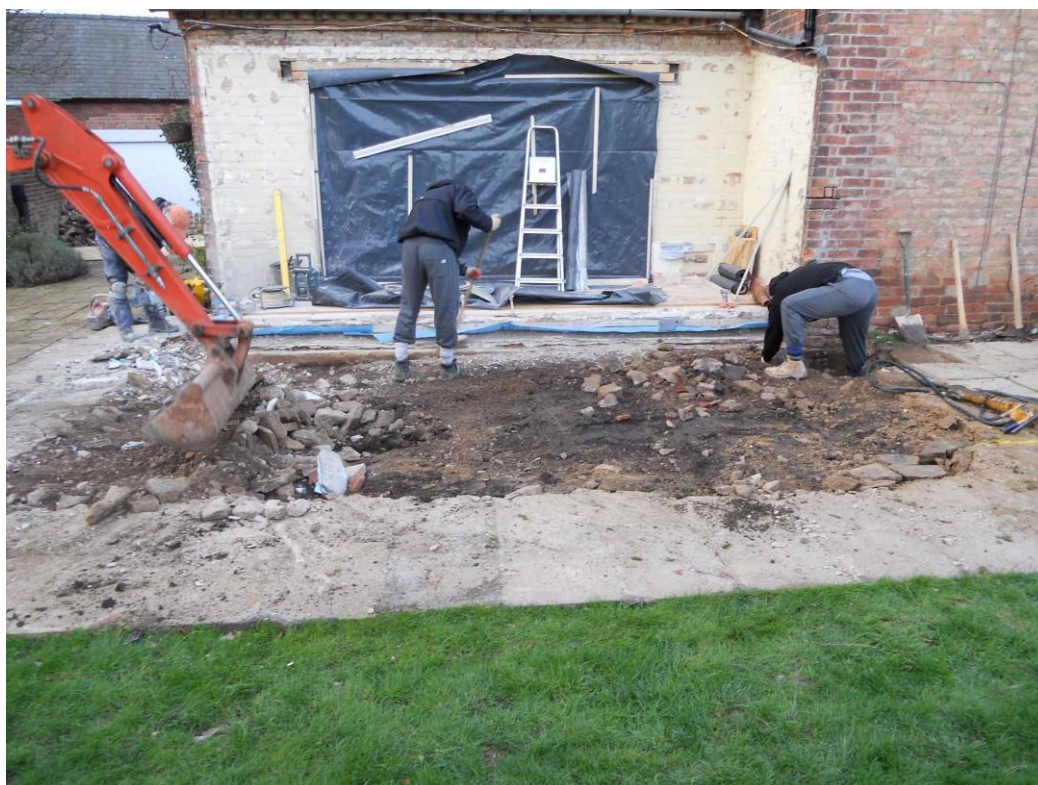
Figure 5. Ground reduction within footprint of new orangery
Looking west

Slabs and a concrete and rubble bedding layer were removed around the base of the old conservatory to reveal a very mixed and disturbed dark reddish brown silty-clay layer. This was further reduced to approximately 300mm below its original depth to expose more dark brown silty clay which had the appearance of redeposited subsoil (Fig. 5).

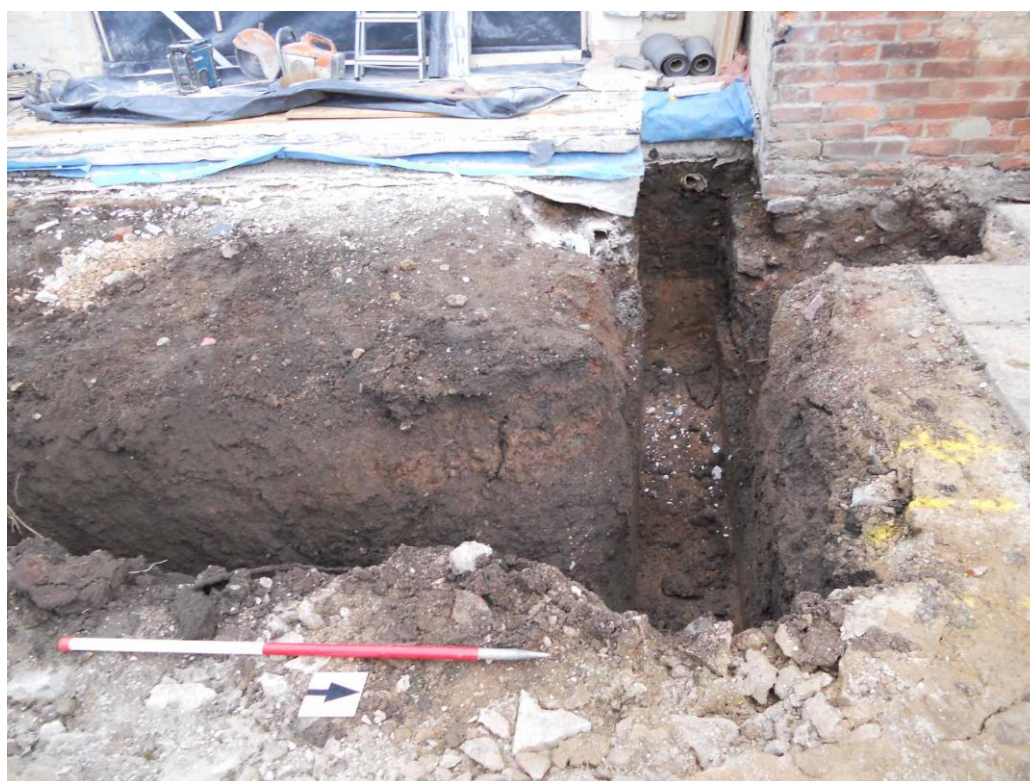
Figure 6. North arm of foundation trench
Looking west. 1m scale

A trench was excavated in an elongated U-shape and measured 0.6m in width and 1m in depth. The two east to west arms of the foundation trench cut through approximately 0.5m of fairly disturbed dark reddish brown silty-clay before reaching the natural substratum which consisted of a mid reddish brown clay (Fig. 6). The natural substratum became slightly lighter in hue towards the base of the trench. Along the front, north to south arm, of the trench the natural substratum was encountered at approximately 0.7m below current ground level (Fig.7). In the north-west corner of the foundation the disturbed ground and natural were badly waterlogged due to a leaking rainwater gutter which appeared to have been damaged during the construction of the old conservatory. This has also caused some damage to the corner of the house which has very shallow foundations. No archaeological features or deposits however were observed within the trench.

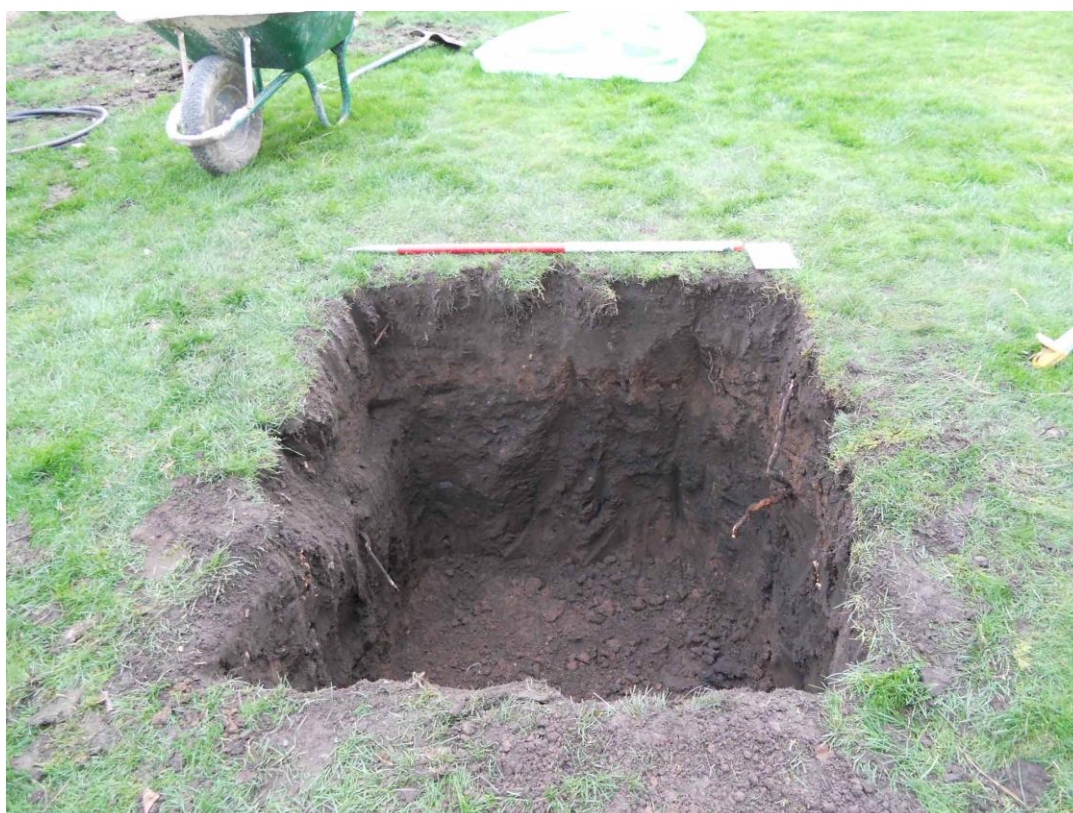
Figure 8. Soakaway, south facing section
Looking north. 1m scale

In addition to the foundations a 1.2m² soakaway was excavation 5m from the south-eastern corner of the trench. This was excavated to a depth of 1.3m through 0.5m of redeposited topsoil with some natural clay onto the original topsoil, subsoil and undisturbed natural at 0.9m below present ground level (Fig. 8). No archaeological features or deposits were observed during the excavation of the soakaway.

The soakaway has an upper fill of redeposited layer of topsoil and some natural clay which is probably the result of the landscaping episode when the retaining wall and level terrace were created.
