**An Archaeological Watching Brief at,  
Hall Farm, Swepstone Road,  
Heather,  
Leicestershire.  
NGR: SK 3788 1027**

ULAS Report No. 2011-186  
©2011

**For: Green Generation**

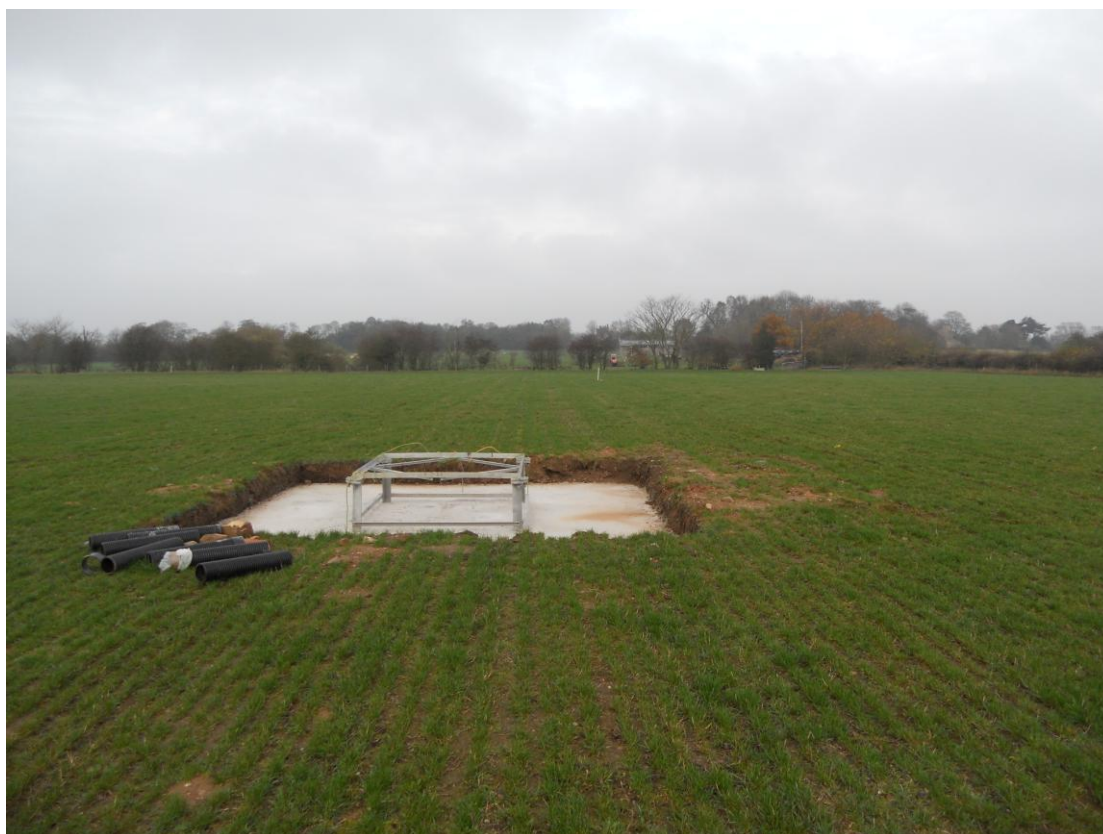
Figure 4. Turbine base

Looking north. Cable trench passes through hedge towards barn in distance

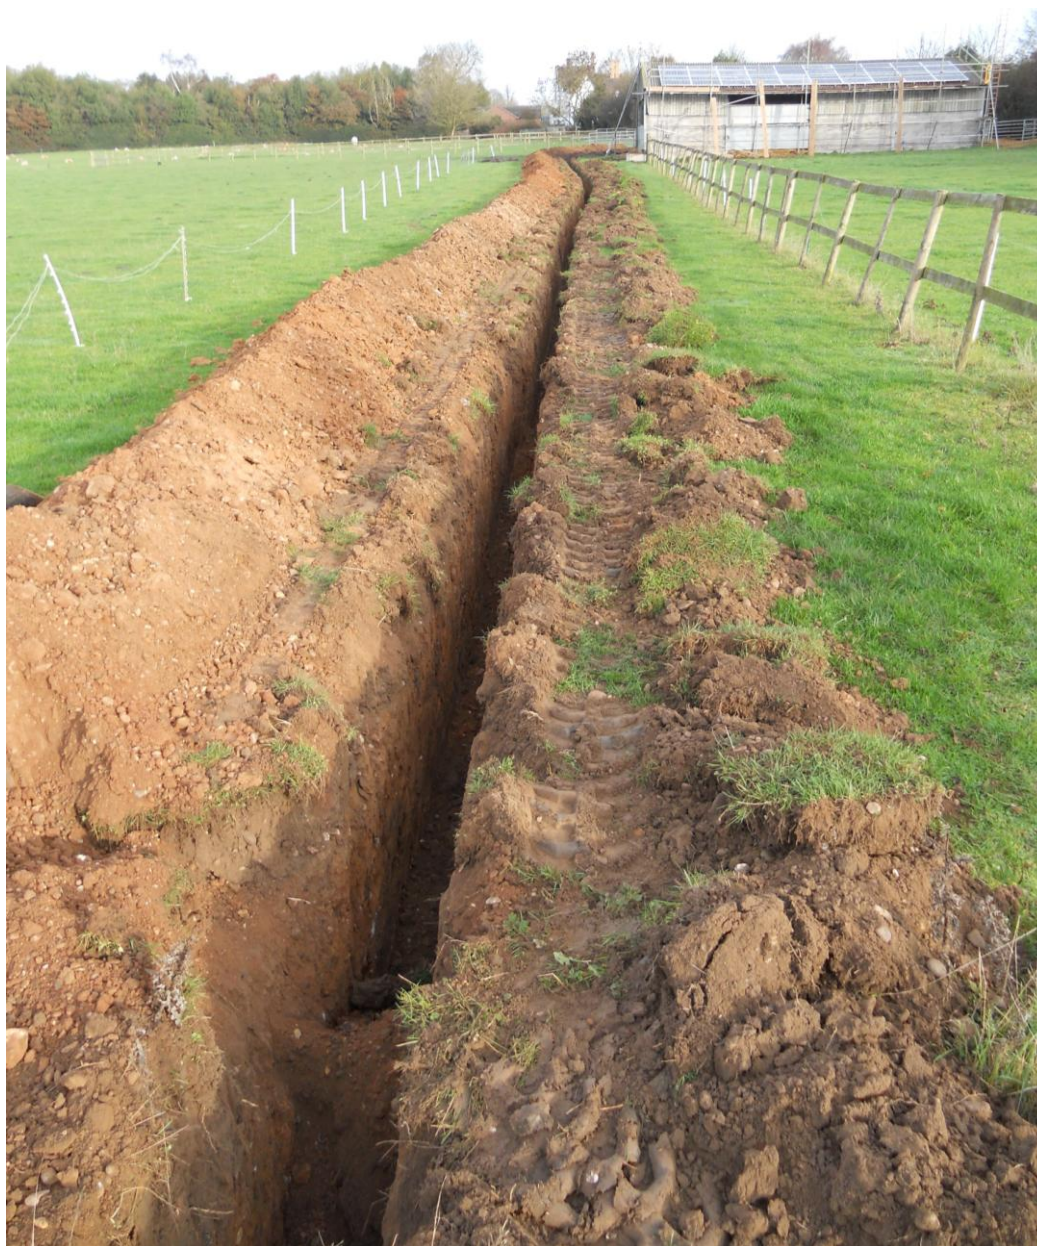
Figure 5. Northern half of Field 1  
Looking north towards farm complex

A layer of mid brown sandy silt topsoil with an average depth of around 0.18m was removed in spits down to a mid brown silty sand subsoil which had an average depth of around 0.15m (Figs. 5 and 6). Beneath this was the natural substratum consisting of a mid orange brown silty sand with frequent sub-rounded stones and flint fragments. The natural was quite dry and very hard along much of the trench length. Where the trench passed to the west of the barns, in the north-east corner of the field, the distinction between the topsoil and subsoil became rather indistinct (Fig.7). This disturbance was probably due to animal and vehicle activity around the barns. Both excavated faces of the trench were closely inspected along their full length and hand cleaned where necessary but no features or deposits were observed. No artefacts were recovered from the spoil heaps.

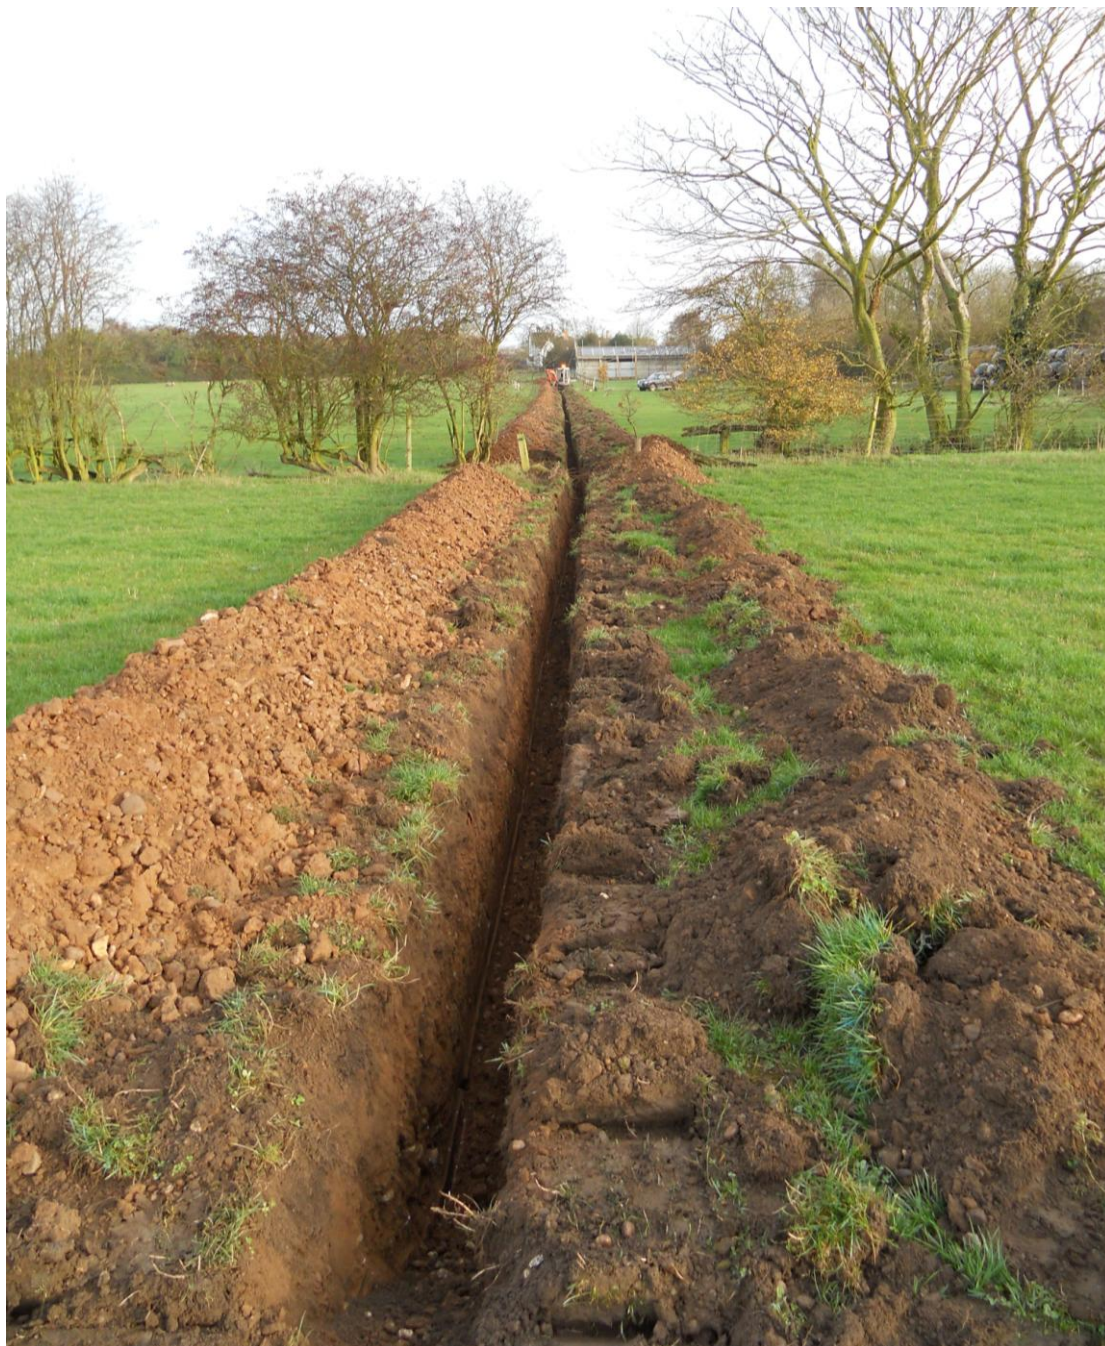
Figure 8. Field 2 looking north towards Field 1

The same topsoil and subsoil were noted in this field as in Field 1 although the topsoil appeared to be slightly thinner with an average depth of around 0.12m. This may be due to the fact that this field was ploughed in 2010 before being re-seeded with grass whereas Field 1 has been under grass for about 20 years. The same hard dry natural substratum was also observed. The area around the north-east to south-west hedgeline was very disturbed with hedge roots and a small water pipe but no archaeological features or deposits were observed in this southern section of trench (Fig. 8). No artefacts were recovered from the spoil heaps.
