**A photographic survey of St.
Bartholomew's Church,
Measham Road, Snarestone,
Leicestershire
NGR: SK 3413 0944**

ULAS Report No 2012-057.
©2012

An English Heritage Level 2 photographic survey was carried out on the 20th of February 2012 by ULAS for Pick Everard, in advance of the demolition of a small, 19th century, lean-to brick store attached to St. Bartholomew's Church, Measham Road, Snarestone, Leicestershire SK 3413 0944. The archive will be deposited with LMARS under the accession number X. A42.2012.

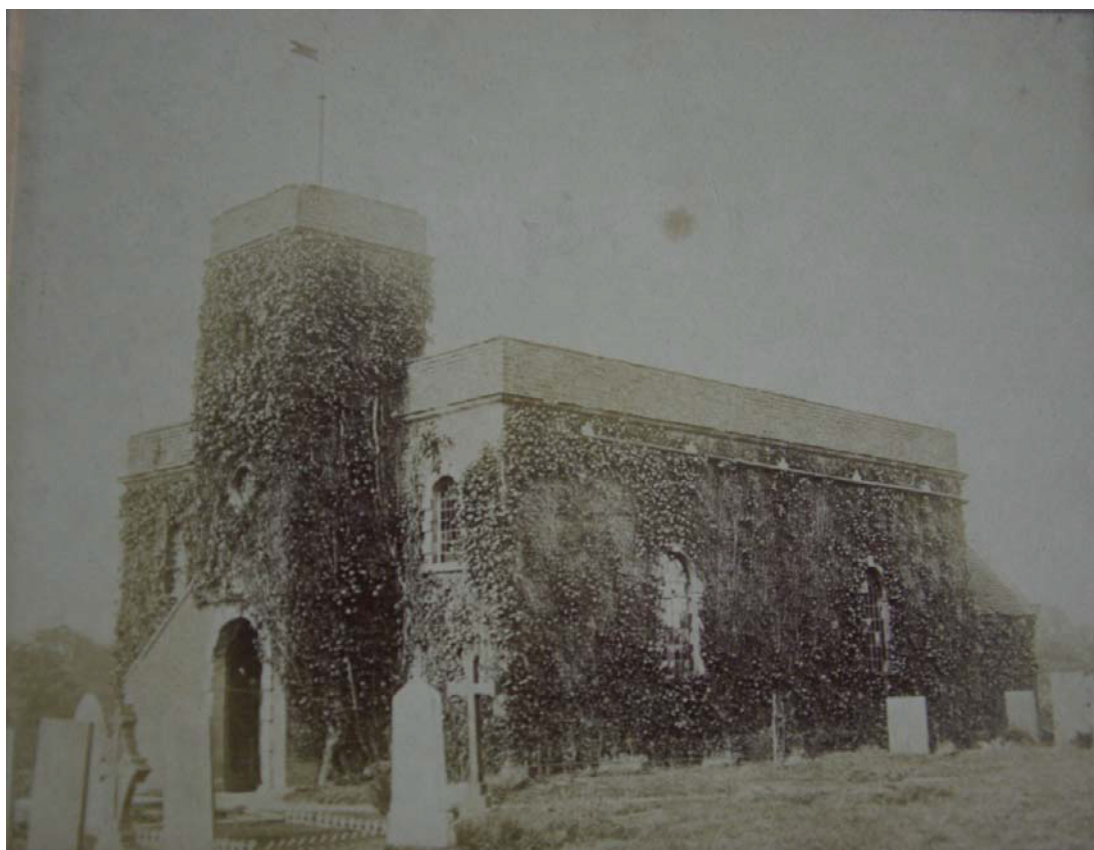
An early photograph of St. Bartholomew's found in the vestry shows the church prior to the extension of the nave (fig. 3): the existence of this photograph suggests that the 1834 date for the 'ungainly' extension, as described by Pevsner (2003, 381) is rather too early. The photograph itself probably dates to *c.* 1850-1860: this appears to show the lean-to building in its present form, with the nave likely to have been extended shortly after the photograph was taken.

Figure 3. 19th century photograph of St. Bartholomew's Church, looking north-east, with lean-to structure apparent on northern side of tower.

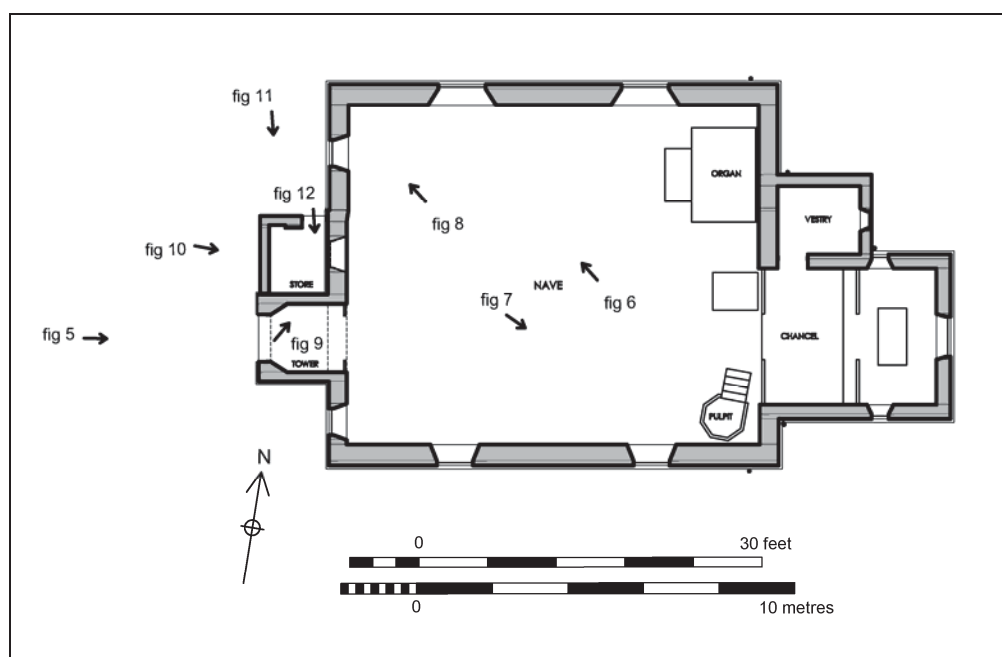
Figure 4. Floor plan of St. Bartholomew's Church, with photographic locations added. Derived from plan supplied by Pick Everard.

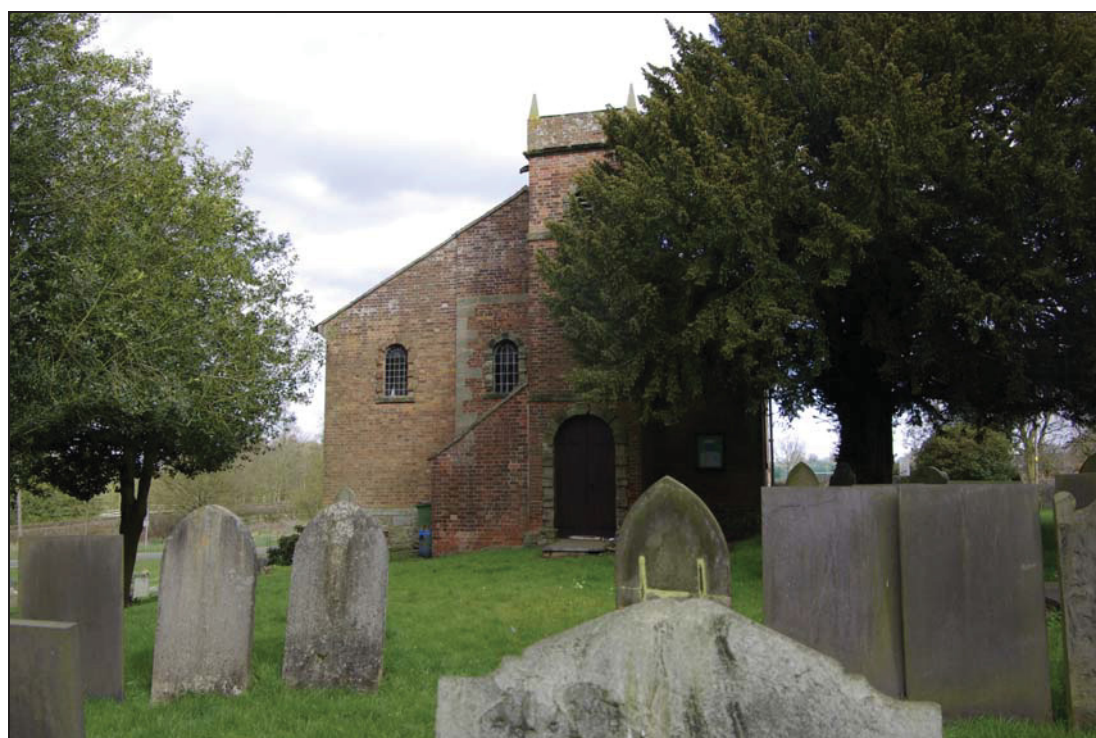
Figure 5. St. Bartholomew's Church, with lean-to on left-hand side of tower. Looking east.

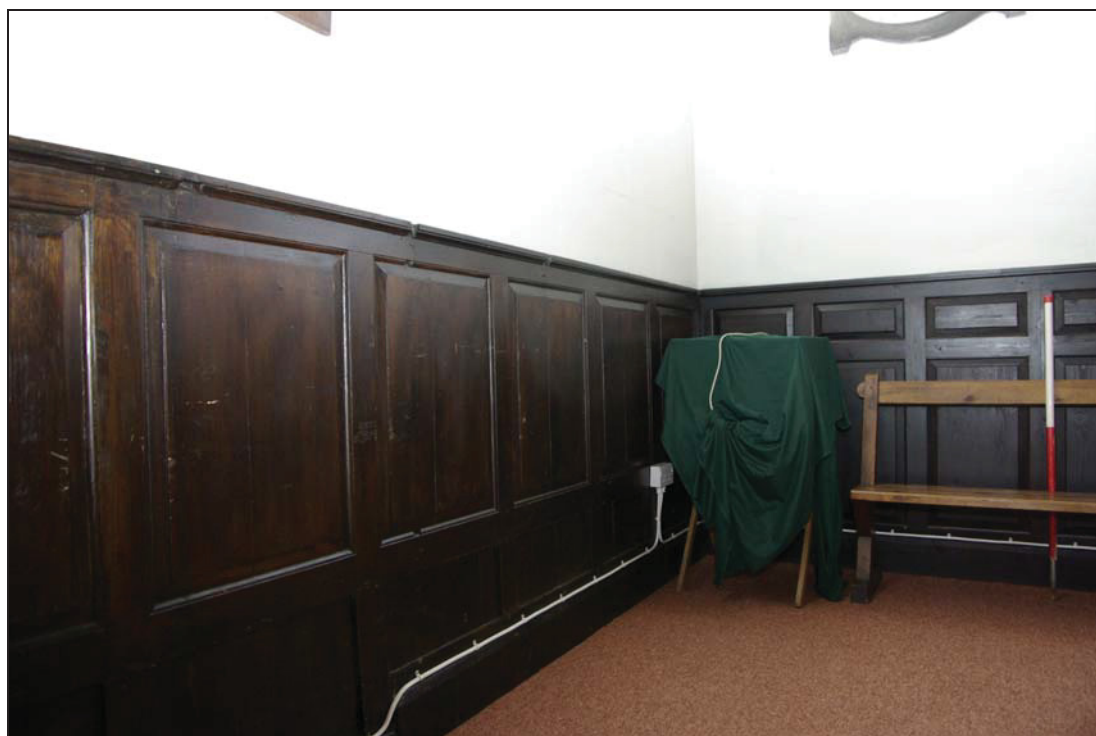
Figure 8. North-west corner of church, with original Georgian wainscoting on left-hand side meeting later Victorian wainscoting lining the northern wall of the nave. Looking north-west.

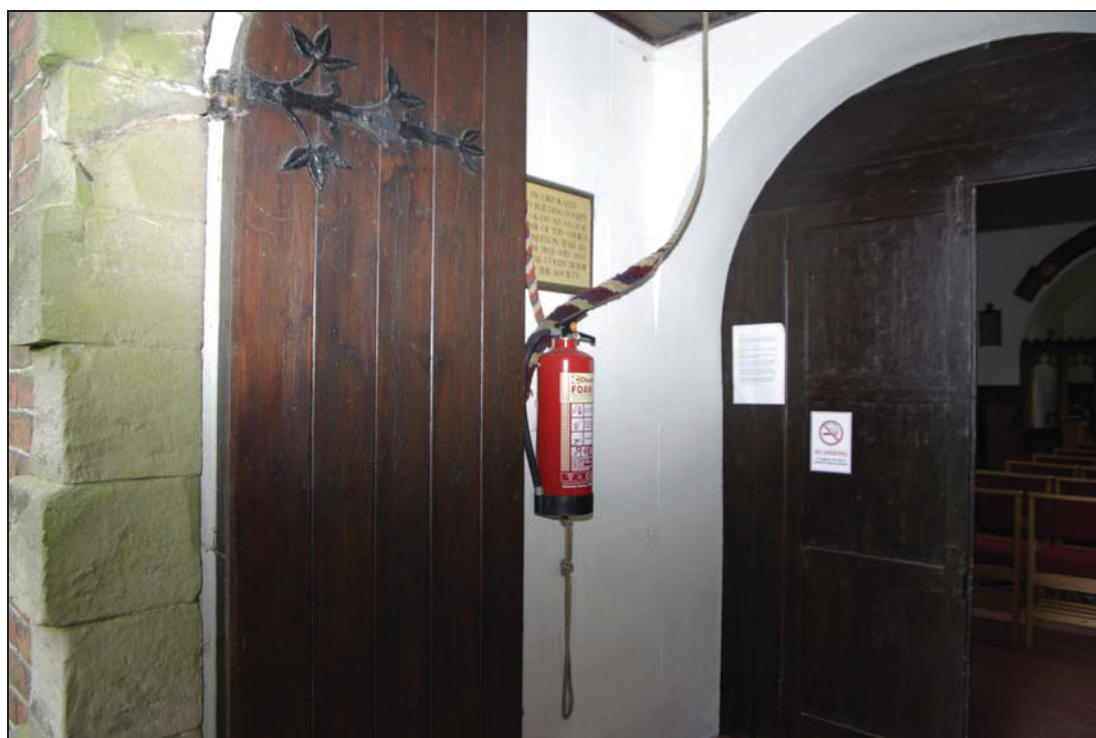
Figure 9. Porch entrance at base of tower: site of proposed doorway into new extension. Looking north-east.

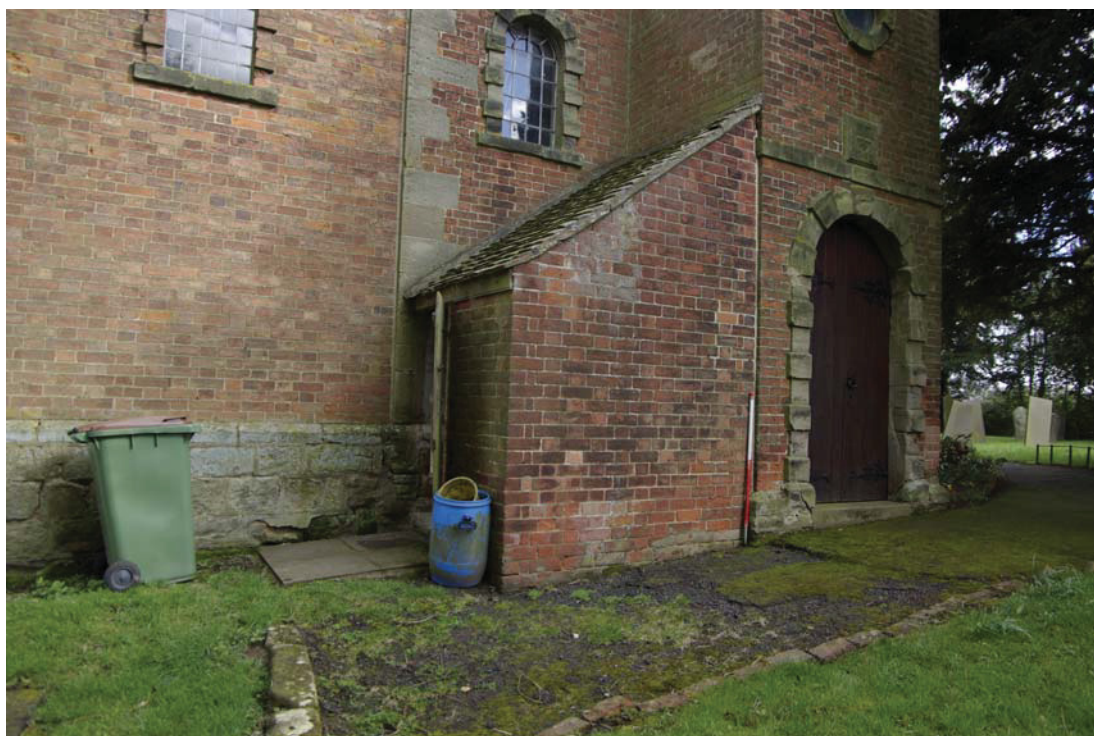
The lean-to structure comprises a stretch of wall, with a single return, constructed of red brick laid in Flemish bond pattern, with queen closers at the return. The roof is tiled.

Figure 10. External 19th century store, proposed for demolition. Looking south-east.

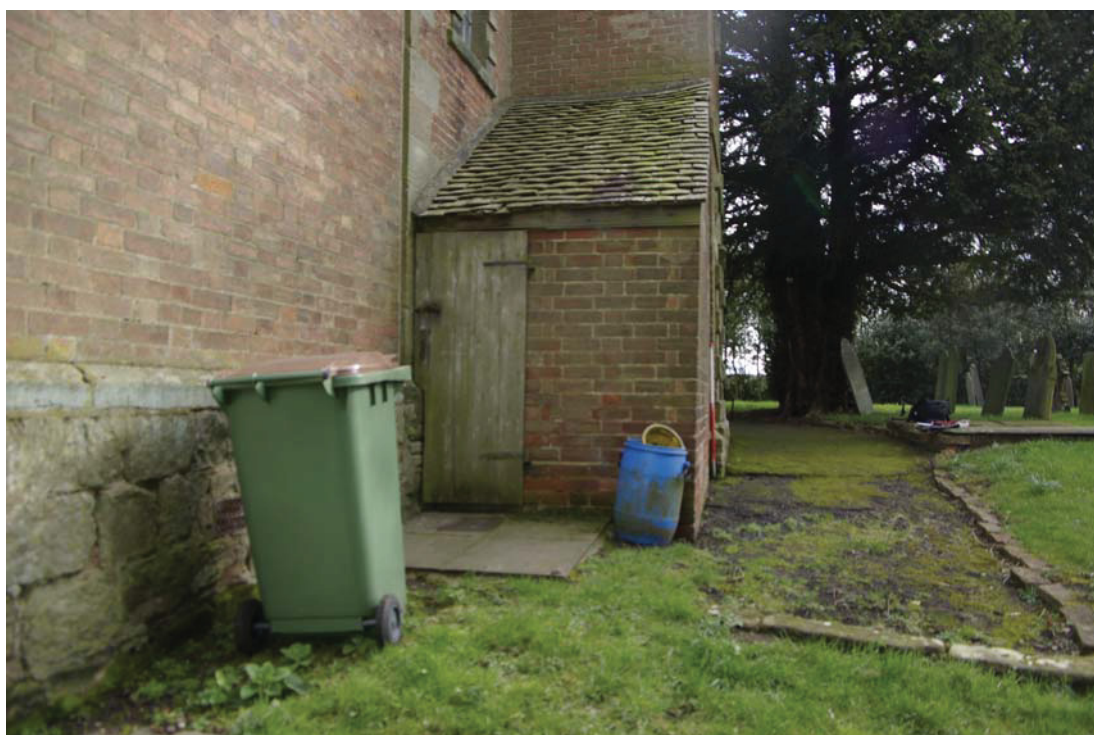
Figure 11. As above, looking south.

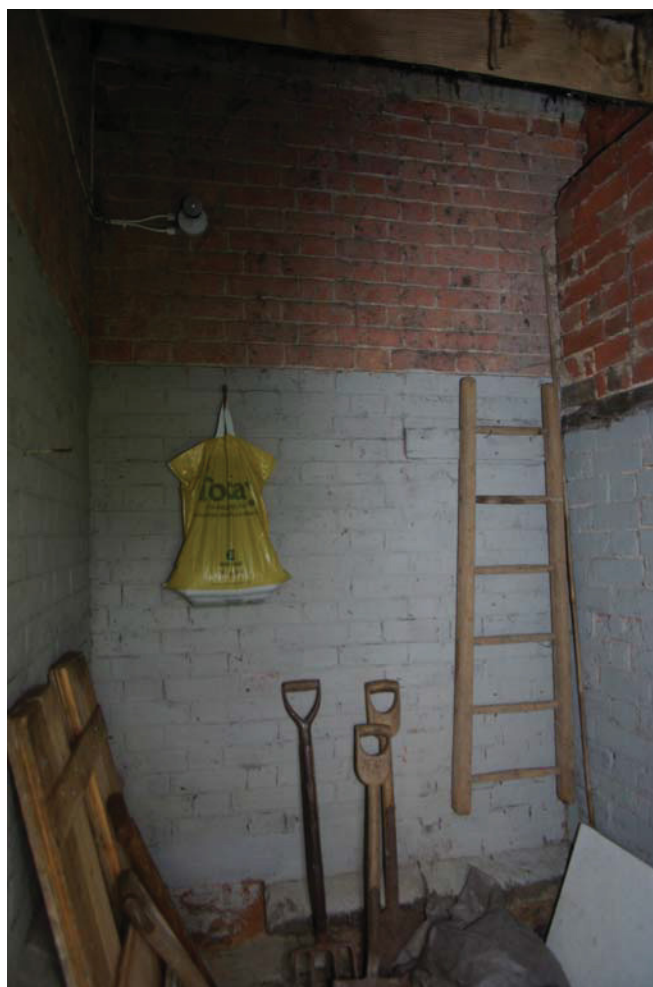
Figure 12. Interior of store, looking south onto north-facing wall of tower, site of proposed entrance to new extension.
