An Archaeological watching Brief at
31 Swan Street,
Seagrave,
Leicestershire.

ULAS Report No. 2012-053
©2012

An Archaeological Watching Brief at 31 Swan Street, Seagrave, Leicestershire. NGR SK 6185 1750

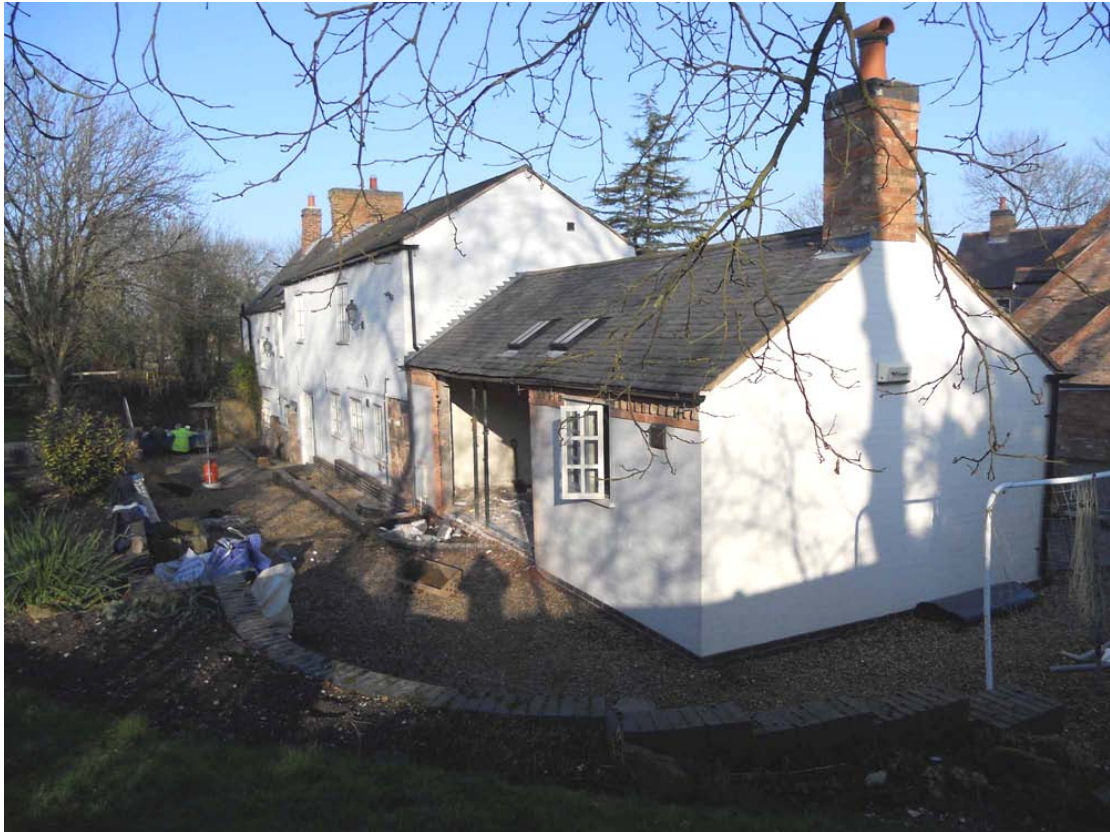
Figure 3. Development area and existing kitchen extension.
Retaining wall in foreground. Looking south-east

narrow plot facing onto Swan Street which forms a small hollow way at this point and extends southwards from a height of *c.* 70m OD at street level up to approximately 74m in the south-west corner of the site (Figs. 2 and 3). A strip along the western and southern sides of the house has been landscaped by cutting into the rising ground to create a level terrace. The Ordnance Survey Geological Survey of Great Britain indicates that the underlying geology is likely to consist of Oadby Member Till and mudstone.

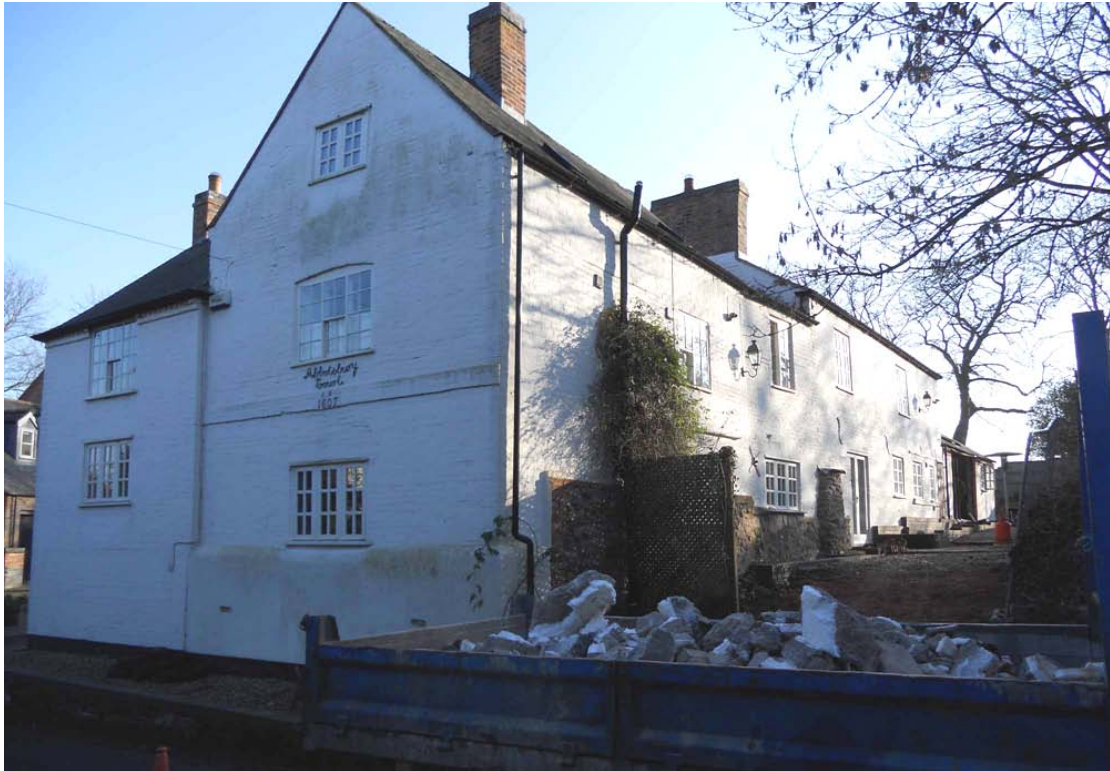
Figure 4. 31 Swan Street.
Looking south-east

The house has the name Abbotsbury House attached to the gable end facing onto Swan Street (Fig. 4). It also has the date 1607 on this face although these numbers are also attached to the brickwork rather than built into the wall. The building has a number of clear phases and the ridgeline steps up as it follows the rise in ground level. It is Grade II listed (listing reference 405458) and is described as:

House. C18, possibly with early C17 origins. Whitewashed brick with high granite rubble stone plinth, band in part, brick nogged eaves in part, and Swithland and Welsh slate roof with brick ridge and left end projecting stacks. Gable to right. 2½ storeys of 2 3-light horizontal sliding sash windows with top lights. 2-light in gable attic. 2 3-light casements on ground floor. Entrance to rear in wing. Dated A.D. 1607 in later figures on band. Chamfered beams, inglenook and tie beam truss are visible inside. Formerly the White Swan Inn.

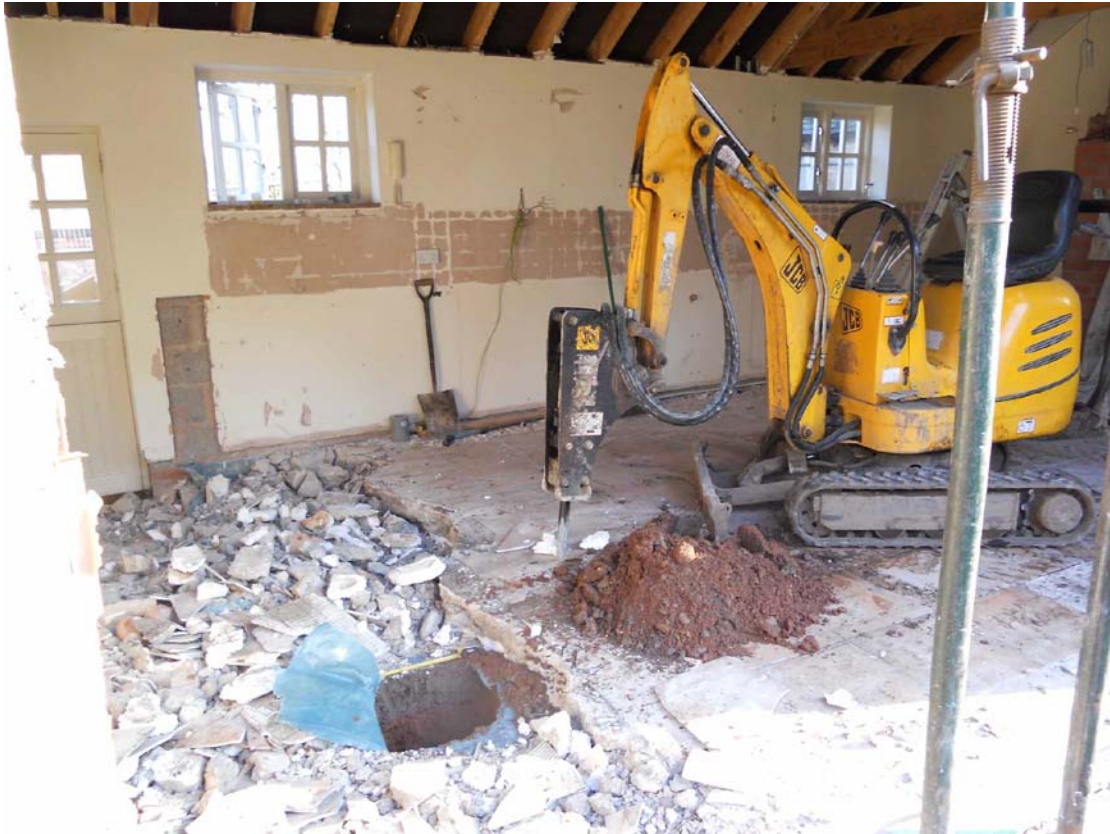
The site was first visited on the 30th of January 2012 to inspect the results of the soft strip of the existing kitchen extension. On arrival all of the internal fittings had been removed along with doors, windows, roof linings and part of the floor. The remaining concrete floor was in the process of being removed using a pneumatic drill attached to the front actor of a mechanical excavator (Fig. 6).

Figure 6. Modern floor being removed after soft strip.
Looking south-east

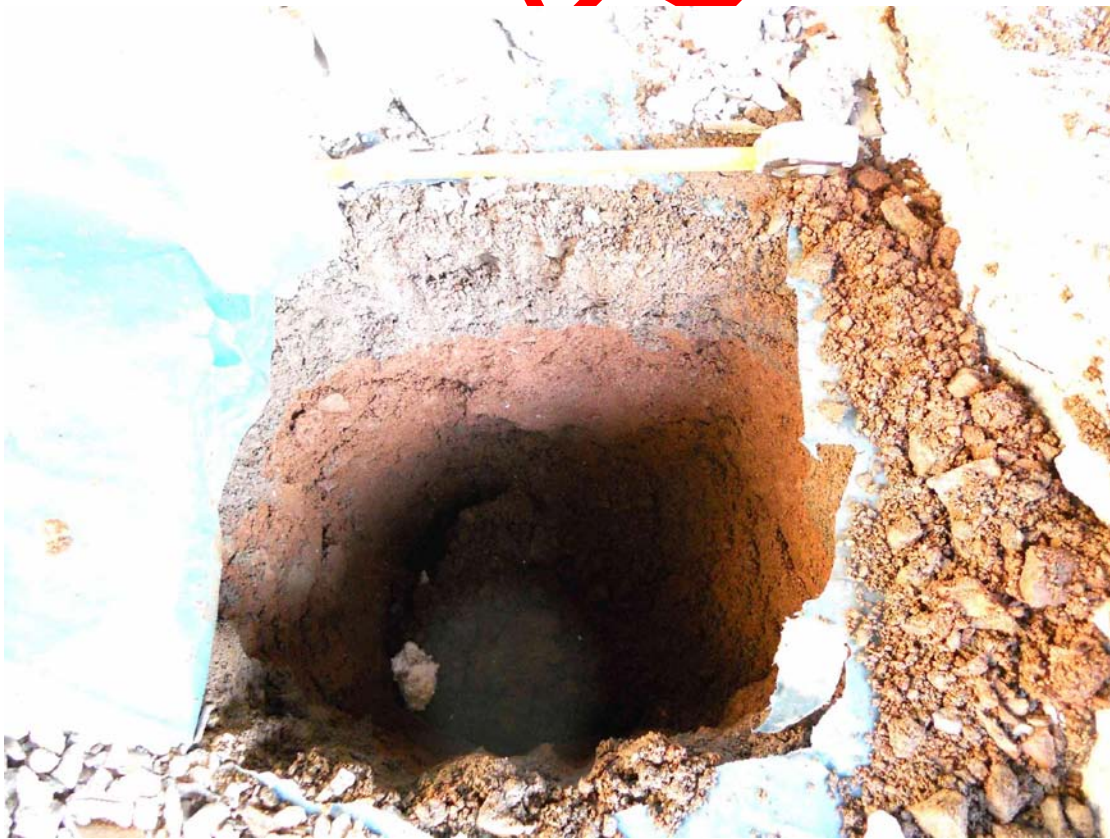
The existing concrete floor measured approximately 0.15m in depth and was laid on a layer of polystyrene foam. This in turn was laid on a 0.1m thick layer of dry mix type cement. A further 0.3m to 0.4m of compacted mill waste was laid beneath this onto the natural clay substratum (Fig. 7). Sample excavations were made in a small area of the floor before complete removal. The use of relatively modern building materials suggests a date for this part of the building was not much more than 30 years. No archaeological features were observed cutting into the natural substratum beneath the removed modern floor.

Figure 7. Sample excavation to assess depth of floor.

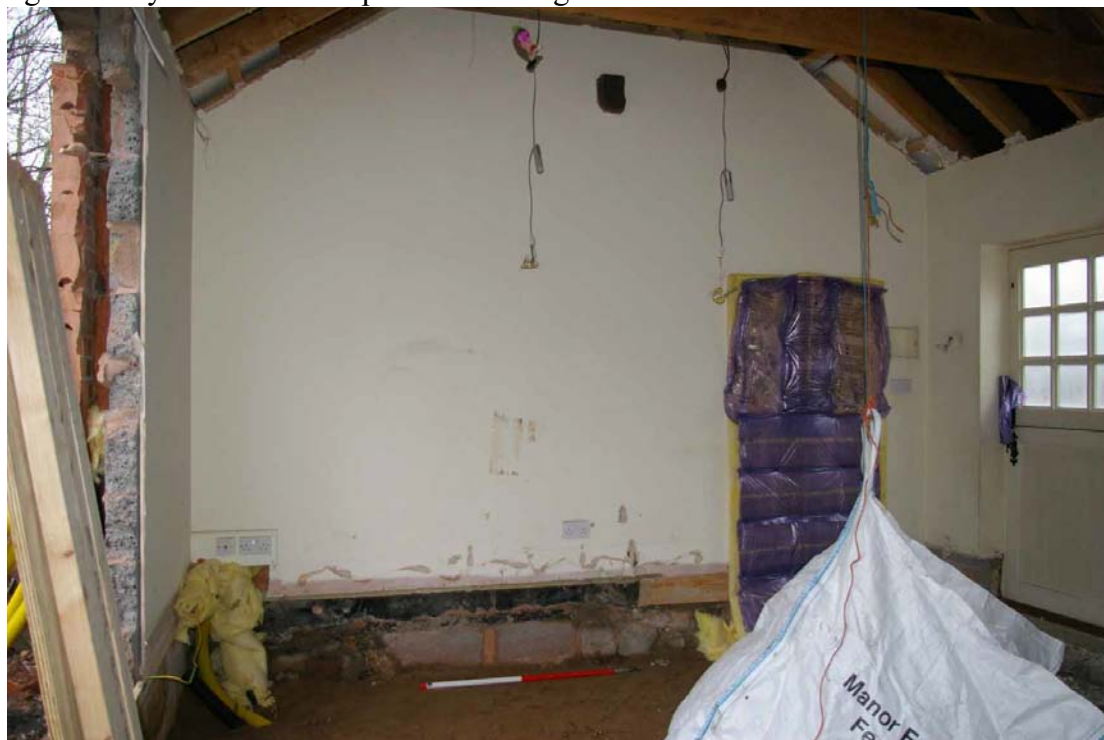
After the floor had been removed it was possible to inspect the foundation of the south gable wall of the main house. Below the plaster line, at skirting height, was a course of unworked limestone blocks and large smooth boulders similar to those already visible in places along the western wall of the house. In the centre of the wall was a 0.95m wide gap indicating a blocked, with breeze blocks, doorway leading from the house into an earlier outbuilding (Fig. 8). A modern doorway pierces the gable on the eastern side. Approximately 3m above ground level in the centre of the gable was a rectangular wooden beam projecting approximately 0.1m out from the wall. This may be the stub of a ridge belonging to an earlier building predating the modern kitchen. If this is so the height is such to suggest that the earlier walls were significantly lower than the present building.

Figure 8. Blocked doorway
Note projecting beam in gable. Looking north. 1m scale

Within the existing kitchen area there is clear evidence that there was a doorway in the centre of the gable end which led into an earlier building. The use of breeze blocks to block this doorway suggests that this blocking happened relatively recently and may have been at the same time as the new kitchen. There is also the indication from the projecting stub of timber that the roof height and walls of the older building were much lower than the present one. No evidence was seen during the site strip outside the building for any earlier buildings which might suggest that the kitchen was built over the earlier footprint. Map evidence also supports this idea.

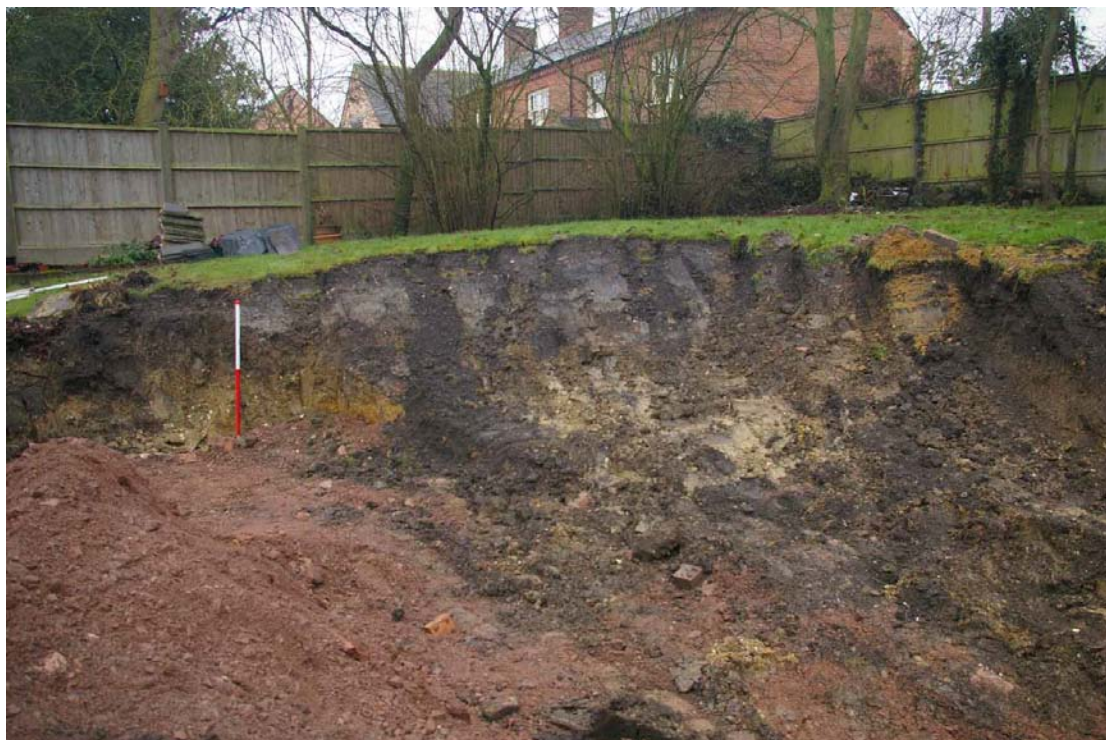
The second site visit, on the 13th of February, was to observe the groundwork preparations for the proposed extension. Before the start of the extension work the garden, to the west of the house, consisted of a narrow terrace at house level which had been cut into the natural ground slope rising to the west and south-west (see Fig. 4). Removal of the brick retaining wall at the southern end and a timber wall to the north revealed that the original natural substratum layer was considerably higher than at present (Fig. 9). A thick layer of topsoil and disturbed subsoil up to 0.6m in depth had been deposited to create the sloping banked garden. The original terracing had cut into the natural greyish yellow silty clay with patches of orange yellow clayish sand by between 0.4m and 0.6m. The undisturbed, truncated, natural clay extended across the terrace towards the house. At the junction where the proposed extension met the existing buildings no evidence of earlier structures could be seen. No archaeological features or deposits were observed within the development area.

Figure 9. Terrace after removal of retaining wall.
Looking south-west. 1m scale

Despite the potential for archaeological features or deposits none were observed during the course of this watching brief. The key reason for this was the earlier truncation of the ground to create a terrace around the house.
