An Archaeological Evaluation at Manor Holt, Mountsorrel, Leicestershire NGR: SK 588 138

ULAS Report No. 2012-024 ©2012

For: William Davies Ltd

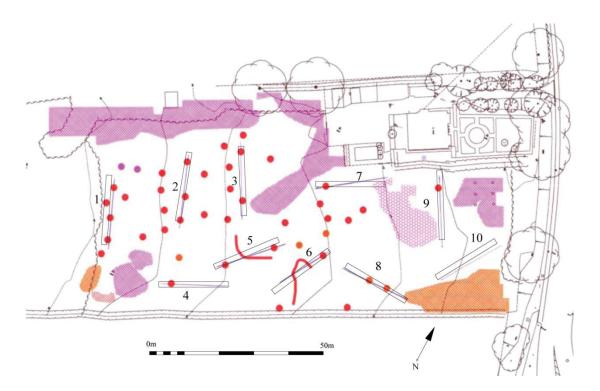
Figure 5. Trench locations Modified from Stratascan survey

Ten 20m long by 1.6m wide trenches were proposed and located to target a number of anomalies suggested by the geophysical survey (Fig. 5). Topsoil/modern overburden was removed in level spits, under continuous archaeological supervision, down to the uppermost archaeological deposits by a mechanical excavator fitted with a toothless ditching bucket. All spoil heaps were inspected for unstratified archaeological material. All trenches were excavated down to the top of archaeological deposits or the natural substratum in the absence of any archaeological deposits.

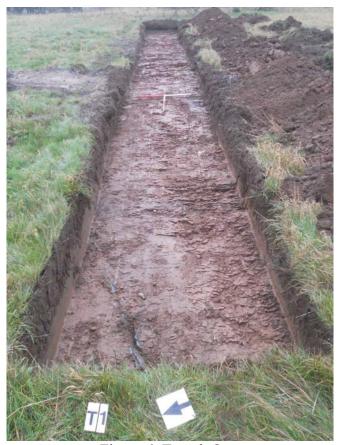
Figure 6. Trench One Looking south-west. 1m scales. Note slate drain in foreground

The topsoil consisted of a mid-reddish brown silty-clay with a lighter brown silty-clay subsoil below it. The subsoil had a slightly higher clay content than the topsoil and, with a maximum depth of only 50mm, formed more of an interface between topsoil and the natural substratum. The majority of the natural substratum consisted of clean mid- orangey red clay with occasional sub-rounded stones. There were however small patches of mid- brownish red slightly sandy-clay spread along the length of the trench. A 0.1m wide land drain made from a double row of pieces of local slate laid on edge cut partially into the natural ran from west to east across the north-western end of the trench (Fig. 6). A similarly constructed drain ran across the trench at right angles to it approximately three metres from the south-eastern end.

No archaeological features or deposits were seen in this trench.

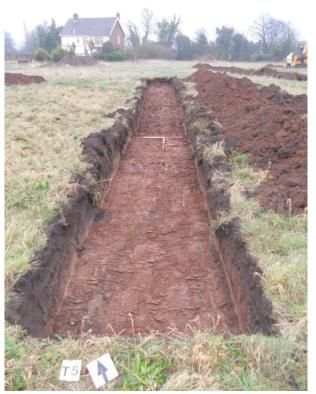
Figure 7. Trench 5 1m scales. Note cut for land drain in foreground

Trench 5 was located between Trenches 3 and 4 on a roughly north to south alignment and targeted a curvilinear anomaly identified in the geophysical survey as a possible cut feature. Once again the same description of topsoil and subsoil were encountered down to the natural substrata which consisted of sandy clay with a band of similar sandy clay but with many more stones running across the middle of the trench. The southern boundary of this interface between the two naturals was very sharp and may account for the geophysical anomaly (Fig. 7). A ceramic land drain ran from the south-western corner of the trench towards the north-east.

No archaeological features or deposits were located in this trench.

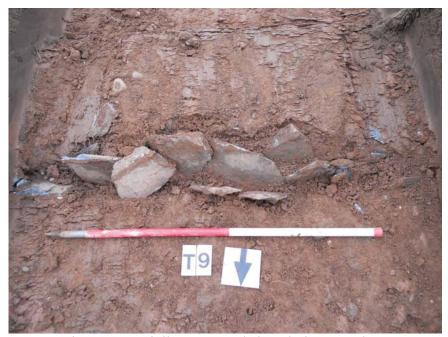
Figure 8. Partially excavated slate drain, Trench 9.

Trench 9 was located to the south-east of the house on a north-west to south-east alignment. A pitched slate drain was observed running across the trench cutting through the alternating bands of natural substrata (Fig. 8). A storm drain, or sewer pipe, ran from the direction of the house towards the eastern corner of the site.

No archaeological features or deposits were present in this trench.

Despite the potential for archaeological features on this site none was observed. The variable nature of the natural substrata seen across the site clearly explains the anomalies noted in the geophysical survey. The pitched slate drains running across the site indicate that the area has had some drainage problems due to the heavy clay substratum. The drains may have been laid possibly around the time of enclosure in the late 18th century. The ceramic land drains noted along the eastern boundary may be from a later episode of draining.
