**An Archaeological Evaluation at  
Parkland House, 73 Main Street, Smeeton Westerby, Leicestershire.**

ULAS Report No 2012-165  
©2012

*University of Leicester Archaeological Services (ULAS) carried out an archaeological evaluation by trial trenching on land at Parkland House, 73 Main Street, Smeeton Westerby, Leicestershire (SP 6787 9273). The work was undertaken as part of an archaeological impact assessment in advance of a proposed residential development.*

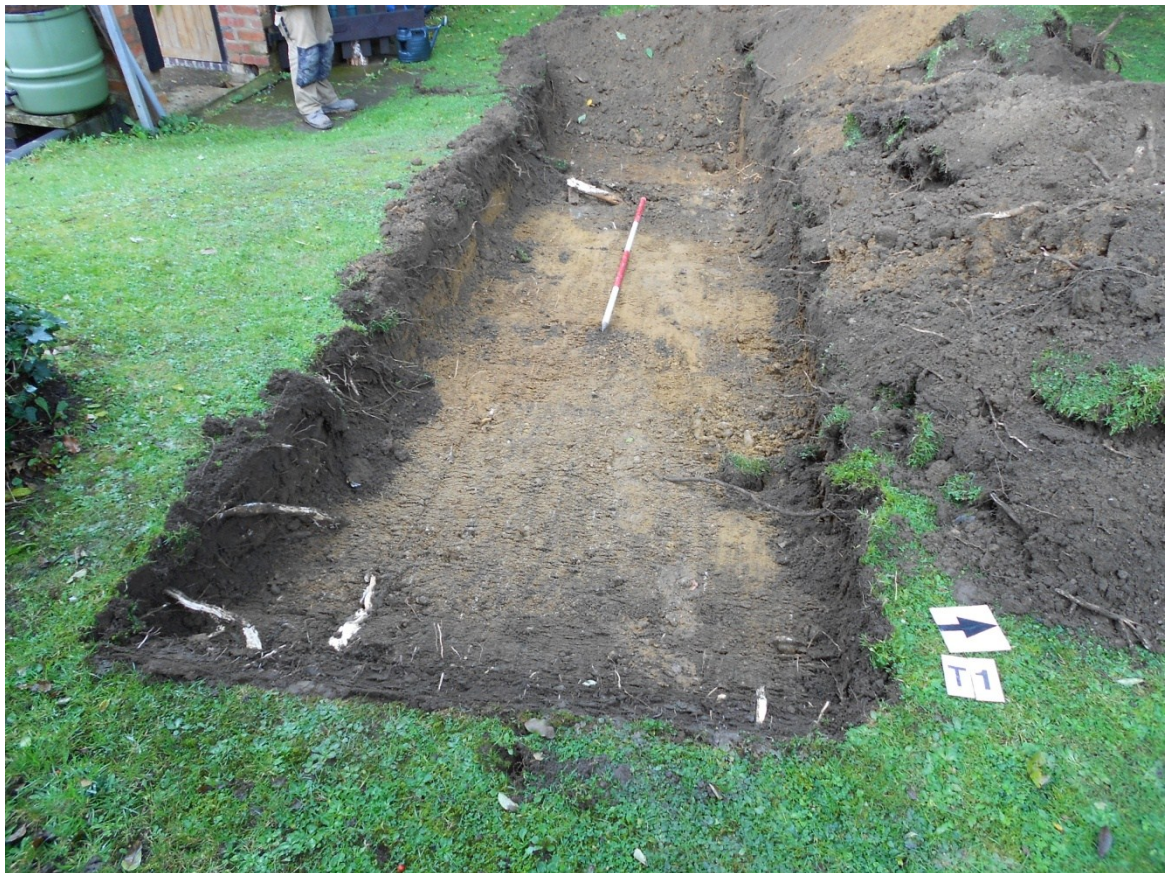
Figure 3: Trench 1, 2m scale

TRENCH	ORIENTATION	LENGTH AND WIDTH (metres)	DESCRIPTION	DEPTH (MIN-MAX metres)
1	E-W	7 x 1.8	Thin topsoil, straight to natural. Substantial root disturbance, slopes down from frontage, appears to be landscaped. No archaeological finds or features.	0.10 – 0.25
2	NE-SW	8 x 1.8	Thicker topsoil, modern (20th century) brick and demolition spreads (backfilled quarry?). No archaeological finds or features.	0.35- 0.48

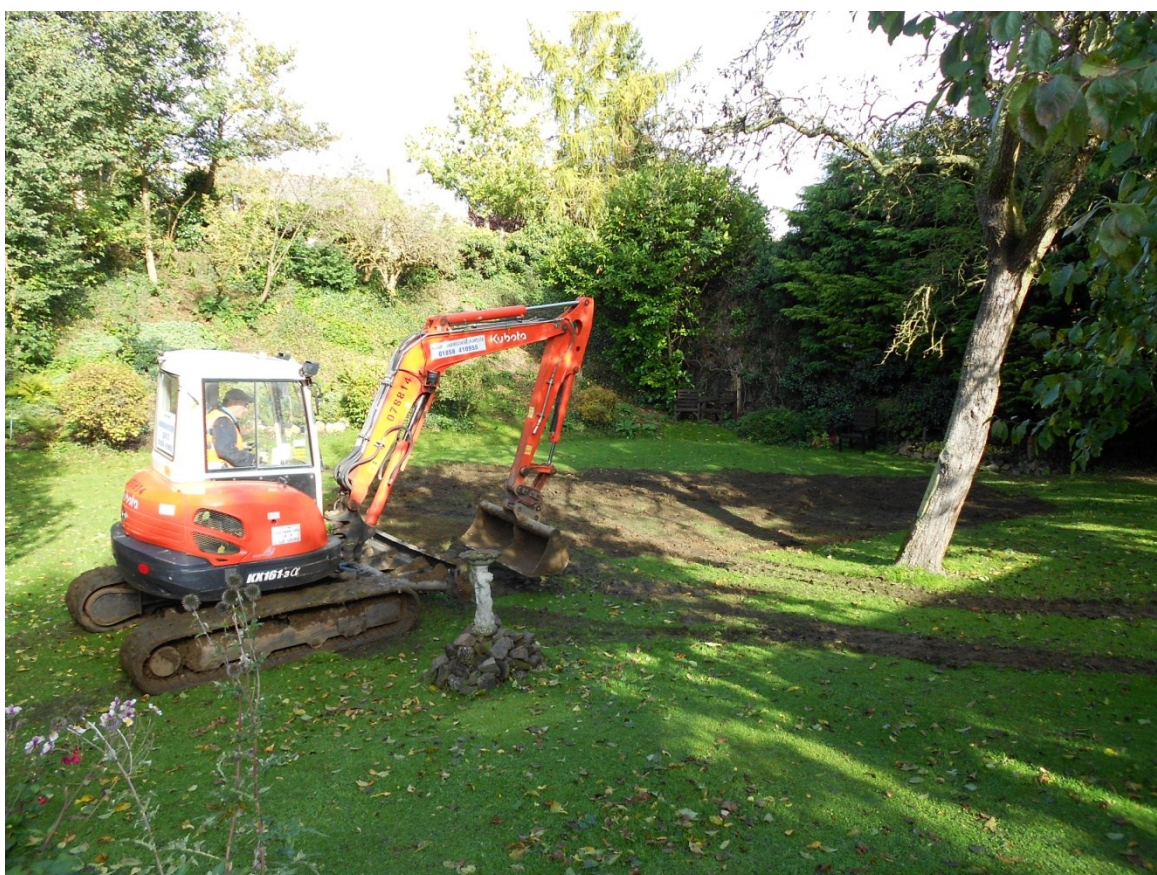
Figure 5: Backfilled Trench 2, and to the rear the large bank, seen on early OS maps

As noted in Section 3, there is some evidence for post-medieval quarrying, which has impacted upon the area. The earliest Ordnance Survey map of 1886 (county series 1:2500) shows a track from the Main Street, and possibly quarry workings in the eastern-half of the neighbour's property to the west (Figure 6). The development site is shown to have trees along the street frontage area. The 1903 edition clearly shows a quarry in the western-end of the neighbour's property to the west (immediately adjacent to Christ Church). No trees are illustrated in the development site (Figure 7). The 1929 edition (and subsequent editions) shows a substantial cut bank along the eastern edge as before, and also along the entire northern border (Figure 5), indicating the quarry had spread eastwards into the current development site, prior to the construction of the existing property (Parkland House) by 1929. This corresponds with results from the evaluation, with the quarry workings focused in the rear of the site (Trench 2). The area closest to the street frontage (Trench 1) appears to have been landscaped with a very thin level of topsoil and substantial root disturbance throughout.
