**An Archaeological Watching Brief on
land to the rear of 12 Peacock Lane,
Leicester**

NGR: SK 58468 04376

ULAS Report No 2011-043.
©2011

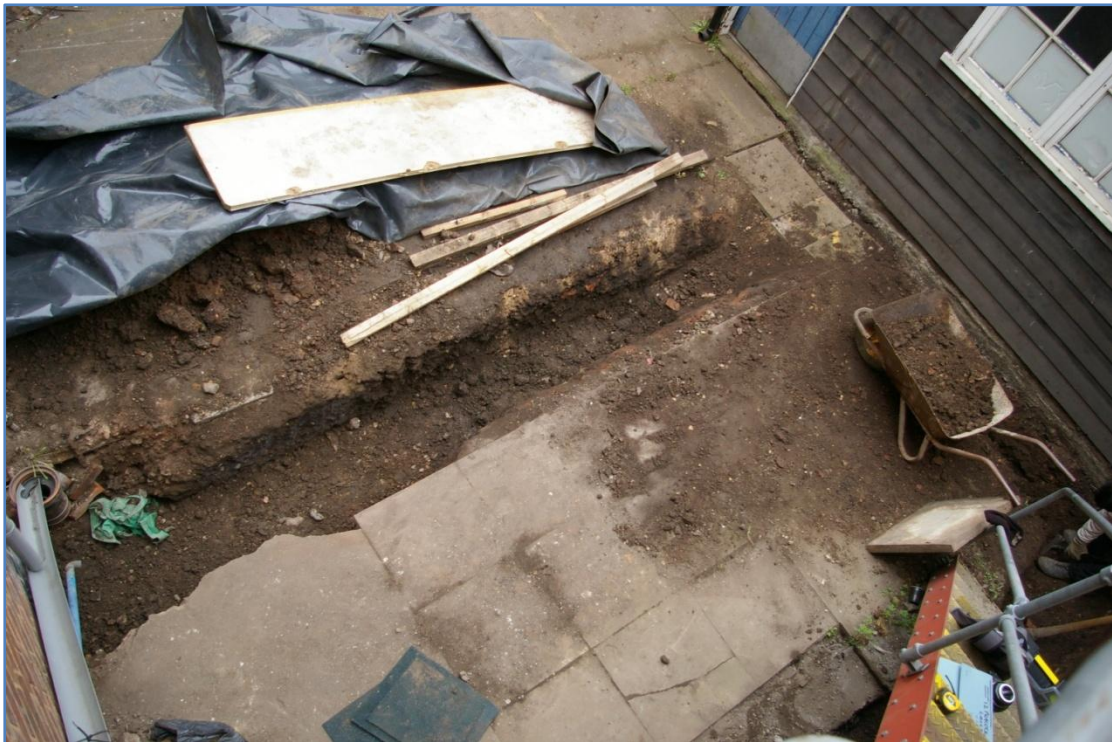
Figure 3 The east trench in the course of excavation. From above, looking south-east.

The trenching extended south of the present structure, enclosing an area of approximately 2.50m east-west by 5.00m north-south (Figure 3, Figure 4, Figure 5). The western and southern footing trenches were dug through a homogenous thick mid grey brown clayish soil which was heavily contaminated with building rubble of no apparent antiquity: fragments of frogless bricks within it looked convincingly Victorian. The eastern trench was cutting through discrete layers of building debris, including red sand, smashed mortar and/or plaster, crushed brick fragments, red clay, burnt material etc. These layers were tending to drop slightly as they headed south. Beneath them at a depth of approximately 0.45m below ground level mid grey-brown clay soil with common small rubble pieces was encountered; this appeared to be the same layer as encountered in the other footing trenches. No structural or cut features were encountered on the way down, nor were visible in the trench base; no finds were retained.

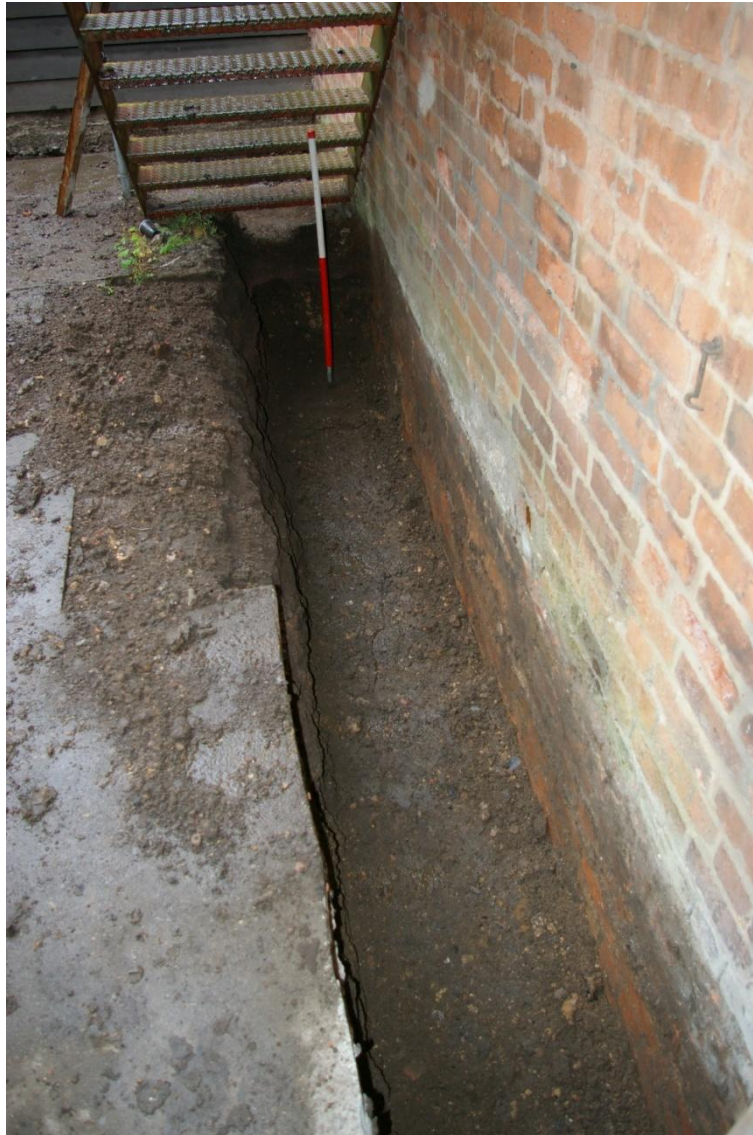
Figure 4 The west trench as excavated. Looking south.

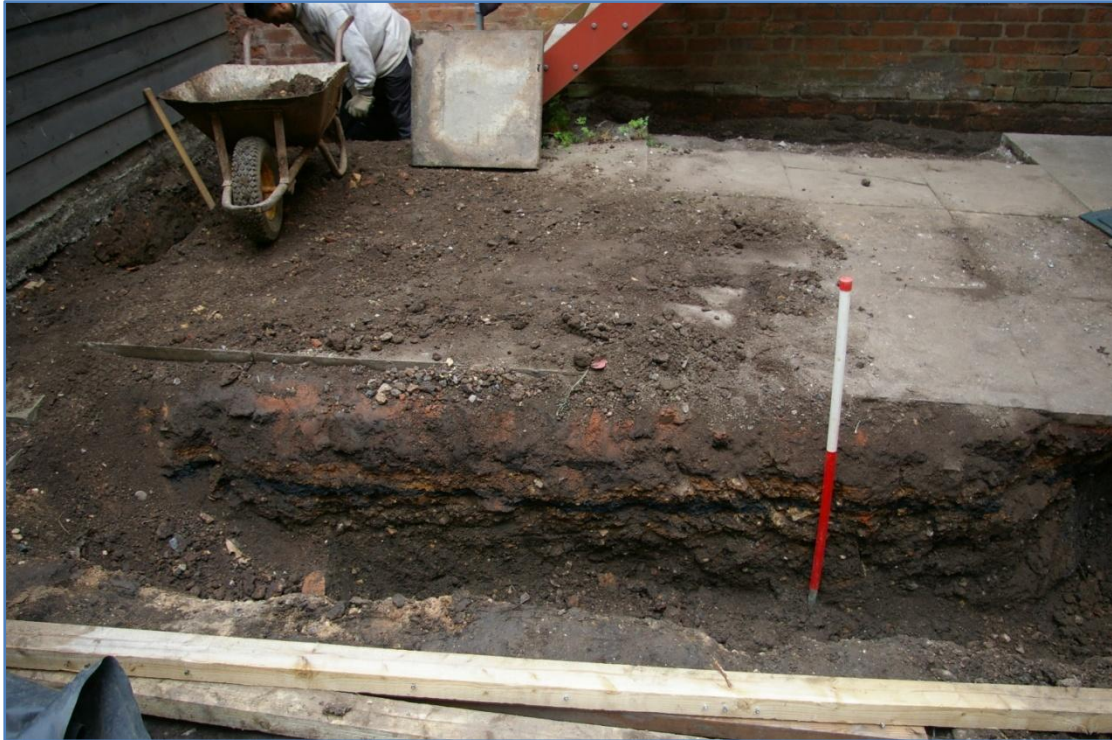
Figure 5 Eastern trench, west baulk.
Note debris layers and slight slope down to south (left). Looking west .

As might be expected, the hand-dug part of the footings were not deep enough to impact on any extant Roman deposits, which are probably a metre or more further down in this part of the town centre. Although exact Ordnance Datum levels could not be obtained as the site is completely enclosed in a rear yard, the ground level at the rear of the property must be very close to the street ground level at the front (*c.* 64.0m OD), as there is no step up or down between the front and back of the building. The potential depth of medieval deposits is more difficult to predict; for example the Guildhall adjacent is very close to present street level. Notwithstanding this uncertainty, the footing trenches did not appear to have gone through any extant *in situ* medieval deposits, so presumably any such deposits in the area are either lower, or have already been removed by previous building activity. In passing, it may be mentioned that the present building is described as mid-19th century in the planning documentation; conversely the author would guess it to be earlier-mid 20th century. If so, this would explain why the new footings appear to be cutting mid-19th century demolition debris.
