**An Archaeological Evaluation
at Lower Grange Farm,
Markfield, Leicestershire
(SK 489 094)**

**An Archaeological Evaluation at
Lower Grange Farm,
London Road, Markfield,
Leicestershire.**

ULAS Report Number 2011-015

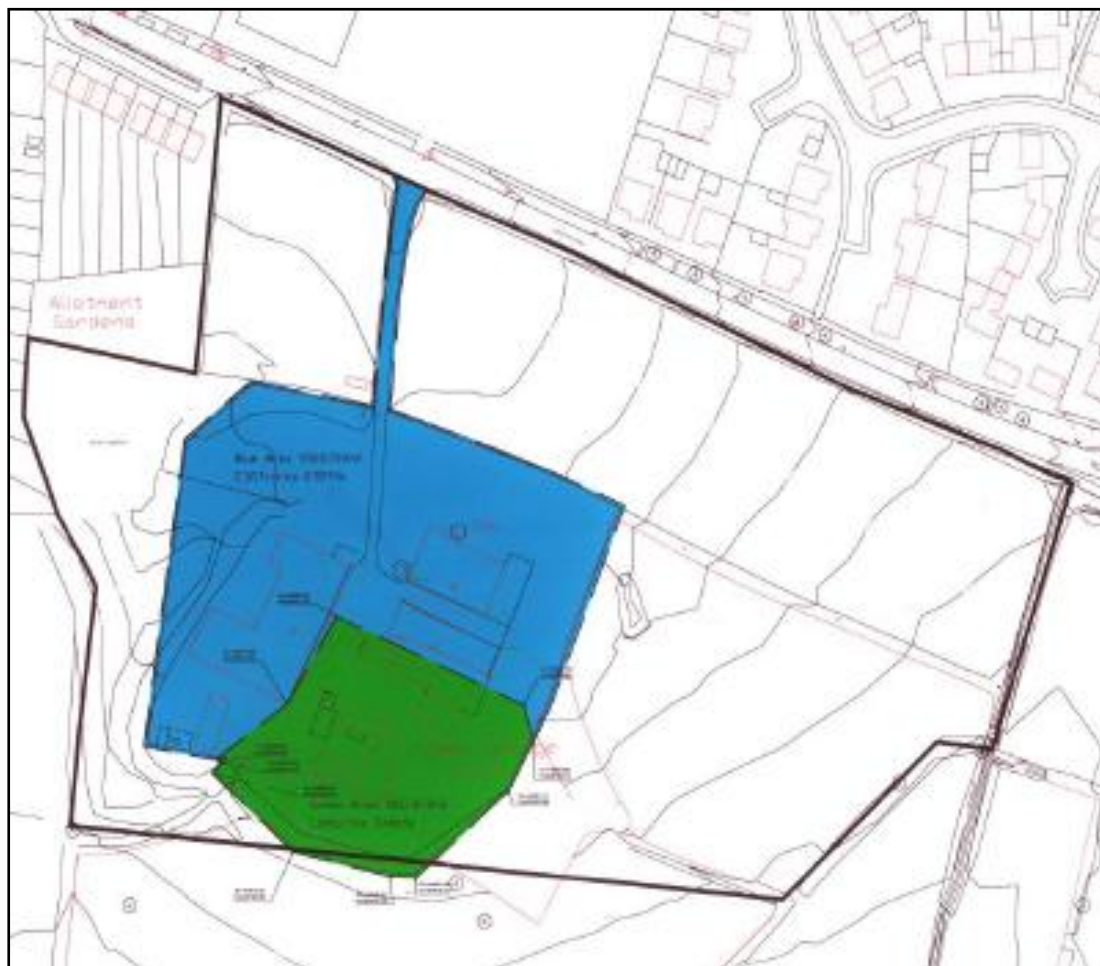
Figure 2:
Proposed development area; the green shaded area is excluded from the development.

In consultation with Planning Control Archaeologist it was decided to evaluate the impact of proposed development with the excavation of 13 20m x 1.6m trenches (Fig. 3). In view of the revised area of exclusion (Fig.2) this was revised to twelve trenches. One trench specifically targeted a potential archaeological anomaly identified by the geophysical survey. The alignment of two further trenches was also altered at the request of the Planning Control Archaeologist. A further trench was also moved to sample the southernmost part of the proposed development area. The evaluation took place between January 25th & 27th 2011. The trenches were excavated by a 16 tonne Back Actor using a ditching bucket.

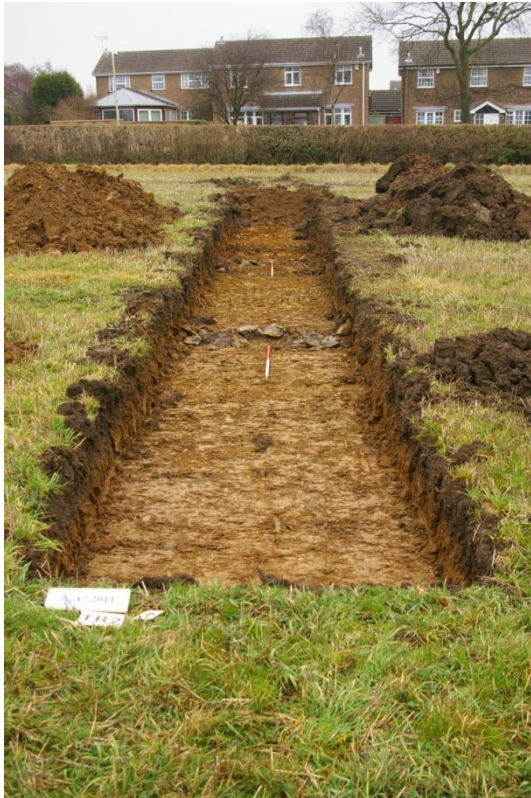
Figure 5 Trench 2 (looking north east).

Approximately 0.23m to 0.32m of plough soil was excavated revealing a similar depth of subsoil as trench 1; the underlying substratum was also the same. Excavation ceased at this level, approximately 0.35m to 0.5m below the existing ground level. Two further granite filled drains were exposed.

Hand cleaning at this level defined an area of sands and gravels substratum which matched the location of the anomaly. This area was further machine reduced to approximately 0.7m below the existing ground level which confirmed that the sands and gravels were geological in origin, possibly a fluvial feature (*Figure 5*).

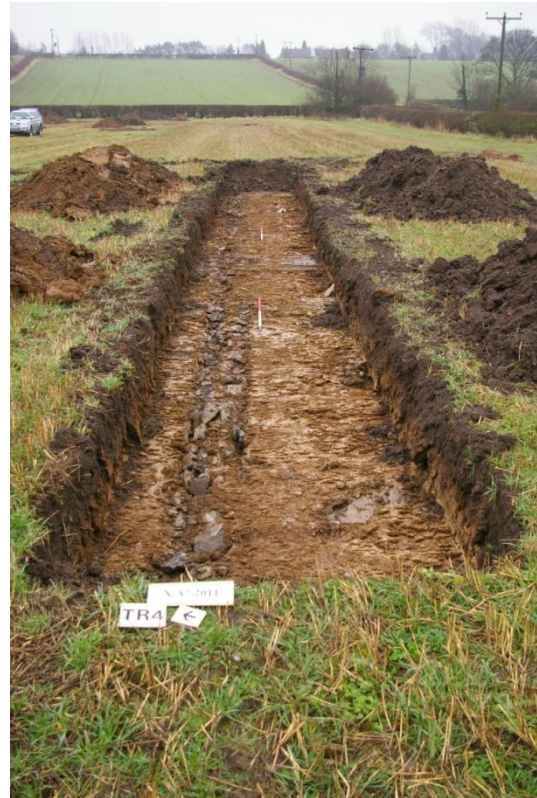
Figure 6 Trench 4 showing granite drain.

Approximately 0.2m to 0.3m of plough soil was excavated revealing a thin layer of subsoil; the underlying substratum was the same as that present in Trench 1. Excavation ceased at this level, approximately 0.35m to 0.6m below the existing ground level. A granite filled drain was exposed towards the northern edge of the trench, on the same alignment as the trench (*Figure 6*). An examination of the greyscale plot of gradiometer data clearly records this drain.

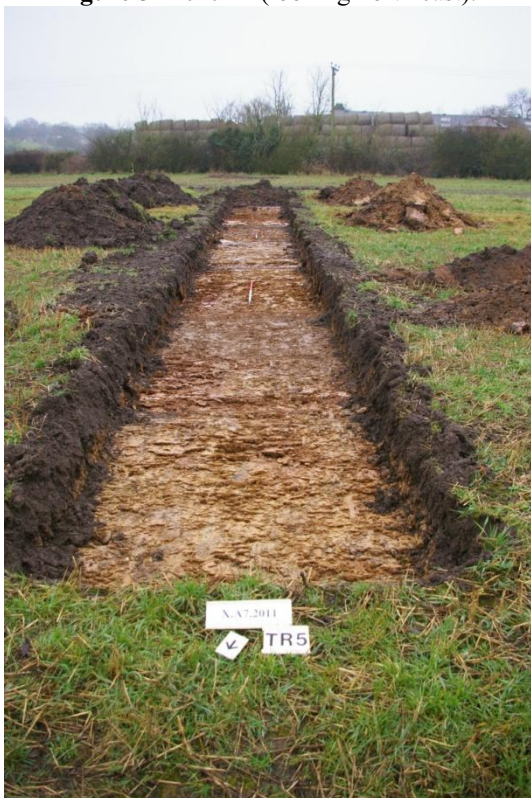
Figure 7 Trench 5 Showing Furrows.

Approximately 0.15m to 0.26m of plough soil was excavated revealing a very thin layer of subsoil; the underlying substratum was light orange-brown clay. Excavation ceased at this level, approximately 0.26m to 0.34m below the existing ground level. Two furrows, aligned east to west were exposed within the trench (*Figure 7*). These furrows relate to early post-medieval ploughing.

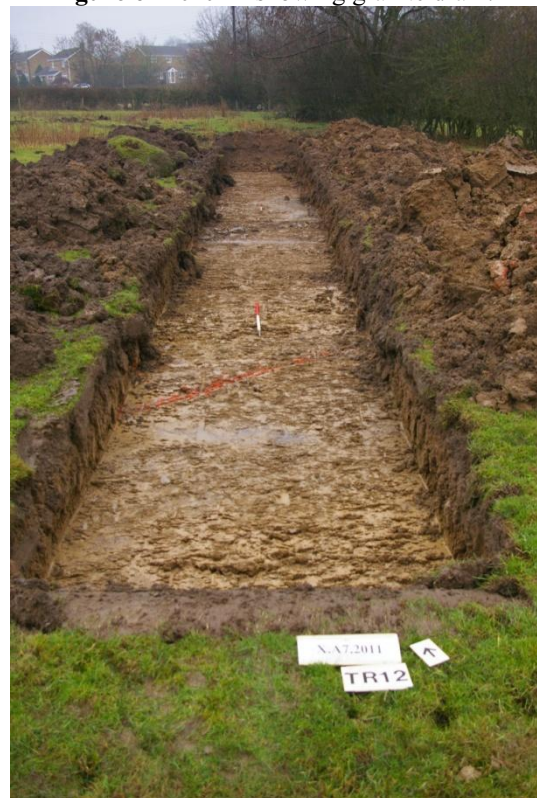
Figure 8 Trench 12.

Approximately 0.17m to 0.26m of topsoil was excavated, exposing a thin layer of silty-clay subsoil. Beneath the subsoil a horizon of lighter yellow brown clay was exposed. Excavation ceased at this level, approximately 0.46m to 0.58m below the existing ground level (*Figure 8*).

No remains of archaeological significance were found within the trench and it was recorded and released for backfilling. A large amount of plastic waste was found within the topsoil at the northern end of the trench, which may have caused the area of magnetic disturbance recorded by the geophysical survey.
