An Archaeological Standing Building Survey of
Rooms and an Outbuilding at
The Old Rectory,
Sibson, Leicestershire (NGR SK 35437 00845)

ULAS Report Number 2011-167

Summary

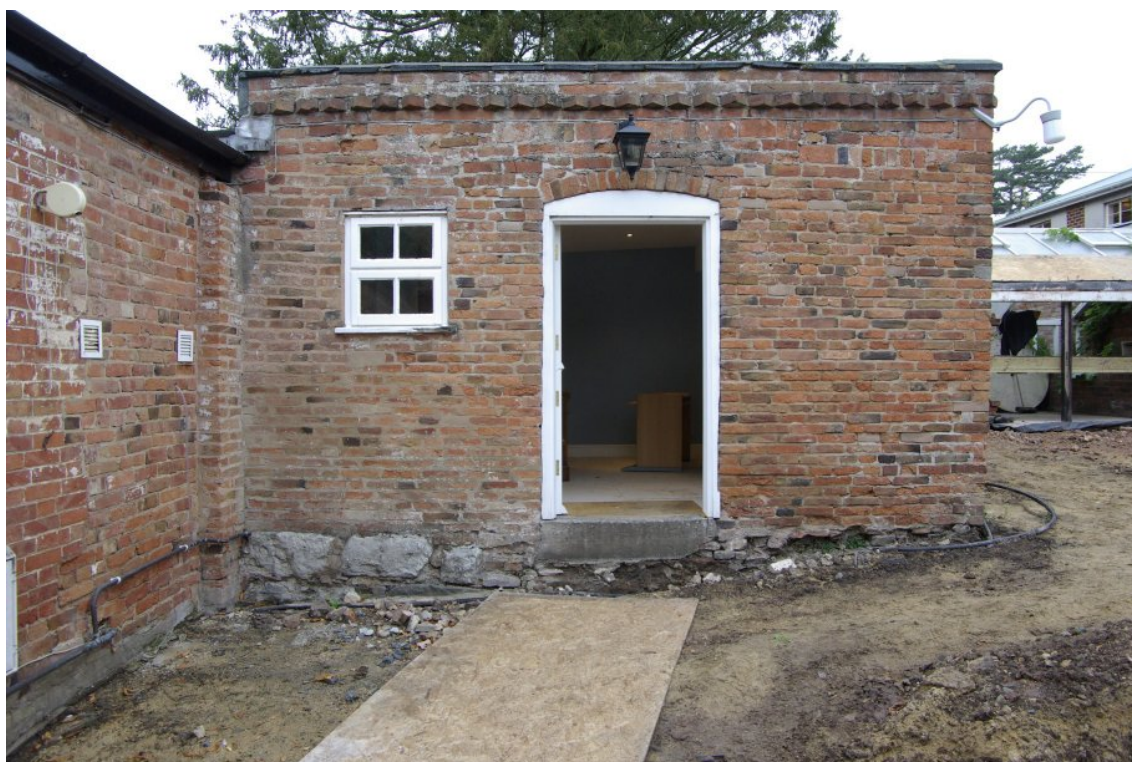
Figure 5 Building A (Outbuilding) south facing elevation.

Building A is a single-storey red-brick building with a flat roof occupying the northernmost part of the easternmost courtyard. The building faces Sheepy Road to the south, but is slightly out of alignment with the remainder of the Rectory (*Figure 4*), there is a central door on the southern elevation as well as a small high level window (*Figure 5*), and on the eastern elevation is a large central arched window (*Figure 6*). Both windows and the door are modern replacements in timber. On the western end of the south-facing elevation there is a substantial mixed sandstone and granite-built plinth, or footing visible (*Figure 5*). It is possible that this plinth/footing continues below the remainder of the building, but is not currently visible.

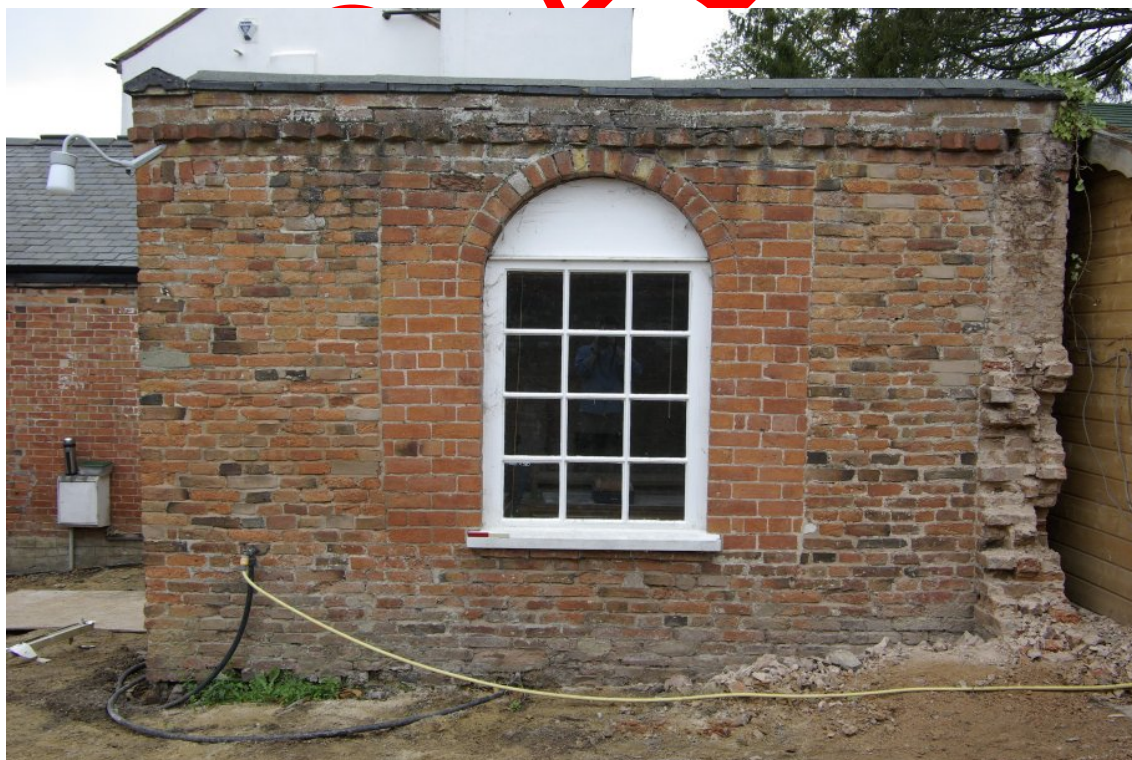
Figure 6 Building A (Outbuilding) east facing elevation.

With the exception of a number of clearly later additions and alterations, the bulk of the brickwork consists of 9inch x 2inch x 4 ½ inch handmade red bricks laid in English Garden Wall Bond (one course of headers to three courses of stretchers). There is however areas of patching with no discernable bond. There has also been extensive re-pointing with cement mortar; there are limited remains of earlier lime mortar pointing. Towards the roof line there was a course of saw tooth corbelling; these bricks were clearly later than the body of the building, suggesting the roofline has been altered. On the eastern wall there is a central arched window, set within what was originally a larger opening. The blocked opening, interestingly does not reach the external ground level, so its original function is unclear. The infill bricks are 9inch x 3inch x 4 ¼ inch reds, rather soft in both colour and strength, suggesting an early to mid 19th century date for this phase of work. It is unclear what purpose this opening originally served.

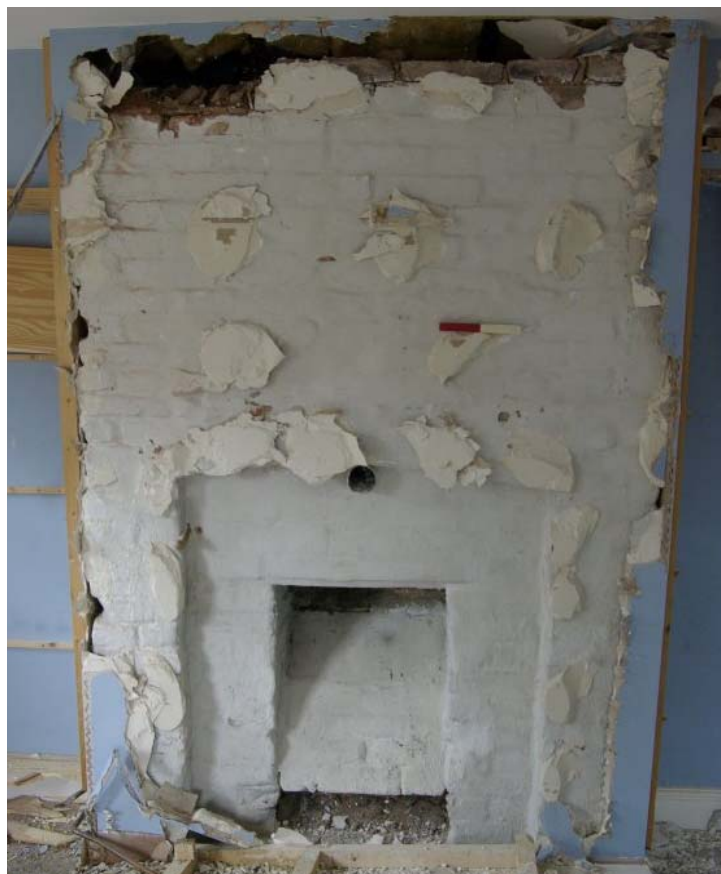
Figure 7 Exposed fireplace and chimney breast (Building A).

Internally the building has undergone significant recent decoration, limited removal of this decoration, did, however reveal some significant architectural and historical features. The most significant of which was the brick-built fireplace on the west wall (*Figure 7*), indicating that the building was originally heated and therefore, likely to have been a domestic structure rather than an outbuilding. Further removal of the dry lining over the chimney breast indicated that the chimney had been rather crudely cut down to an arbitrary point, only concealed by the newly under-boarded ceiling. This suggests that the chimney was originally taller and the building was originally two storied. Which is supported by the later brickwork, including the saw tooth corbelling recorded on the external walls.

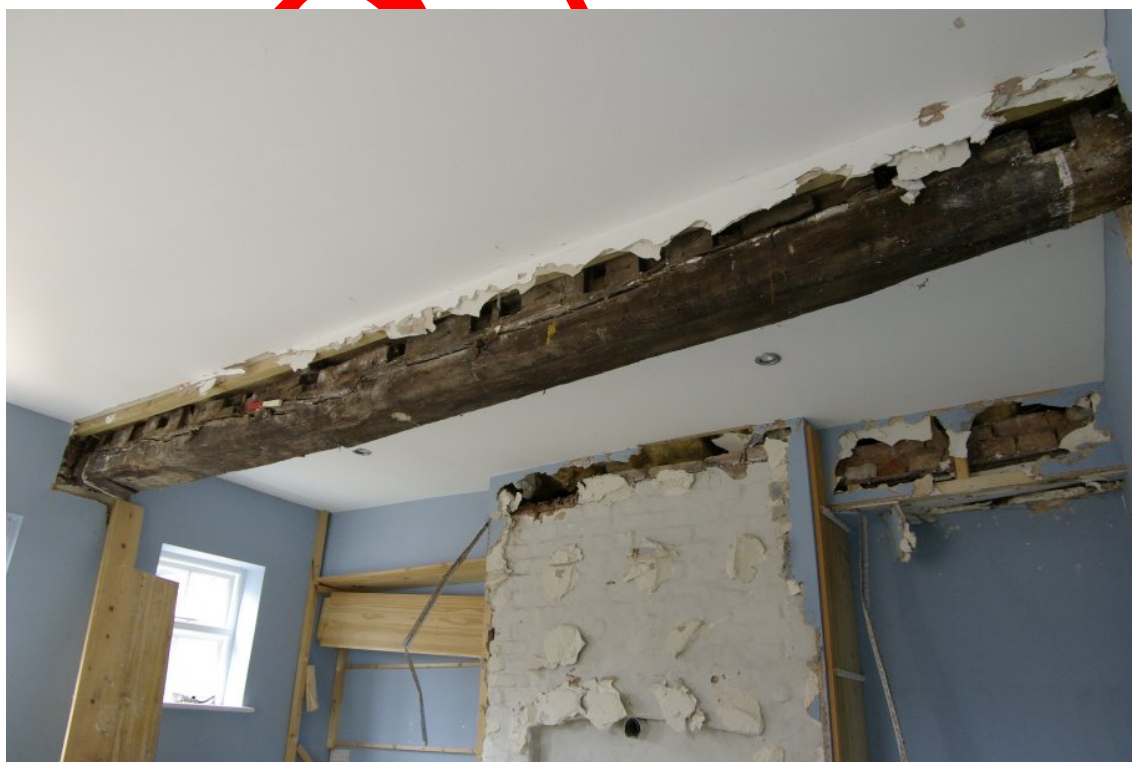
Figure 8 Westernmost beam (Building A).

The under-boarded ceiling also appeared to conceal two axial beams, removal of this cladding confirmed this (*Figures 4, 8 & 9*). There were two large oak beams, apparently re-used. Both had joist holes on each face. These joist holes did not line up, suggesting that the beams were not in their original positions, further evidence of which was the 'birds mouth' openings on the east face of the east beam, indicating that this beam was originally a wall plate. Some of these openings had been filled with plaster (*Figure 9*) suggesting that they were at some point in their history exposed and merited

Both the size and the location of these beams are interesting; both beams are large, 300mm by 300mm in comparison to the weight they carry as well as the use of two beams in a room only 4.4metres wide. A single central beam of the above dimensions would have been more than adequate. It is possible, therefore, that these beams are evidence that the building as well as being originally two storied was originally longer also. The joists carrying the roof are modern replacements.

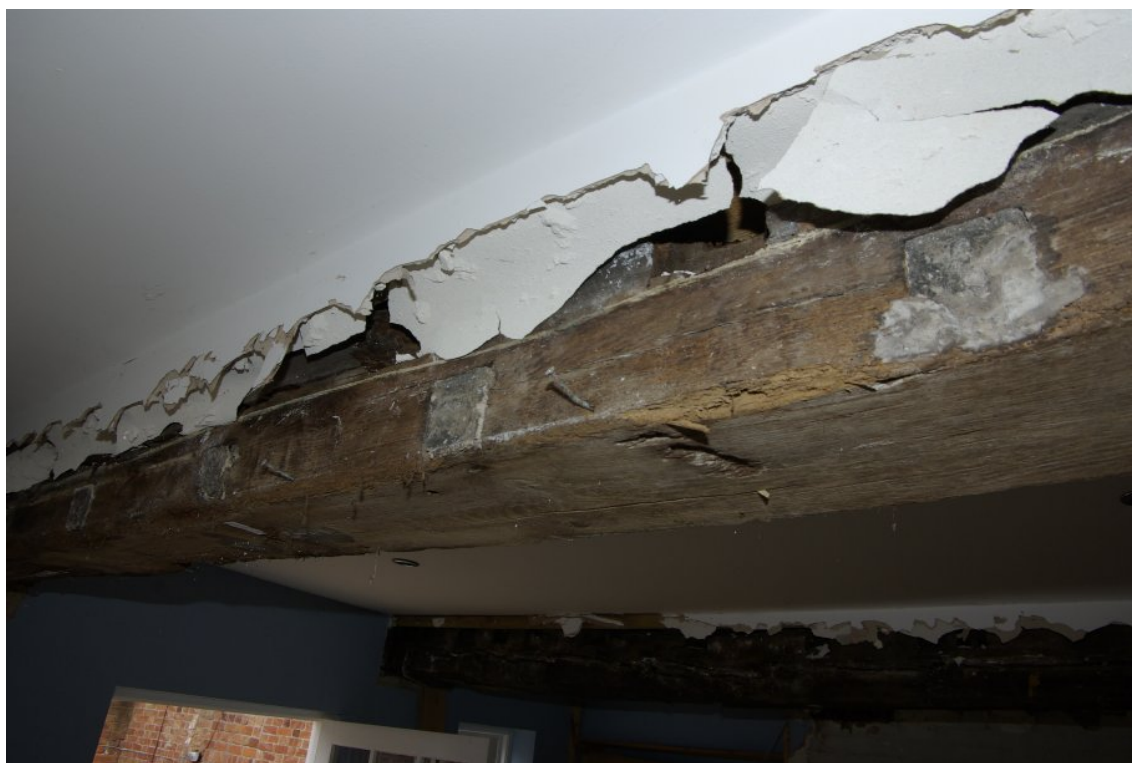
Figure 9 “Birds mouth openings” in easternmost beam (Building A).

this additional, and somewhat un-necessary re-finishing, evidence again that the building was originally domestic.

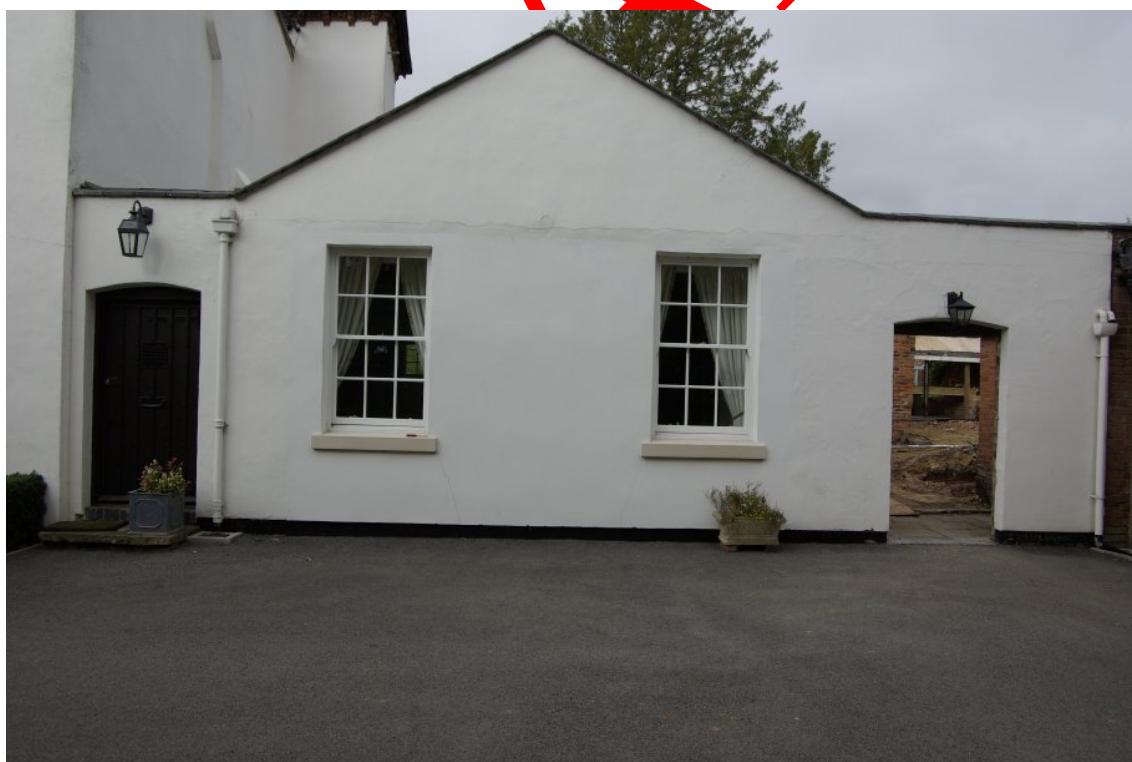
Figure 10 Building B (The Old Rectory), south facing elevation.

Although rendered, the southern elevation (*Figure 10*) still contains significant information relating to the Old Rectory and its evolution. Most significantly, its alignment follows that of the 18th-century Rectory so is likely to post-date building A and the northernmost parts of building B. There is also the outline of a large blocked garage or carriage door visible within the elevation, suggesting the range may have originally been built as a coach house or even as a garage in the early years of the 20th century.

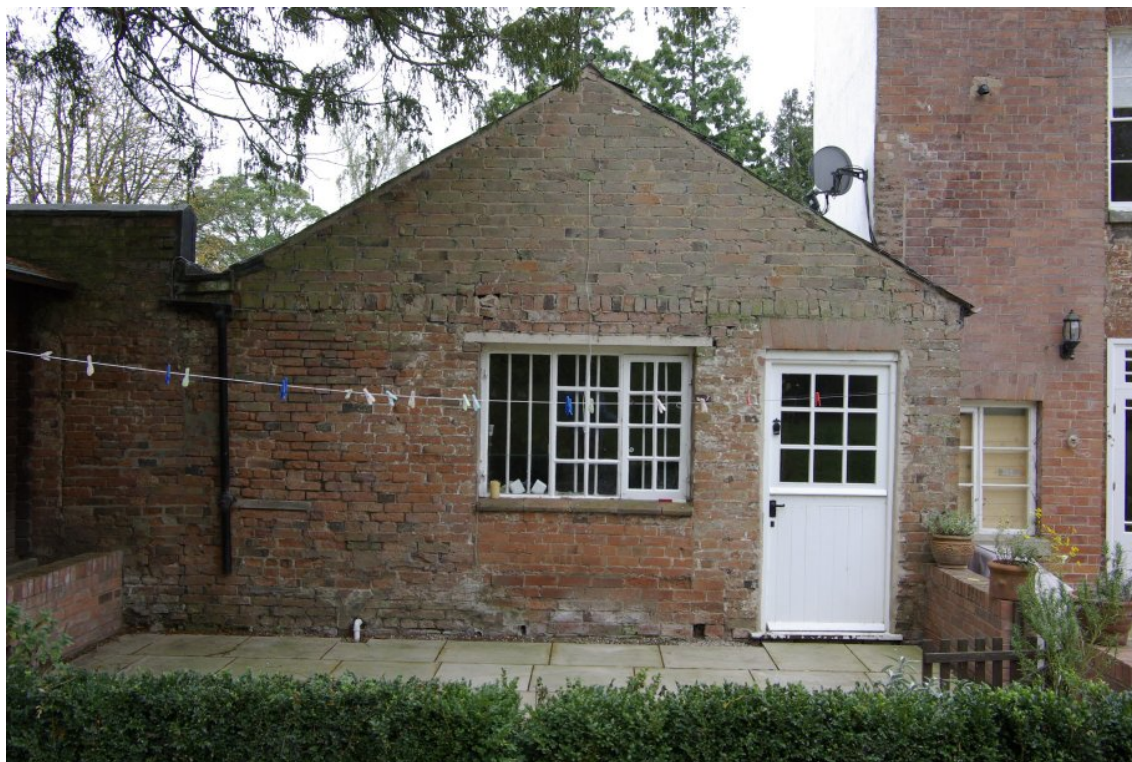
Figure 11 Building B (The Old Rectory), north facing elevation.

Building B consisted of a single range; perpendicular to Sheepy Road, the southern gable is parallel with the road and on the same alignment as the remainder of the Rectory, the remainder of the walls, however is on the same alignment as building A. The range is brick built with a pitched roof of Welsh Slate, the southern elevation is rendered, and the northern and eastern elevations are exposed brickwork. The exposed brickwork appears to be mixed and possible multiple phased. The northern wall (*Figure 11*) consists of 9 inch by 2 ½ inch by 4 inch handmade red bricks laid in an uneven English Garden Wall Bond (one course of headers to three or five courses of stretchers, but in this example the stretcher courses vary between three and five). At eaves level there is a course of bricks on end, reminiscent of coping bricks, above which is clearly later brickwork. It is almost certain, therefore, that the pitched roof is a later addition and the coping bricks suggest that this wall may have originally been garden wall. Both the door and the window on this elevation have the appearance of having been inserted; below the window there is a straight joint in the brickwork indicating an in-filled opening, the infill bricks appear to be early to mid 19th century in date.

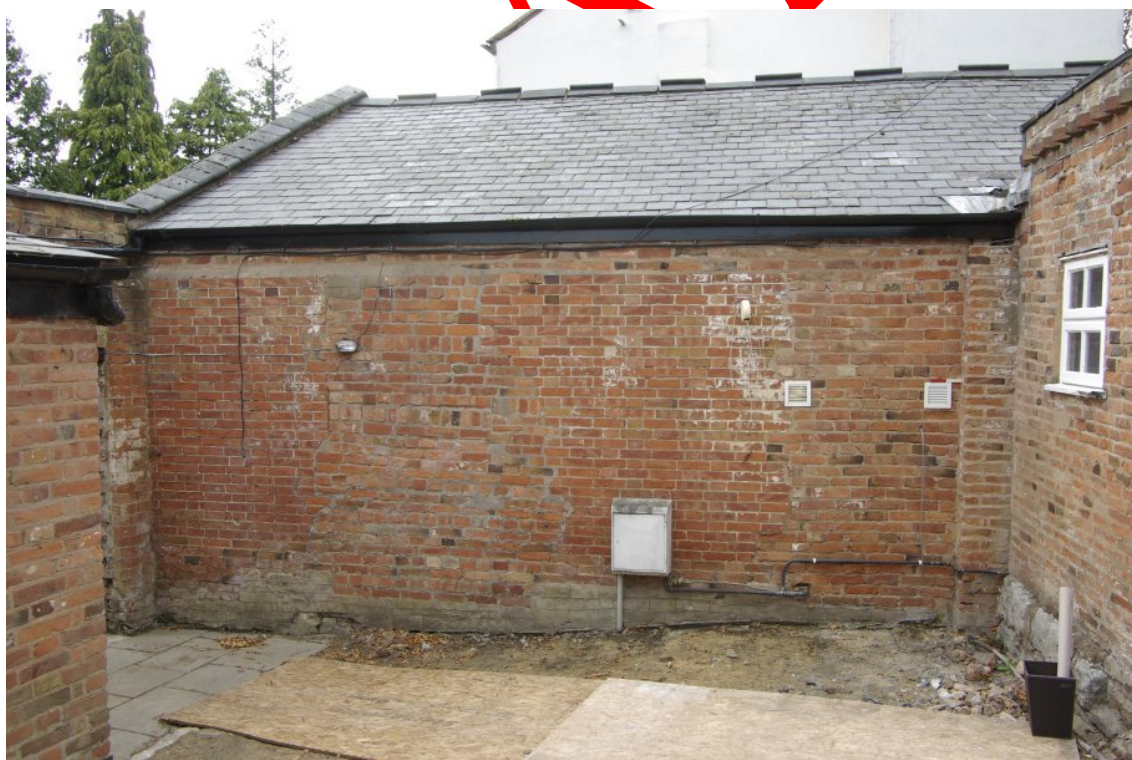
Figure 12 Building B (The Old Rectory), east facing elevation.

The brickwork on the eastern elevation is rather more complicated and consists of at least three phases (*Figure 12*). There is one obvious blocked opening towards the southern end of the elevation with clearly 20th century cement mortar pointing. The remainder of the elevation consists of mixed brickwork of similar dimensions but visually different laid largely in a Flemish Garden Wall bond (three or five stretchers to one header in each course). There is a straight joint between this elevation and building A, suggesting the two are not contemporary.

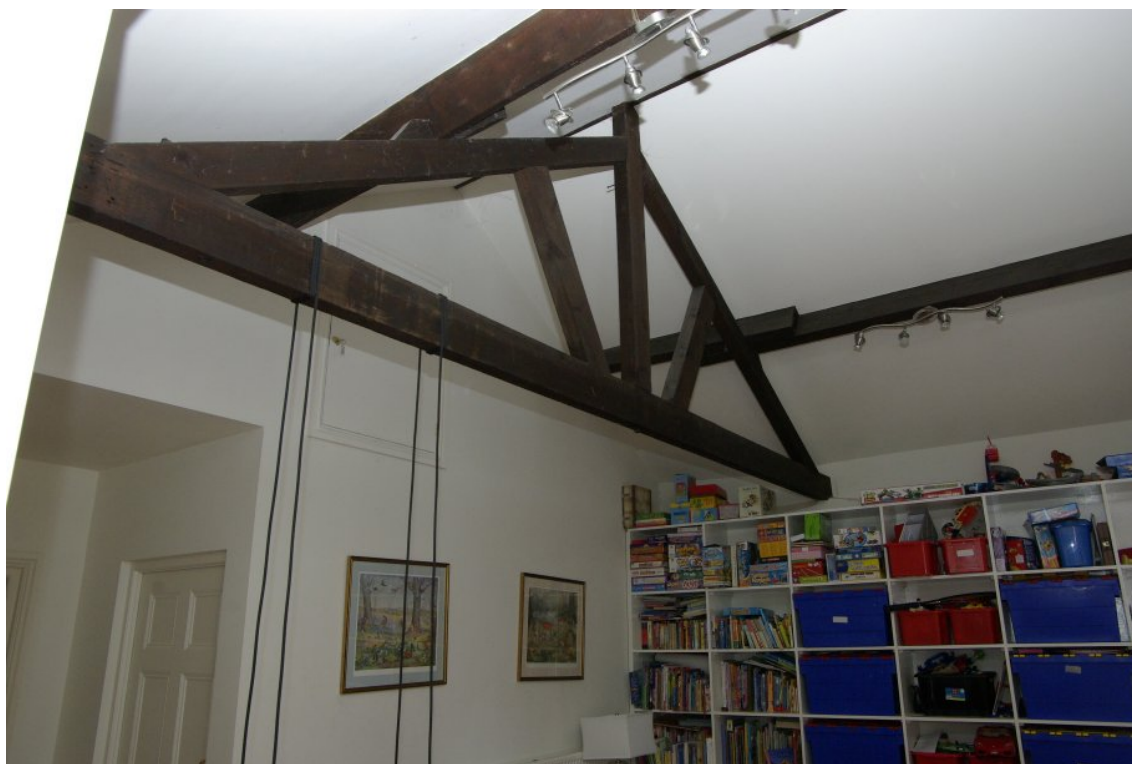
Figure 13 Exposed roof truss, building B (Play Room).

Internally, there is very little of architectural or historical interest visible. The range has been sub-divided with apparently modern stud walls creating two large rooms and a single small room (the larder). There is no clear evidence of a fireplace or chimney, which along with the lack of any original partitions suggests the range, was originally a single large, unheated space. The only significant feature which is visible is the exposed roof truss in the frontage room (*Figure 13*). The truss itself is a bolted king post truss with a raised head and raking struts. Interestingly, the struts are at a very steep angle.

A detailed examination was not possible, however the visible dimensions of the timber suggest the truss is softwood and is likely to be late 19th or more likely early 20th century in date.
