An Archaeological
Evaluation at
Welland Farm,
Main Street, Barrowden,
Rutland (SK 949 000).

For: Burghley House Preservation Trust.

University of Leicester Archaeological Services
Report 2005/127

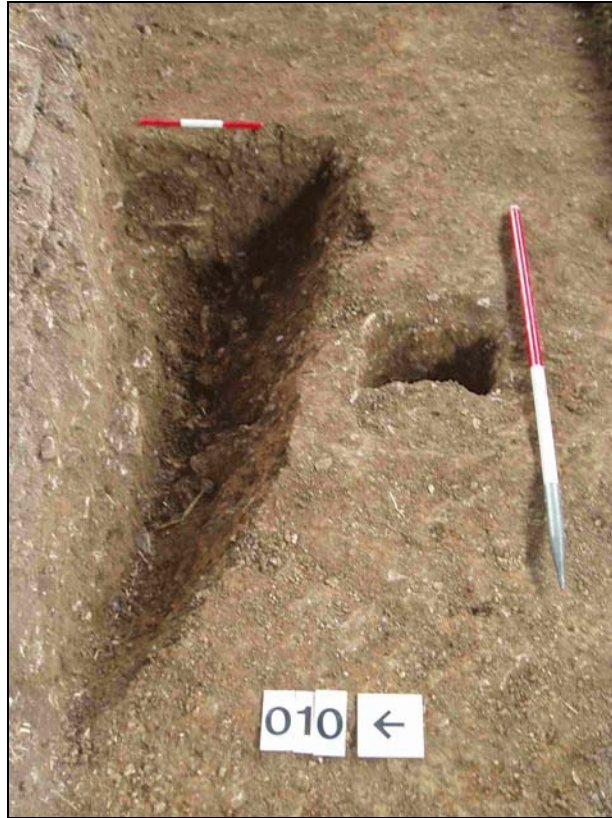
Cutting the substratum were a number of features (figs. 8, 10 and 11). In the west of the trench was a shallow feature, [008] that was orientated northwest to southeast and is probably part of (004). In the eastern half of the trench two features were revealed. The first, [012] was a possible post hole. It was 0.40m wide and 0.28m deep and contained a mid orangish brown clayey sand fill. The full extent of the second feature, [010], was not established as part of it lay beneath the northern baulk. Excavation of its western half revealed that it was up to 0.50m in depth. It contained a primary fill of mid orange brown clayey sand and a secondary fill of light orange brown clayey sand that contained stone lines indicating deliberate backfilling. The modern pottery and glass found at the top of this layer cannot be used to date the feature as they could well be intrusive from later levelling episodes.

The pits [010] and [018] were similar in nature to features encountered to the north of the site at Main Street Farm (Meek 1999) where they were interpreted as medieval quarry pits associated with the construction of buildings. The depths of the pits, in particular [018] was likely to be greater when first excavated as the area beneath the barn appears to have been levelled prior to its construction. The date of the pits is uncertain due to the lack of finds though they could be from the same period as those at Main Street Farm.

Plate 1. Trench 03, quarry pit [010] and post-hole [012] looking east.

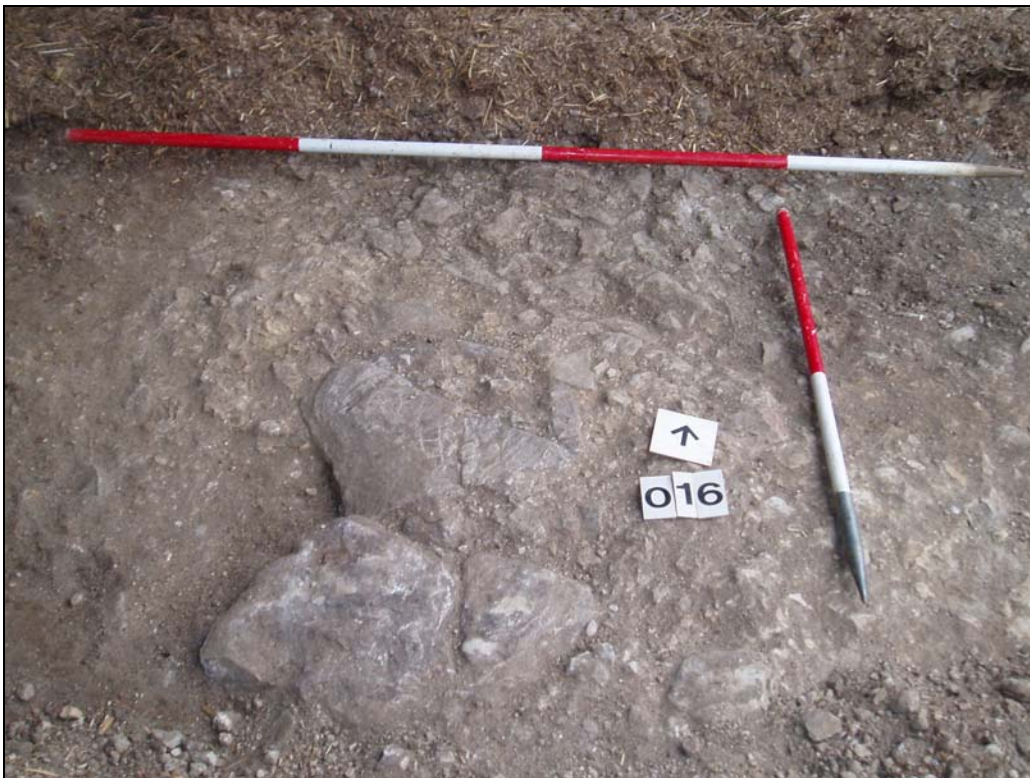
At the western end of the trench the remains of a wall was revealed (006). There was no foundation cut present, it was butted up against and knitted to the stoney natural substratum of the site. It was constructed of irregular, un-worked limestone pieces up to 0.40m by 0.24m in size, one course thick and had no bonding material. Remains of another wall or post pad, (016) were encountered to the to the east comprising of three flat limestone slabs up to 0.35m by 0.22m laid onto the natural substratum.

Plate 2. Trench 04 post pad (016) looking north

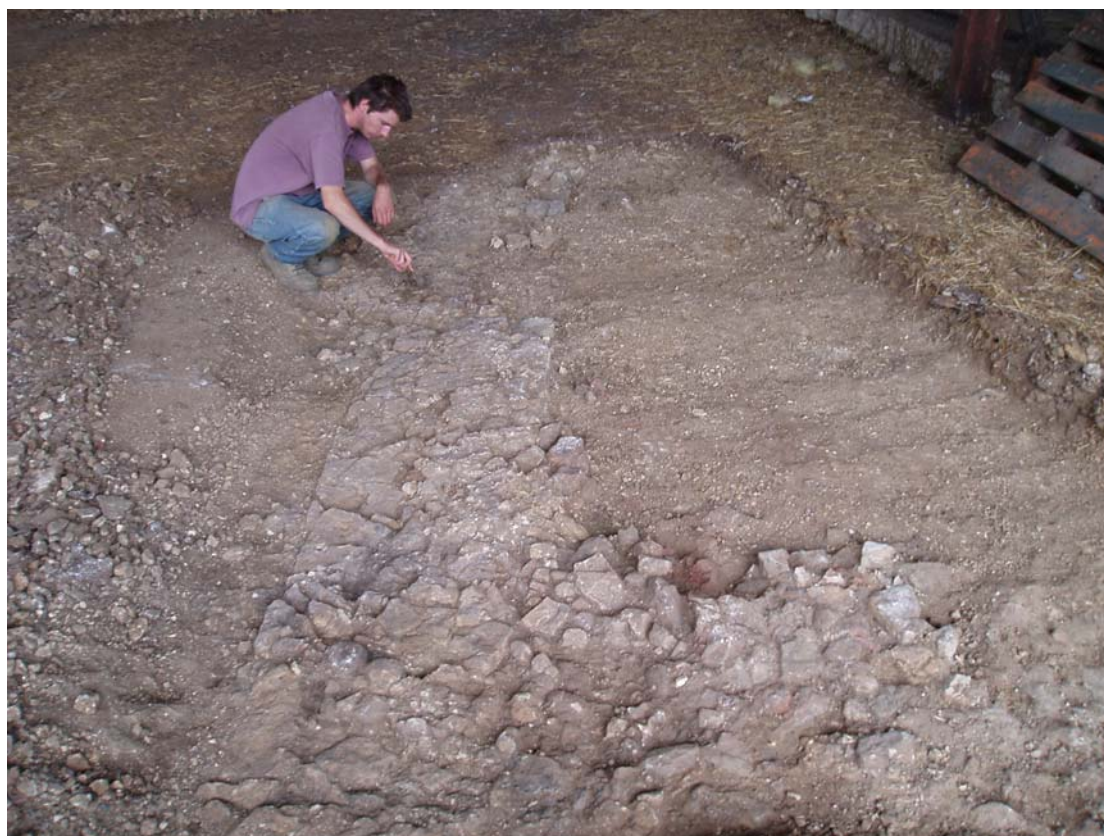
The stone present on site is not good building stone but would be adequate for unmortared foundations. The wall (006) was most likely a dwarf wall onto which a timber superstructure was erected, a style commonly used throughout England by the 13th century (Hinton 1993) and which continued in use until the late post-medieval

period in Leicestershire and Rutland (N. Finn pers. com). The wall was constructed in the same way as those found across the road at Main Street Farm that were medieval in date (Meek 1999). A date for (006) cannot be ascribed as no dating evidence was recovered though either a medieval or post-medieval date is possible. Map evidence indicates that the building was present in 1844 and survived until 1886 but had been demolished by 1900.

Plate 3. Trench 04 wall (006) looking north west.
