An Archaeological Evaluation at Medbourne Grange, Drayton Road, Nevill Holt, Leicestershire NGR: SP 81620 94540 centre

ULAS Report No 2013-061 ©2013

University of Leicester Archaeological Services (ULAS) carried out an archaeological evaluation by trial trenching on land at Medbourne Grange, Drayton Road, Nevill Holt, Leicestershire (SP 81620 94540). The fieldwork was a post-determination requirement on a planning application in advance of the proposed construction of an anaerobic digestion plant.

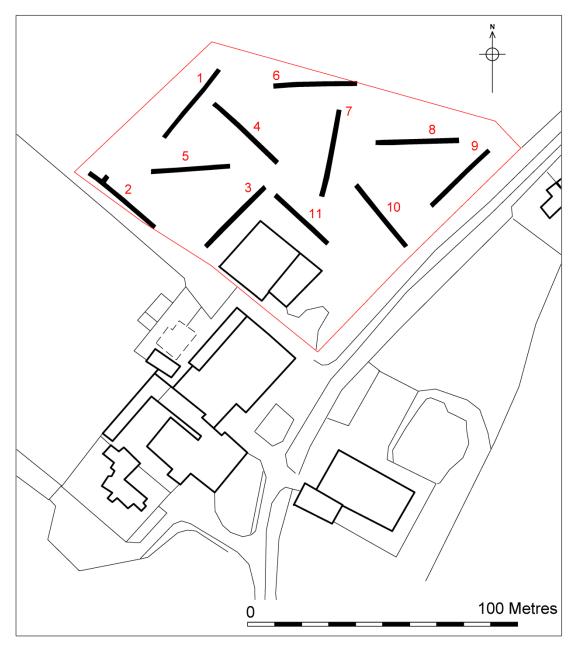
Figure 3 Trench Location Plan. Scale 1:1200

The excavated trenches closely matched the trenches set out in the WSI (Fig. 3). However the southernmost trench (Trench 11) was moved to the eastern side of the existing barn as its original position had previously been excavated and built up again with hard core. As the machine bucket used to excavate the trenches was only 1.5m wide an additional trench was excavated within the eastern part of the site (Trench 8) in order to meet the area requirements set out within the brief.

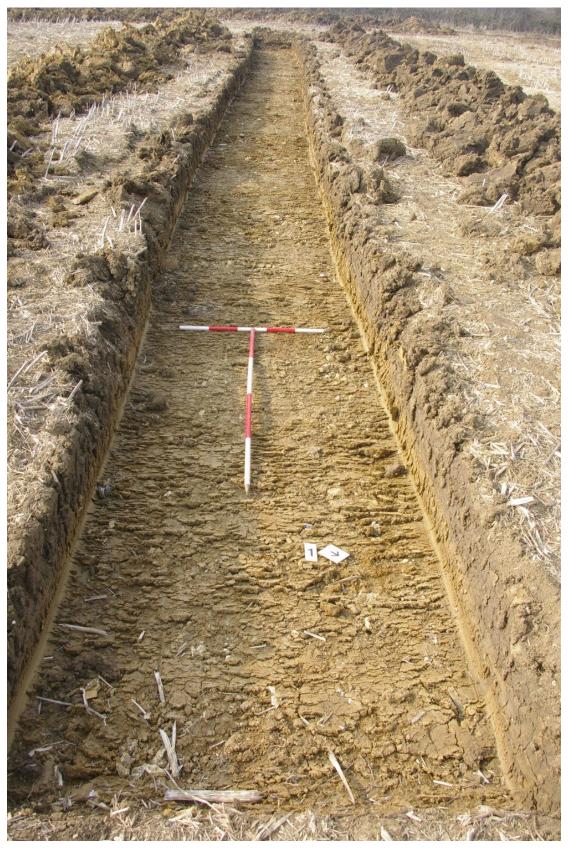
Plate 1: Trench 1 looking south-west

Trench 1 was located on the north-west edge of the site and was orientated north-east to south-west. Two modern field drains were recorded that cut the natural substratum. No archaeological features or finds were recorded within this trench.

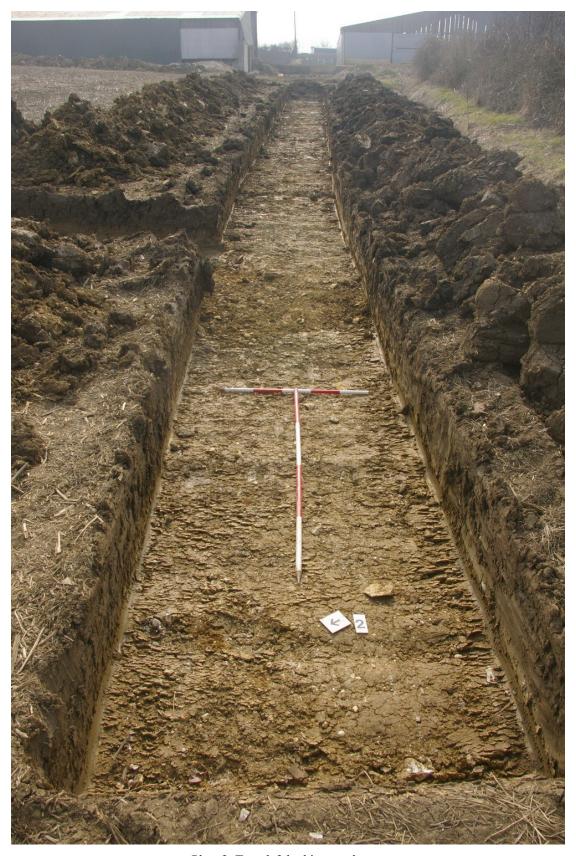
Plate 2: Trench 2 looking south-east

Trench 2 was located along the south-western edge of the site, c.25m south-west of Trench 1. The trench was orientated north-west to south-east and a small extension was also excavated at the north-west end. Two modern field drains were recorded that cut the natural substratum. No archaeological features or finds were recorded within this trench.

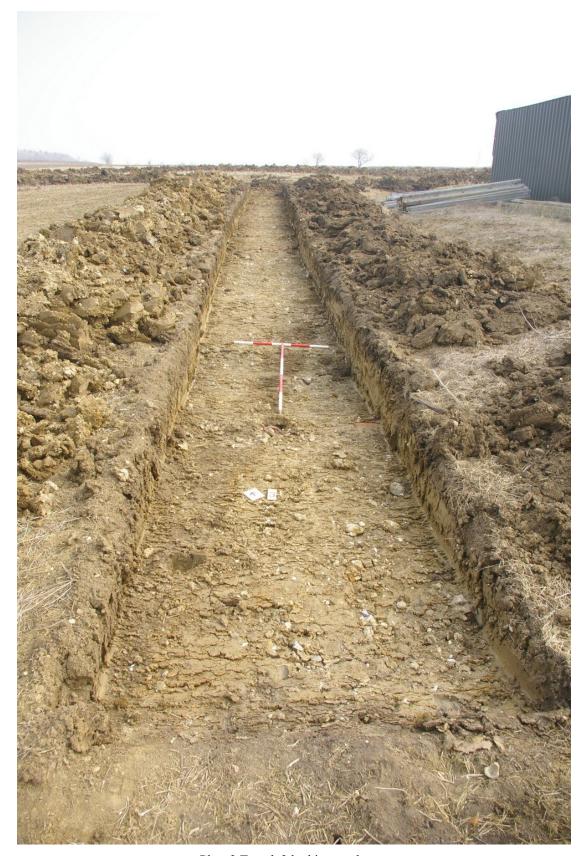
Plate 3 Trench 3 looking north-east

Trench 3 was parallel to the north-west existing barn on a north-east to south-west alignment. Two modern field drains and a larger ceramic storm drain were recorded that cut the natural substratum. The topsoil was very thin at the south-west end of the

trench, relating to ground reduction in this area. No archaeological features or finds were recorded within this trench.

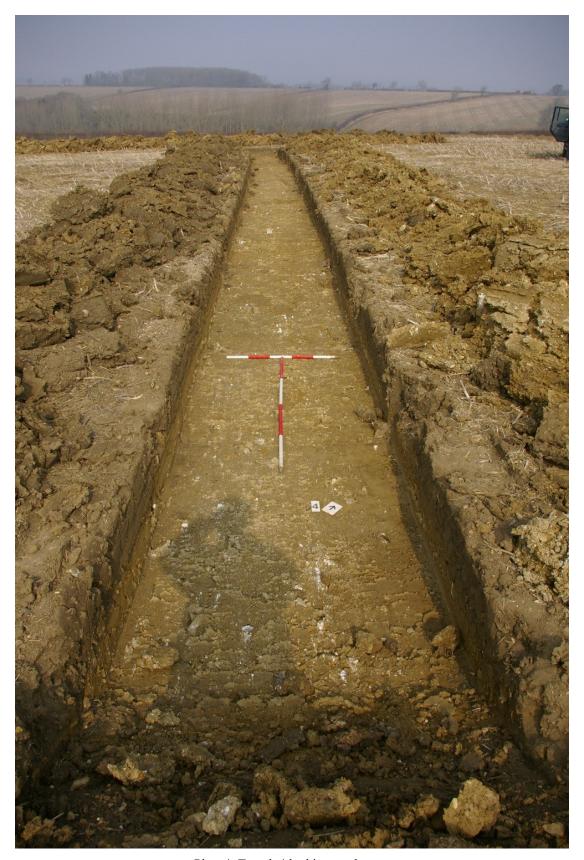
Plate 4: Trench 4 looking north-west

Trench 4 was located c.5m south-east of Trench 1 on a perpendicular north-west to south-east alignment. A small area of disturbance in the natural substratum was recorded c.3m from the north-west end of the trench that probably relates to a natural tree bowl feature. One modern field drain was also recorded that cut the natural substratum. No archaeological features or finds were recorded within this trench.

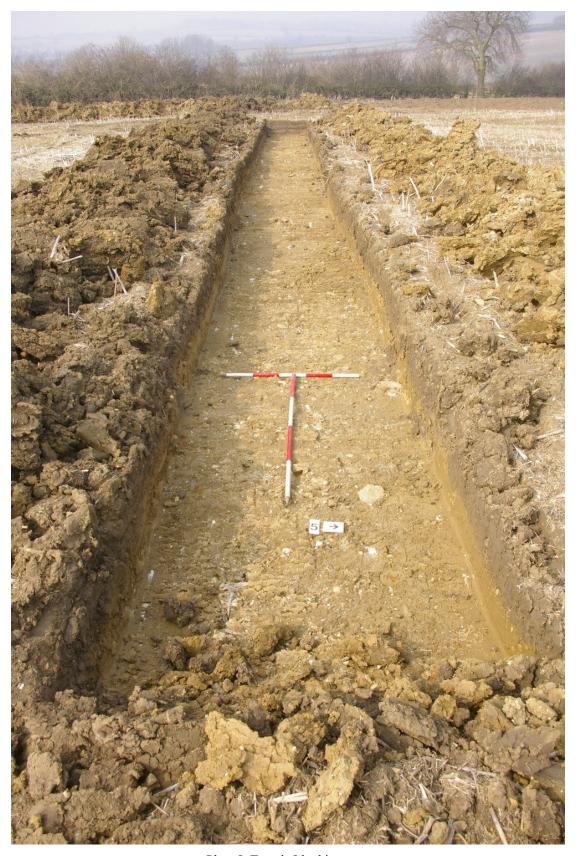
Plate 5: Trench 5 looking west

Trench 5 was located between Trenches 1 and 3 and was orientated east to west. Two modern field drains were recorded that cut the natural substratum. No archaeological features or finds were recorded within this trench.

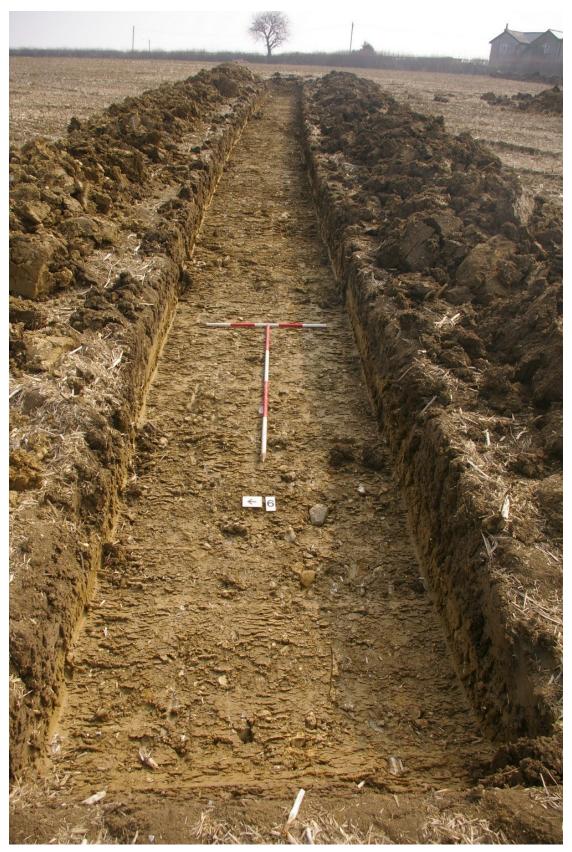
Plate 6: Trench 6 looking east

Trench 6 was located close to the north-eastern edge of the site, c.20m east of Trench 1. One modern field drain was recorded that cut the natural substratum. No archaeological features or finds were recorded within this trench.

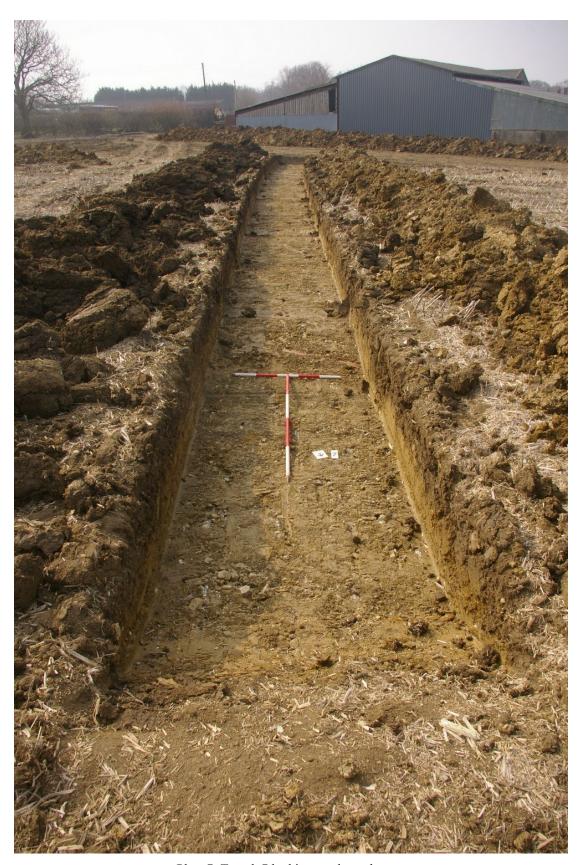
Plate 7: Trench 7 looking south south-west

Trench 7 was located c.8m south of Trench 6 on a north north-east to south south-west orientation. Five modern field drains were recorded that cut the natural substratum. No archaeological features or finds were recorded within this trench.

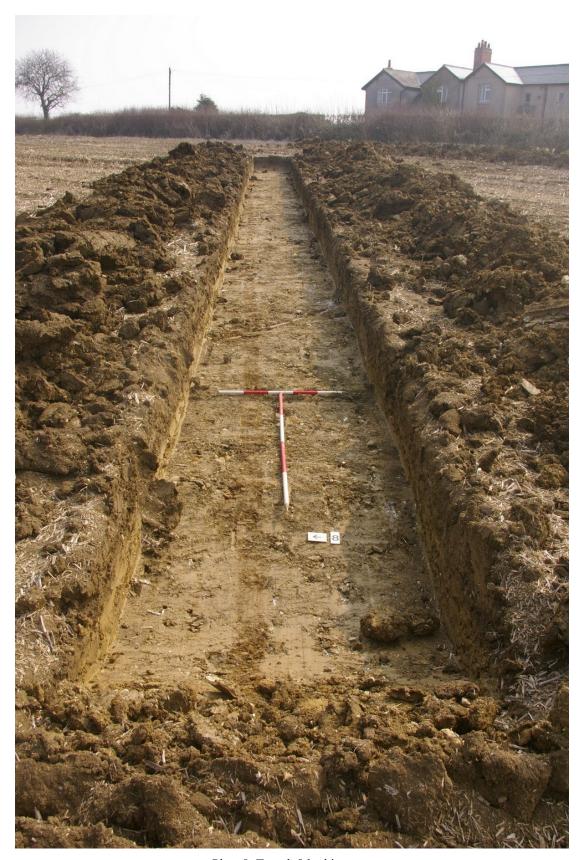
Plate 8: Trench 8 looking east

Trench 8 was located close to the north-eastern edge of the site, c.14m east of Trench 7 on an east to west orientation. Two modern field drains were recorded that cut the natural substratum. No archaeological features or finds were recorded within this trench.

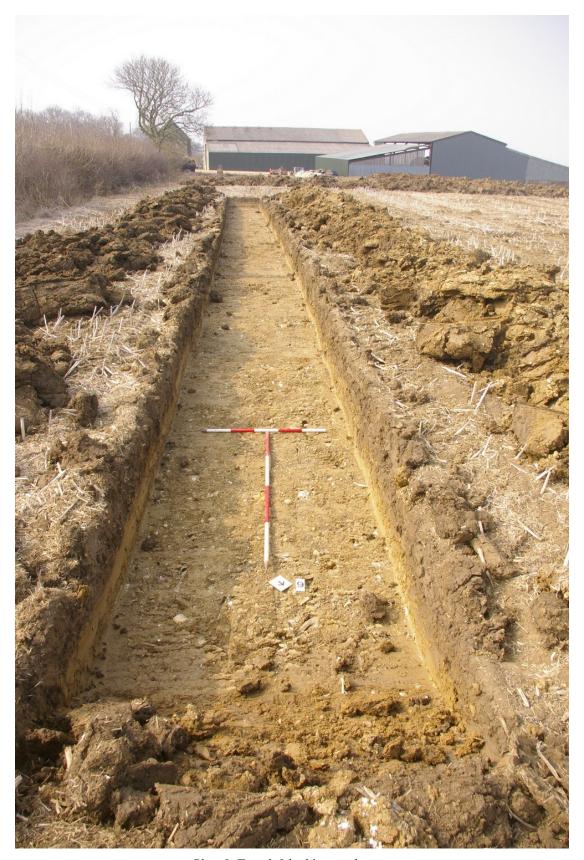
Plate 9: Trench 9 looking south-west

Trench 9 was located close to the south-east edge of the site, c.9m south-east of Trench 8 on a north-east to south-west orientation. Three modern field drains were recorded that cut the natural substratum. No archaeological features or finds were recorded within this trench.

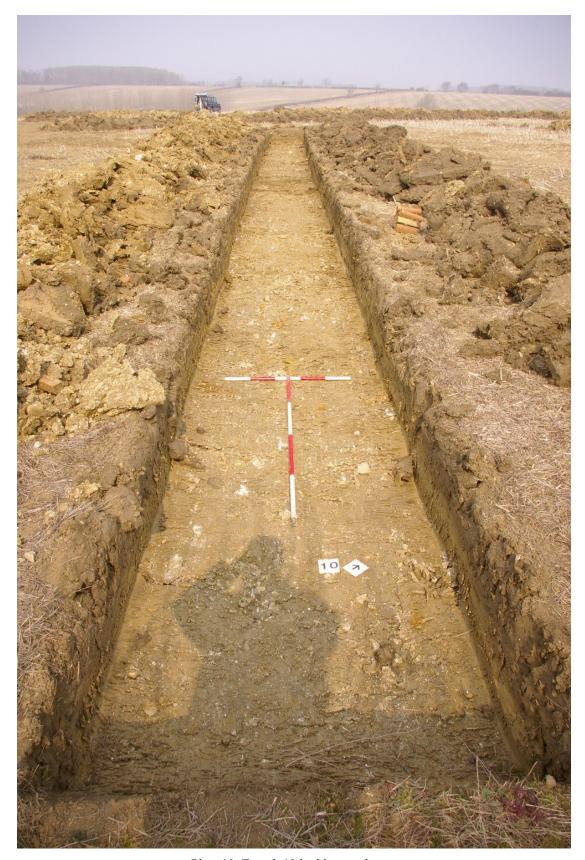
Plate 10: Trench 10 looking north-east

Trench 10 was located c.13m south-west of Trench 9 on a perpendicular north-west to south-east orientation. Two modern field drains were recorded that cut the natural substratum. No archaeological features or finds were recorded within this trench.

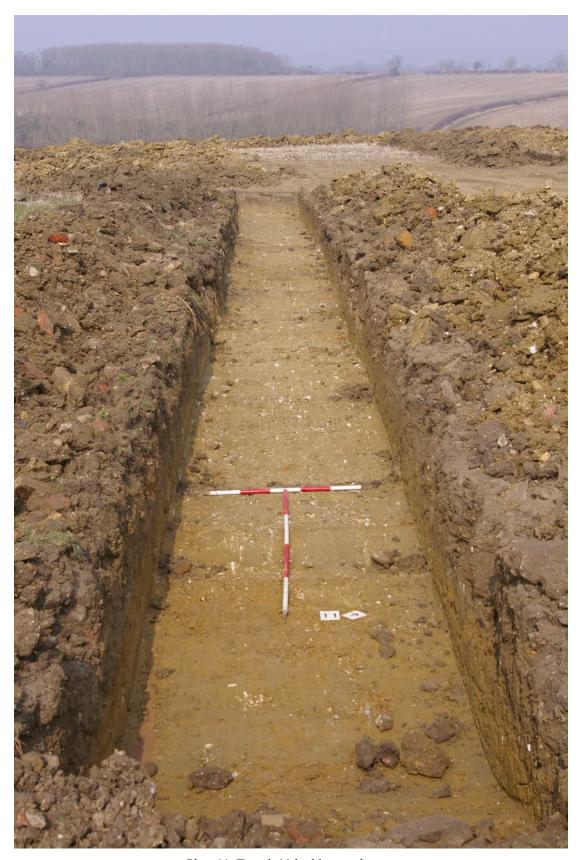
Plate 11: Trench 11 looking north-west

Trench 11 was located parallel to the north-east side of the existing barn on a north-west to south-east orientation. The topsoil within this trench was noticeably thicker and mixed with a large quantity of modern building rubble. Part of a modern pit was recorded c.7m from the north-west end of the trench. The feature could be seen as a rectangular earthwork extending towards the barn.
