**An Archaeological Field Evaluation
At Manor Farm, Drayton,
Leicestershire
(SP 832 919)**

ULAS Report Number 2006-057 ©2006

Summary

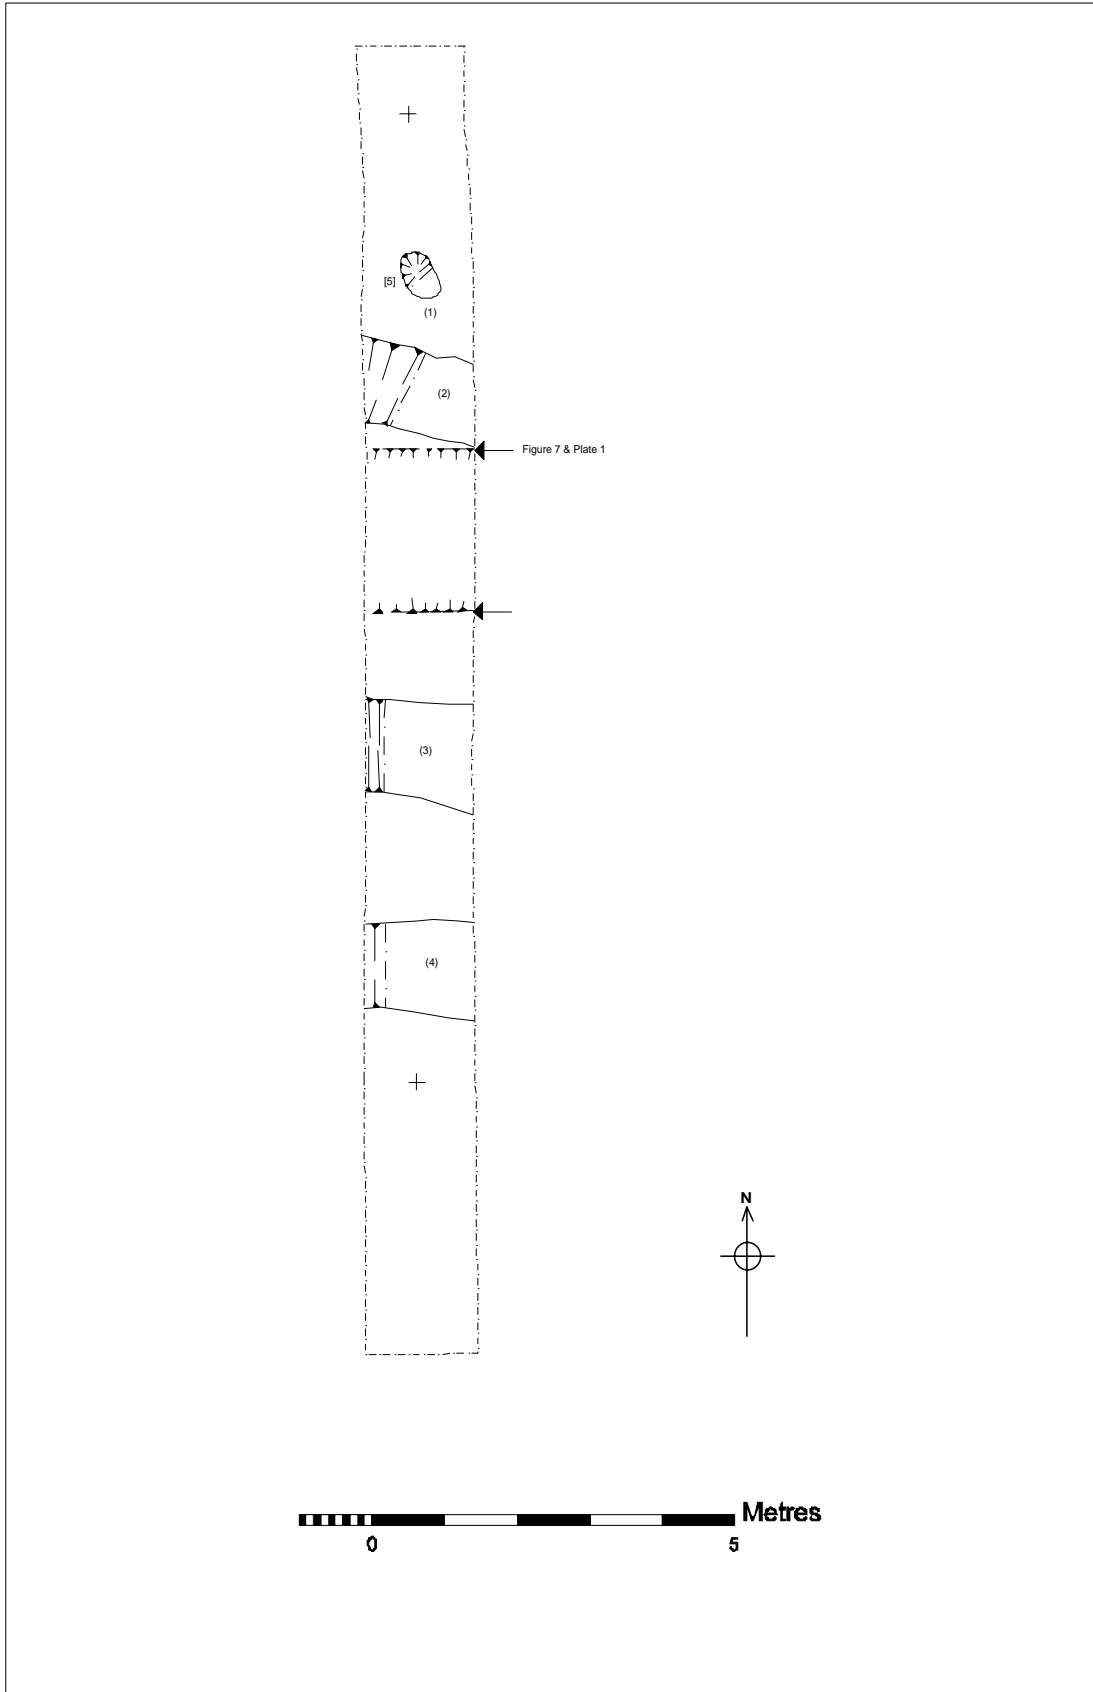
Figure 5: Post- excavation plan of Trench 01

The trench contained four features; three linear features, running east to west across the trench and a small oval pit [5] close to the northern end. The three linear features were fairly equally spaced from each other, at about 2-3m.

Feature (2), towards the northern end was on a slightly different alignment to the others. It was 0.95m wide and 0.08m deep and contained a fill of yellowish brown

silty clay with occasional very small stones and charcoal flecks. The base of the feature was almost flat. Features (3) and (4) contained very similar fills to (2), but were wider, at 1.3m. Both these features contained Roman pottery dated to the first century AD.

Feature [5] consisted of an oval pit with even sloping sides and a curved base. It contained a fill (1) that consisted of crumbly yellowish brown silty clay. A piece of post-medieval brick was found within this feature.

This trench was situated inside the large open barn at the eastern edge of the site (Figure 4). It was oriented north-south, was 19m long and 1.5m wide (Figure 5).

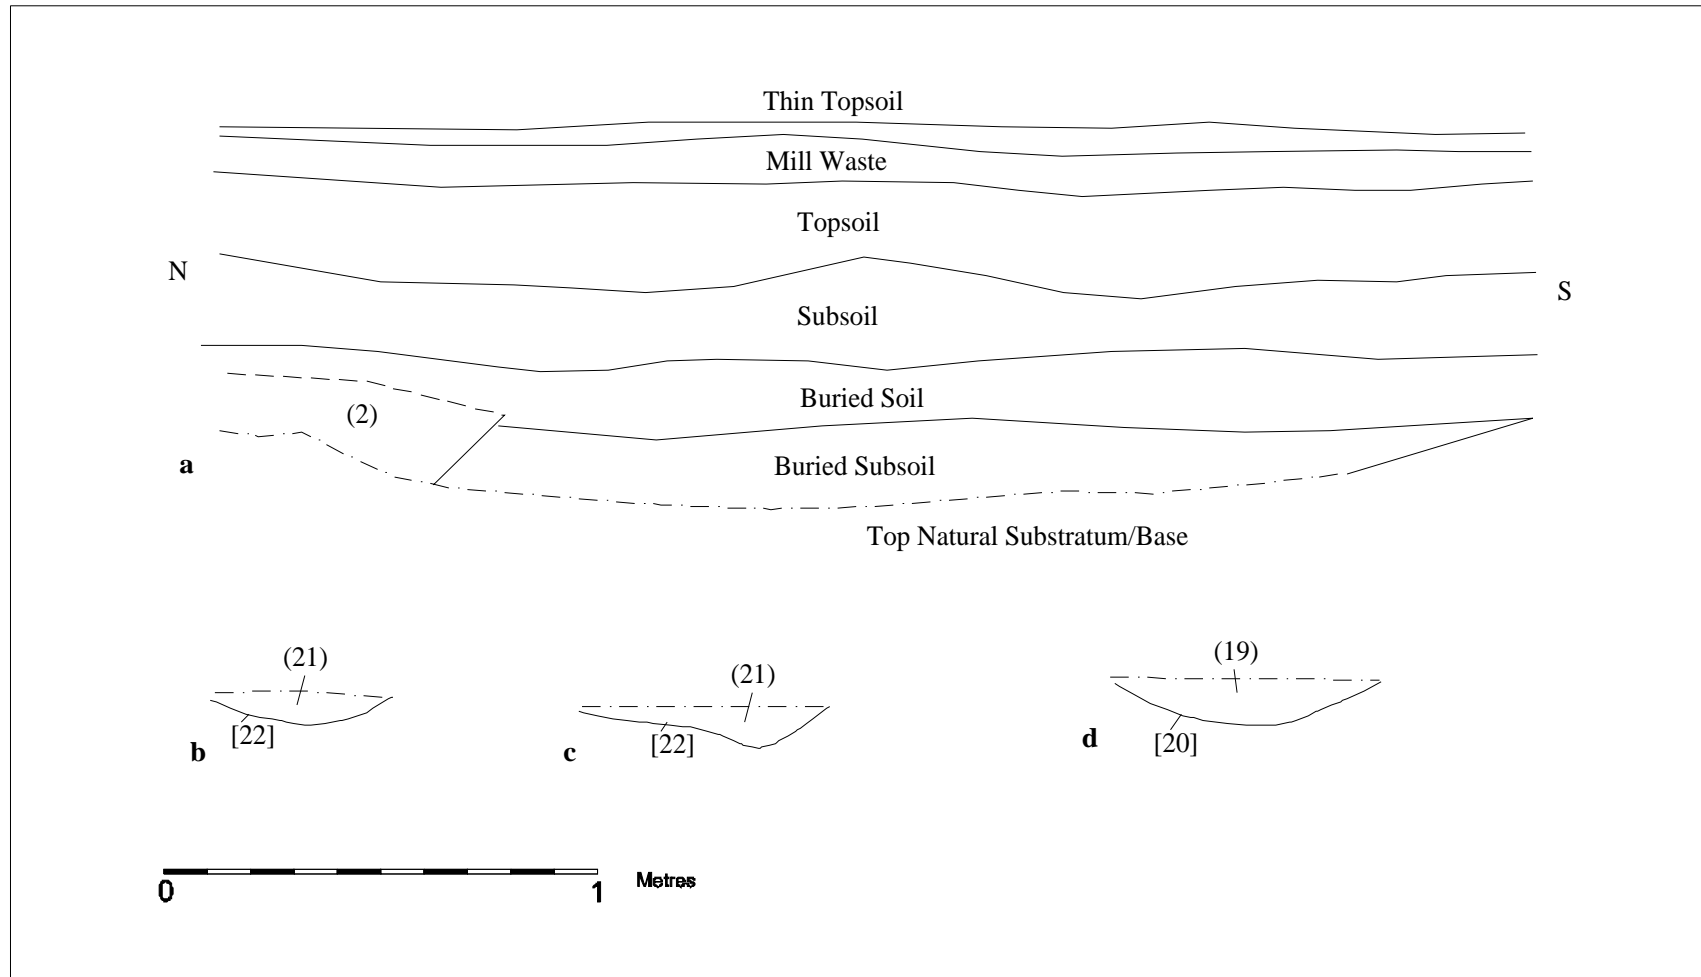
Figure 7: a. West Facing Section of Trench 01, showing soil sequence. b. South facing Section of [22]. c. West Facing Section of [22]. d. SW facing section of [20]

During the excavation of the trench it was often difficult to tell whether the natural substratum had been reached. As work progressed it became apparent that the trench contained a complex series of deposits, containing buried soils and layers that may have been the result of levelling or colluvial deposition (Figure 7a & Plate 1). In order to attempt to clarify the descriptions of these layers, the very thin layer of topsoil and grass at the top of the trench has been called 'turf' layer. The make-up layer consisted of grey mill waste hardcore. The upper topsoil consisted of yellowish grey and brown silty clay with very few small stones and was compacted under the mill waste. The subsoil was yellowish brown silty clay with iron pan flecks, whereas the buried topsoil was compacted dark yellowish brown silty clay.

The trench contained a sub-circular pit, with a shallow and a steep sided cut [20] (Figures 6& 7d). The pit measured 0.6m in diameter and was 0.1m deep with a fill (19) of reddish brown silty clay. The feature contained no dating evidence.

A further linear feature ran across the trench from northwest to southeast, with an apparent return at the northwest end, which ran south. The cut [22] was shallow and was 0.6m wide and 0.1m deep and contained a fill (21) of reddish brown silty clay (Figures 7b & 7c & Plate 4). The feature contained no dating evidence.

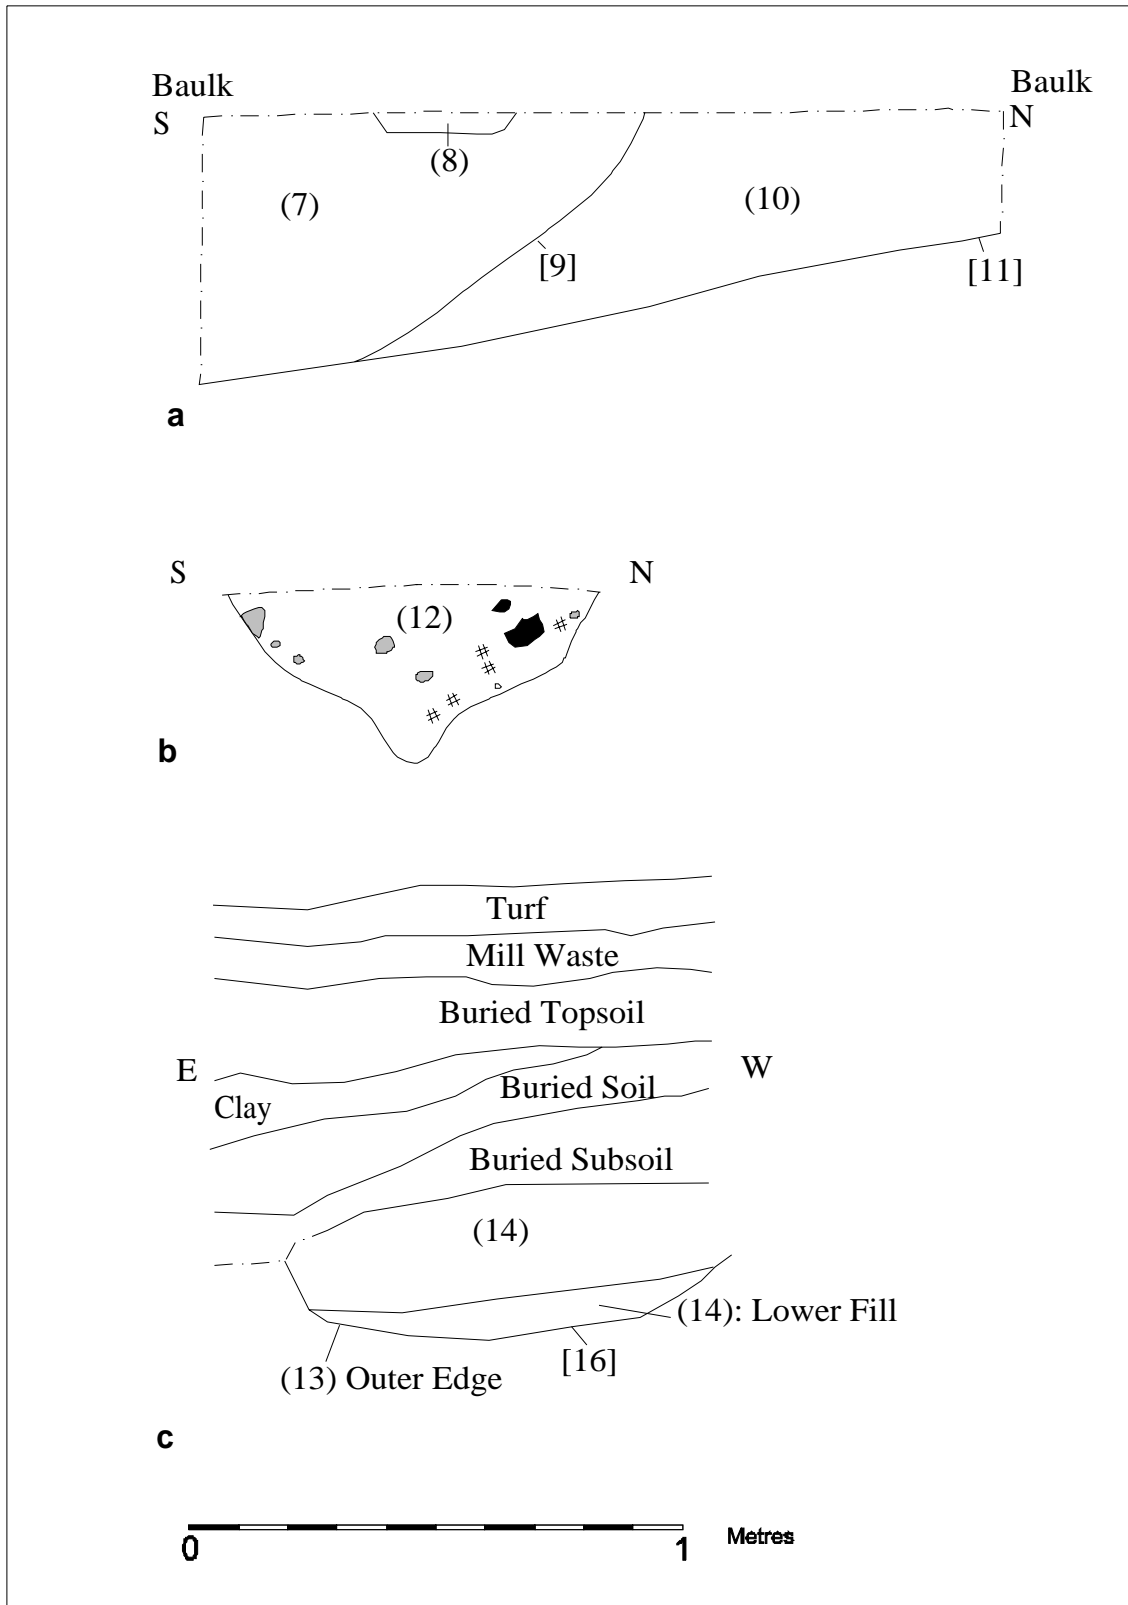
Figure 8: a. East facing box section of ditch features, Trench 03. b. East Facing Section of (12). c. North facing Section of Trench 03, showing [16].

The trench contained many features. A series of varied cuts and fills ran across the trench at the east end from south east to north west. A box section was placed across this end of the trench in order to clarify these features (Figure 8a). A large linear cut [11] ran across most of the width of the trench, with its northern side obscured by the baulk of the trench. This cut contained a heavily compacted reddish brown silty clay fill (10) and a further steep cut [9], which itself contained a fill (7) of compacted mid-brown silty clay. Within this fill was a thin layer of yellow sand (8), which also ran along the same alignment. This fill was less than 0.05m thick.

A curved linear feature (12) lay across the centre of the trench and ran, broadly east to west, although it meandered somewhat and appeared to end in a butt-end to the north west. It varied in size from 0.2-0.6m wide and in places the edges were very vague, particularly where it met the linear features [11] and [9] at the eastern end of the trench. There appeared to be no obvious cut for this feature and the fill was very varied. The fill was mostly brown and grey silt and silty clay and contained a variety of small and large stones, charcoal chunks and very large degraded roots (Figure 8b & Plate 2). It also contained post-medieval brick and pottery and also a fragment of a Late Saxon bowl rim.

Two further features ran across the trench from north to south. Feature [16] (Figure 8c) appeared to cut (12) and also a further feature (13), which lay close to the intersection of (12) and [16]. Feature [16] was 0.75m wide and 0.15-0.25m deep with a flat base and steep sides and contained a fill (14) of mid-yellowish brown silty clay that contained pieces of bone and small stones. This fill appeared to consist of solid clay at the base.

By far the most substantial and interpretable features discovered during this evaluation are the series of features in Trench 03. Initially, feature (12) seemed vague and difficult to interpret with an uneven structure and size and a fill that contained finds from many periods including Saxon pottery, post-medieval pottery and brick and modern metal. Further investigation showed that the structure of parts of the feature resembled the remains left by trees or bushes. As this feature appears to follow the same line as cuts [11] and [9] it is most likely that these features represent a hedge line with and substantial ditch [11] to the north, which has been recut at some point and is represented by cut [9]. The tiny stake holes close to the southern baulk of Trench 03 may be evidence of the hedge having been laid at some time to hold in stock. The tree-bole type feature (6) in Trench 02, is on a similar alignment to (12) and may also represent another component of the hedge. Fill (8) is more puzzling, but its sandy nature may suggest the bedding for a drain, now removed, that lay within the edge of the ditch, possibly after the hedge had been removed.

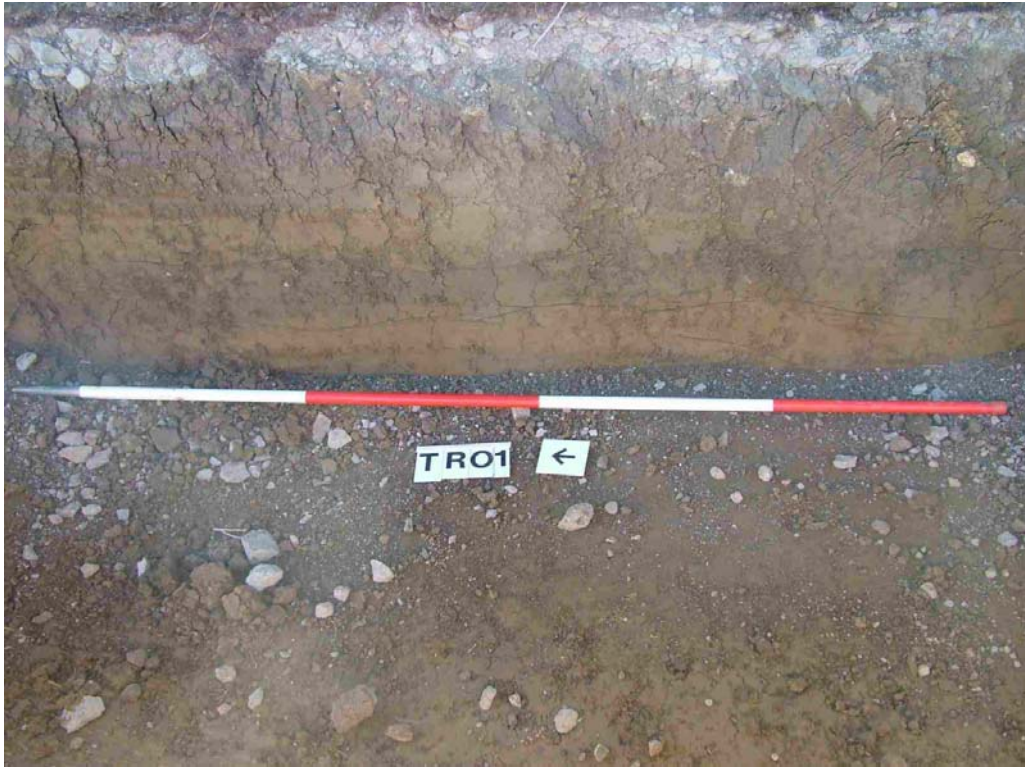
Plate 1: West facing section of Trench 01, showing buried soils

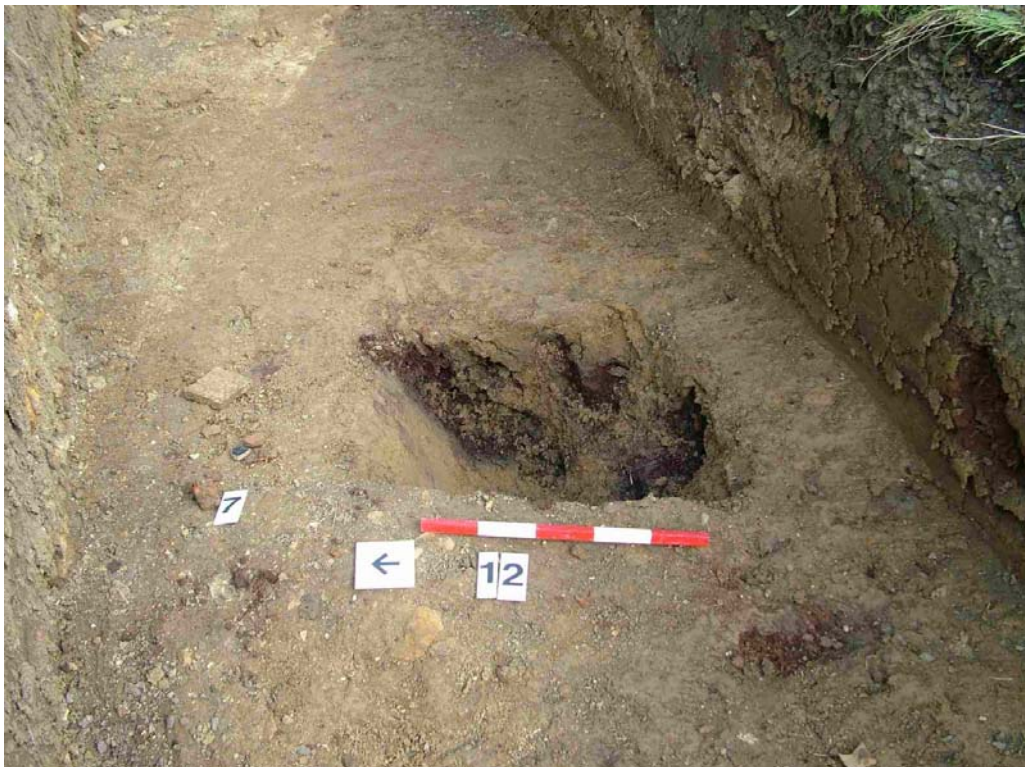
Plate 2: West facing Section of (12), showing heavy root action

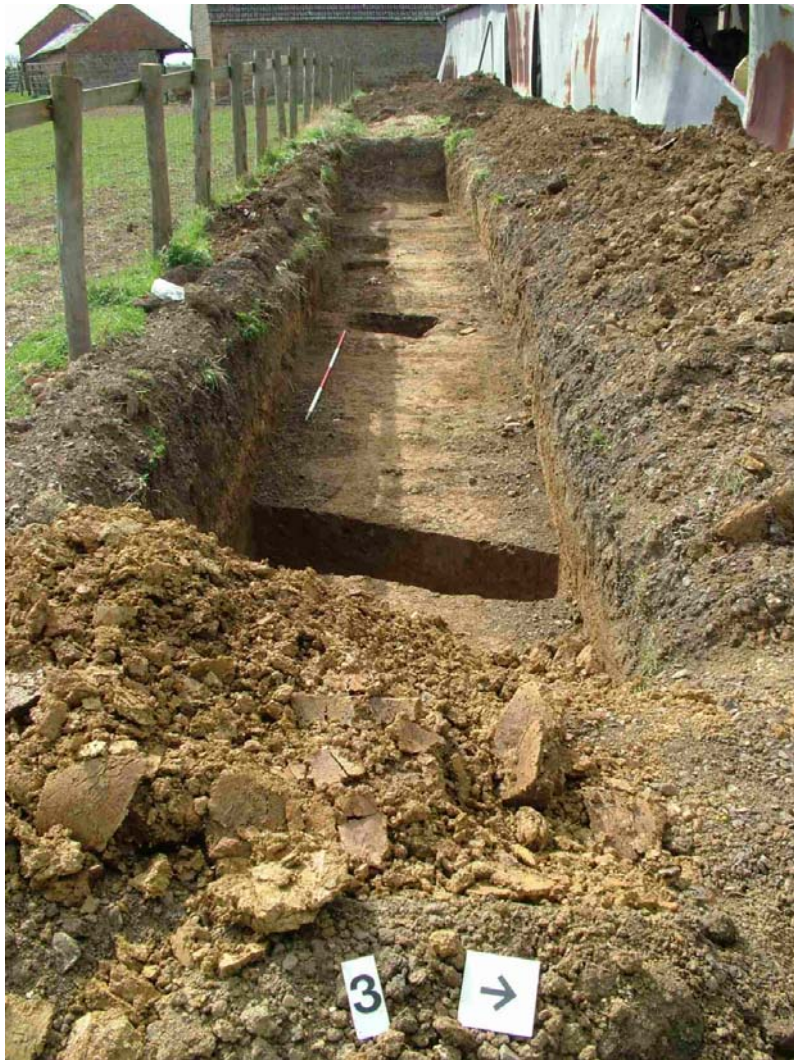
Plate 3: Post-excavation photo of Trench 03, looking West

This trench was also placed to the south of the large central barn a few metres to the east of Trench 02 (Figures 4 & 6b & Plate 3). The sequence in the south facing section was very similar to that of Trench 02, but the north facing section was closer to the sequence in Trench 01, with a layer of buried topsoil and subsoil under the upper soils. The trench was 13.9m long and 1.5m wide.

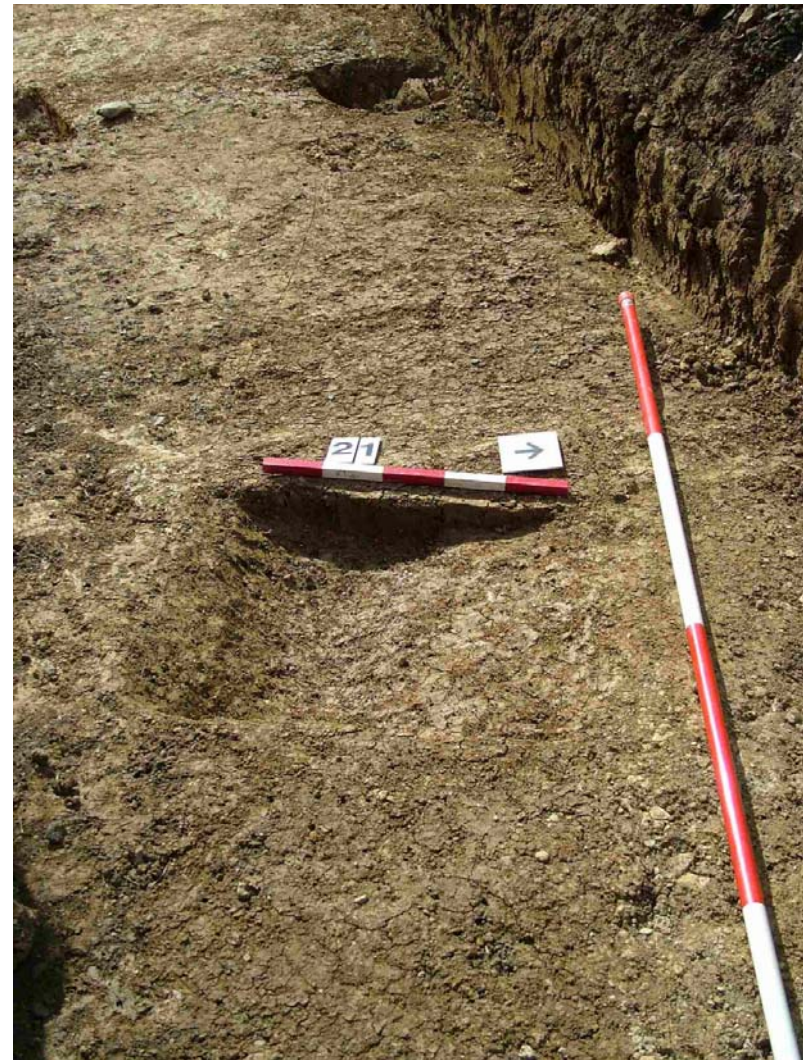
Plate 4: SE Facing Section of (21)[22], looking NW

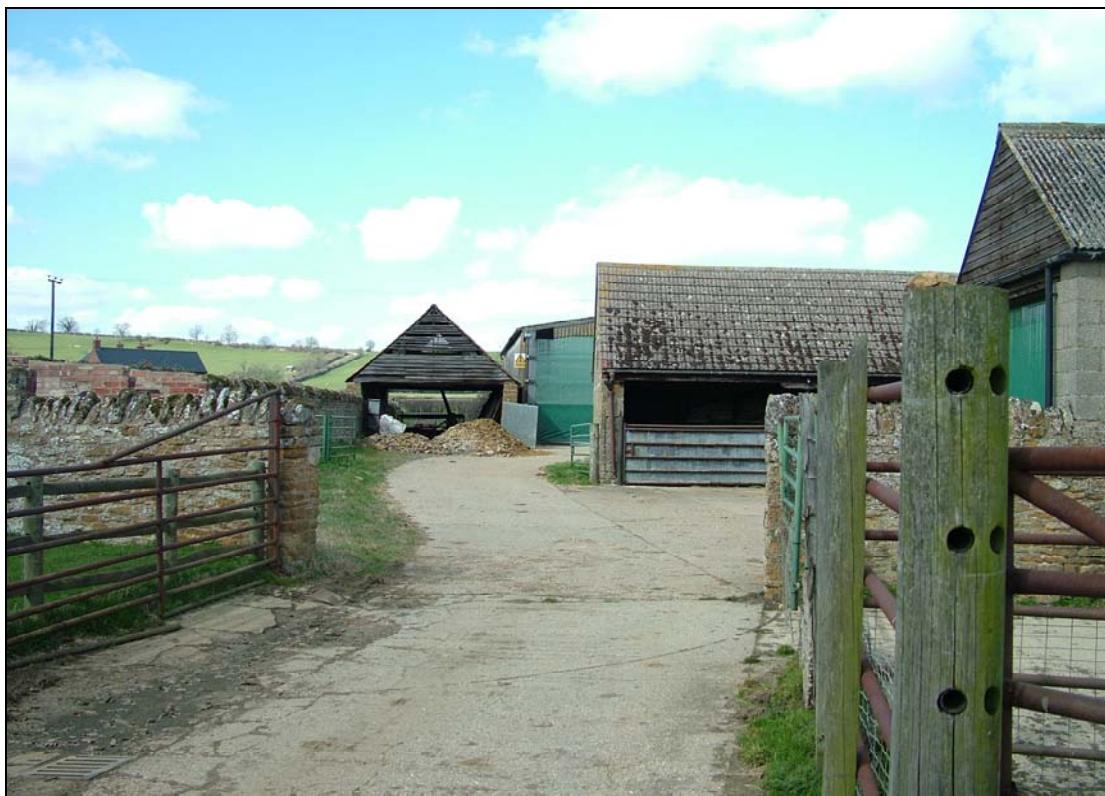
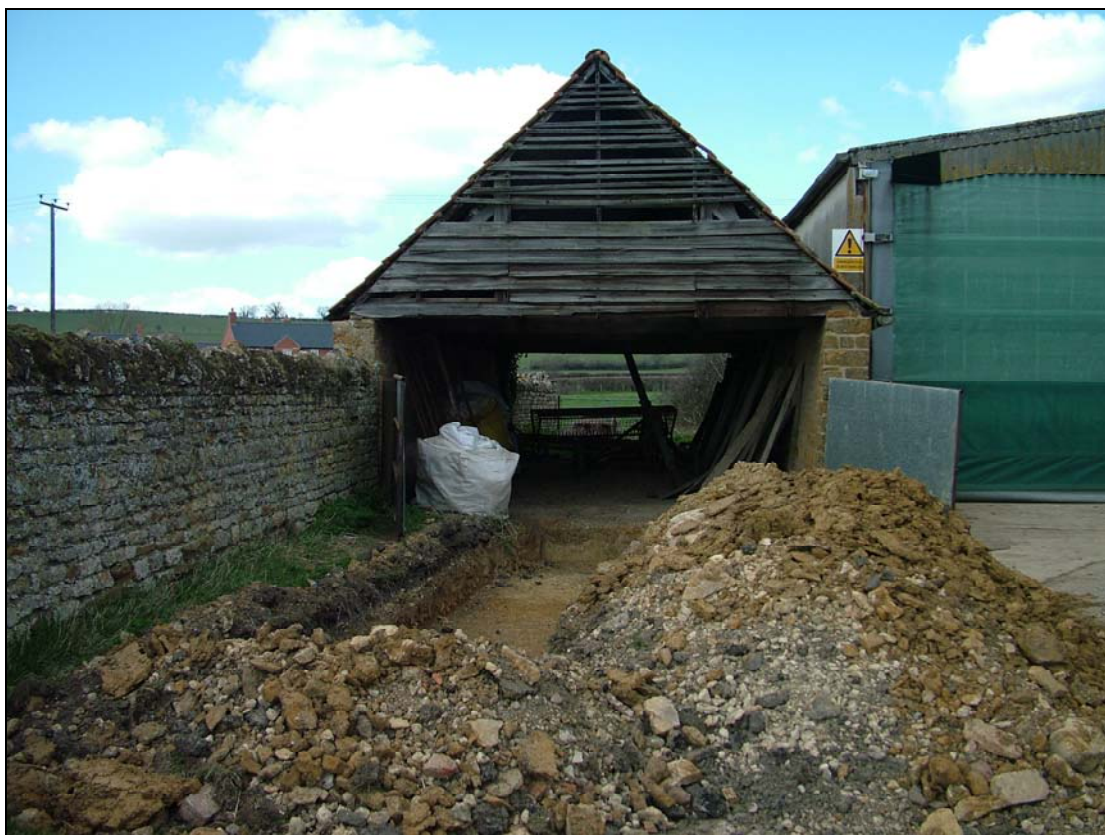
Located in the western side of the site on a northwest to southeast alignment (Plates 5 and 6). It is constructed of coursed ironstone rubble with a wooden roof structure covered in clay pantiles. Each gable end is closed using horizontal wooden slats. Both ends are open with no evidence for the existence of doors. The eastern wall is constructed from large blocks of coursed ironstone rubble with a distinct outward lean probably caused by the weight of the roof. Most of the outer side of this wall is obscured by a modern steel framed barn. The western barn wall has been constructed in two stages. The lower 1.5m is made of narrow courses of ironstone rubble which appears to have originated as a substantial boundary wall running the from the northern edge of the site towards Main Street (Plate 7). The full barn height has then been achieved using larger coursed blocks of ironstone. The barn floor consists of a closely packed layer of ironstone chippings covered by silt.

Plate 5: Barn/ cart shed looking north. Courtyard buildings on right

Plate 6: Barn/cart shed, looking north

The roof is based on a series of queen posts/struts which are fixed to tie-beams using iron stirrups. A strainer beam is located between the queen post/struts. The queen post/struts are notched to accept the principals which rise from the tie-beam. The purlins are carried on cleats fixed to the backs of the principals supporting the common rafters which are fixed at the apex to a ridge piece. In a comparative study of roof structures in Staffordshire J E C Peters suggests that such a roof was not seen until after 1820 (Peters 1988).

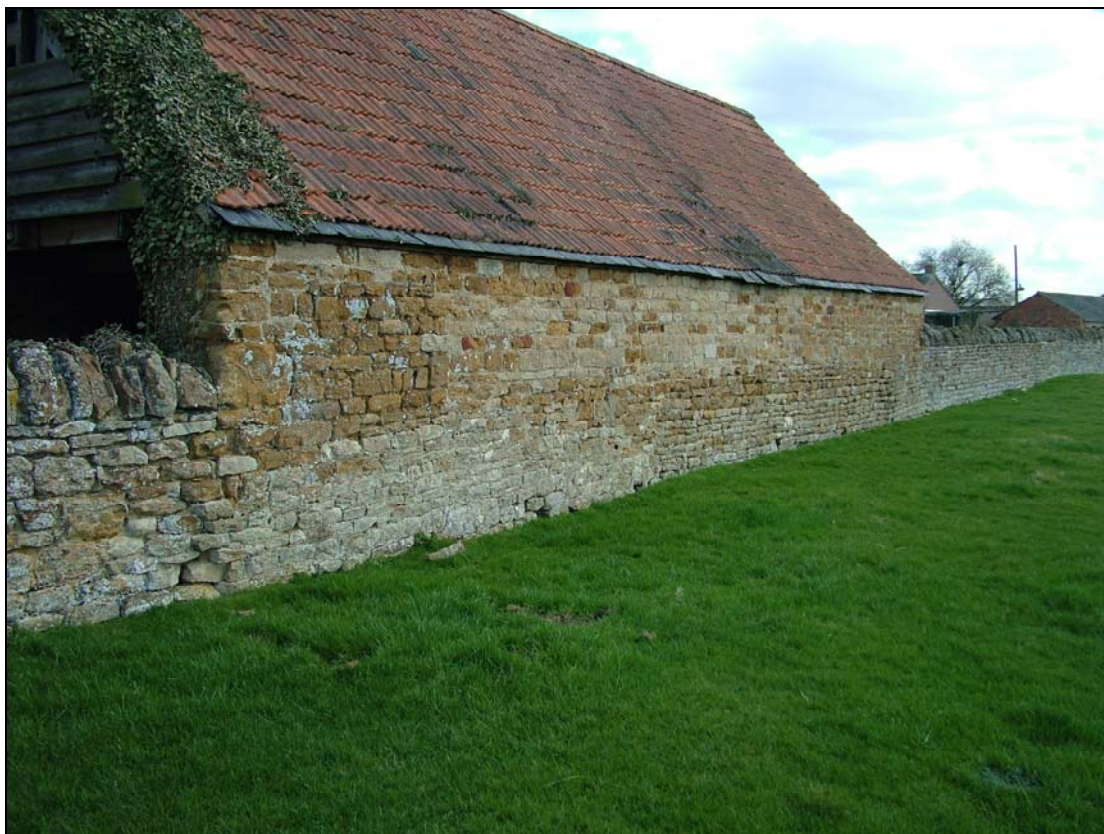
Plate 7: West wall of barn/ cart shed showing use of existing boundary wall, looking SE

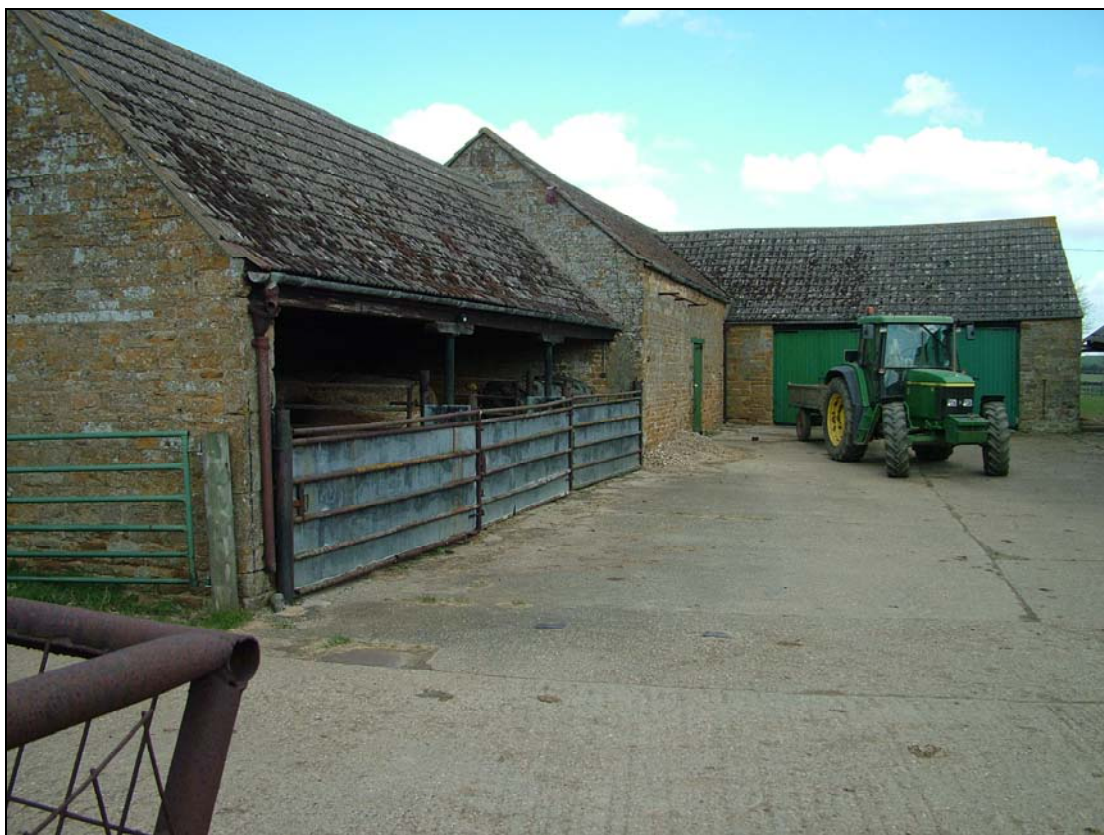
Located in the northwest of the courtyard the barn is open fronted to the south (Plate 8). The north and west walls are of coursed ironstone rubble with the corner being made from alternate squared blocks some of which appear to be limestone, the remainder being ironstone. The external face of the north wall is screened by a

Located in the northeast corner of the courtyard this is the largest of the courtyard complex of barns (Plate 8). All walls are of coursed ironstone rubble with large dressed alternate quoins with a cement tile roof using the same construction method as in the cart shed roof (Plate 10).

Plate 8: Barns C1, C2, C3, looking northeastwards

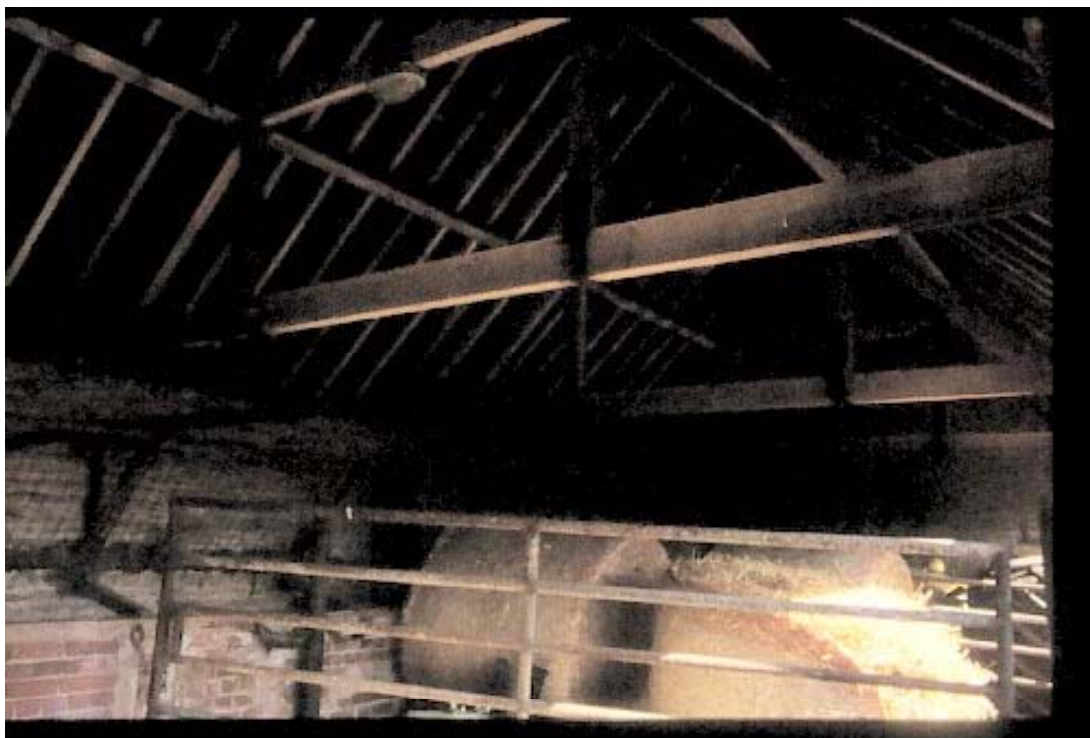
modern steel framed barn making inspection impossible. The east end of the north wall butts against the west end of barn C2 so that C1 uses this as its east wall. The gable of the roof is around 0.5m lower than that of adjacent barn C2. A small square window has been blocked off just below gable height in the west wall. The open south face of the barn is divided into three bays with two cast iron pillars supporting the cement tiled roof having the same wooden structure as the cart shed. The purlins of this roof have been let into the west wall of barn C2. Inside, a brick built animal trough runs along the length of the back, north, wall.

Plate 9: Internal north wall of C1

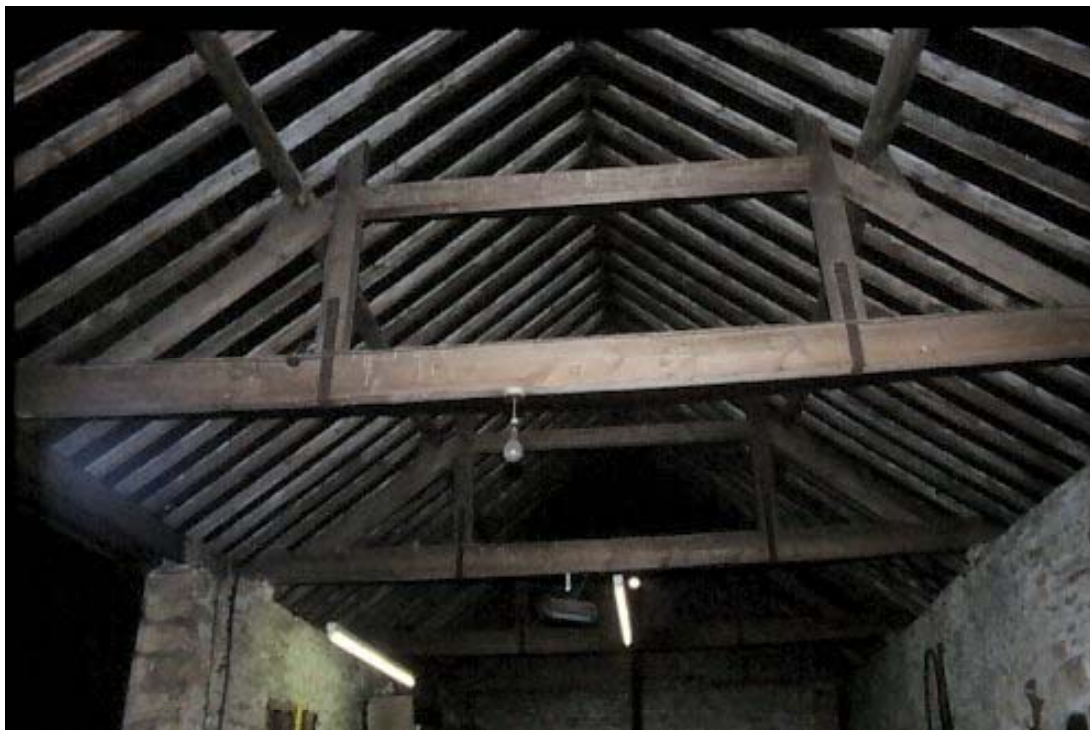
Plate 10: Internal roof structure of Barn C2

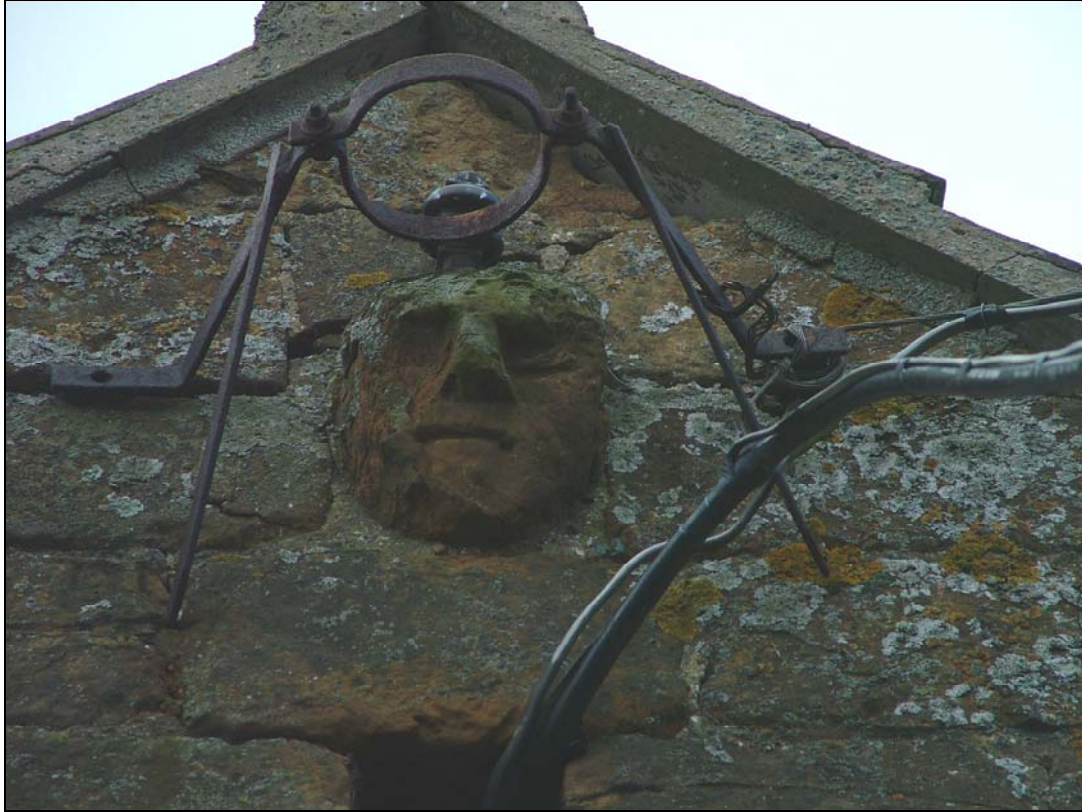
Plate 11: Ironstone face on east gable of barn C2

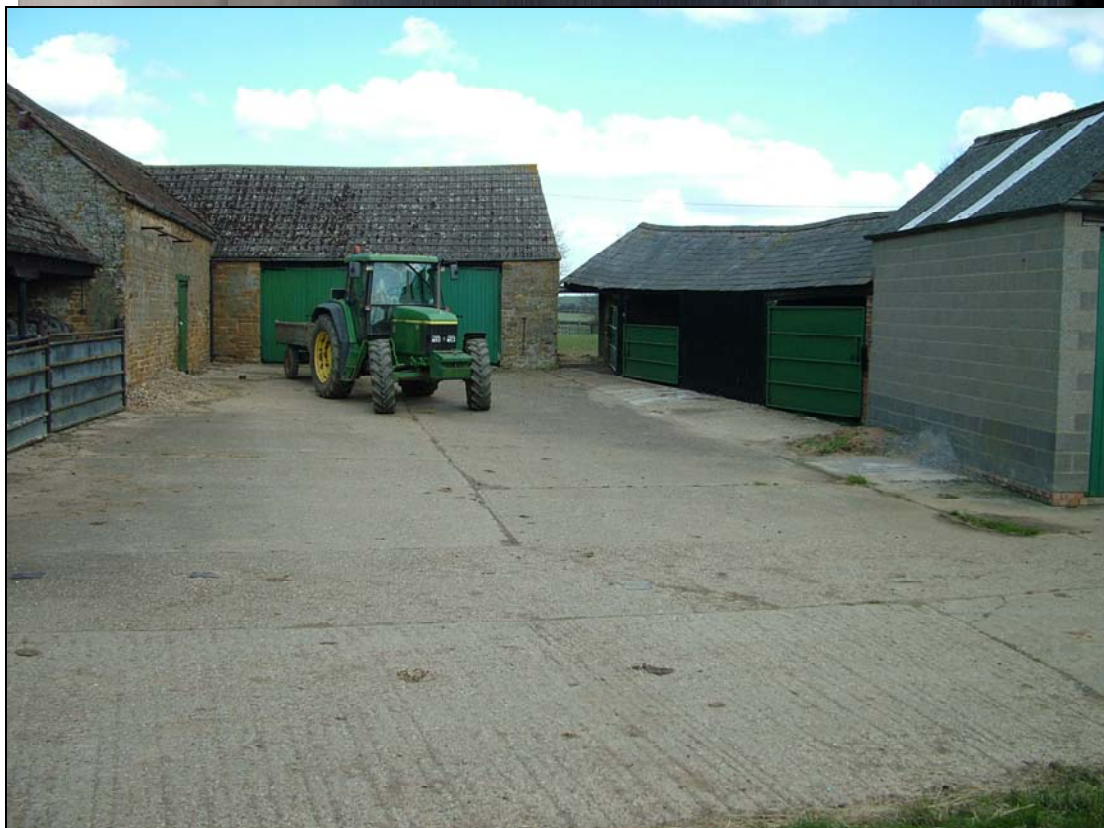
Barn C3 uses barn C2 as its northern wall as mentioned above. The west wall has two double full height doors opening onto the courtyard but with no other openings (Plate 13). A slight chamfer has been cut to round the southwestern corner where a narrow entrance gives access to a rear paddock. A narrow slit window has been blocked with brick on the otherwise featureless south wall. The eastern wall was also blank.

brick gable ends (Plate 14). The timber roof structure is the same as the other buildings in this survey but supports a Welsh slate roof. Internally the floor is of concrete, which extends continuously from the courtyard into the barn. Brick built animal troughs run along the length of the south wall.

Plate 14: Courtyard buildings. West face of barn C3 and north face of barn C4

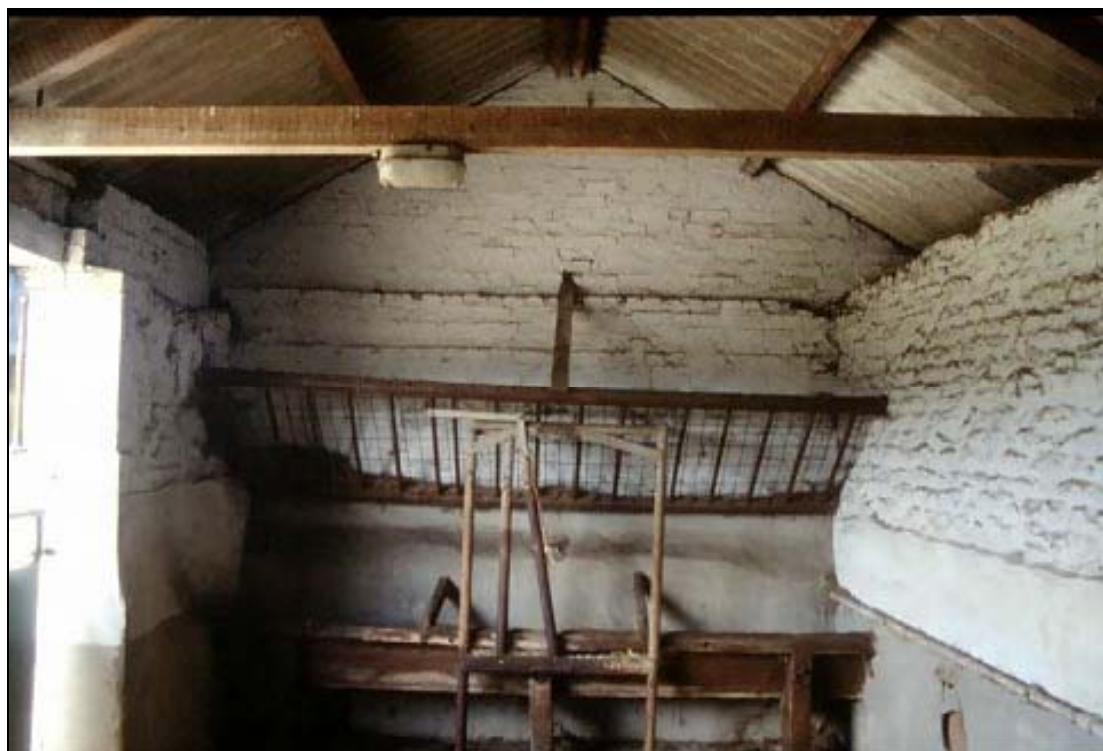
The later part of the stables steps back from the driveway to create a narrower structure. The east and west walls butt against the north wall of the earlier building. It has two full height double doors opening onto the driveway and square central window on the eastern side. The window is timber framed and has a re-used lintel with numerous mortice holes from an earlier use. Internally there are animal troughs at the north and south ends of the building (Plate 16).

Plate 16: Stable interior looking north
