An archaeological desk-based  
assessment for land off  
Main Street,  
Frisby on the Wreake,  
Leicestershire  
(SK 694 176)

ULAS Report No 2012-011  
©2012

## **An archaeological desk-based assessment for land off Main Street, Frisby on the Wreake, Leicestershire (SK 694 176)**

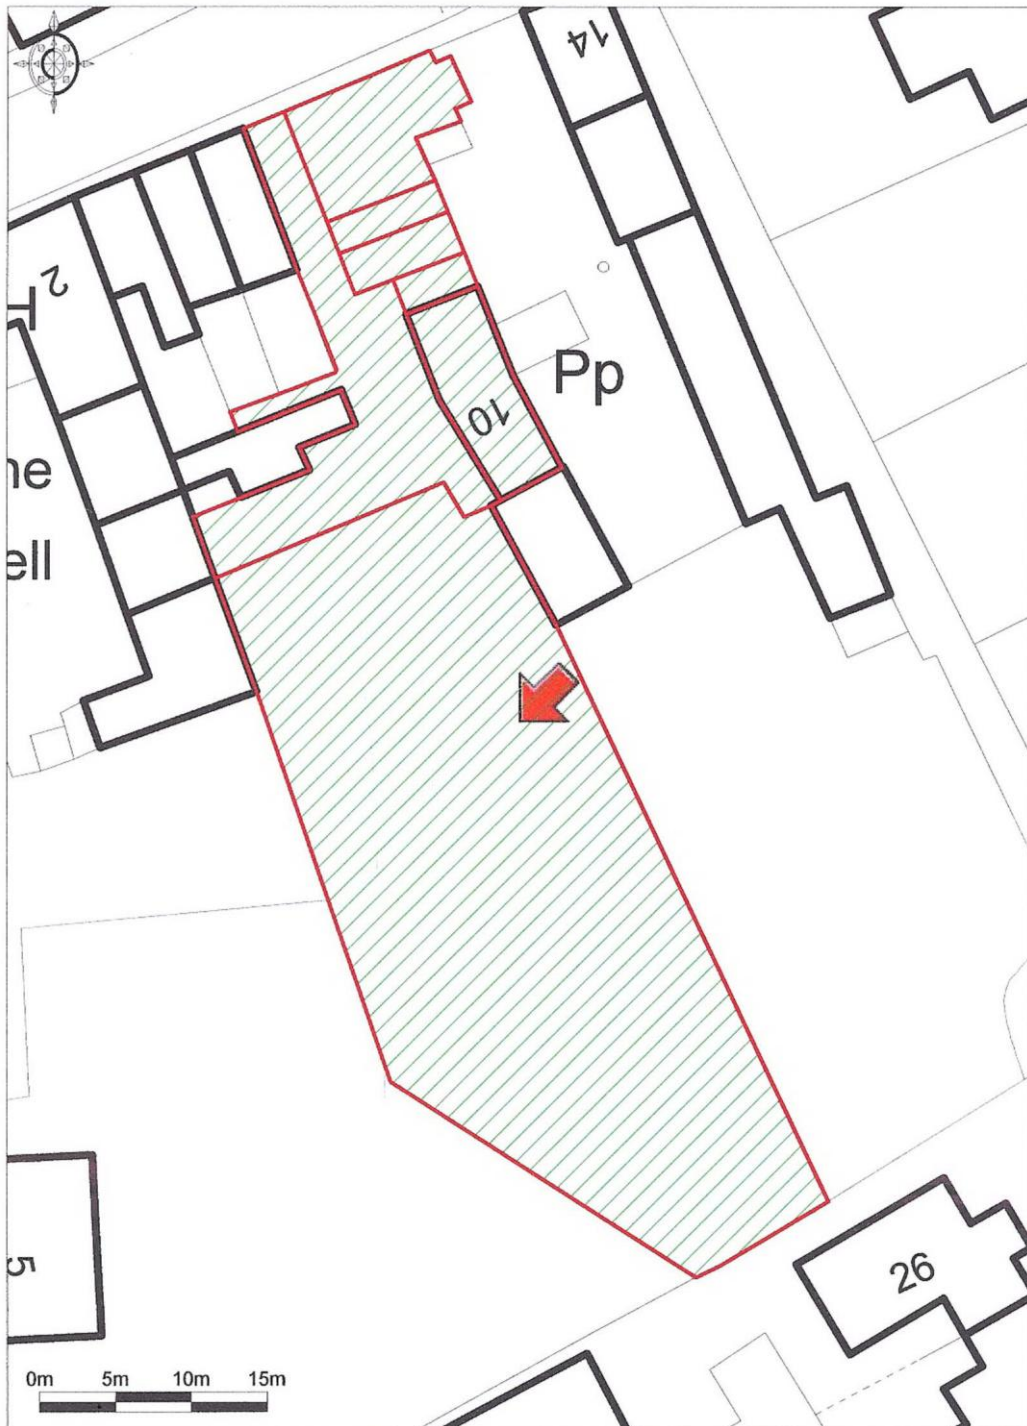
Figure 2: Site location plan. Provided by developer

Frisby on the Wreake lies in the Melton District of Leicestershire, around 4.5 miles (6km) west of Melton Mowbray (Figure 1). The site lies to the rear of 8a, Main Street, Frisby and consists of a narrow grassed entranceway, leading to a small area of grass

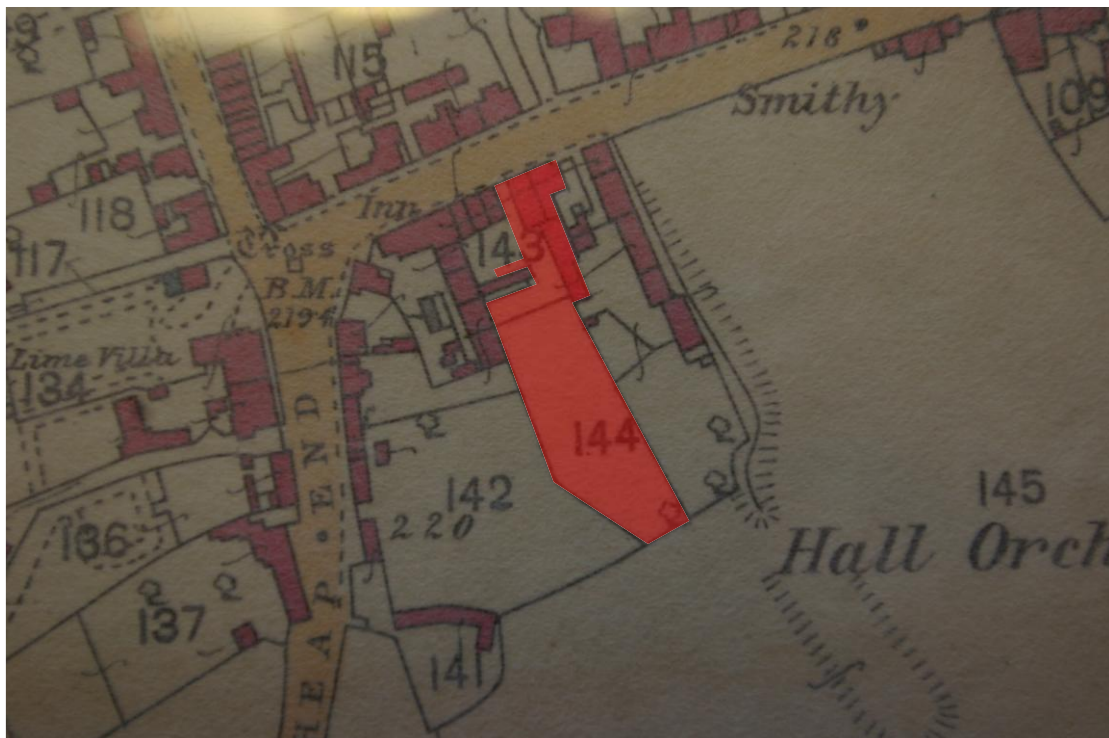
Figure 3: Detail of 1st edition OS map, sheet XIX.11, with assessment area highlighted. Scale 25 inch to 1 mile

The 1st edition map shows the site in a form very similar to the present day (Figure 3). The 2nd edition map, dated 1900, is much the same with a small edition to the neighbouring buildings (Figure 4).

There are no early maps of Frisby on the Wreake available. The earliest map available is the 1st edition Ordnance Survey map, dated 1886 (Figure 3).

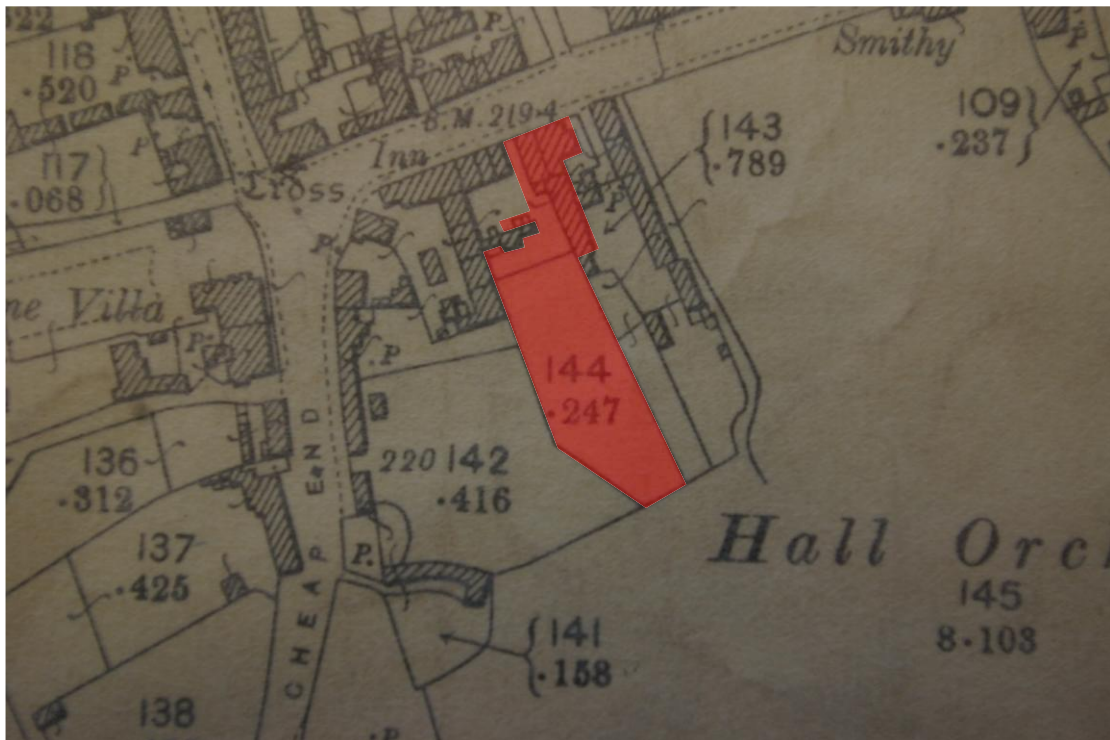
Figure 4: Detail of 1900 OS map, sheet XIX.11, with assessment area highlighted. Scale 25 inch to 1 mile

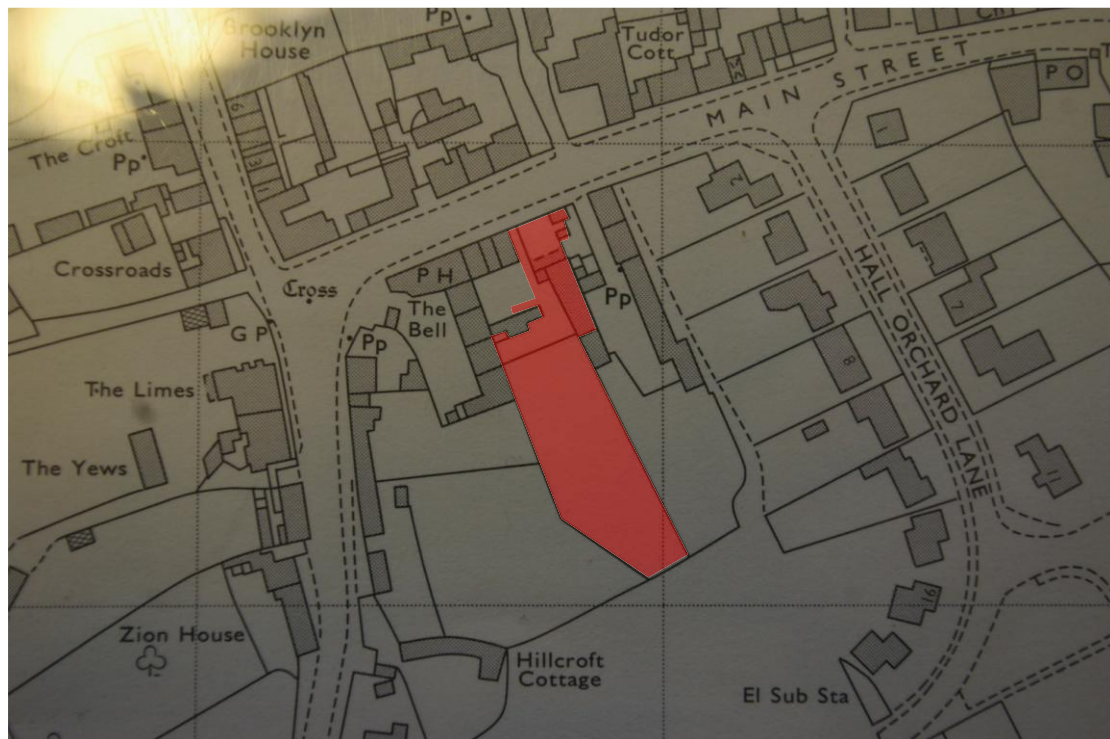
Figure 5: Detail of 1973 OS map, sheet SK 6817-6917, with assessment area highlighted. Scale 1: 2500

There are no further maps at this scale until the 1973 edition, which shows an identical layout to the present one. There is a 1986 edition, but this is identical to the 1973 edition and is therefore not illustrated.

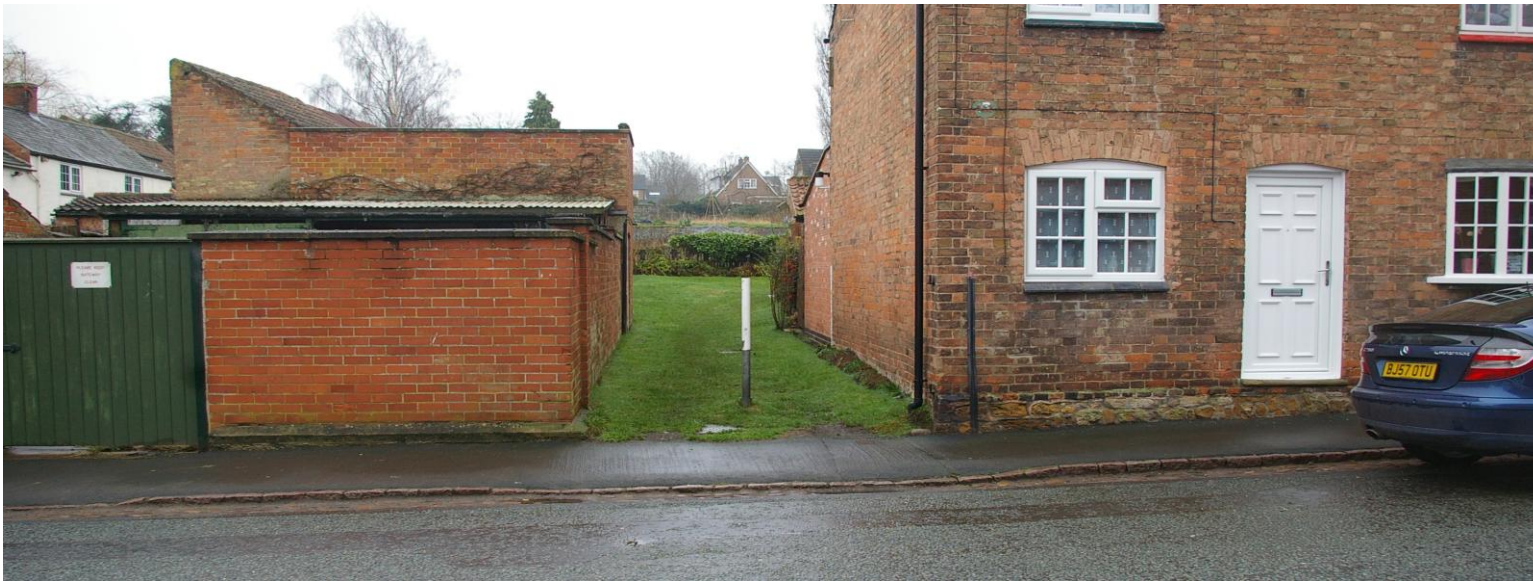
The site is accessed via a narrow grassed path between the neighbouring properties (Plate 1). The path leads around to the back of the properties to the west of the site. On the eastern side of the site are a number of dilapidated brick out-buildings, which face eastwards (Plate 2). This area is mainly flat with a slight rise to the south.

Plate 1: Entrance to the site along Main Street, looking south south-east  
Plate 2: The grass and the out-buildings at the north-east edge of the site, looking north-east

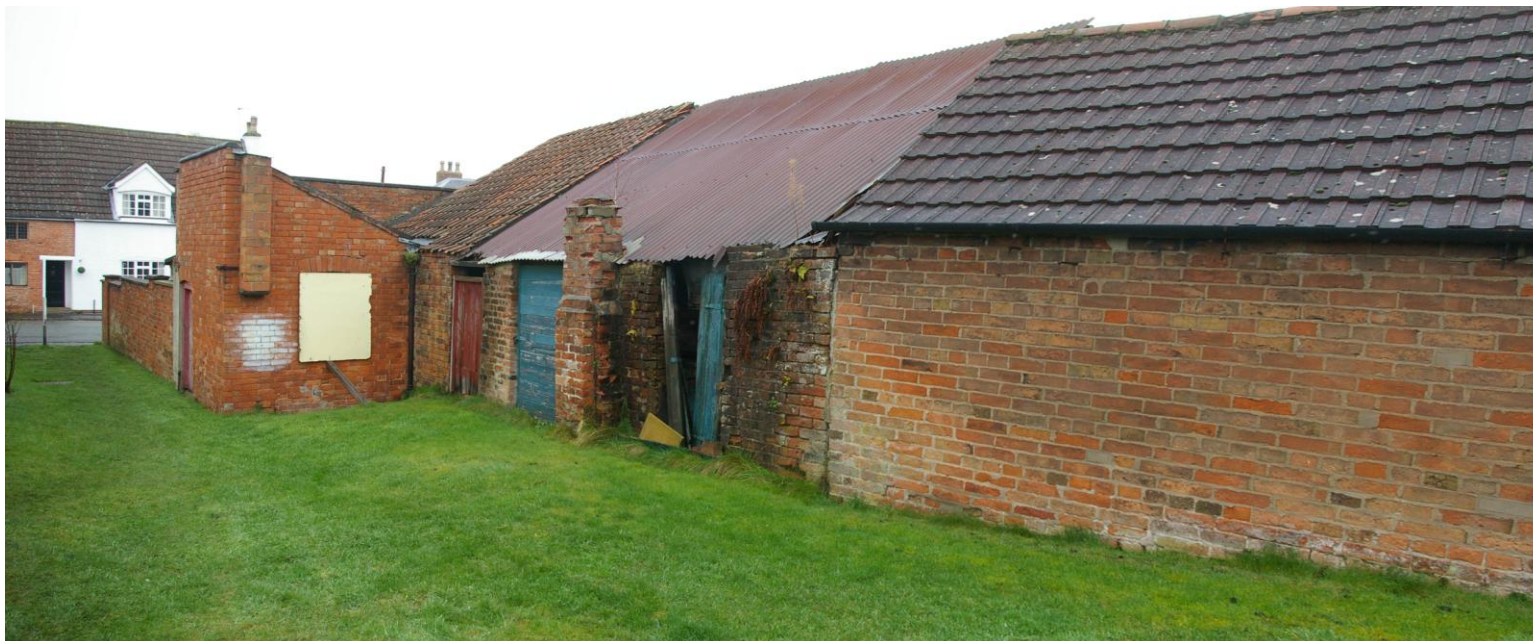
The proposed development would appear to include the demolition of the dilapidated out-buildings at the north-east edge of the site. This may be of some interest as vernacular buildings and may warrant an appraisal or survey.

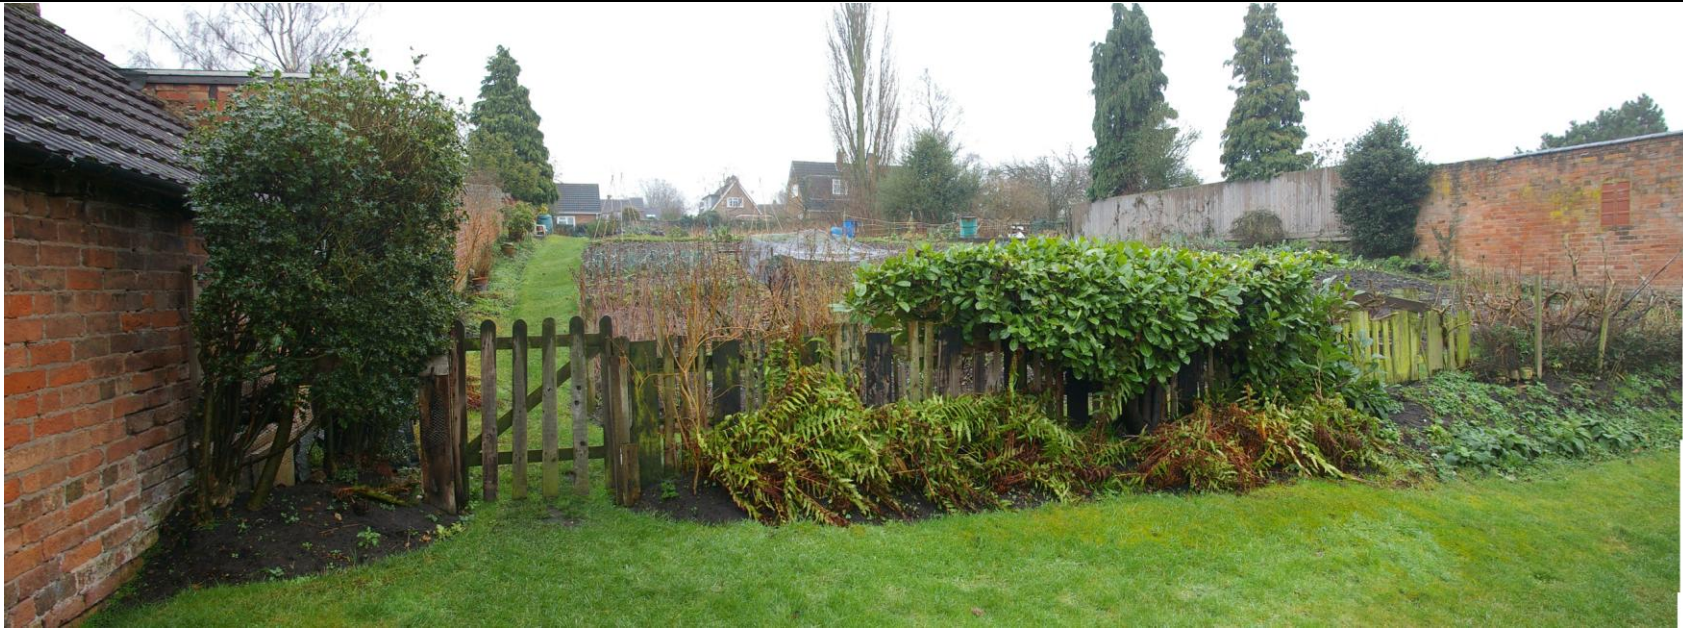
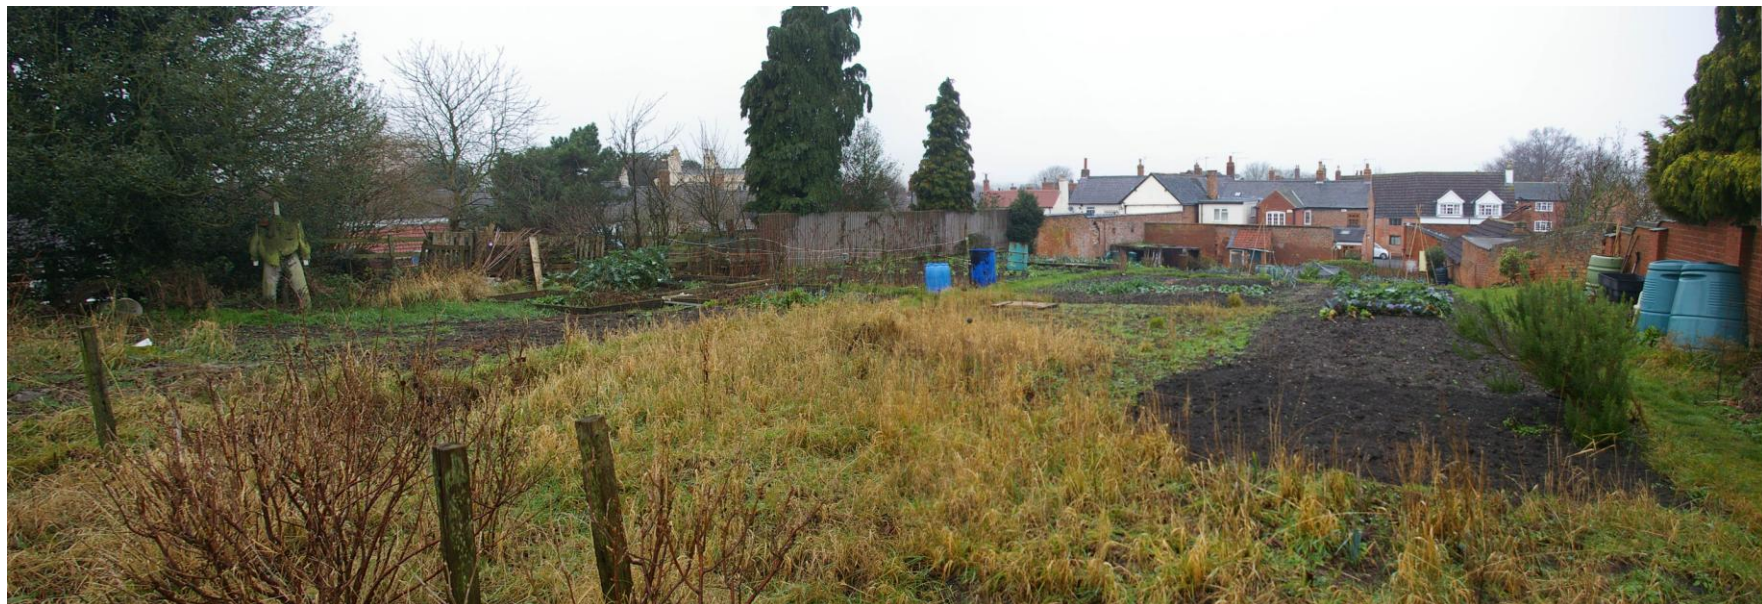
Beyond this area is a wooden gate leading to the allotments (Plate 3). The land rises here by a few metres and then levels off at the southern end of the site. The whole of this area is covered in allotment beds (Plate 4). At the very southern end of the site there is a further small allotment fenced off from the main area (Plate 5).

Plate 3: The entrance into the allotments, looking south south-east  
Plate 4: The allotments, looking north

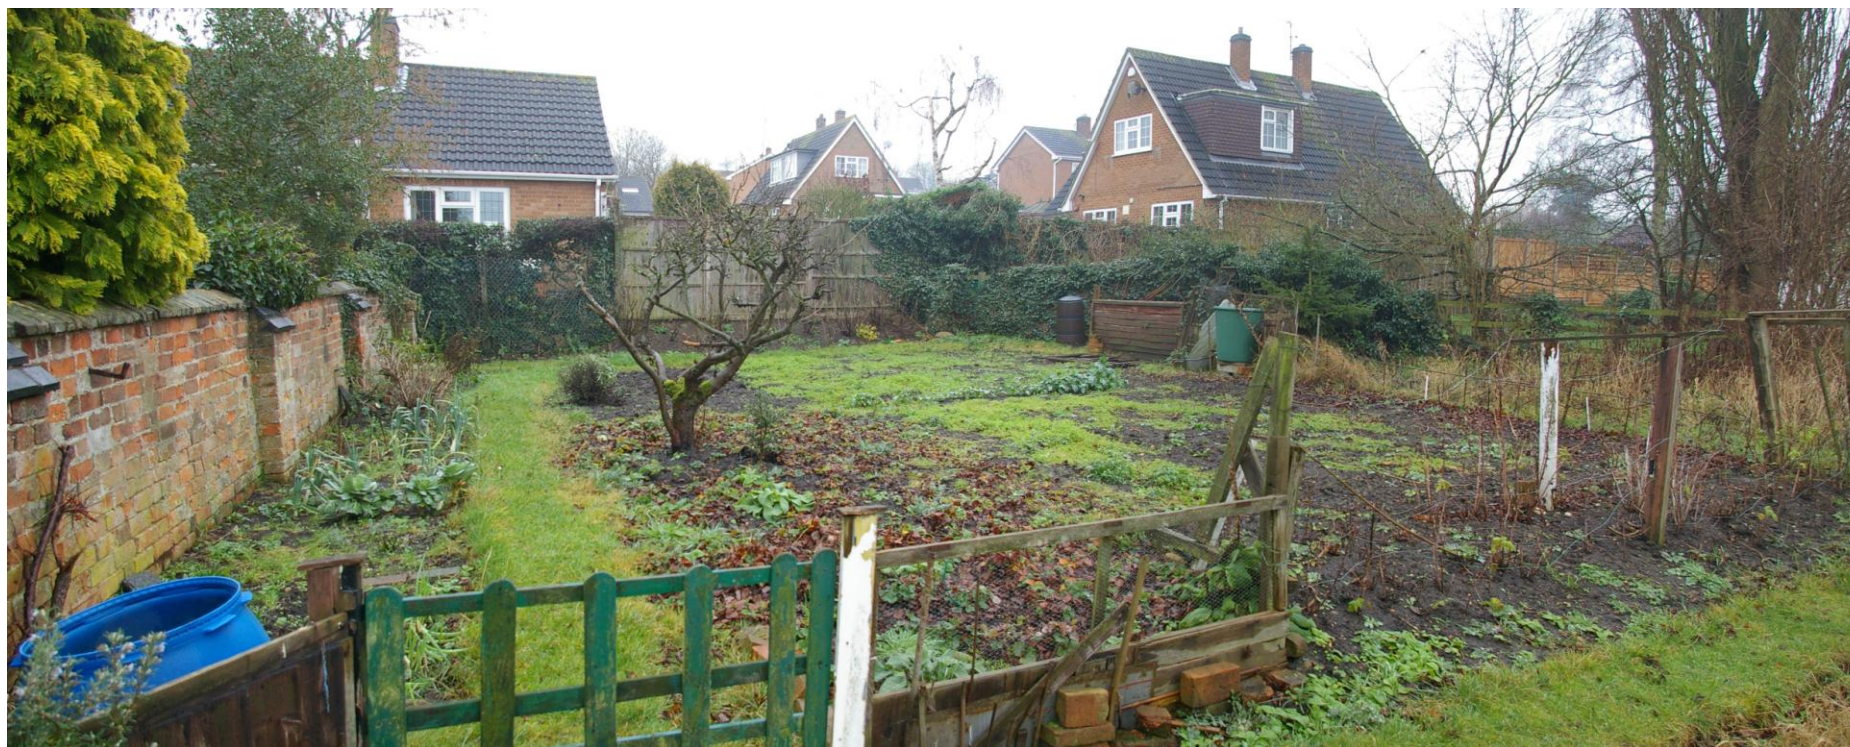
Plate 5: The southern end of the site, looking south
