**A Series of Archaeological Investigations
during the excavation of the
Orchestra Pit at Nevill Holt Hall,
Nevill Holt, Leicestershire (SP 816 937)**

ULAS Report No.2006-030 ©2006

A series of Archaeological Investigations during the excavation of the Orchestra Pit, Nevill Holt Hall, Nevill Holt, Leicestershire (SP 816 937)

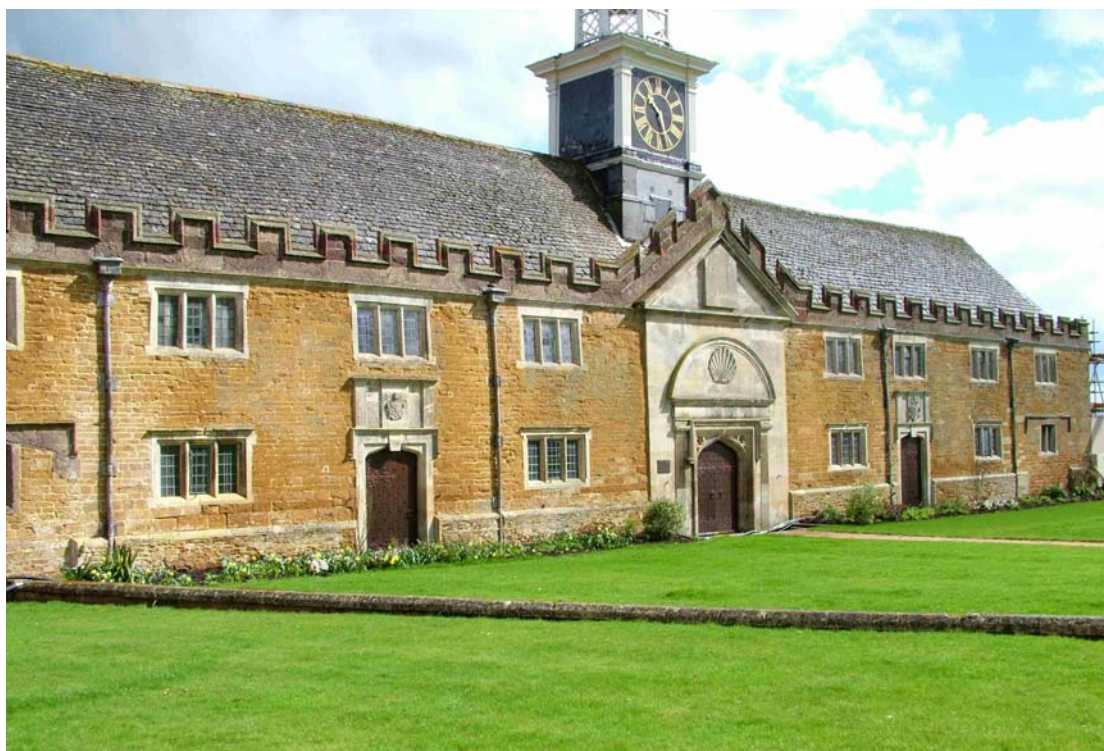
Figure 2: West facing frontage of 17th century stable block

The stable block also covers many periods. The west wing (Fig. 2) dates from the late 17th century when it appears to have been built on top of the ruins of an old medieval

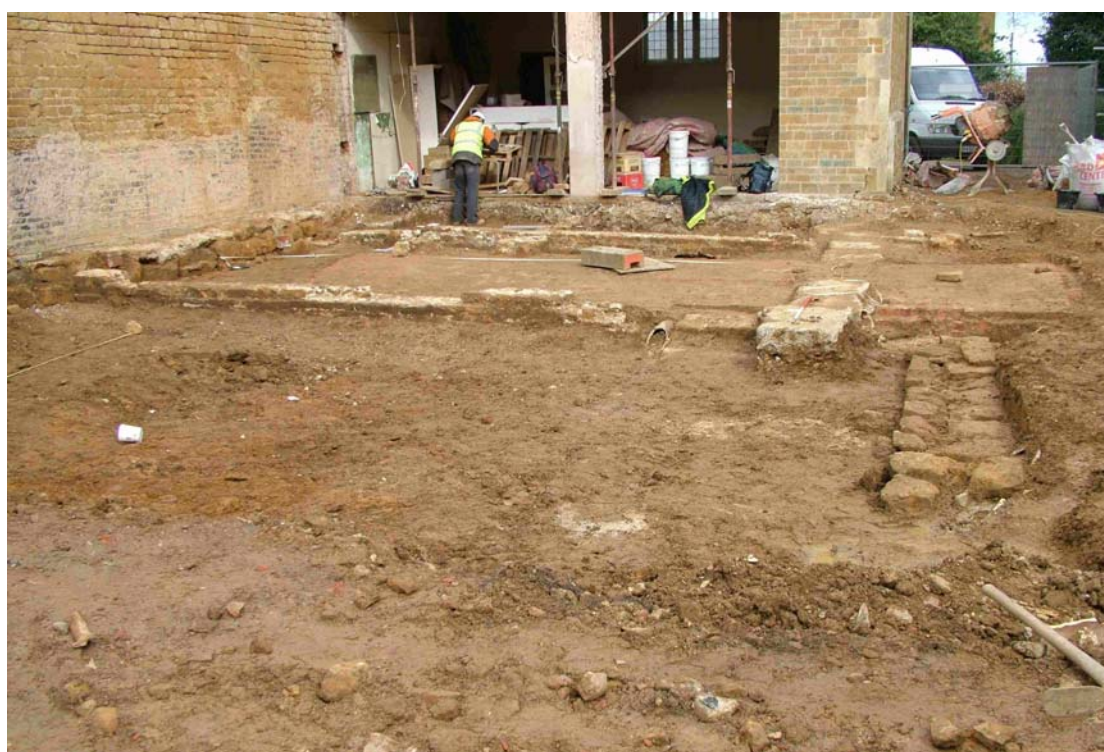
Figure 3: Work in progress at northern end of courtyard during evaluation

The evaluation within the northern end of the stable block courtyard area revealed a series of walls and other features (Figures 3 & 5). A large brick built cess-pit or water tank (32) was situated at the northern end of the stable block a few metres from the northwest wing. This had destroyed some archaeology, and was approximately 3-4 metres deep. The tank was situated between the remains of two walls (25) and (33), which ran east to west across the courtyard. These were constructed of roughly hewn ironstone blocks, bonded together with lime mortar (figure 6b). Small sections of wall (26), (27), (28) running north to south were butted up against this wall, but had been truncated by the tank. One section, despite truncation, appeared to continue under the northwest wing of the stable block (26). The northernmost wall (25) had been partially damaged by a modern concrete foundation wall (30). This northern wall continued to a corner (31) and then turned south to be damaged by the water tank.

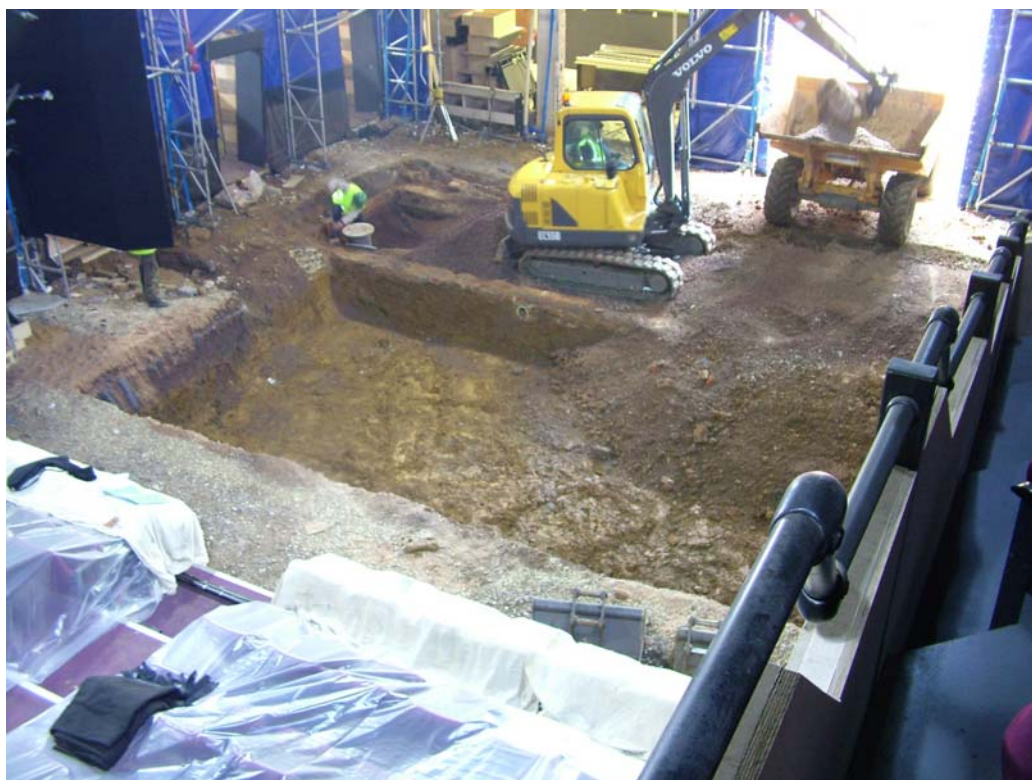
Figure 4: Work in progress on orchestra pit excavation, looking north west

The four test pits were placed in the southern end of the courtyard (Fig. 4) and excavated by hand down to archaeological levels or the natural soil level.

Running from the northwest corner of the southeastern wing on a similar alignment to these foundations a mortared ironstone wall was revealed (42) (Fig.4). This ran for 10.2 metres towards the middle of the courtyard, with a short hiatus around the middle section. It had been damaged at its northern end by a ceramic drain, but it appeared to continue towards the north-south aligned walls discovered during the evaluation.

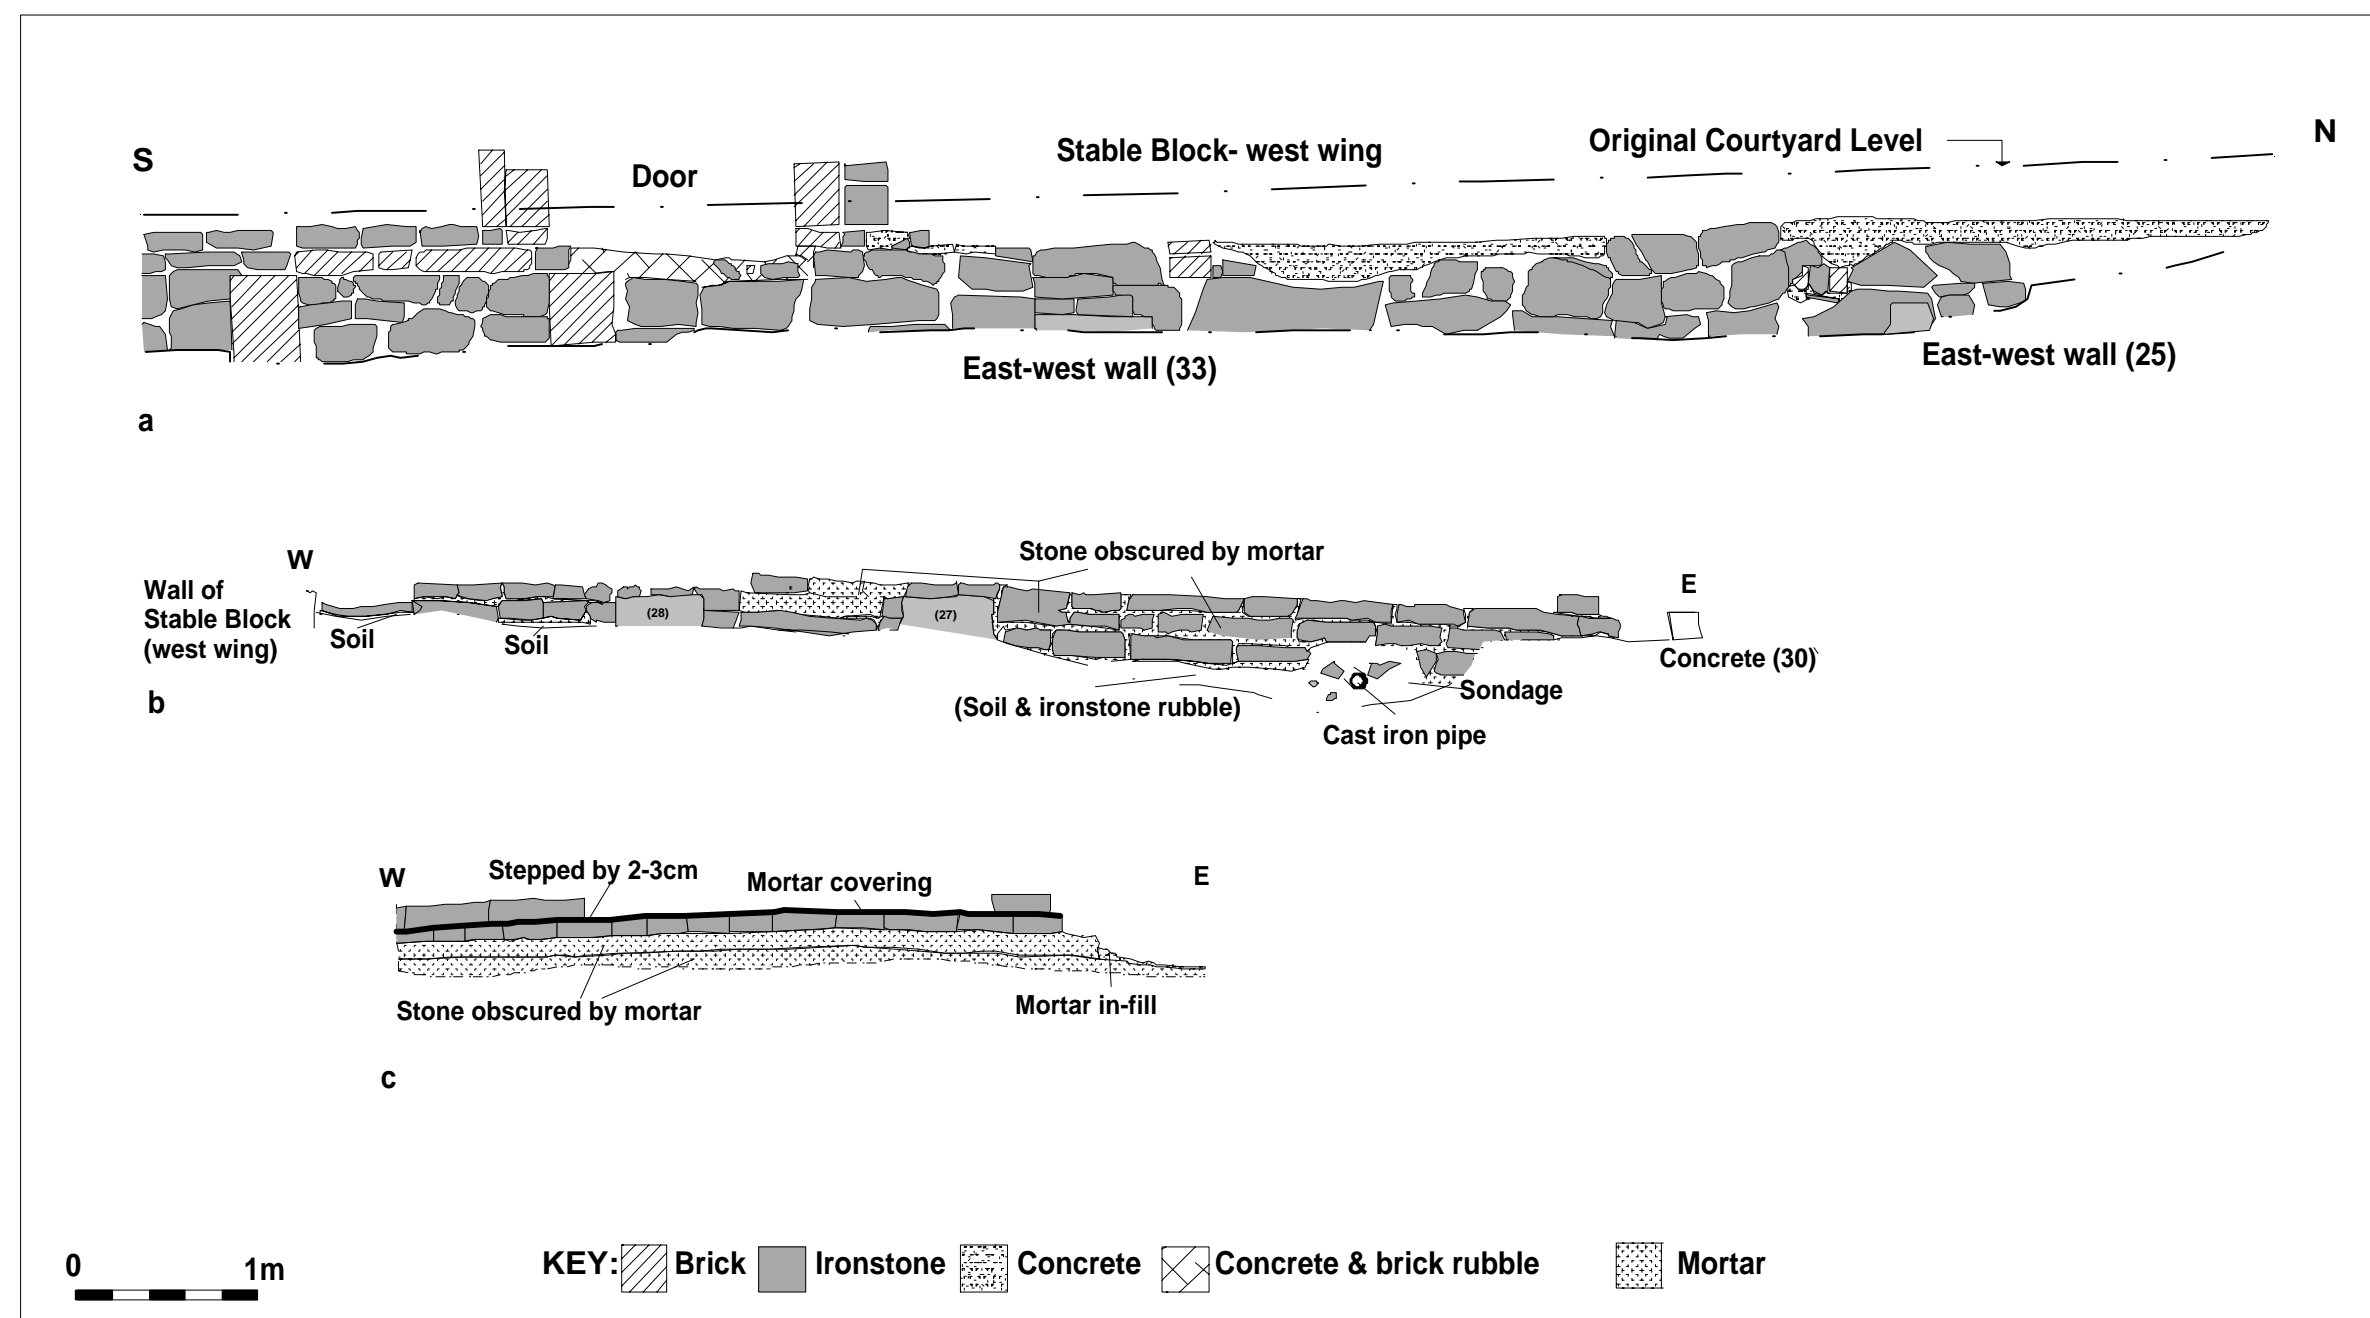
Figure 8a: East facing section of west wall foundations (41)

Figure 8b: South facing section of wall (25)

Figure 8c: South facing section of wall (33)

The southernmost wall (33) seen during the previous work was revealed and was recorded (Figure 8c). The north-south wall (34) was also observed, and it was confirmed that the previously observed course of this feature was the only remaining course. The drain, which ran north-south across the stable yard, and seen during the evaluation, was also uncovered and a small sherd of datable pottery discovered. This was a piece of slipware, which was dated to the 17th century.

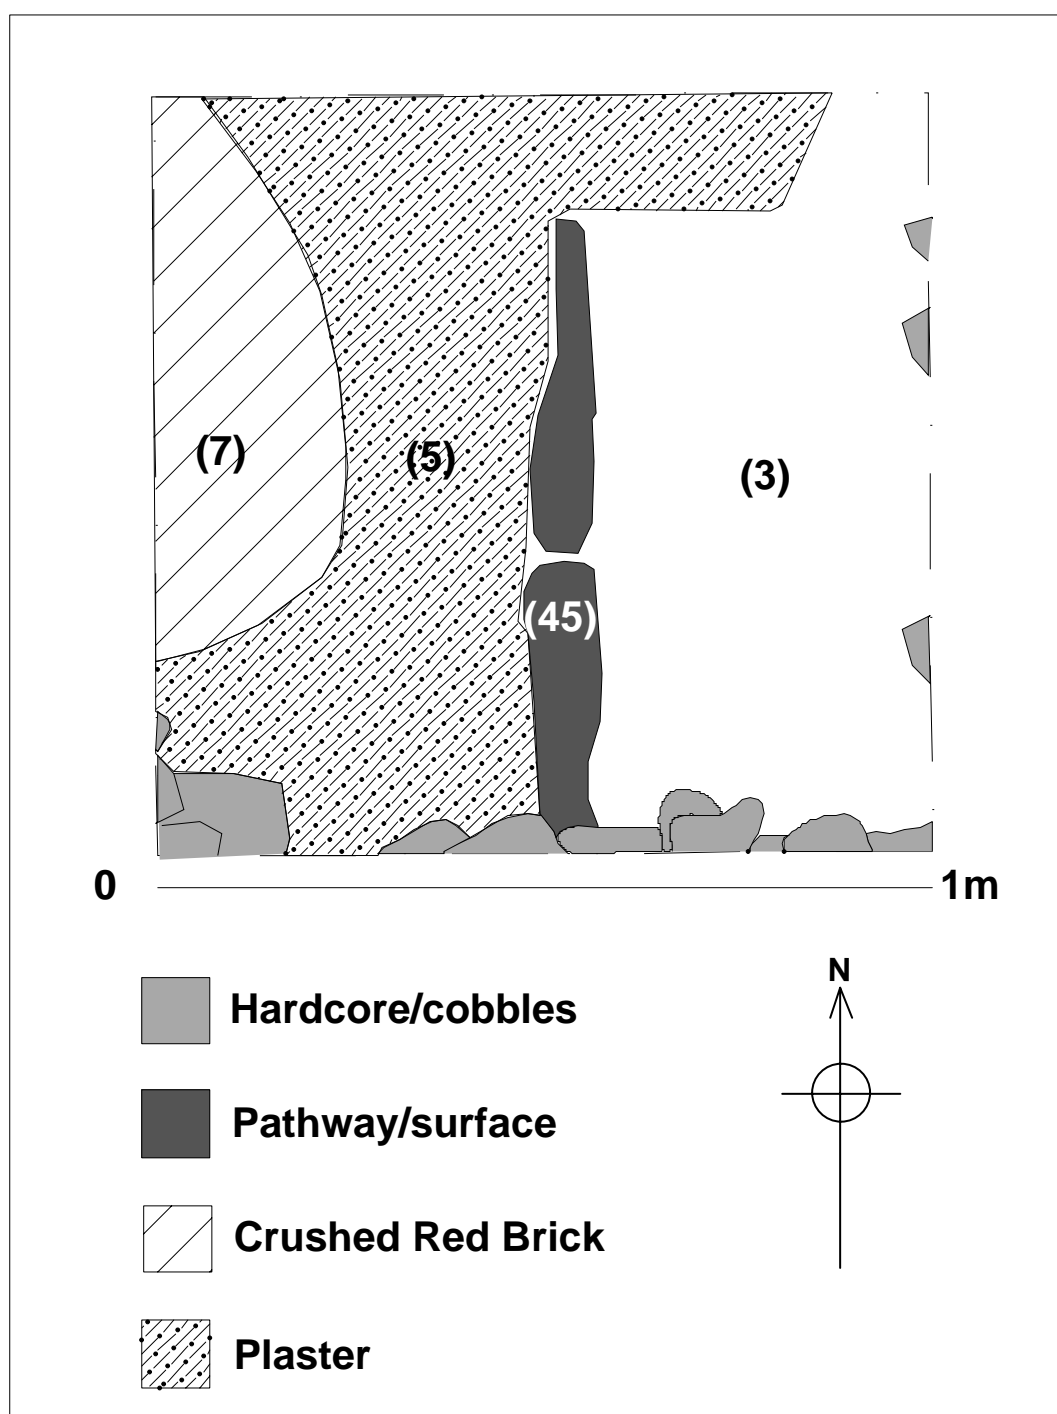
Figure 9: Post excavation plan of test pit 3
