**An Archaeological Watching Brief
During ground-works at
Hallaton Hall,
Hallaton, Leicestershire,
(SP 790 066)**

ULAS Report No. 2005-043 ©2006

An Archaeological Watching Brief During ground-works at Hallaton Hall, Hallaton, Leicestershire, (SP 790 066)

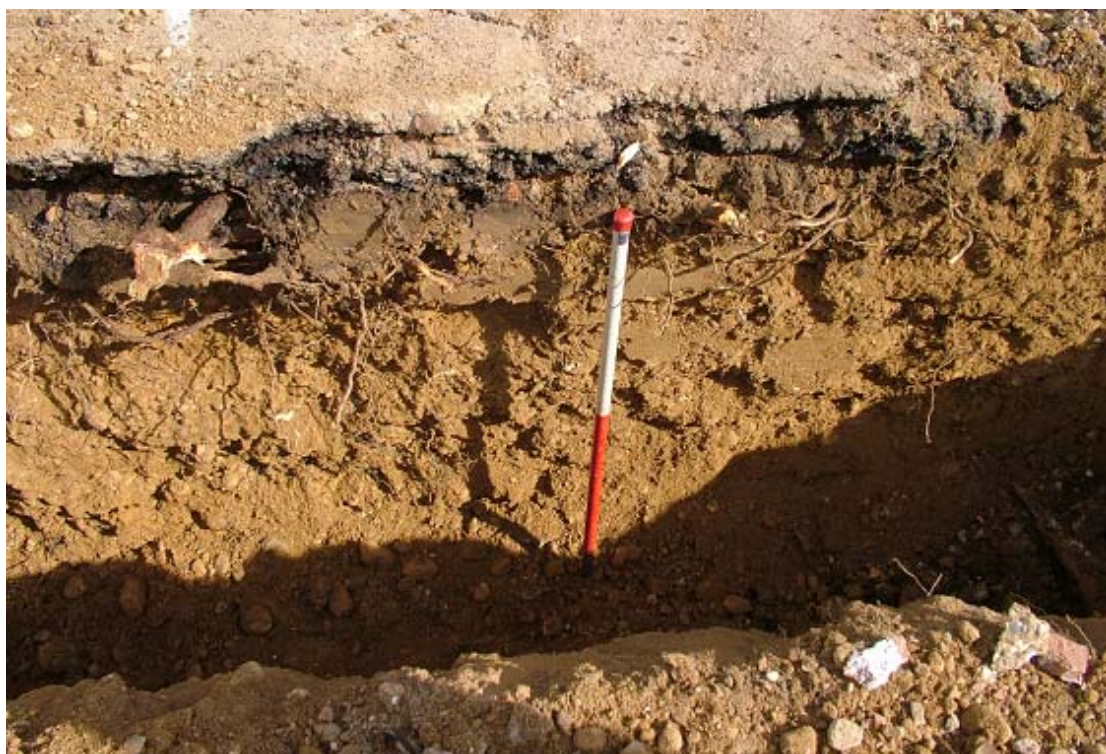
Plate 3: Typical section, trench 1

trenches were excavated to a depth of 1.7m and were 1.6m wide. The excavations revealed a mixed grey brown clay and a considerable amount of brick rubble (Plate 3). The area looked very disturbed by previous construction and demolition rubble. Existing water pipes and other services could be seen within the trench.

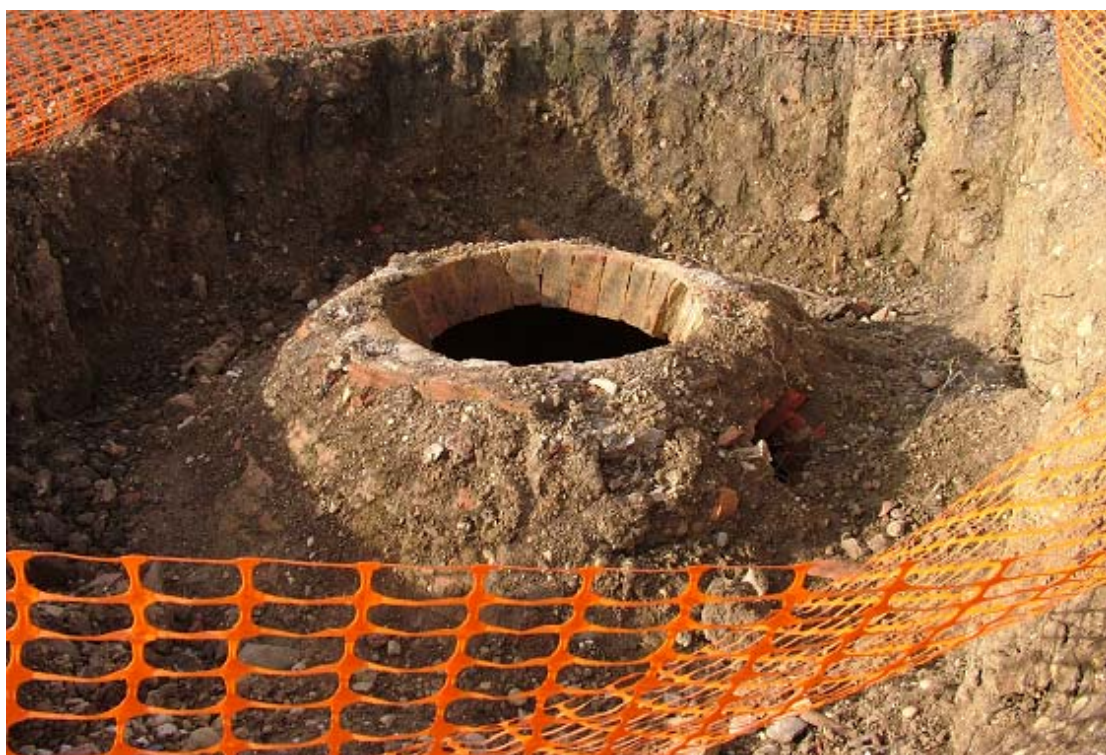
Plate 4: Brick water tank

A large brick built domed structure was seen in the southern part of the site (Plate 4). The dome had an opening at the top with a diameter of c.1m, and a pipe could be seen entering into the structure from the eastern side. This feature was likely to be a soft water tank.
