An archaeological strip, plan and sample excavation on land at Kingswood Lodge, London Road, Great Glen, Leicestershire

NGR: SP 657 974

ULAS Report Number 2013-161 ©2013 X.A155.2013

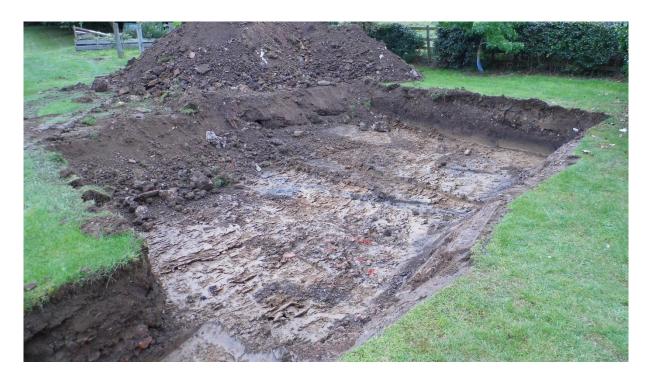
Overburden was stripped down to archaeology or natural substratum across approximately seventy-five percent of the proposed building footprint (Figure 2), the only area unavailable for examination being it's south-western corner because an existing hedge/wall had yet to be removed. Along the southern side of the site natural substratum was reached at c.0.7m below ground level; along the northern side it was c.0.97m below ground level.

Figure 2: the southern half of the building footprint, looking south-east

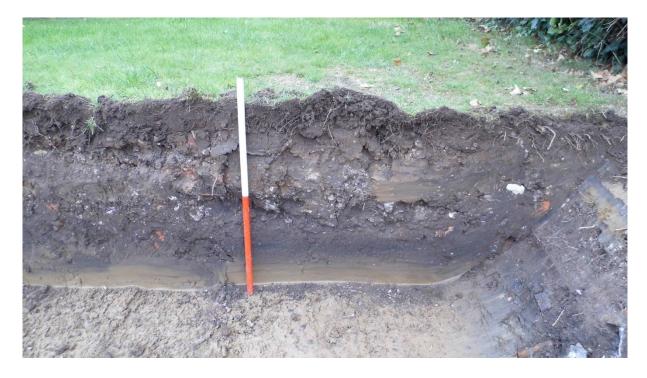
In the southern half of the building footprint, c.0.1m of turf and c.0.5m of modern overburden (believed by the client to relate to the demolition of farm buildings associated with Manor Farm before he built Kingswood Lodge) was found to cover c.0.1m of dark grey clayey-silt (Figure 3). The modern overburden was a mixture of soil, 19th and 20th century building rubble (including plastic sheeting) and redeposited natural clay; the grey clayey-silt underneath appeared to be preserved topsoil, representing the original ground level. This was removed to expose natural greyish-orange clay.

Figure 3: section showing stratigraphic sequence on southern side of the building footprint, looking south

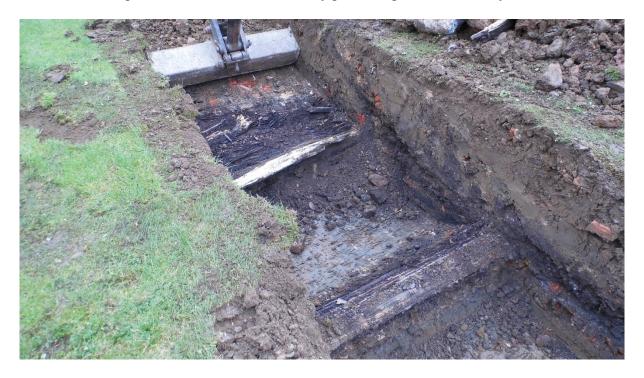
In the northern half of the building footprint continuing into the area of the new access road, c.0.1m of turf and c.0.7m of modern overburden were removed to expose a series of parallel

pitch-coated timber planks placed side by side (Figure 4). These may have been the remains of a plank floor or a collapsed wall panel of a timber building. They rested on c.50mm of cinder and c.0.12m of brick rubble which was impressed into mottled greyish-brown/orange clay.

Figure 4: timber planks, possibly the floor of an ephemeral farm building in the northern half of the building footprint, looking north-east

If the timber planks found in the northern half of the area do represent a floor, no evidence of building walls was found. This suggests it may have been something ephemeral such as a large shed. No evidence for such a building appears on available historic mapping dating back to the 19th century, spanning a period during which the building must have existed judging by the relatively modern brick rubble present beneath it. This reinforces the notion that it is the remains of an ephemeral farm building.

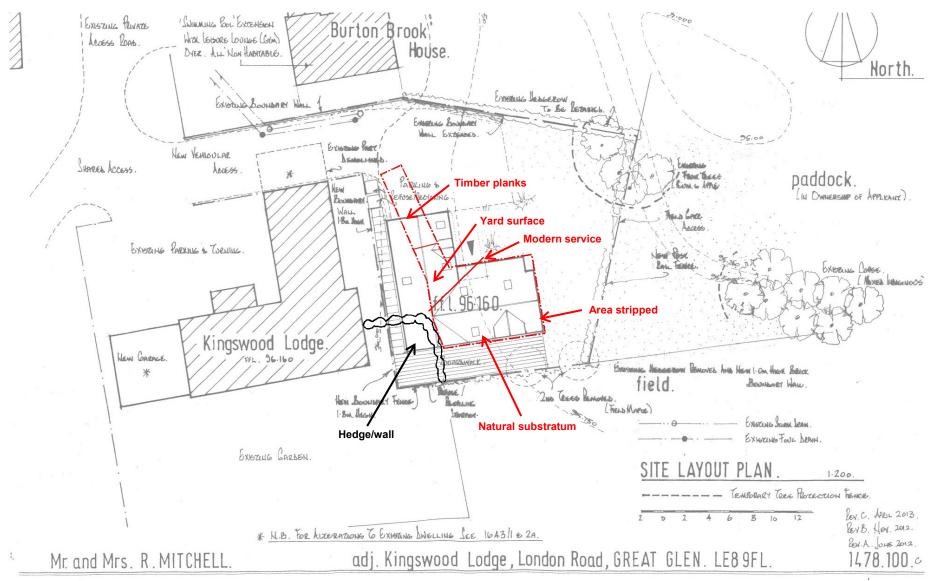
A modern service trench ran across the project area from south-west to north-east (Figure 5). North of this, the stratigraphic sequence was broadly the same except that the preserved topsoil was no longer present. Instead, a crude fieldstone and crushed brick surface was impressed into the natural clay. This is presumed to be a yard associated with the former Manor Farm.

Overall, no archaeological features, deposits or finds were observed during the course of the work and the result of the investigation proved negative (Figure 5). Much of the ground within the site appeared to have been extensively disturbed during previous occupation from the 19th century onwards, presumably activity associated with Manor Farm which was formerly located immediately west of the site.

Figure 5: Plan showing project area and the results of the archaeological work, plan supplied by client
