#### An Archaeological Evaluation on land at Moat Street, Wigston, Leicestershire

NGR: SP 6069 9855

ULAS Report No. 2013-180 © ULAS 2013

For: GS Developments (Leicester) Ltd. Planning application no. w/c 29/09/2013

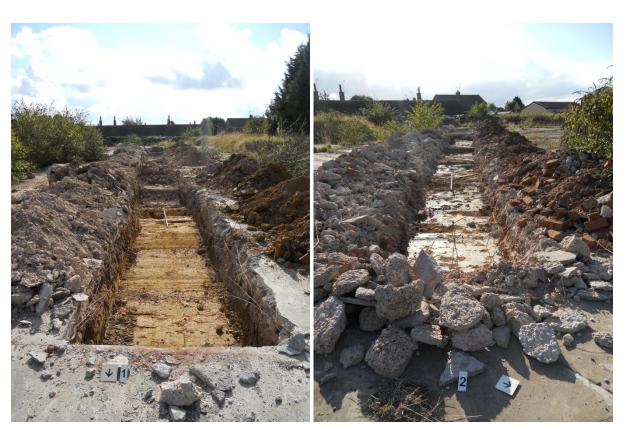
Trench 1 was located on the western side of the site, orientated broadly north/south within the footprint of the former St Georges Houses building (Figure 3). Machining initially removed reinforced concrete covering modern brick and concrete rubble; natural yellowish-brown clay was observed directly beneath the modern overburden at c.0.4-0.8m below ground level. No subsoil was observed and ground level appeared to have been reduced prior to construction of St Georges Houses.

East/west aligned modern brick and concrete wall footings were observed cutting the natural substratum c.2m, c.16m, c.20m and c.27m from the southern end of the trench. The natural substratum was not reached between c.20-27m because of a concrete floor which could not be machined out.

Trench 2 was located in the south-western quarter of the site, orientated broadly northeast/south-west crossing the footprint of the former St Georges Houses building and another building to the rear (Figure 4). Machining initially removed reinforced concrete covering modern brick and concrete rubble; natural yellowish-brown clay was observed directly beneath the modern overburden at c.0.3-0.9m below ground level. No subsoil was observed and ground level appeared to have been reduced prior to construction of St Georges Houses.

An east/west brick wall was observed cutting the natural substratum c.7m from the northeastern end of the trench. North/south brick and concrete wall footings were also observed at c.9m, c.14m, c.30m and c.33m from the end of the trench, whilst a break sump was recorded at the trenches south-western end.

Figure 3: Trench 1, looking south

Figure 4: Trench 2, looking south-west

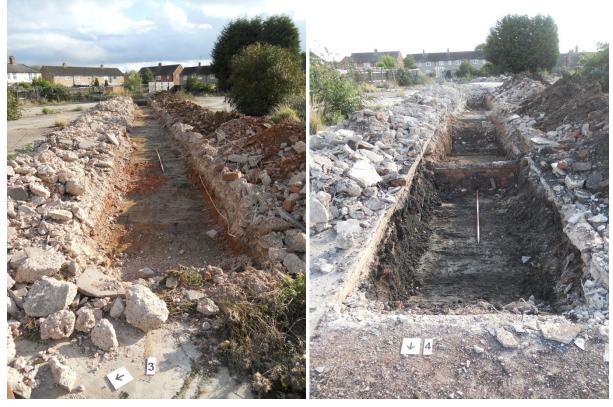
Trench 3 was located in the south-eastern quarter of the site, orientated broadly northwest/south-east within the footprint of the former St Georges Houses building (Figure 5). Machining initially removed c.0.3m reinforced concrete covering modern brick and concrete rubble; natural yellowish-brown clay was observed directly beneath the modern overburden at c.0.3-0.45m below ground level. No subsoil was observed and ground level appeared to have been reduced prior to construction of St Georges Houses.

An east/west brick wall footings was observed cutting natural c.17 from the north-western end of the trench, whilst the natural had been disturbed by a modern pit at the south-eastern end of

Figure 5: Trench 3, looking south-east

Figure 6: Trench 4, looking south

Trench 4 was located on the eastern side of the site, orientated broadly north/south within the footprint of the former St Georges Houses building (Figure 6). Machining initially removed reinforced concrete covering modern brick and concrete rubble; natural yellowish-brown clay was sporadically observed beneath the modern overburden at c.0.6-1.1m below ground level. No subsoil was observed and ground level appeared to have been reduced prior to construction of St Georges Houses.

The northern c.4m of the trench was disturbed and natural ground level was not seen. At c.4m an east/west brick wall crossed the trench. South of this, a wall footing was found to run down the western side of the trench, its foundation trench destroying much of the area within the trench. Machining of the trench was aborted at c.23m of its c.30m because of this disturbance.

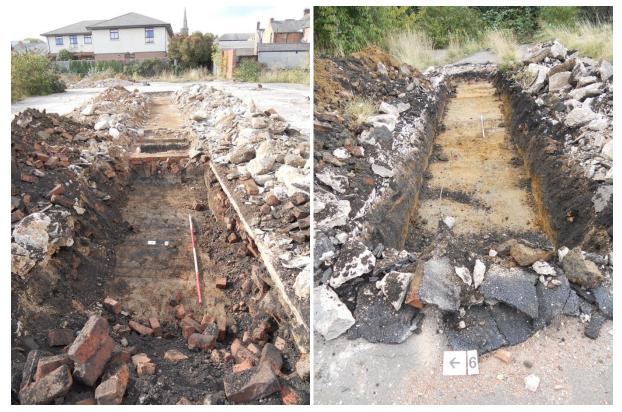
Figure 7: Trench 5, looking west

Figure 8: Trench 6, looking east

Trench 5 was located on the northern side of the site, orientated broadly east/west within the footprint of the former St Georges Houses building (Figure 7). At the eastern end of the trench, machining initially removed reinforced concrete covering modern brick and concrete rubble; natural yellowish-brown clay was observed directly beneath the modern overburden at c.0.6-0.7m below ground level. No subsoil was observed and ground level appeared to have been reduced prior to construction of St Georges Houses.

A north/south brick wall footing was observed cutting the natural substratum c.4.5m from the eastern end of the trench. Approximately c.2m west of that, c.0.2m below ground level, a second reinforced concrete surface was uncovered, seemingly a floor for an earlier structure on the site. This could not be removed and was left in-situ.

Trench 6 was located in the north-east corner of the site, orientated broadly east-west outside the footprint of the former St Georges Houses building, close to the Moat Street frontage (Figure 8Figure 3). Machining initially removed reinforced concrete covering modern brick and concrete rubble; natural yellowish-brown clay was observed directly beneath the modern overburden at c.0.4-0.5m below ground level. No subsoil was observed and ground level appeared to have been reduced prior to construction of St Georges Houses.
