**An Archaeological Watching Brief During  
Groundworks For A New Link Pathway  
At Leicester Castle, Castle Ward,  
Leicester (NGR SK 5824 0416)**

**Scheduled Monument No: SM 17127, HA 1012147  
English Heritage SMC Ref: S00056186**

ULAS Report No 2013-138  
©2013

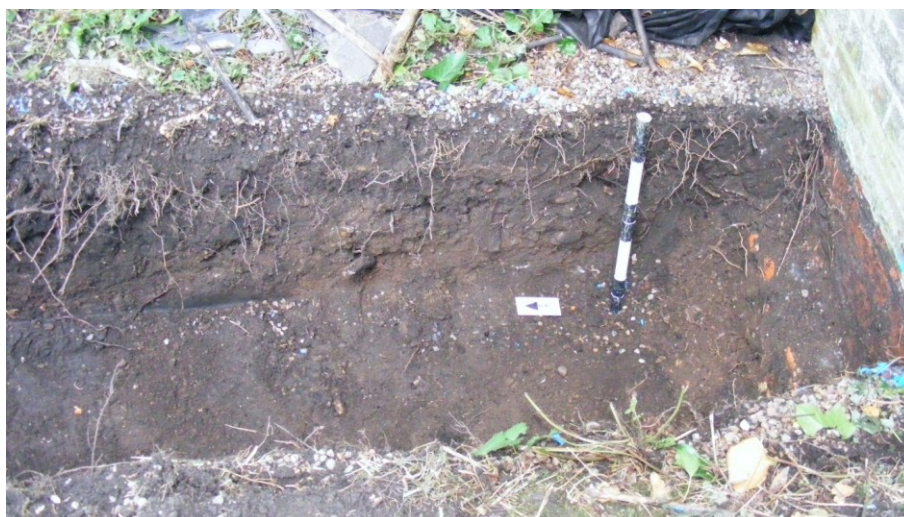
Figure 5: Trench section at southern end of wall footing. Looking east.

The site was visited on the 8th, 13th and 14th August 2013. The new footpath was to cross the garden formerly belonging to No 5 Castle View and consequently it was necessary to build a new garden wall to screen the property from the footpath. The trench measured 0.7m wide and was orientated north-south, spanning the width of the garden (see Figure 4). It was excavated to a maximum depth of 0.8m at the northern end but was only 0.5m deep at the southern end. Topsoil was 0.2m thick and consisted of dark brown rich humic sandy loam, with common root disturbance and occasional small stones. The overburden/garden soil was mid grey brown silty sand, friable in texture and containing moderate charcoal flecks and occasional small fragments of brick/tile, slate, mortar and occasional small stones (context 2). This was the extent of the excavations at the southern (shallower) end of the trench. At the northern end a further deposit was exposed at a depth of 0.55m below ground level. This consisted of mid-orange brown sandy silt, with moderate to frequent mortar fragments, occasional slate fragments and occasional charcoal flecks (context 3).

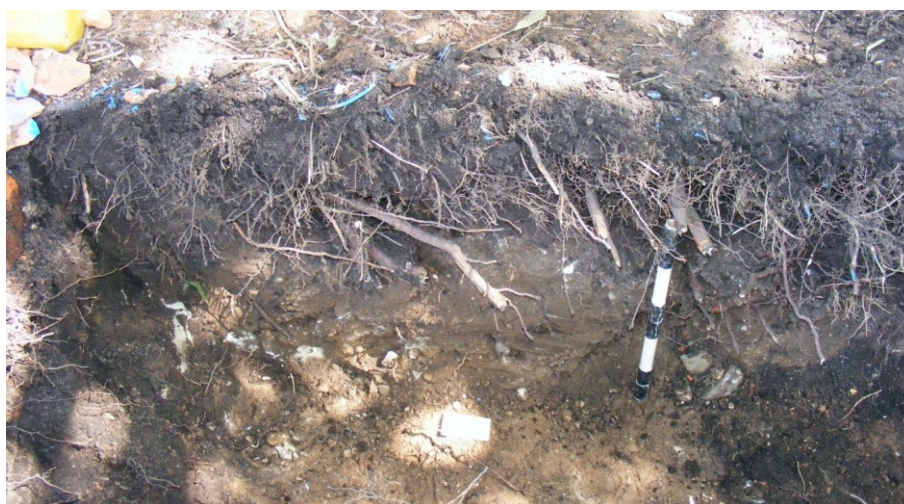
Figure 6: Trench sections at the northern end of wall footing. Looking east.

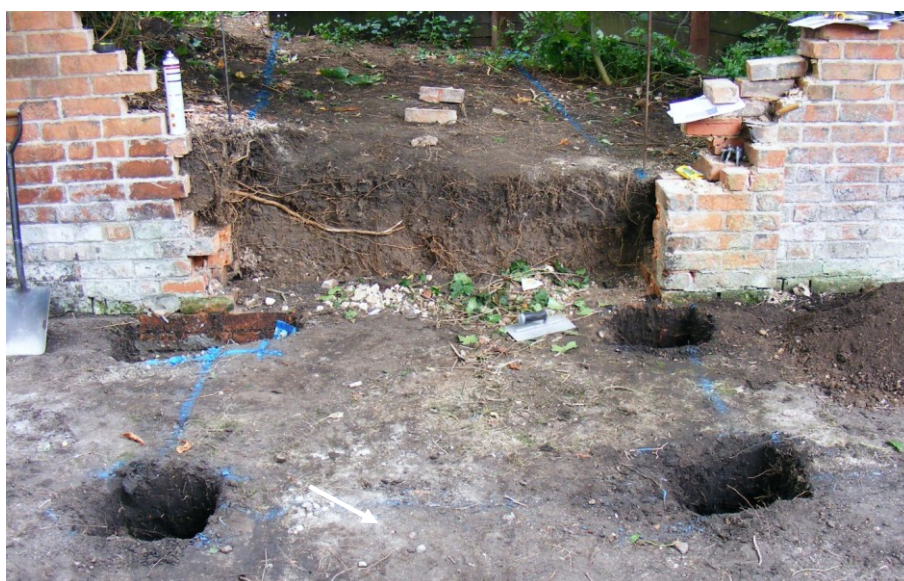
An opening was made in the southern garden wall, which revealed a section through the strata at the base of the motte. This showed that the ground level was 0.6m higher than north of the wall (Figure 7). Topsoil was 0.2m thick, consisting of mid brown silty loam with frequent roots, below which was overburden/garden soil comprising mid-orange brown silty sand with frequent roots and occasional stones, flints and mortar fragments.

Figure 7: Cross section through the build-up behind the garden wall. Post holes 1-3 in foreground. Looking south.

Six new post holes were excavated by hand to accommodate the new posts supporting the walkway as it joined the new footpath to the existing steps on the side of the motte. Three were excavated on the northern side of the garden wall and a further three close to the steps at the base of the motte. These measured approximately 0.38 x 0.38m and were excavated to a depth of 0.55-0.6m deep. The holes were visually inspected and the spoil heaps were checked for artefacts. The first group of three (located in the former garden of No 5 Castle View) did not expose any archaeological deposits. Topsoil was 0.25m thick below which was garden soil/overburden to base (as previously observed in the footing trench).

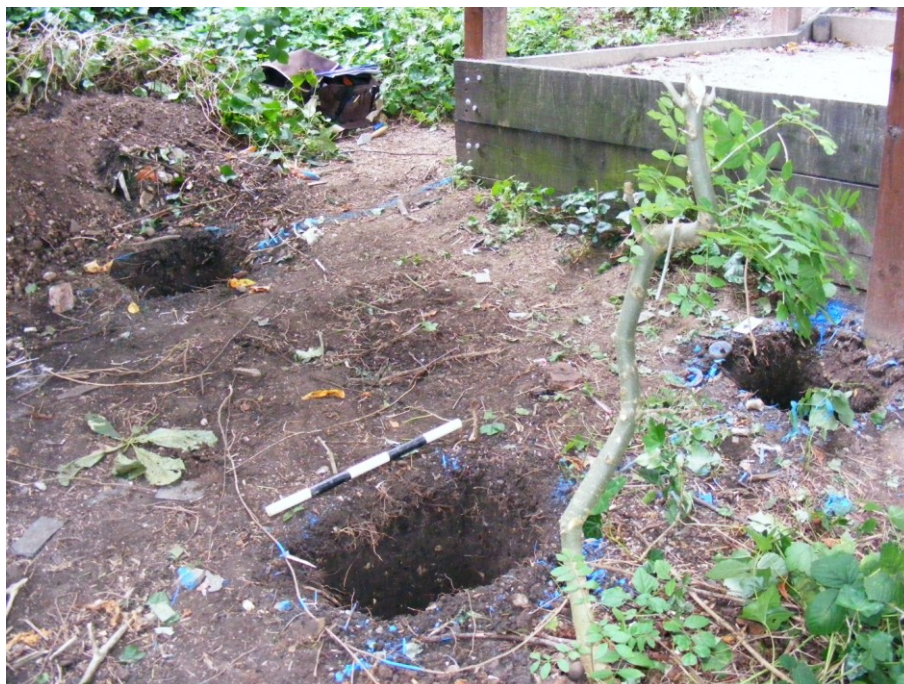
Figure 8: Overview of post holes 4, 5 and 6. Looking south-east.

The second group of three post holes were excavated immediately south of the existing steps. Observations of post holes 4 and 6, indicated that the deposits consisted of topsoil 0.2m thick, which overlay garden soil, as described, to the base of the holes. A variation was noted in post hole 5, located slightly higher on the motte, where a deposit consisting of mid reddish brown clay, mixed with grey mudstone and occasional charcoal flecks (context 4), was encountered at 0.45m below ground level. This could potentially represent an archaeological level but it was difficult to be certain in such a small hole.

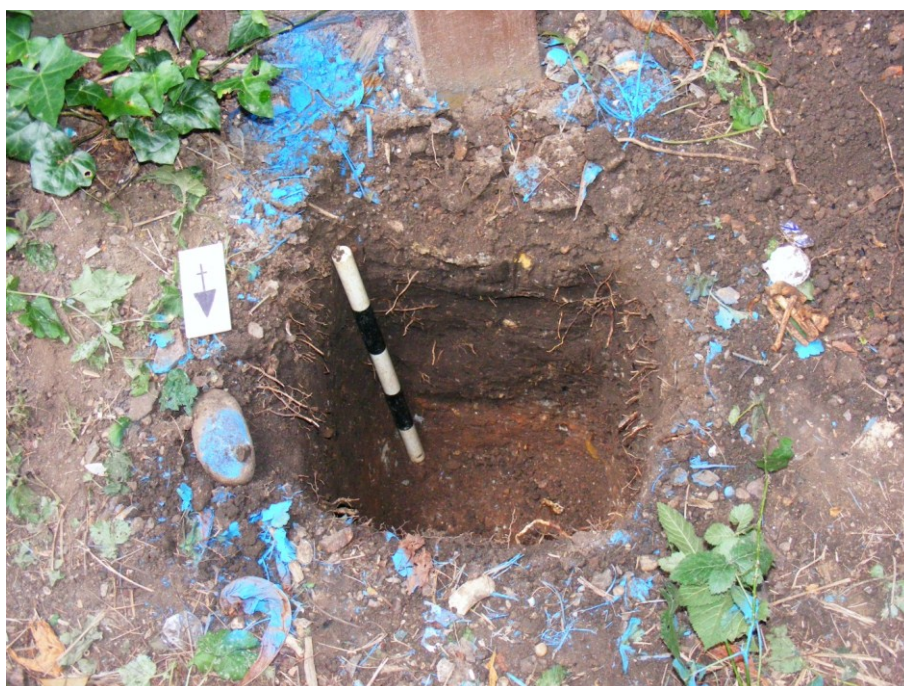
Figure 9: Post hole showing depth of deposit at the base. Looking south.
