**An archaeological investigation
(test pitting) inside St Nicholas
Church, Frolesworth,
Leicestershire**

(SP 503 906)

ULAS Report No 2014-088

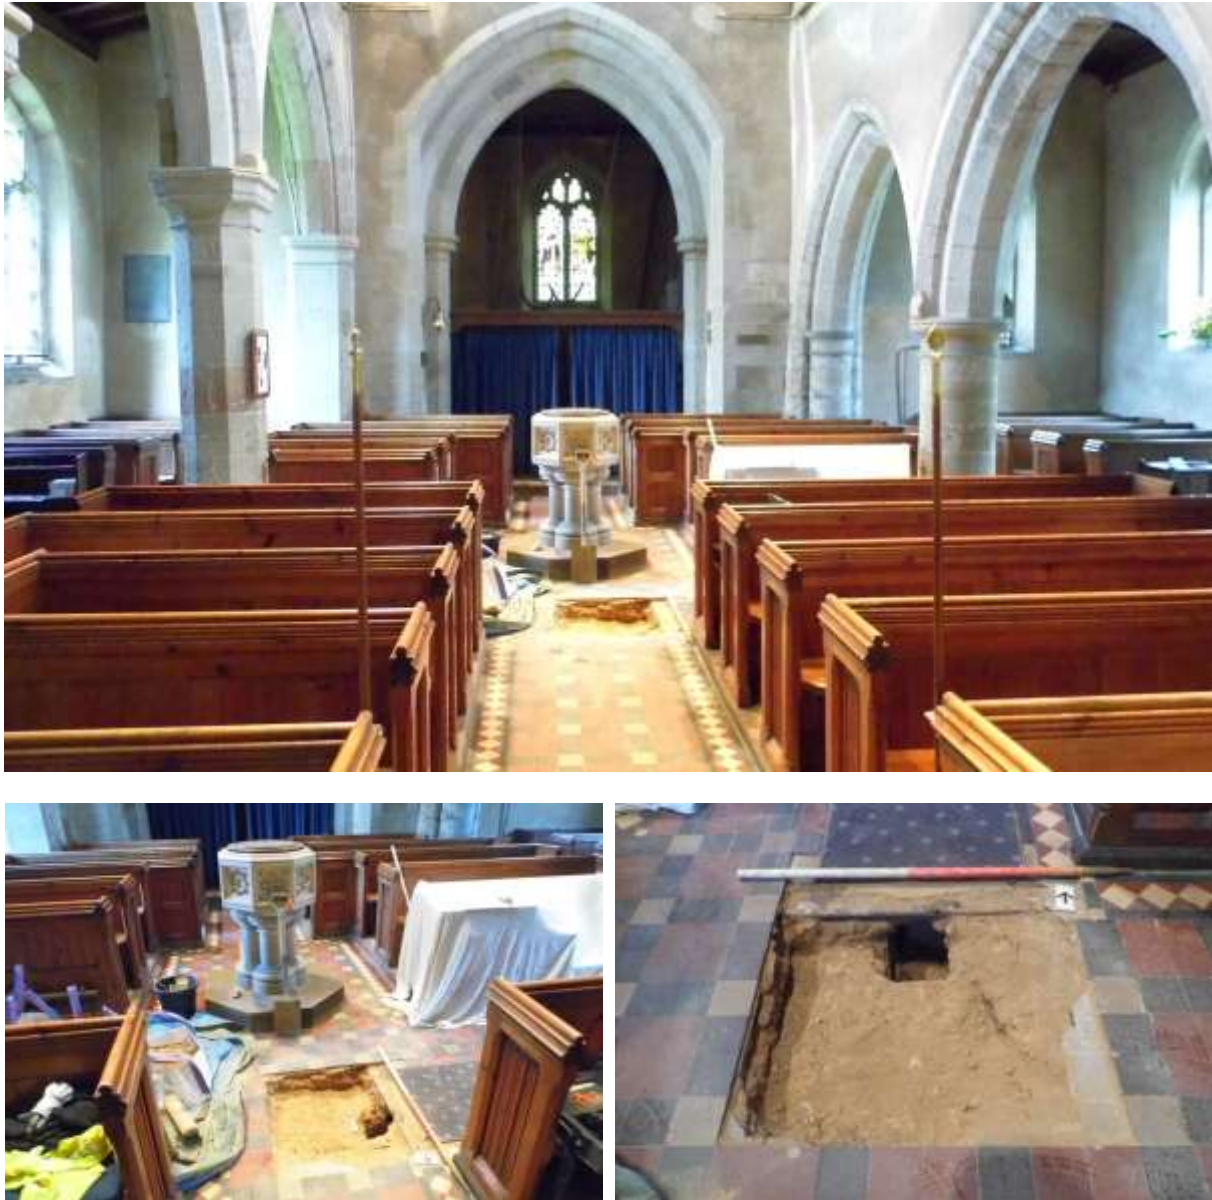
Figure 3: top, church nave looking west; bottom left, location of test pit in church floor; bottom right, test pit looking north, showing void into brick lined heating duct.

Floor tiles were removed from an area measuring c.0.8m x 0.8m in the centre of the church nave, c.0.5m east of the font (Figure 2). This placed the test pit immediately south of a covered heating grate set into the church floor (Figure 3). The test pit was sited to investigate localised structural damage to the floor surrounding the grate and spreading away from it to the south.

The hardcore covered a second layer of cement *c.*0.17m below present floor level. On the northern side of the trench, a 3mm thick iron plate was found between the screed and the hardcore. This projected *c.*0.1m into the test pit along its northern side and appeared to surround the heating grate to the north, providing a sill on which the grate rested. Beneath the plate, a void in the cement revealed a brick lined duct extending north beneath the heating grate (Figure 3), whilst the second layer of concrete in the test pit covered a large ceramic pipe which appeared to curve away to the south-west. The bottom of the duct/pipe was *c.*0.44m below floor level.

The primary goal of the archaeological investigation was to establish a possible cause for localised structural damage to the floor in the church nave. No evidence of subsidence in the substrata was observed and the layers of hardcore and cement beneath the floor, presumably associated with the raising of the nave's floor during the restoration of the church in 1887-8, appeared compacted and stable. Of interest, building rubble mixed in with this hardcore appeared to be of medieval origin and was perhaps formerly church fabric which had been discarded during the restoration. No evidence of earlier church floors was found.

With the exception of the brick duct beneath the heating grate, the old underfloor heating appeared to be channelled beneath the floor in concreted ceramic pipes. One possible cause of the structural damage was damp getting between the floor tiles and concrete screed, or the screed and hardcore, and lifting the tiles up. Another cause may be the iron plate surrounding the heating grate. Corrosion may be causing it to expand, lifting the floor tiles.
