**An Archaeological Watching Brief  
At Sandhills Avenue (Phase 4),  
North Hamilton,  
Leicester (SK 636 071)**

ULAS Report No. 2005-177 ©2005

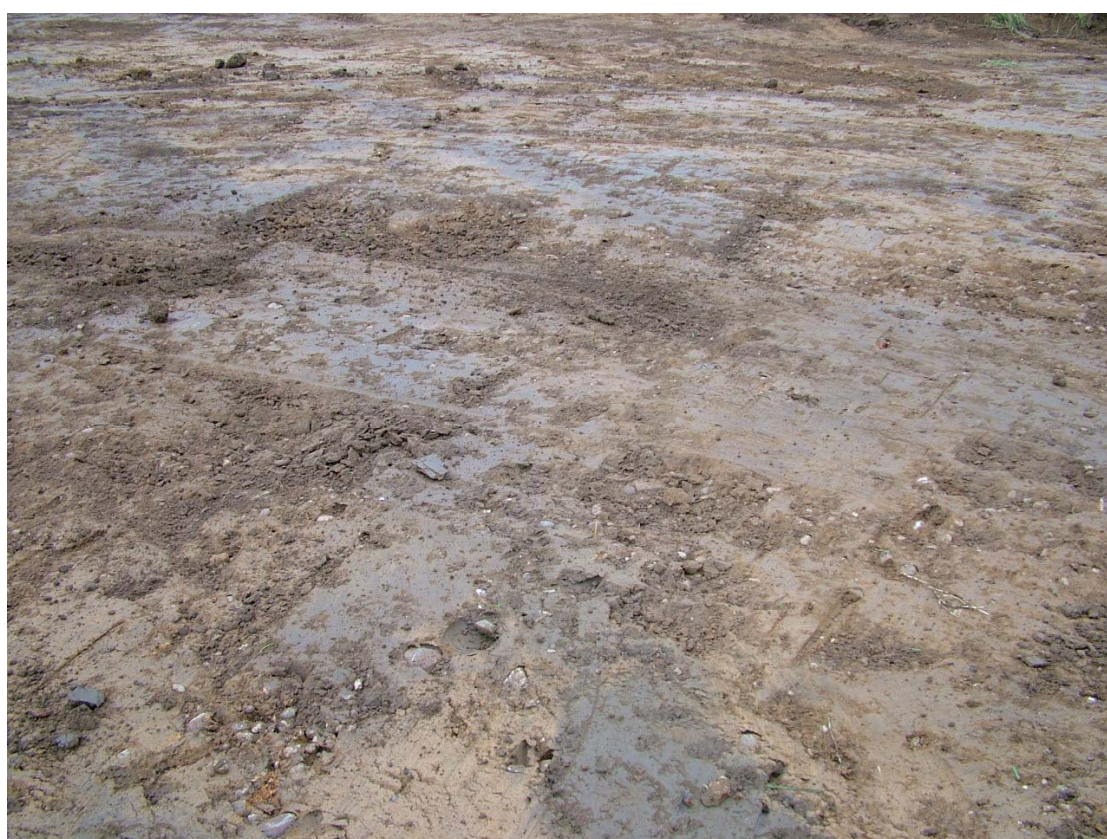
**Plate 2 :** Linear features observed on 18/10/05, looking north

During the visit of 18th October the stripping revealed orangey brown silty clay under the fairly thin (0.2m) topsoil. Several narrow dark linear features were observed (Plate 2), running mainly north-south across the site. These contained a compacted dark grey fill, which appeared very loam like.

The dark linear marks encountered during the visit of 18th October 2006 (Plate 2) appeared to contain topsoil and were likely to be wheel ruts from previous ground-works.
