**An Archaeological LiDAR study and Walkover Survey at  
Bradgate Park,  
Newtown Linford,  
Leicestershire.**

**NGR: SK 532 108 (centre)**

ULAS Report No.2014-076

**For: Cookson and Tickner  
on behalf of the Bradgate Park Trust**

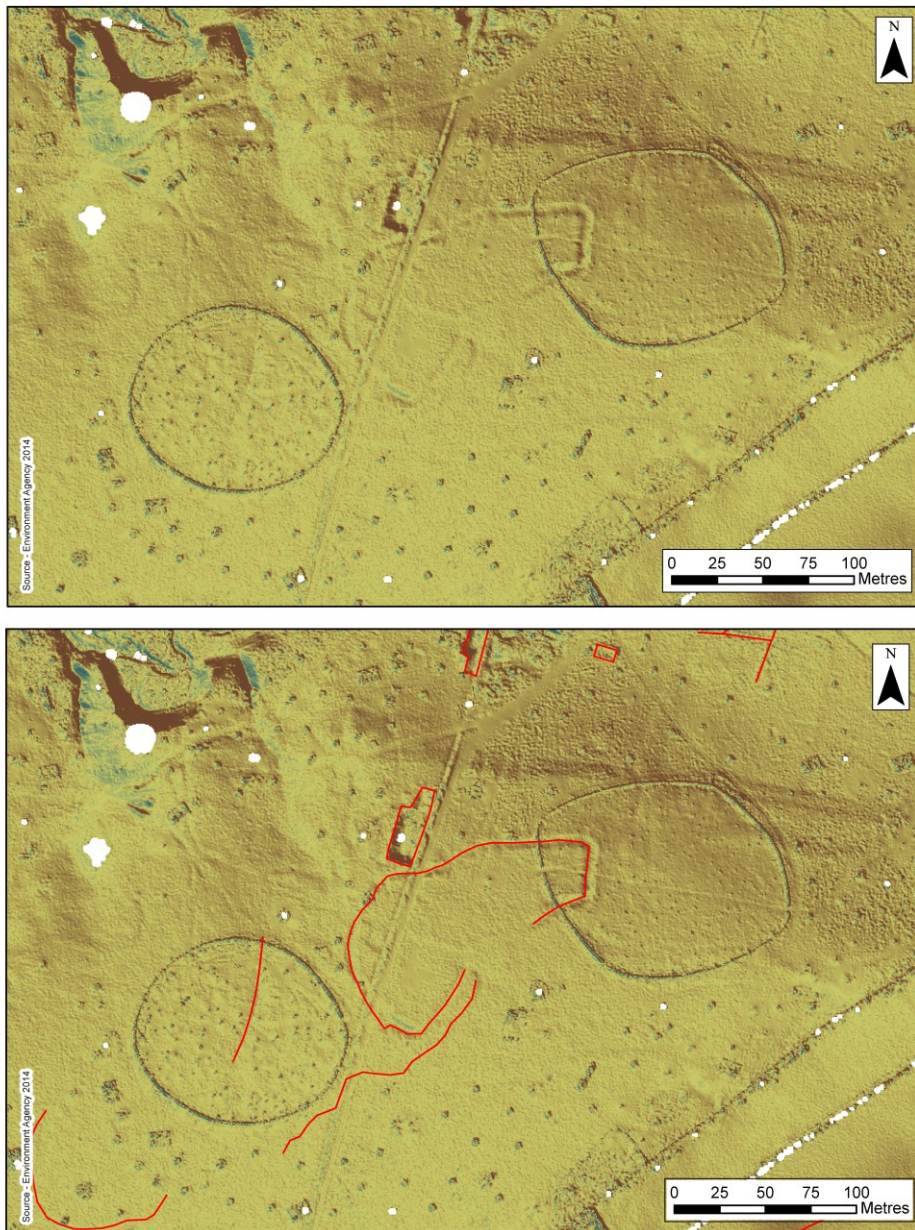
Figure 3: Earthwork enclosure between Holly Plantation and Thorn Spinney. (Hillshade 225302 with false colour)

On a small hilltop between Holly Plantation and Thorn Spinney lies a large ditched enclosure measuring c.140m by c.55m (Figure 3). The irregular form of the enclosure would be entirely consistent with a late prehistoric date although the wide south-facing entrance is uncommon. The eastern portion of this enclosure is overlain by the avenue of trees representing the park's early main entrance (MLE18596) showing the enclosure's early origins. This enclosure had in part been observed during recent study of aerial photographs and field observations (Hartley & Squires forthcoming).

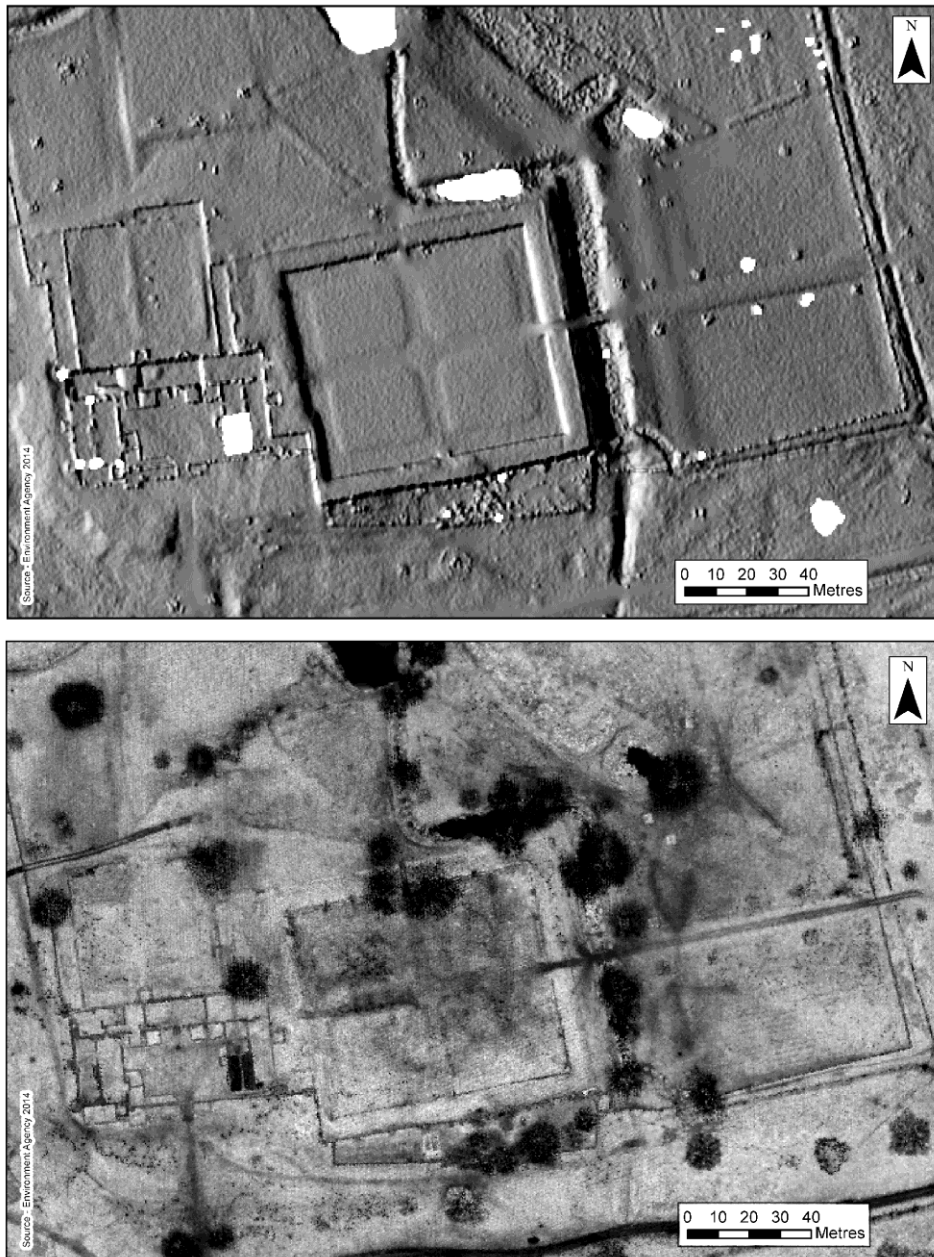
Figure 4: Bradgate House Garden. Elevation data (above), Intensity data (below) revealing a possible circular feature signalled in the garden soils.

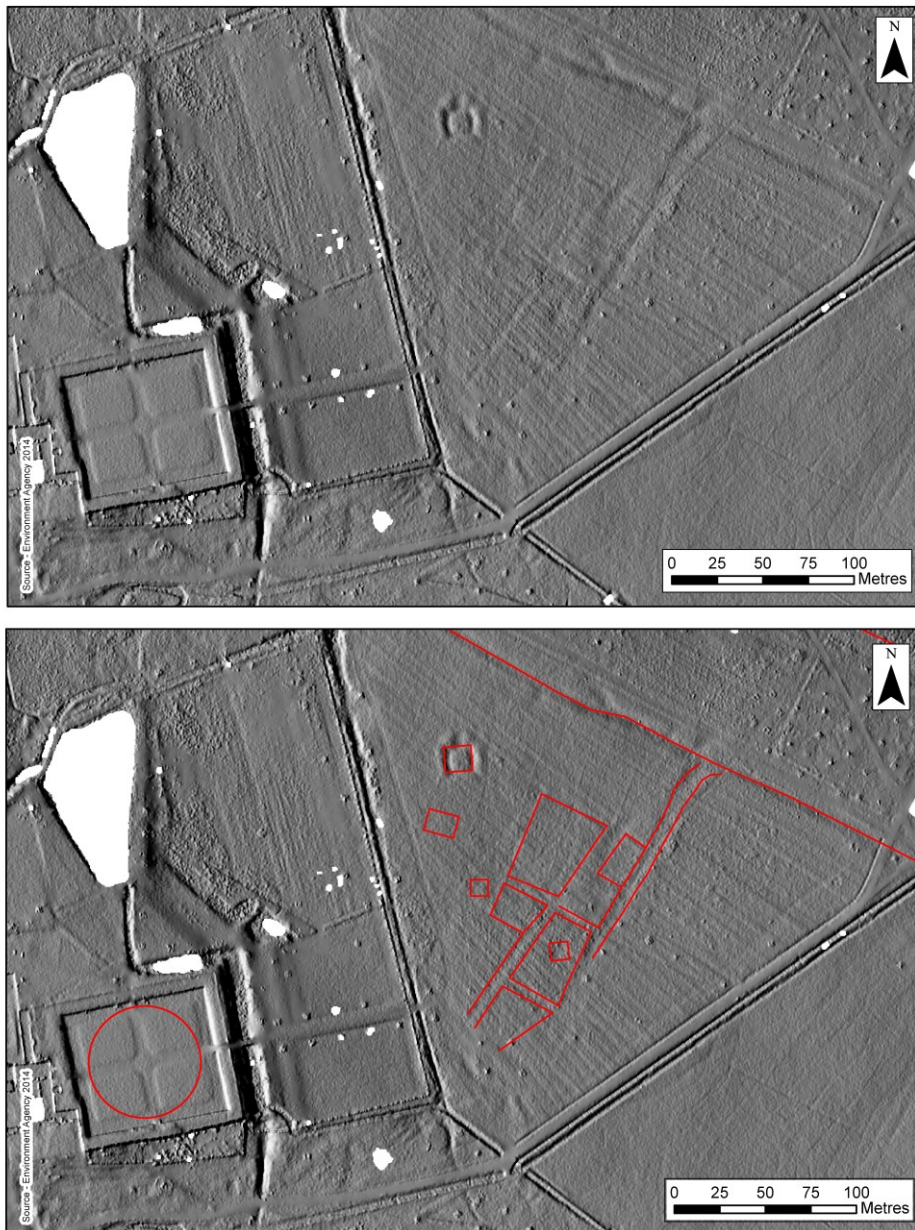
Figure 5: Possible evidence of medieval settlement to the east of Bradgate House

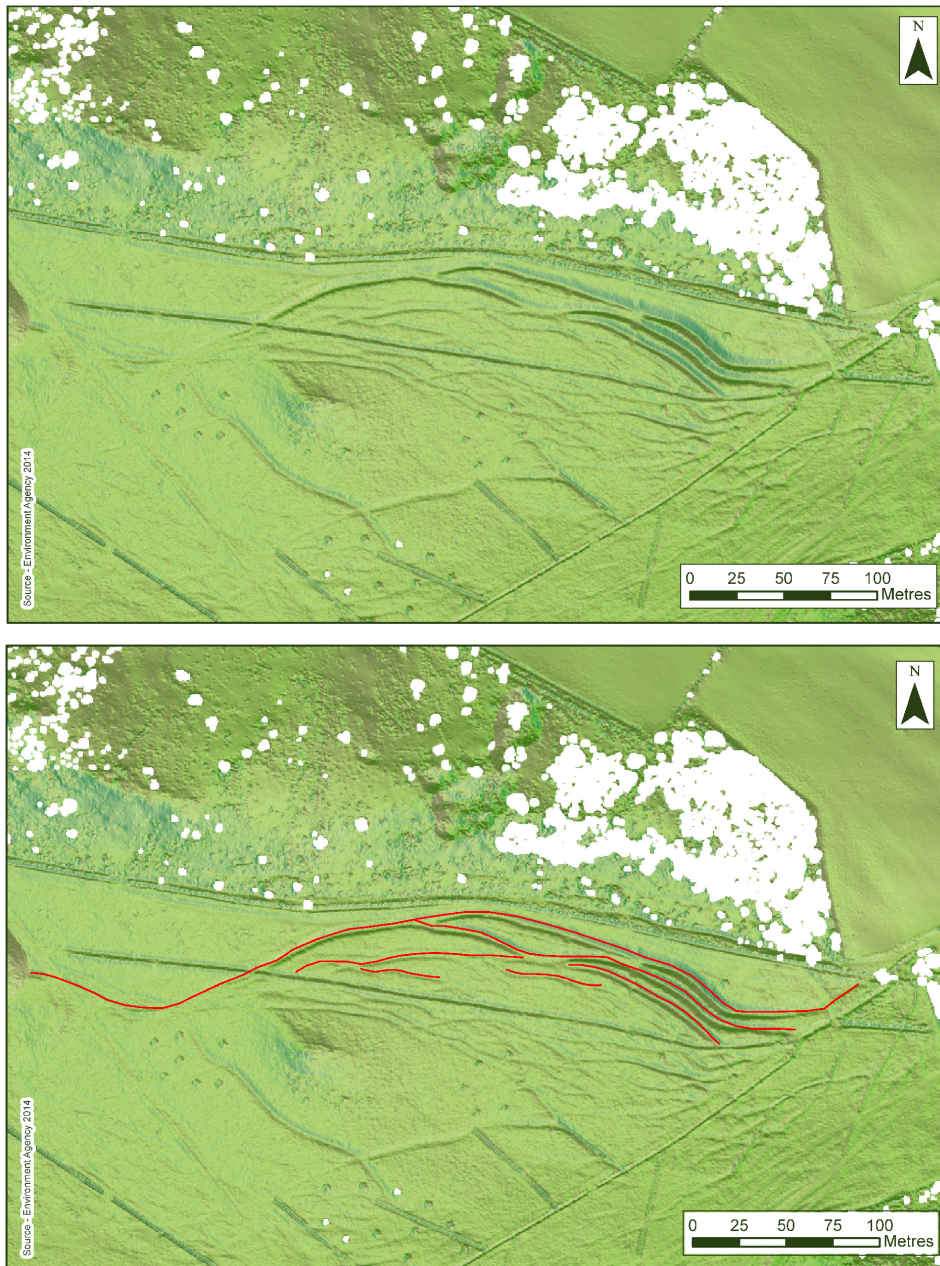
Figure 6: Ditch type features west of Hallgates Farm. (Hillshade 135/30/2 with false colour)

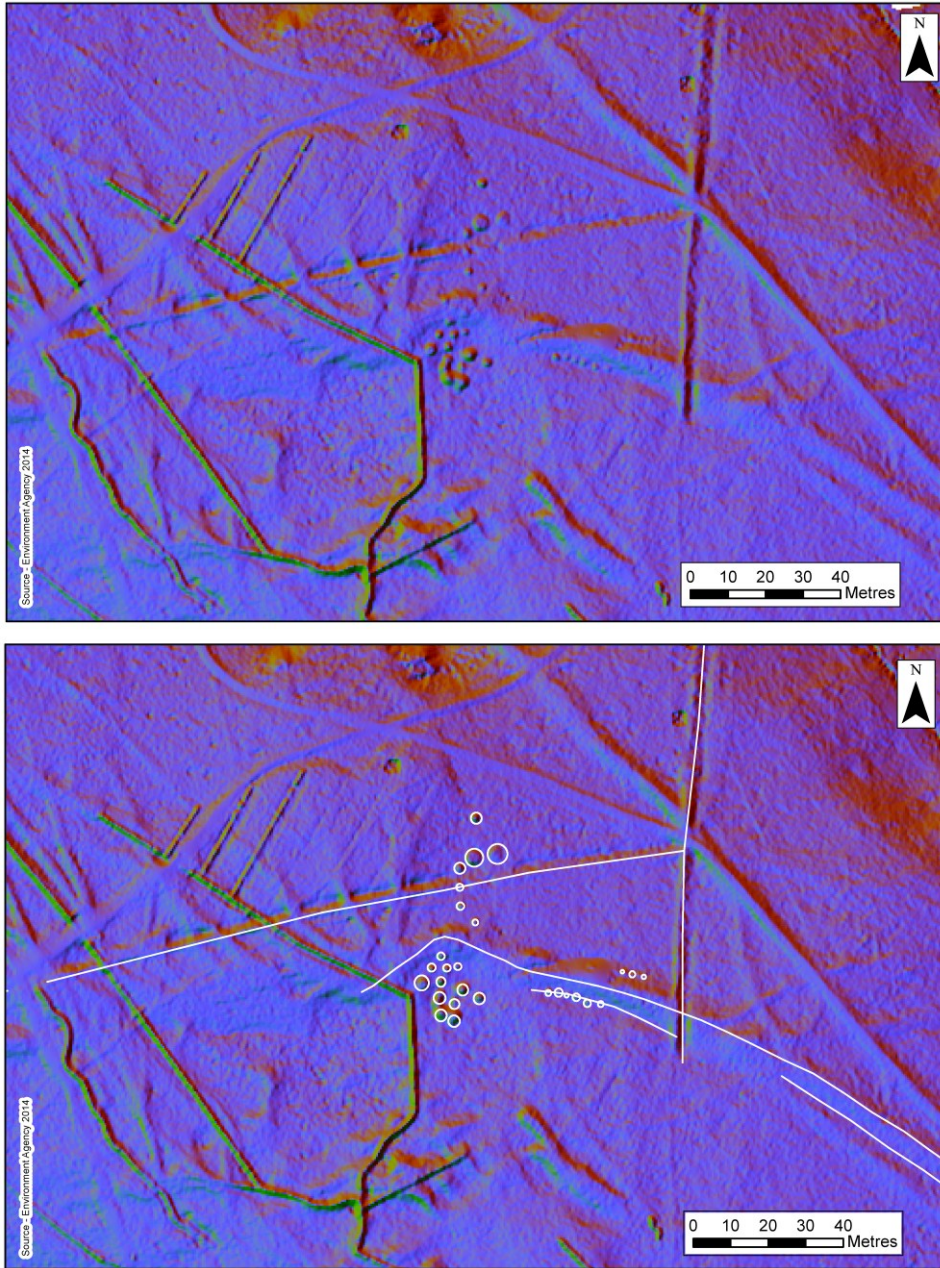
Figure 7: Area of Pit type features west of Dale Spinney. PCA Altitude 30.

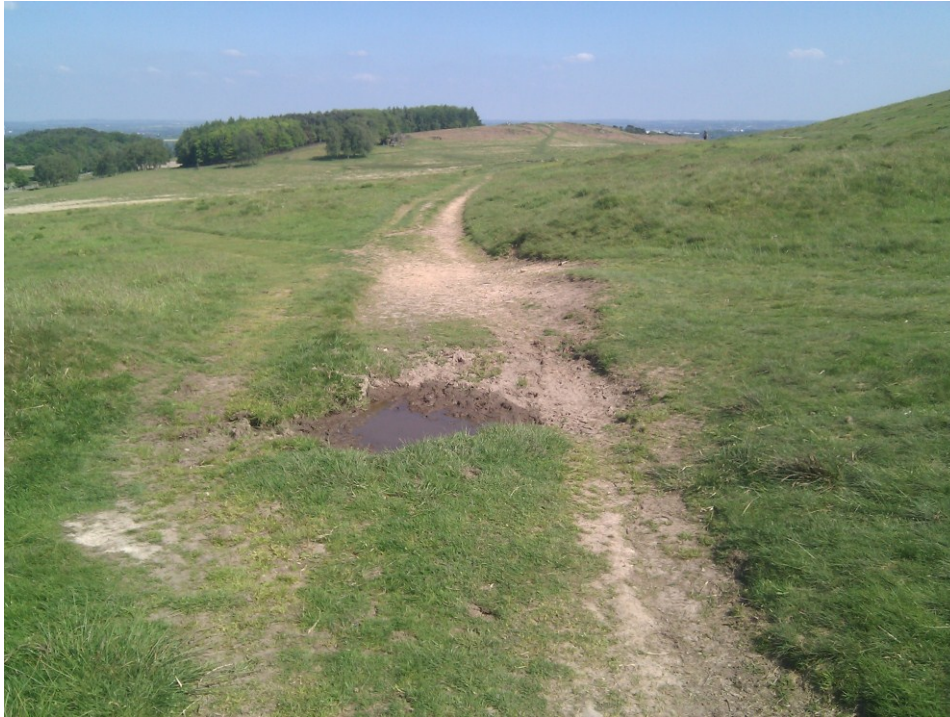
Erosion has recently (May 2014) been noted on the west side of the newly identified enclosure to the north of Old John (FL00447) where several paths converge. This earthwork is currently undated but may be of later prehistoric date and measures to prevent further erosion of these features should be considered.

Figure 22: Path erosion across ditch and bank of undated enclosure (FL00447) to the north of Old John

The main threat to archaeology within the park is from localised erosion, due to visitor pressures in areas of high footfall and from deer in other localised areas. Evaluative test pitting of the Late Upper Palaeolithic site has provided information to enable an understanding of the site's condition, character and associated significance and, based on that, to inform management decisions regarding its future treatment. A number of earthwork features are also suffering from erosion, including stretches of medieval park Pale and the leat through Newtown Lawns.

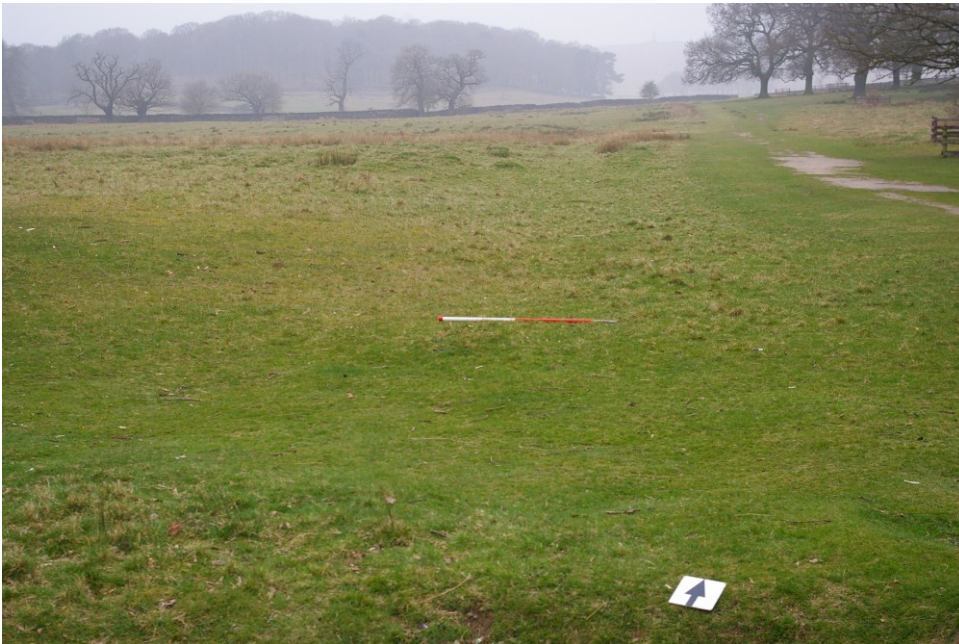
To the east of Bradgate House gardens is an area of holloways and possible building platforms (FL00011-12 and MLE756) which may be the remnant of a Deserted Medieval Village (DMV) (Figure 30). Close to this on the north-east side is a curious moated site (FL00009) (Figure 50) which appears to be too small to contain a structure and is very well-preserved. It is possible that it has an association with the nearby gardens. A chain of fish ponds lies to the east of the house (MLE18594) (Figure 38). More eroded tracks and hollow ways can be seen across the area, most noticeably joining those noted in Area Sheet 4 and another series in the north-east (FL00643 – 645). Again the origin and date of these features is not clear. Well-preserved banks and ditches run across the area. The 18th Century approach to the house was a tree lined avenue depicted by Kiddiar, (MLE18596) (Figure 39), with the Deer Barn to the north (Figure 45). A small enclosed area may be the location of a building represented in the foreground of Kniffe's engraving (FL00635) (Figure 68). A sinuous bank not specifically identified in the LiDAR survey runs from the north-east of the Ruins Enclosure toward Hallgates (W007) (Figure 73). World War II activity can be seen as another bare bank (W008) with spent bullets in and a large number of what look like mortar or shell holes (FL00454 -481) (Figure 58). Many of these pit-like features intercut each other and have cut nearby banks and ditches. There is evidence of a possible bunker or trench at this point too.

Figure 30: MLE756 possible remains of medieval settlement Photo 3901 Looking NW

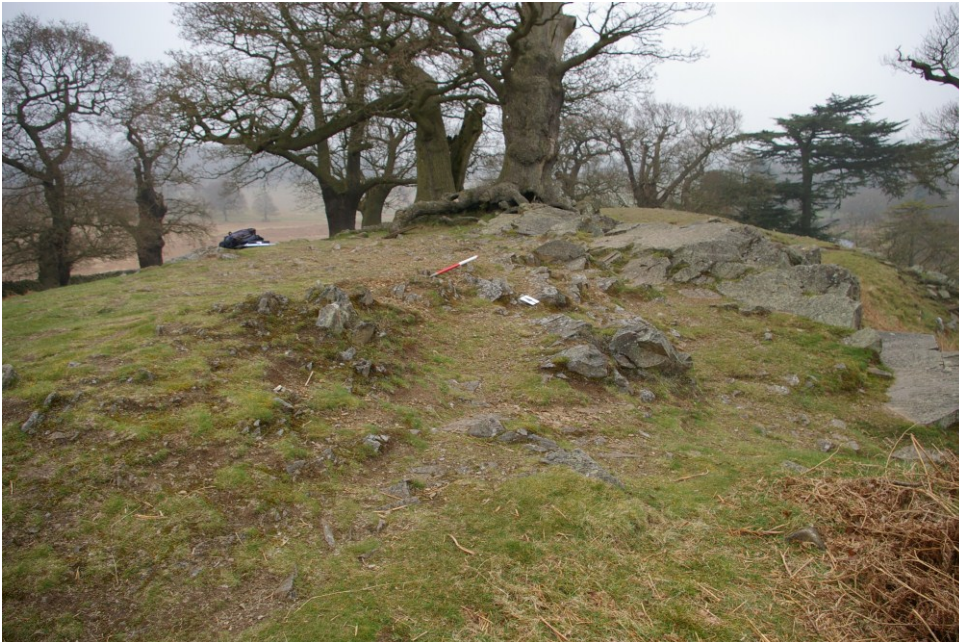
Designated sites: Specific erosion problems were noted for the known Creswellian Upper Palaeolithic site (MLE9435) (which has been the subject of evaluative work reported separately) and also for another area where worked lithics have been recovered which have been dated to the Mesolithic (MLE9436).

Figure 31 :MLE9435 Late Upper Palaeolithic site Photo 3824 Looking NE

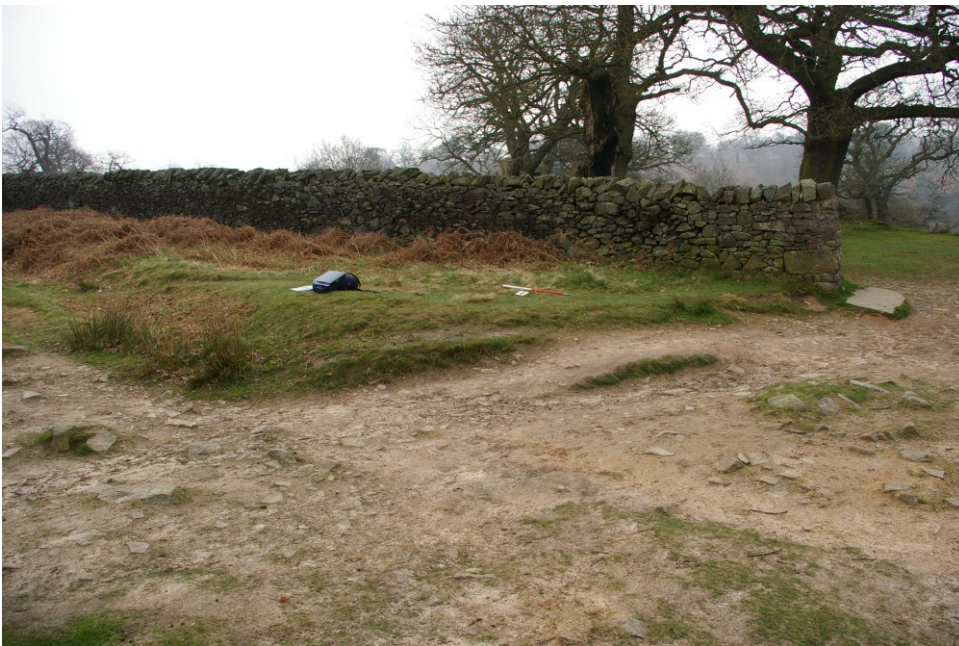
Figure 32: MLE9436 Mesolithic flint findspot Photo 3826 Looking SE

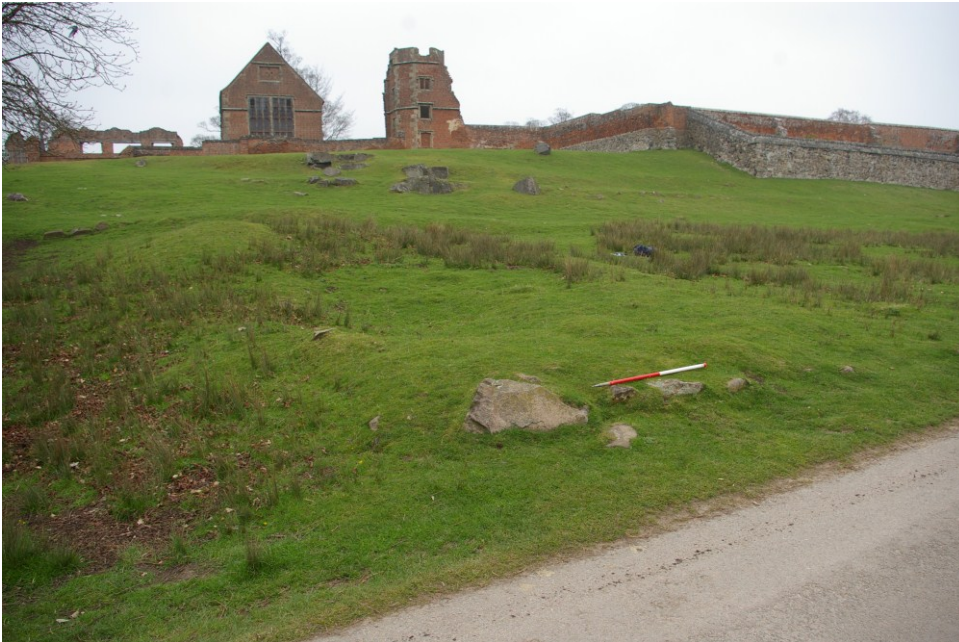
The dog kennels MLE18598 to the south of the house ruins are in the east of the area. This area currently is disturbed ground with possible foundation stone visible due to some erosion.

The Mill Leat (MLE18603) is suffering ongoing erosion especially around NGR SK5287 1015, and there is also damage being caused to the Dog Kennels (MLE18598) where possible foundation stone is being exposed.

Figure 41: MLE18598 dog kennels Photo 3842 Looking NE

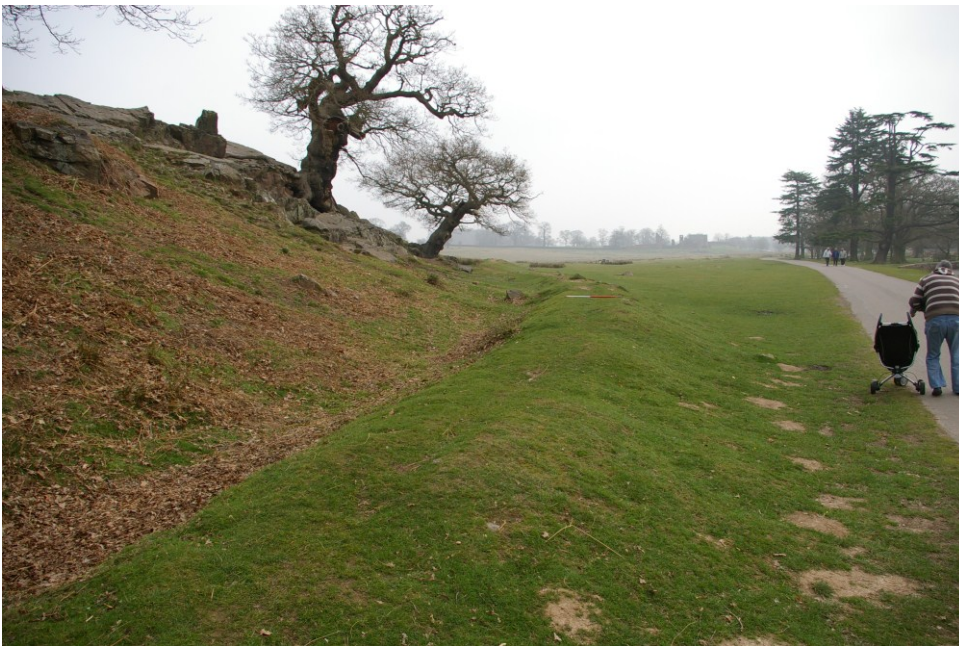
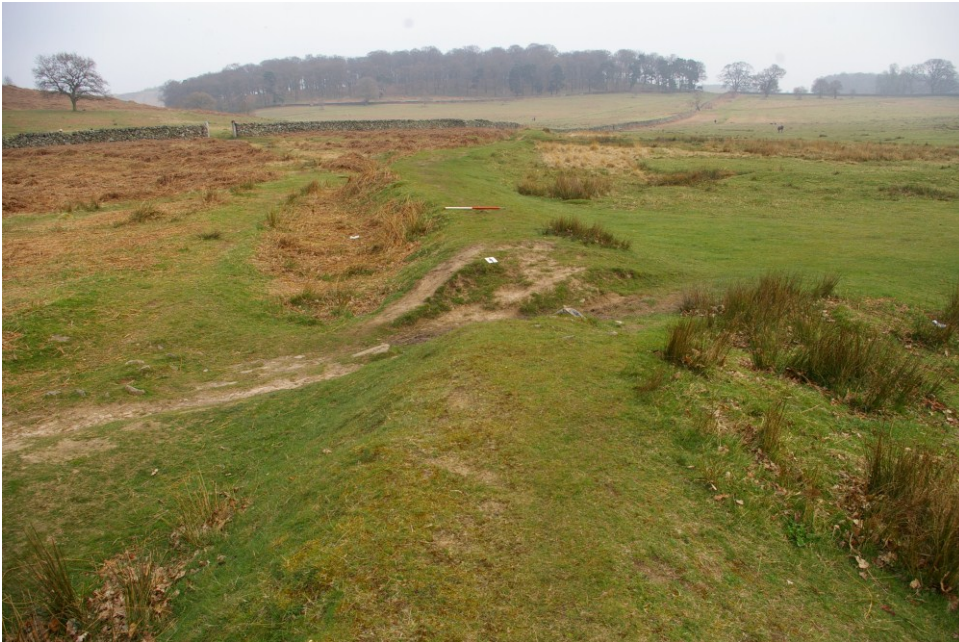
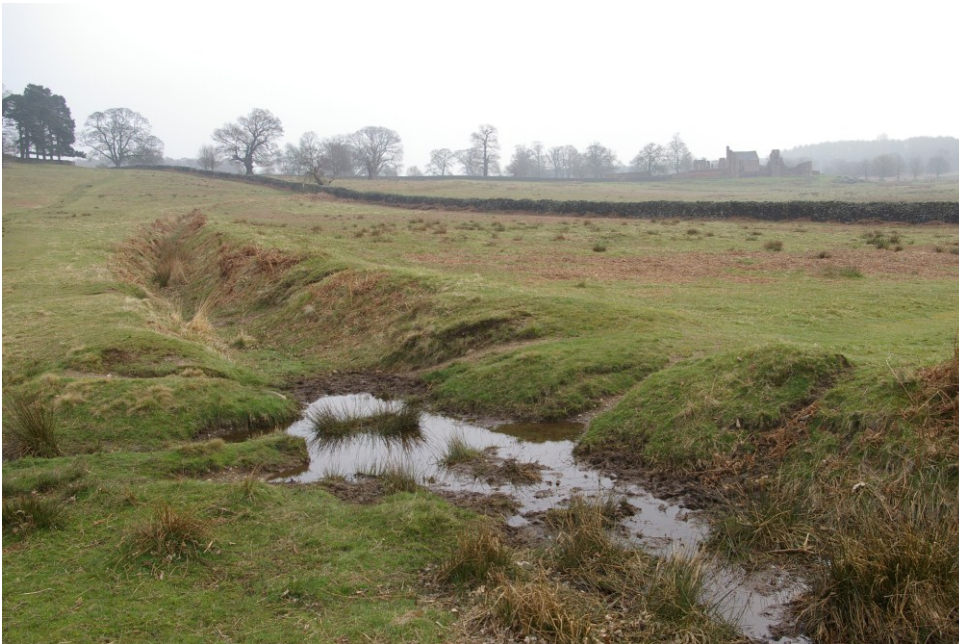
Figure 46: MLE18603 leat (adjacent to river) Photo 3830 Looking E

Figure 47: MLE18603 leat      Photo 3831      Looking NE

Figure 48: MLE18603 leat      Photo 3833      Looking E

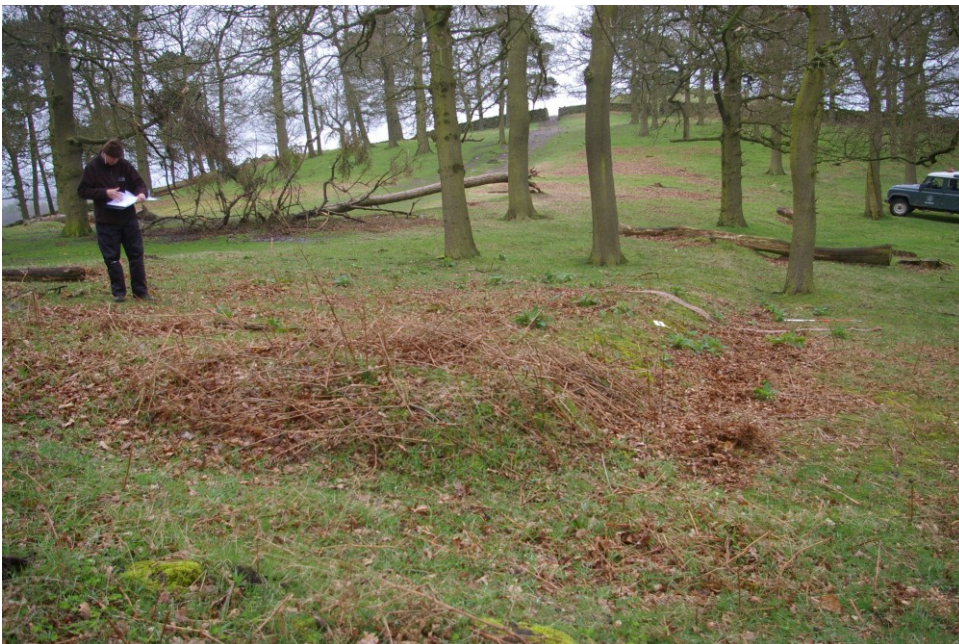
More potential terrace-like features (FL00502) can be seen on the southern slope leading up to Old John although these are not as clear or extensive as elsewhere in the park. A well-preserved ditched enclosure site with a possible entrance (FL00446-447) can be seen near to the Hunts Hill entrance (Figure 55), with another possibly associated feature parallel to the north (FL00655) (Figure 71). Some localised erosion is noted where a track crosses the west side of the enclosure (Figure 22). Further terraces are visible on the west side of Old John e.g. (FL00452) (Figure 57) and (FL00534) (Figure 61). As with many of the features identified by LiDAR there is no clear indication of a date for this. The remains of the 18th century race track (FL00778, 779, 780, 781) running around Old John can be seen in the form of large boundary stones either side of a flat track (especially clear between SK 52438 11377 and SK 52363 11277) cutting the enclosure (FL00446/7) and another bank type feature (FL00619) (Figure 67). Adjacent to Old John are the remains of stables (Figure 74). Within Old John Spinney a square area (FL00451) is defined in the LiDAR, visible as clearly defined negative feature on the ground (Figure 56).

Figure 56: FL00451 square enclosure Photo 4037 Looking NE

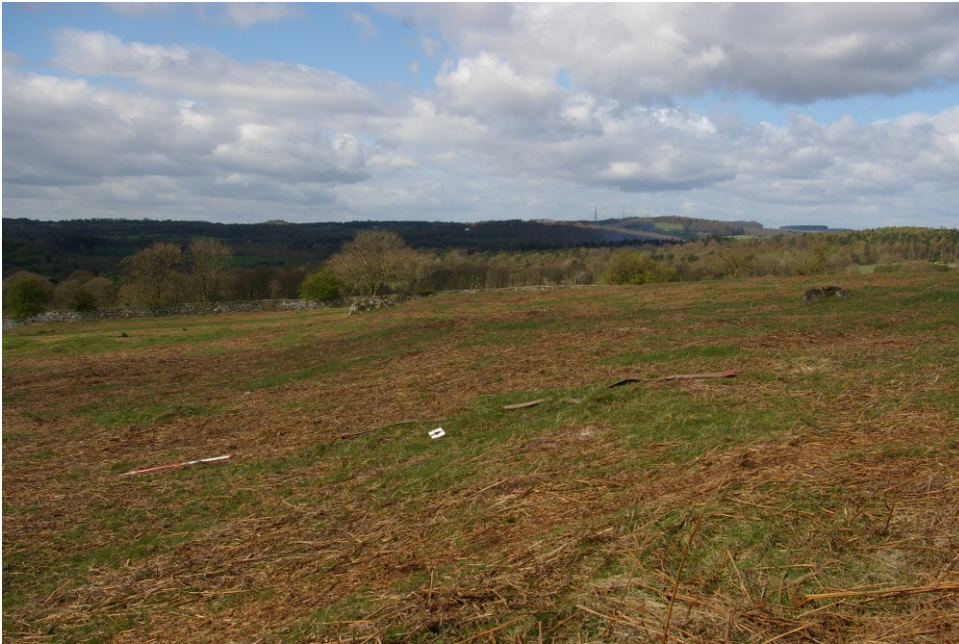
Figure 61: FL00534 bank Photo 4078 Looking W

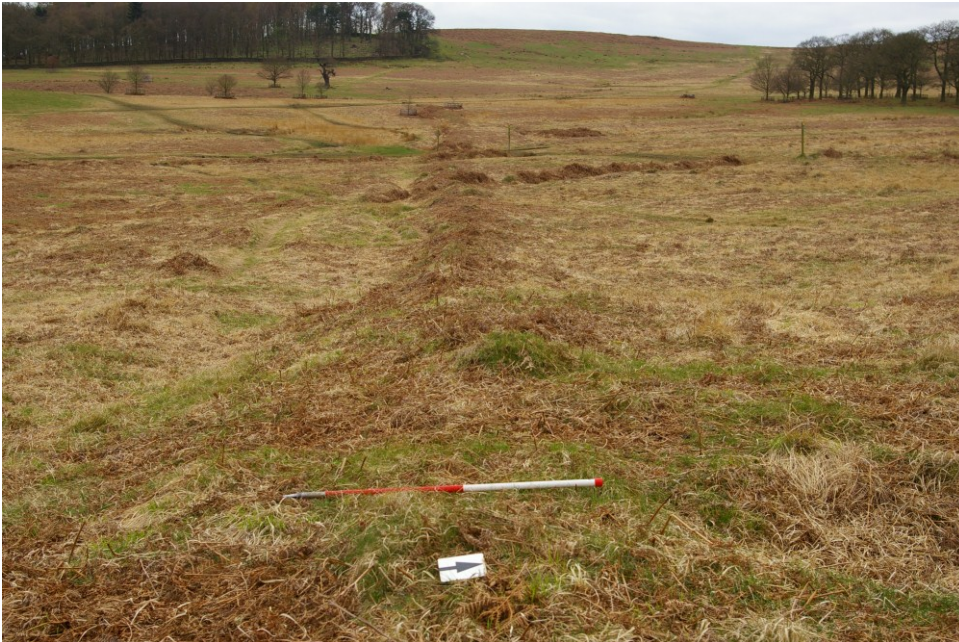
The medieval Park Pale crosses the eastern side of this area curving slightly to the north (FL00639) (Figure 69). Modern, regularly spaced, drainage ditches run across the area as do a large number of small parallel ridges running across large parts of the area. The function of these ridges is not clear but their regular spacing and very straight lines suggest a relatively modern date. World War II activity is evidenced by a bank of bare earth caused by chemicals leaching out of numerous bullets which can still be seen on the surface (this bare earth feature has been identified within the LiDAR data as is numbered FL00786). A number of possible slit trenches can be seen to the south of this bank (centred on SK5298 1051). In the north-eastern corner of the area are a series of worn hollow ways and possible tracks leading north-westwards. These undated features have not been identified on the LiDAR survey.

Figure 69: FL00639 pale Photo 3966 Looking W

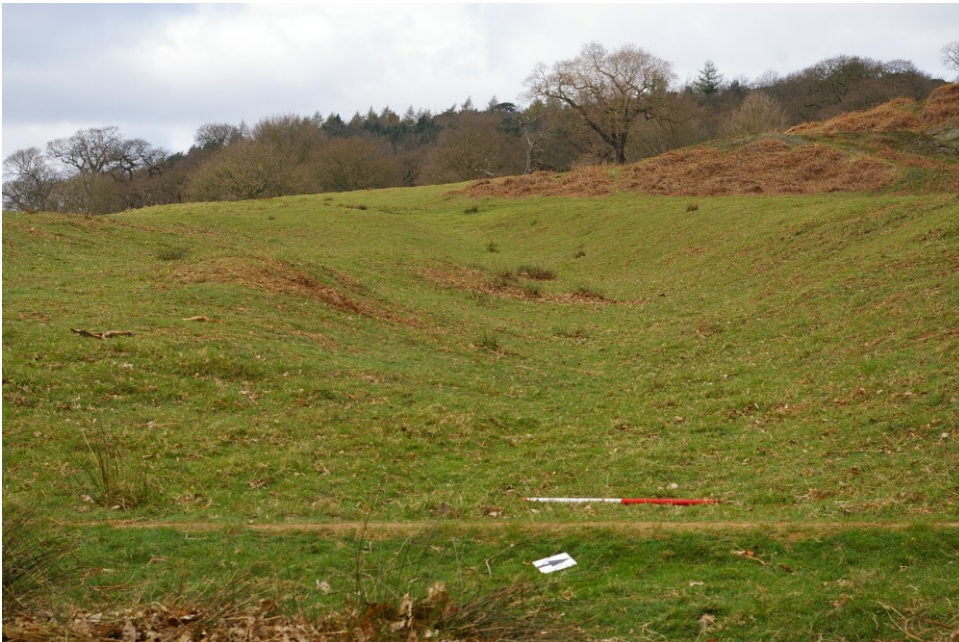
Within the park there are a number of bank and ditch features and probable eroded tracks running into the park. Part of a group of immediately adjacent parallel features of unknown function can be found on the western side of the area (FL00647) (Figure 70).

Figure 70: FL00647 ditch Photo 3935 Looking W

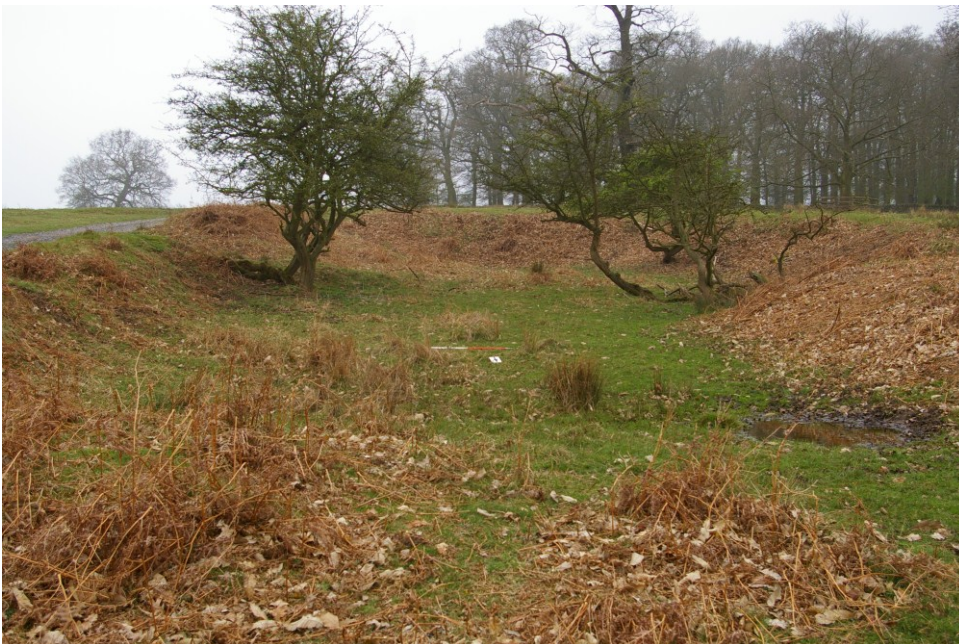
The house ruins, mill, stables, dog kennels, gatehouse, associated structures, gardens and pheasantry have not been assessed in any detail, but were visited during the walkover and an overall note on condition made (see Figure 25, Figure 26, Figure 27, Figure 29, Figure 33, Figure 34, Figure 37, Figure 40, Figure 41, Figure 42, Figure 43). Other noteworthy features that are not designated or included in non-designated records include an irregularly shaped enclosure (FL00006) (Figure 49) which appeared to have been cut by later features associated with the house which might therefore suggest a relatively early date. A substantial moated site (FL00008/MLE739 Scheduled Monument 108813) (Figure 23, Figure 24) to the west of the house offers the potential of an earlier residence for the landowners, alternatively this has been identified as the parker's house. A possible rectangular area inside the enclosure may indicate a building. To the north of this site is another rectangular enclosure (FL00016) (Figure 51). South-west of Holly Plantation, the LiDAR revealed a curving ditch which is visible on the ground as an area of marshy ground (Figure 54). A pair of rectangular depressions (W005) tentatively described as saw pits appear to be rather too large for a single saw pit, and may perhaps be a timber processing area or clay pit (Figure 72).

Figure 72: W005 sunken feature/saw pit? Photo 3890 Looking S
