**An Archaeological Evaluation at
2 Back Lane, Long Clawson,
Leicestershire.
NGR: SK 7255 2730**

ULAS Report No. 2011-171
©2011

An archaeological evaluation was undertaken by the University of Leicester Archaeological Services (ULAS) at 2 Back Lane, Long Clawson, Leicestershire. The work took place on the 1st of November 2011 in advance of the demolition of the existing bungalow and the construction of a new house on a similar footprint. The development site lies within the core of the medieval and post-medieval village and records show that a timber cruck-framed cottage was located to the east of the plot, hence the requirement for archaeological work. One 11m long trench was excavated to the west of the bungalow and a second 19.6m long L-shaped trench was excavated to the east.

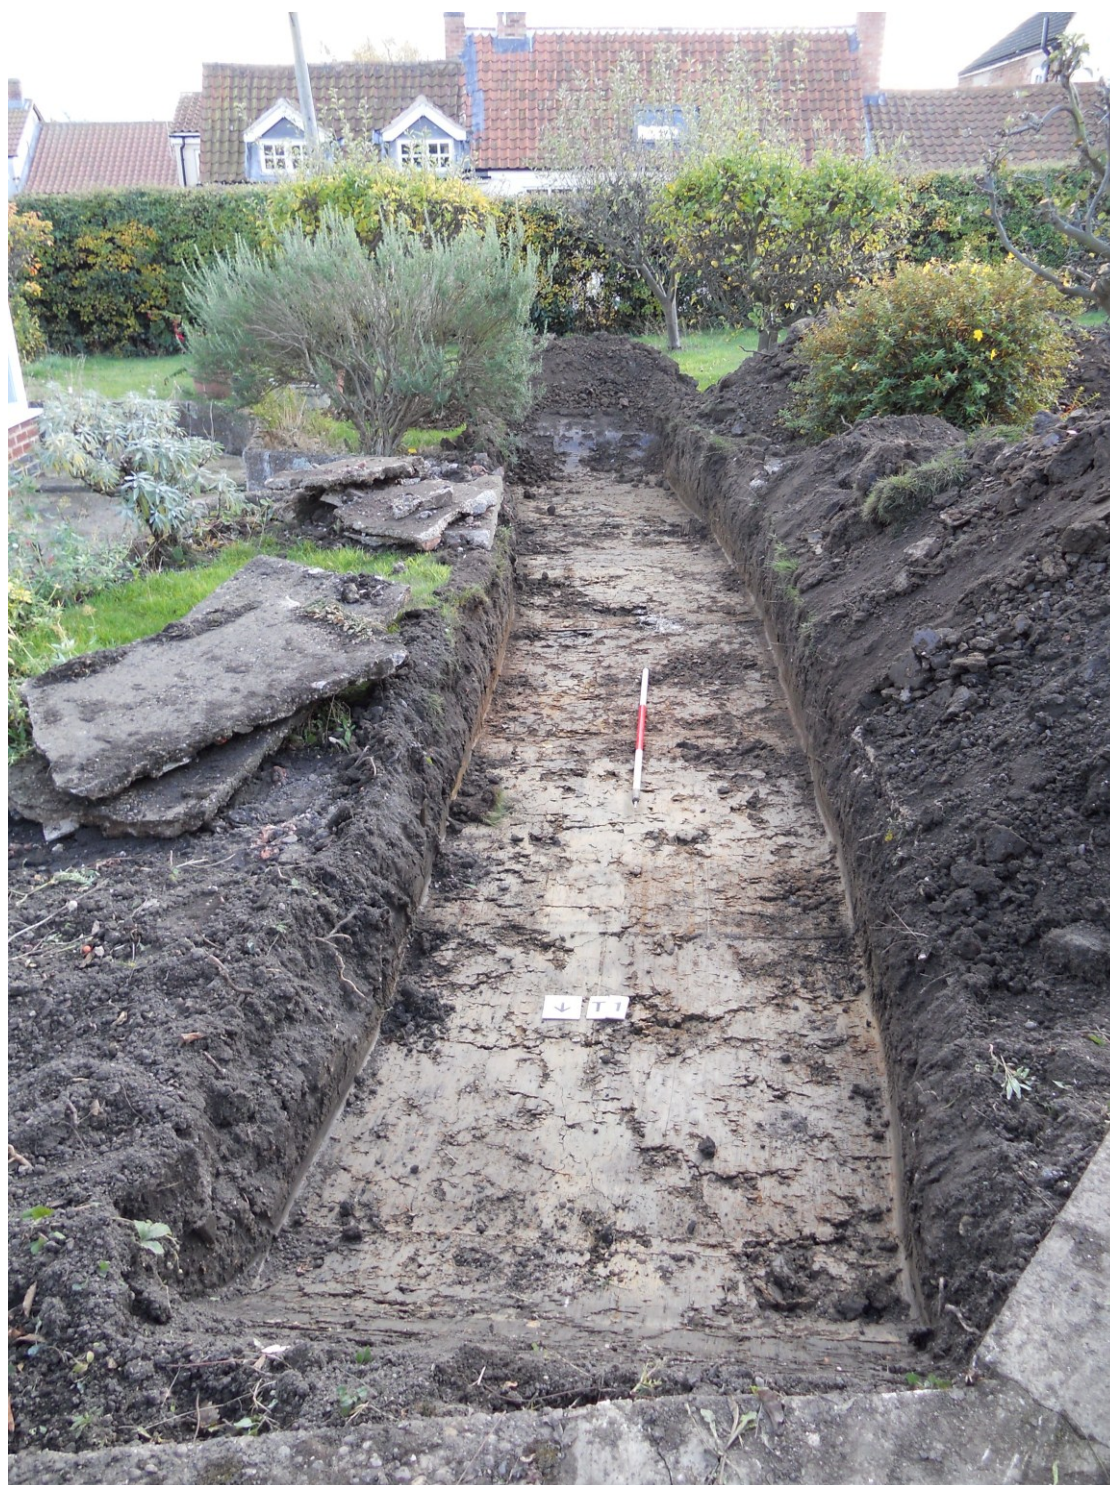
Figure 9. Trench 1
Looking south. 1.5m scale

As noted above, the initial specified location of the first trench was for it to follow a north-east to south-west alignment which would set it at an angle to the bungalow. Because of the location of a number of apple trees and the potential for damaging a sewer pipe near to the front of the property a shortened trench with a slight curve was excavated on a near north to south alignment.

The topsoil was a fine garden soil consisting of a dark grey slightly clayish sandy silt with an average depth of 0.30m. This layer was quite disturbed with roots and contained a number of brick fragments which matched the bricks used in the bungalow. There was also a considerable quantity of coal ash and cinders. Beneath this was a thin layer of orange grey clayish sand and silt subsoil with a depth between 0.09m and 0.10m. Removal of the subsoil revealed a natural substratum of mid orange grey sandy clay with mottled patches of brighter orange sand. Two wooden posts seen

from just below ground level extended into the natural but were of recent date. No archaeological features or deposits were observed within the trench.

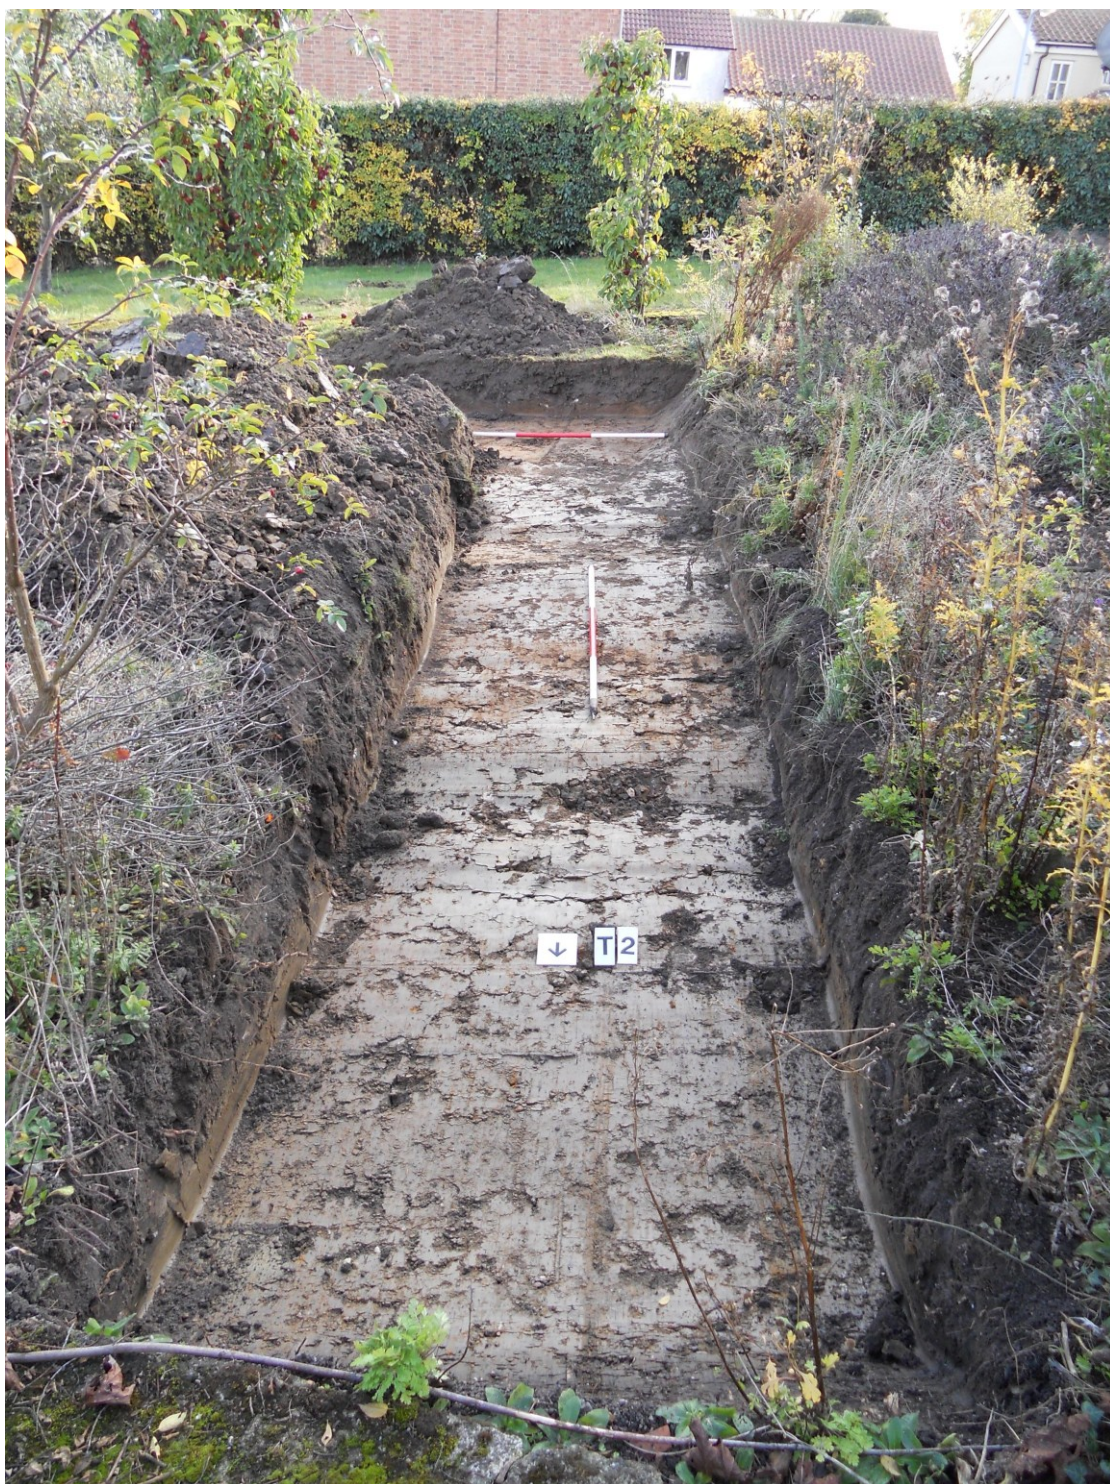
Figure 11. Trench 2. N-S arm
Looking south. 1.5m scales

The specified trench, to the west of the bungalow, was intended to run from west to east at an angle of approximately 45 degrees to the building. Because of the location of more apple trees and to maintain a total trench length of 30m an L-shaped trench was excavated (Figs. 11 and 12). This was laid out to initially run parallel to the bungalow before turning eastwards to run down the slope of the garden.

As in Trench 1 the topsoil, or garden soil, consisted of a dark grey slightly clayish sandy silt but with a depth varying between 0.21m and 0.30m. The same orange grey clayish sand and silt was observed although there were a number of ironstone fragments scattered throughout this layer which had a depth varying between 0.07m and 0.12m. The natural was the same as in Trench 1 although there were more patches of orange grey clay.

The cut for a ceramic drain was seen running from the north-west to the south-east across the south-west corner of the trench. Another ceramic drain was seen on a parallel alignment to this approximately 6m further east (Fig. 8). No archaeological features or deposits were observed in this trench.
