**An Archaeological Attendance,
Inspection and Recording Exercise
(Watching Brief) at
St. Denys Church, Church Road,
Evington, Leicester.**

NGR: SK 62759 02764

ULAS Report No. 2013-090
©2013

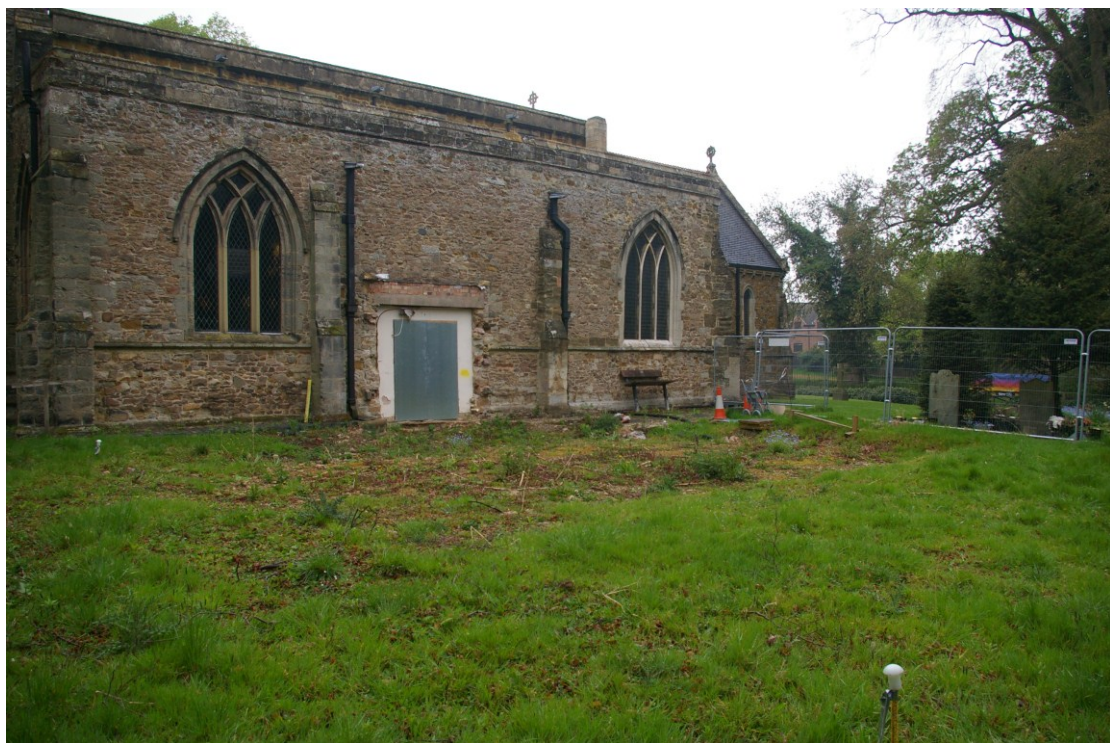
Figure 4 Site prior to levelling and trench excavation
Looking north-east

The area around the proposed new Vestry, prior to the commencement of the work, comprised an open space covered in turf. A disturbed area of ground shows where the earlier Vestry building once stood but nothing remains in-situ (Fig. 4). The land is generally level but tends to drop away to the south along the southern edge of the development area. Beyond the south and western boundaries of the churchyard the land drops away towards the Evington Arboretum and to the site of the moat earthworks.

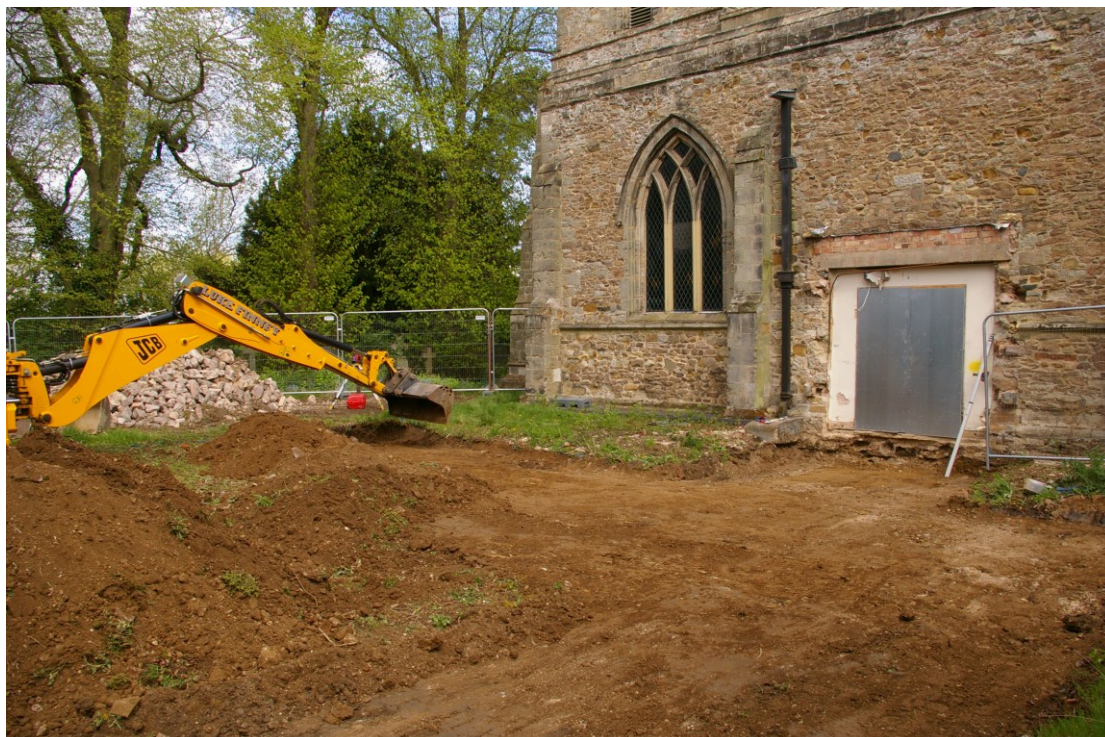
Figure 5 Site reduction phase
Looking north-west

In order to create a level site at the correct building height all of the turf was removed across the entire footprint of the new extension. Approximately 0.3m of turf and dark brown silty topsoil was removed across the northern side of the development, reducing down to less than 0.1m along the southern edge as the slope of the site increased. This levelling strip revealed a consistent, but mixed, mid-brown sandy-silt containing some building material and disarticulated human bone (Fig. 5). The ground to the south of the earlier Vestry was quite heavily disturbed by root action.

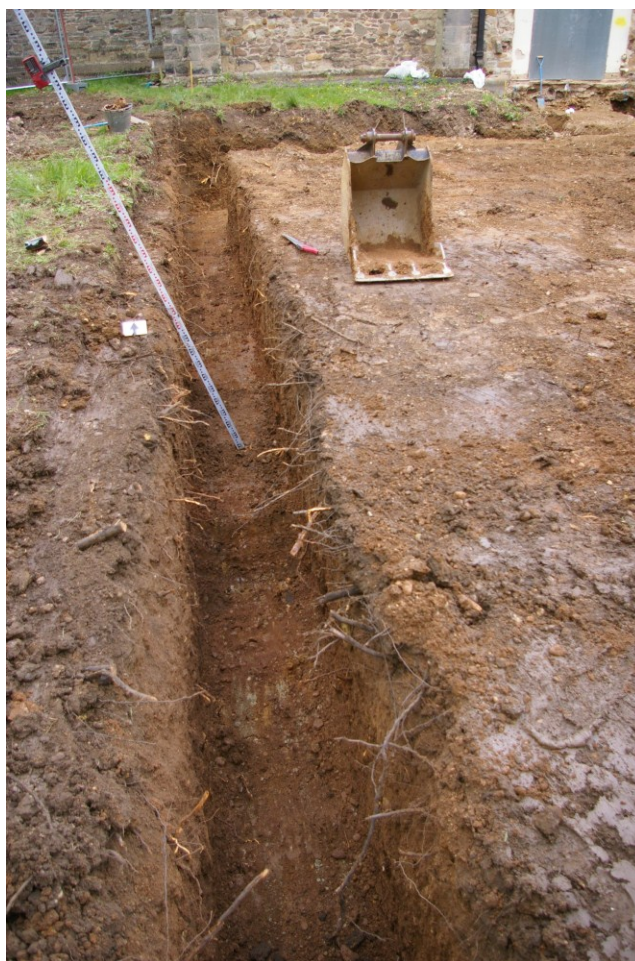
Figure 6 Site after western trench excavation
Looking north

Once the correct levels had been achieved, the foundation trenches were then excavated. Two short trenches were excavated extending out from the southern wall of the church where a small corridor connecting the Vestry to the main church building will be located. With the exception of a north to south disused pipe the mixed mid-brown sandy-silt layer continued down to a depth of approximately 1m before the mid-orange brown sand and gravel natural substratum was encountered. Excavation of the remaining trenches around the perimeter and across the centre of the new building revealed similar results (Figs. 6 and 7). All of the foundation trenches, with the exception of the easternmost trench were observed and inspected. Areas of disturbed bones were seen across the site which suggested earlier disturbance and re-interment during the digging of new graves.

The natural substratum remained at a fairly constant 1m below current ground level across the site. The relatively shallow foundations for the old Vestry building appeared to be only around 0.5m below current ground level. Although clearly, and heavily, disturbed the mid-brown sandy-silt layer did not contain any archaeological features or deposits.

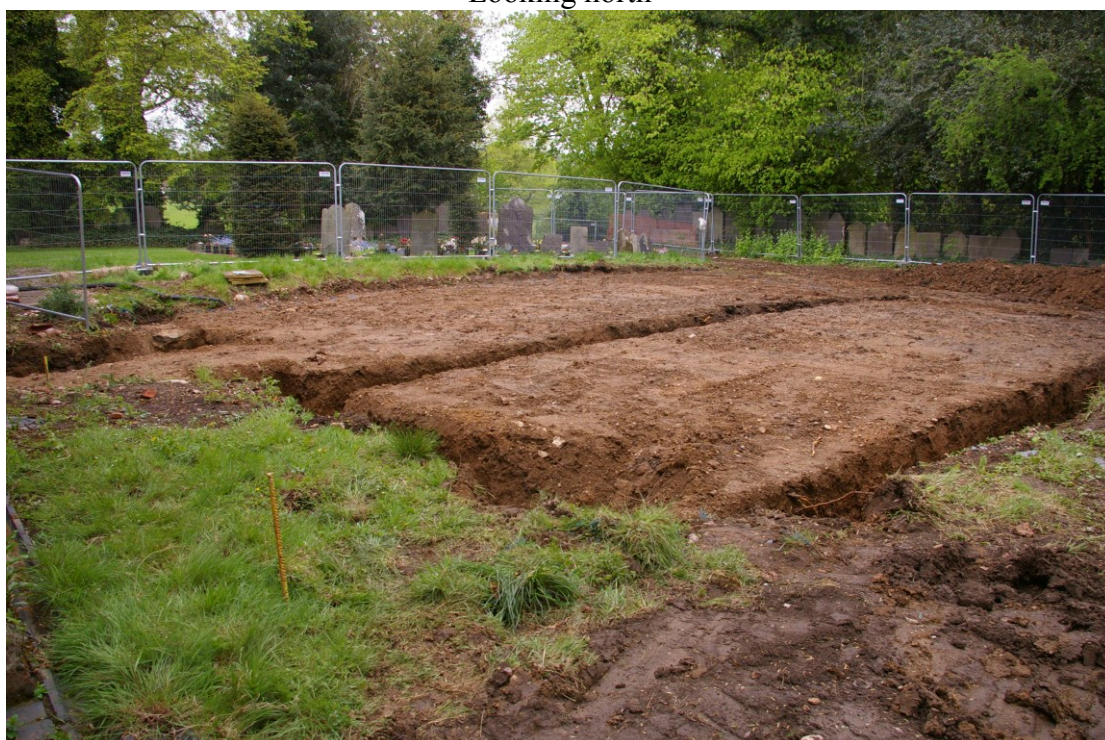
Figure 7 Site after excavation of trenches
Looking south-east

Despite the proximity to the Scheduled Monument earthworks and its position within the heart of the village core no archaeological features or deposits were encountered during this watching brief. If any were present it seems highly likely that they may have been disturbed and destroyed by continual and repeated grave digging.
