**An Additional Archaeological Standing Building Survey of  
the Former Lisk Controls Site, Nottingham Road,  
Lount, Leicestershire (NGR SK 387 193)**

ULAS Report No 2012-025  
©2012

**For: Bellway Homes**

*University of Leicester Archaeological Services were commissioned by Bellway Homes Ltd to undertake an archaeological standing building survey (to English Heritage Level 2) of the former Lisk Controls site, Nottingham Road, Lount, Leicestershire. Planning permission is being sought to re-develop the site for residential use. The proposed re-development requires the demolition of the existing buildings on the site of the former Coleorton Pottery.*

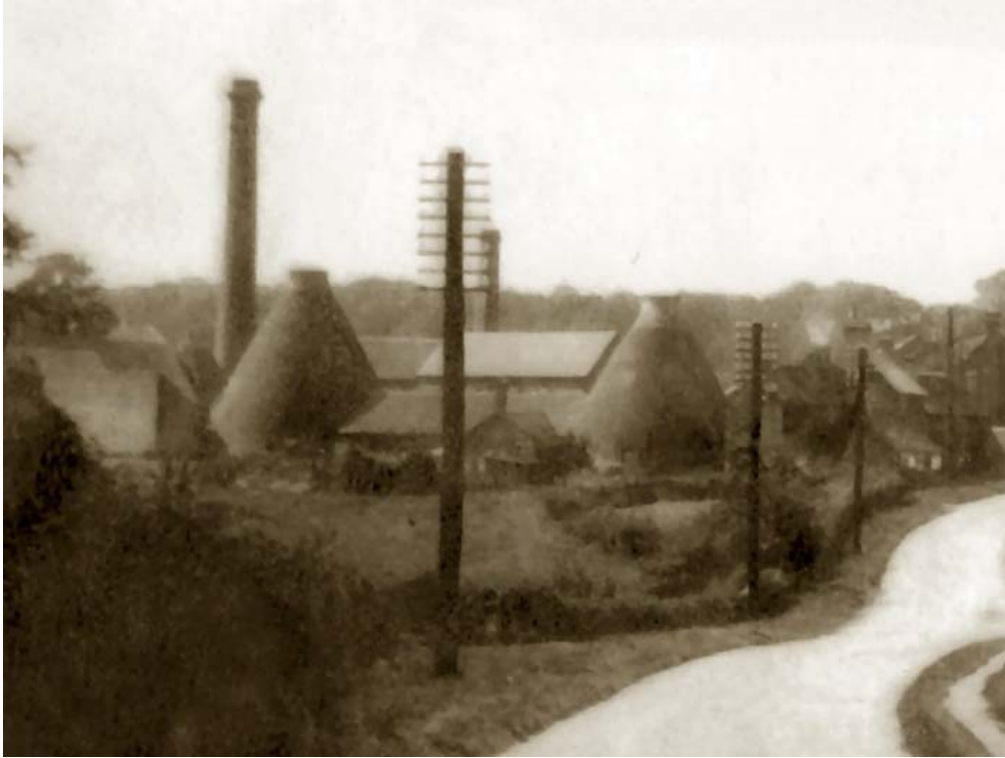
**Figure 2**

Coleorton Pottery from the north-east (unknown date, probably late 19th/early 20th century).

Cartographic evidence (*Figures 26-29*) indicates that building 1b is the earliest remaining within the proposed development area and is likely to be part of the original Coleorton Pottery works and the roof of which can be seen in Figure 2. The photograph also confirms the division between the northern and southernmost parts of the building, showing both a change in roof level and roofing materials. The 1903 Ordnance Survey map appears to show the southern portion of Building 1b but the northern part is only depicted after the 1923 edition.

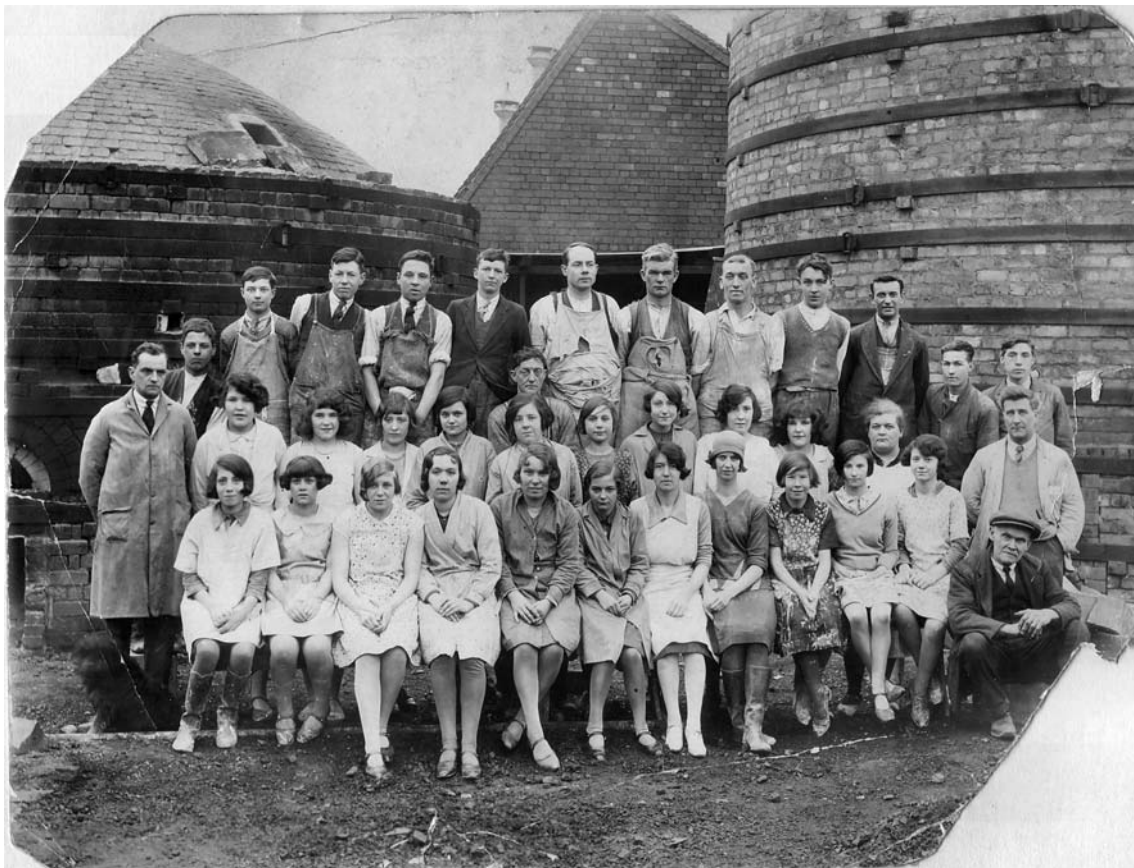
**Figure 5**

Coleorton Pottery staff, with limited view of building 4 (approximately within the future footprint of building 3d).

Because the pottery was closed in 1932 it is unlikely that 3d was built prior to World War II, and photographic evidence shows the Coleorton Pottery staff posing in front of two kilns and the western elevation of building 4 (*Figure 5*). Cartographic sources indicate that these three kilns are at least partially within the footprint of Building 3d, and although undated the clothing worn by the staff suggests a late 1920s or early 1930s date. It is almost certain, therefore, that building 3d dates from the 1950s, or very early 1960s, with the earlier date being the most likely.

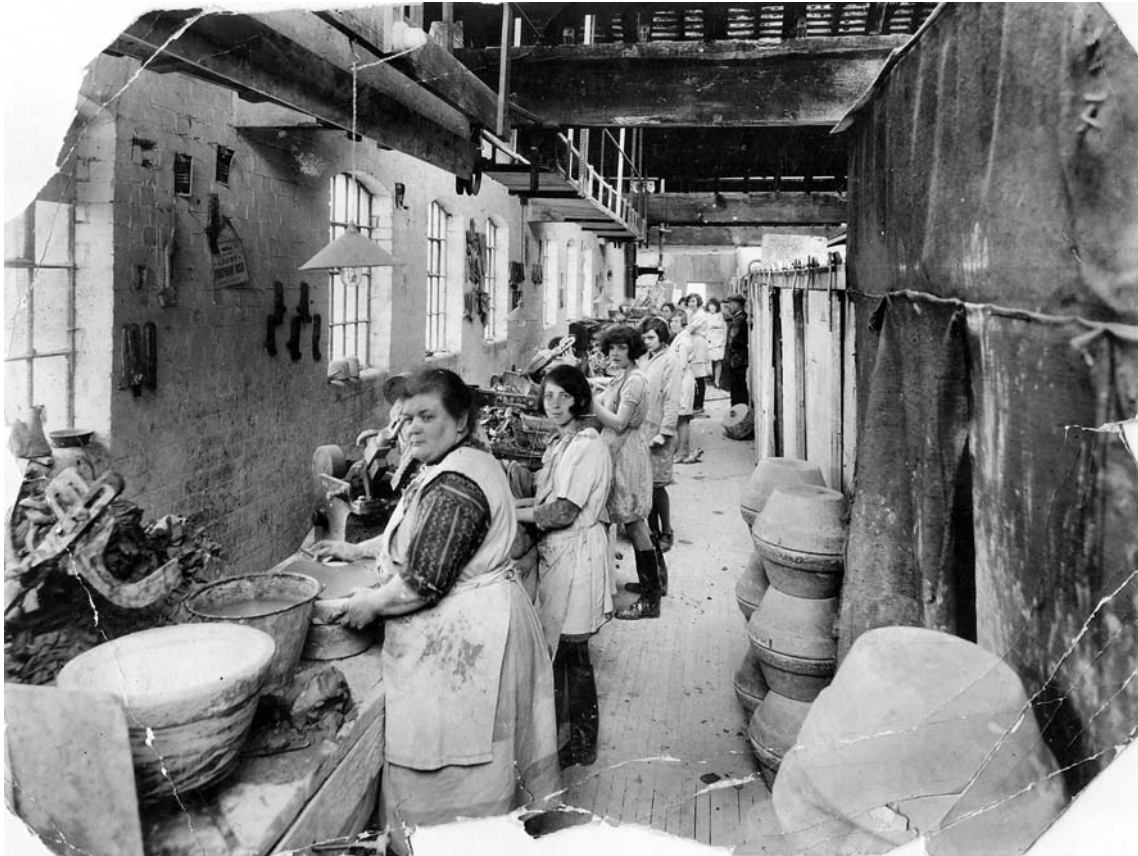
**Figure 6**

Coleorton Pottery staff inside building 4a (the left hand wall is the easternmost wall of 4a).

Although slightly out of line with the trusses in the two southern bays, the those within 4b (to the north) are identical, suggesting, despite the brick-built partition, that all three bays are contemporary and represent a single phase of building. Also within 4b there is a blocked flat arched carriage entrance on the western wall, providing further confirmation that building 3c is later infilling. On the eastern wall there are a number of blocked flat arched windows, again confirming that the easternmost bay is a later addition. These windows are almost certainly those which can be seen to the left of *Figure 6*.

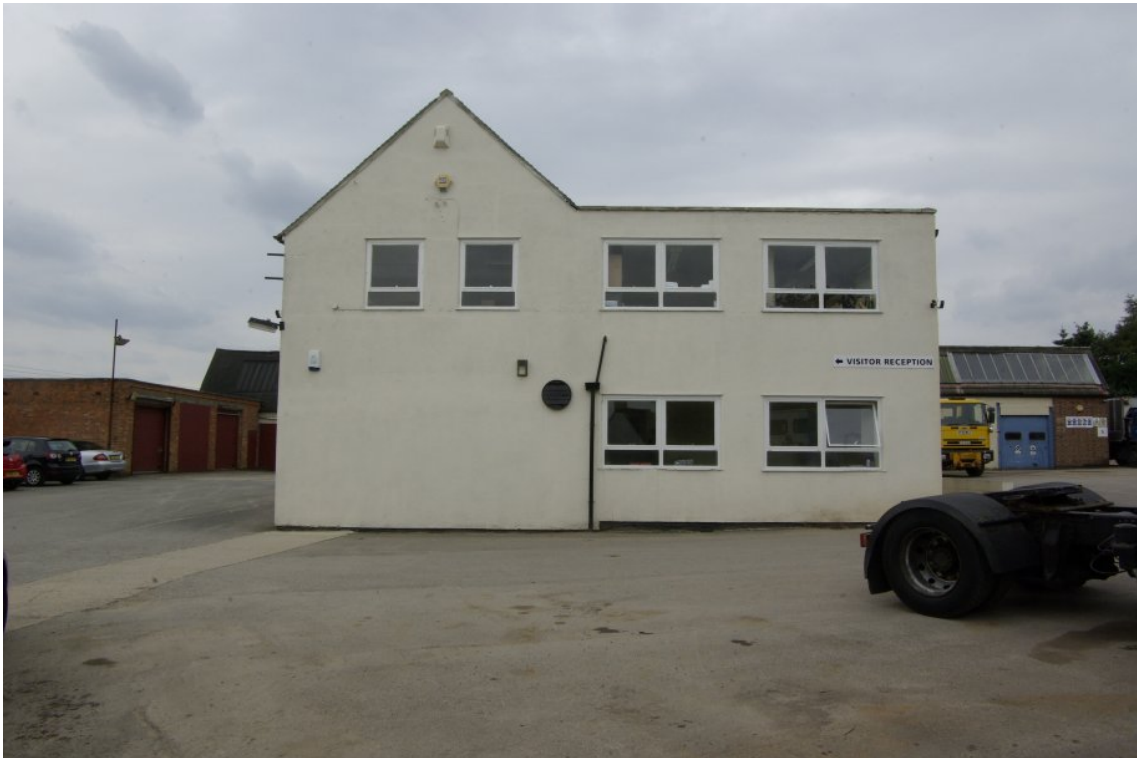
**Figure 10** North-facing elevation of building 1.

Building 1 is the northernmost building, adjacent to Nottingham Road. It is two storied and aligned north-south, with the gable fronting Nottingham Road. The building is stucco rendered with a pitched roof on the eastern side and a flat roof on the western side (Building 1a to the west, 1b to the east), indicating two separate phases, as well as a change in roof heights which may also suggest a third phase. The step in roof height can be seen midway along building 1b (*Figures 9 and 11*). The windows on the eastern elevation are modern uPVC while on the western elevation they are a mix of modern uPVC and older Crittal style steel-framed windows; the roof is modern ceramic roof tiles.

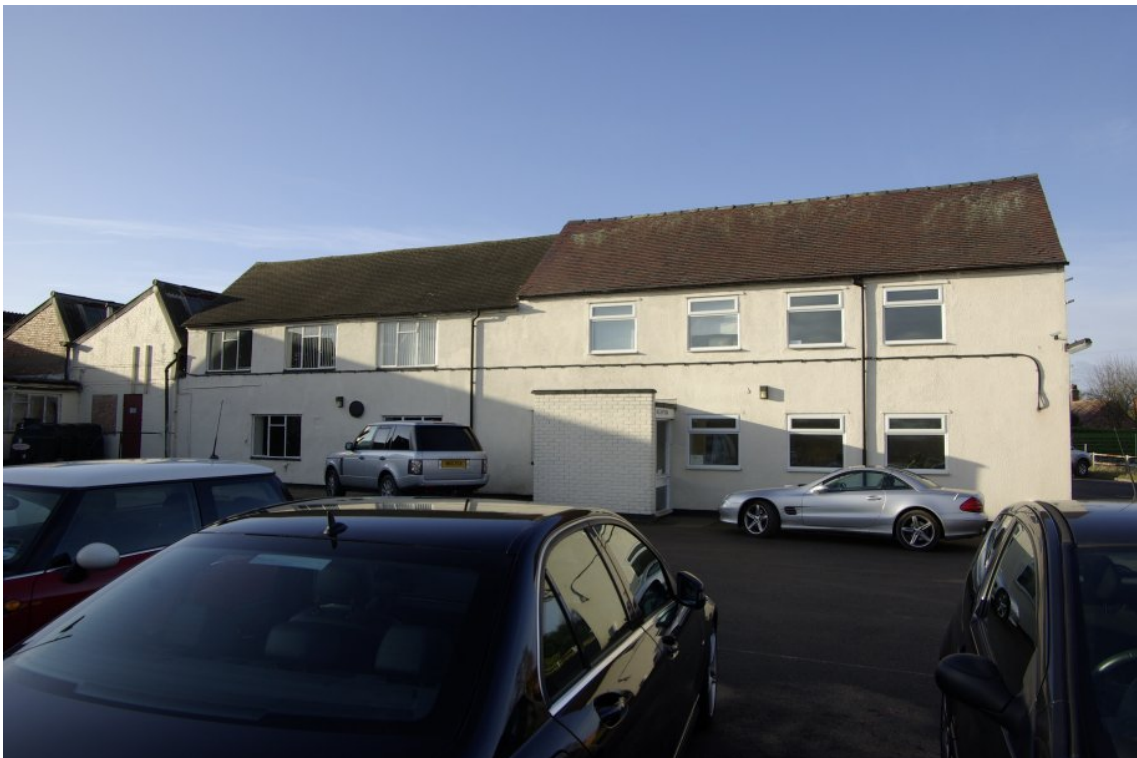
**Figure 11** East facing elevation of building 1b, showing change in roof line.

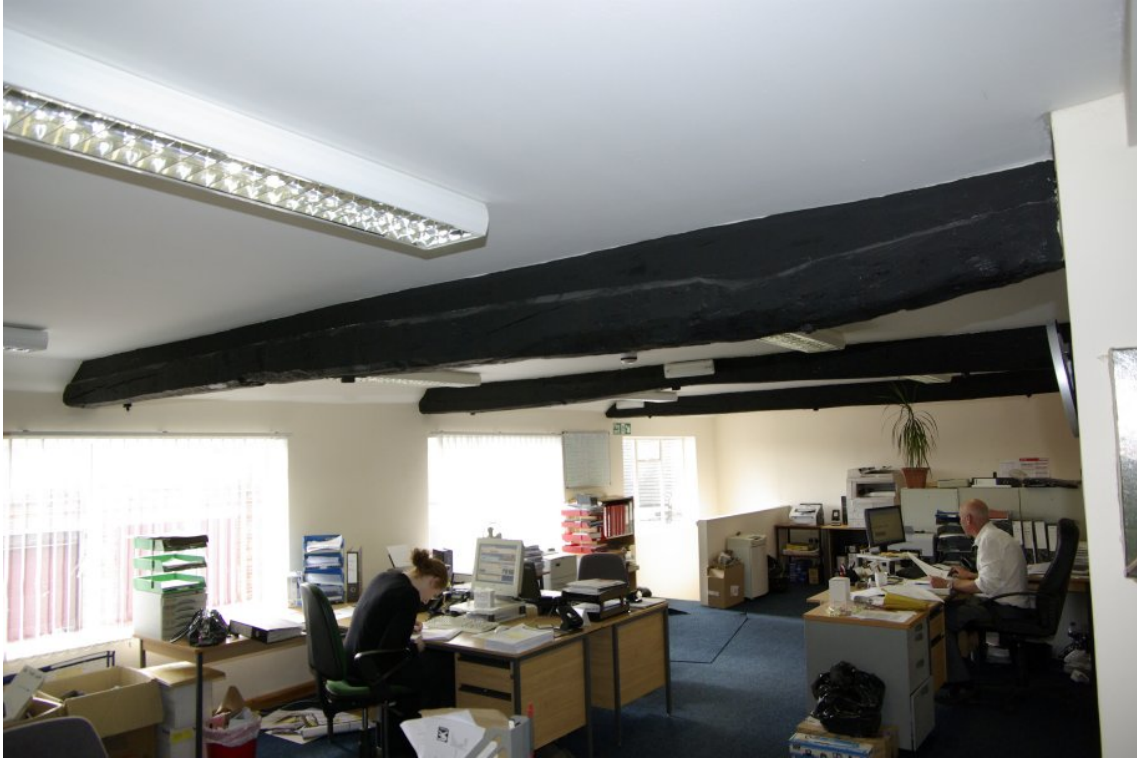
**Figure 12** Tie beams visible within building 1b.

Internally, there is very little of historical or architectural interest remaining within either building. Both had been extensively renovated by the new owners. The only exceptions are the partially exposed timbers, the tie beams of the roof trusses, on the first floor of building 1b (*Figures 12 & 13*). A more detailed examination of these beams indicates a clear division between the northernmost and southernmost beams. After the soft strip and before final demolition, a blocked staircase could be seen in the floor of the southern room in the north part of the building (*Figure 17*). This was presumably superseded and replaced when the western Building 1a was added.

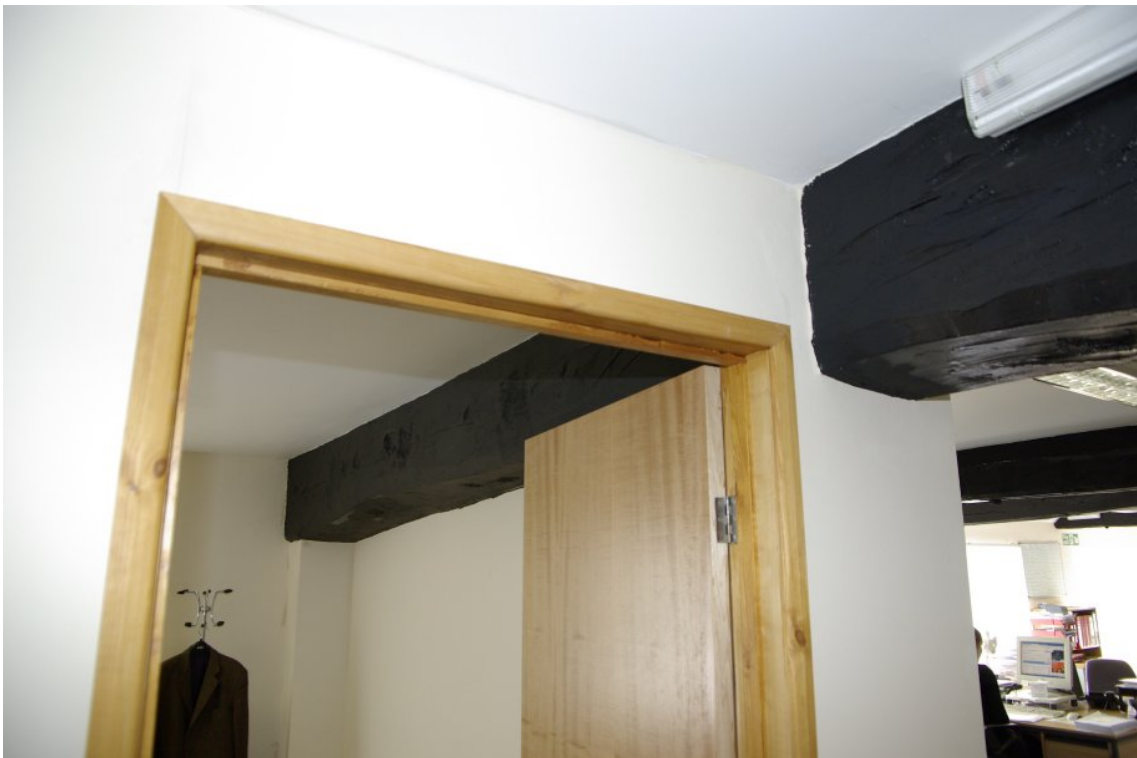
**Figure 13** Tie beams visible within building 1b.

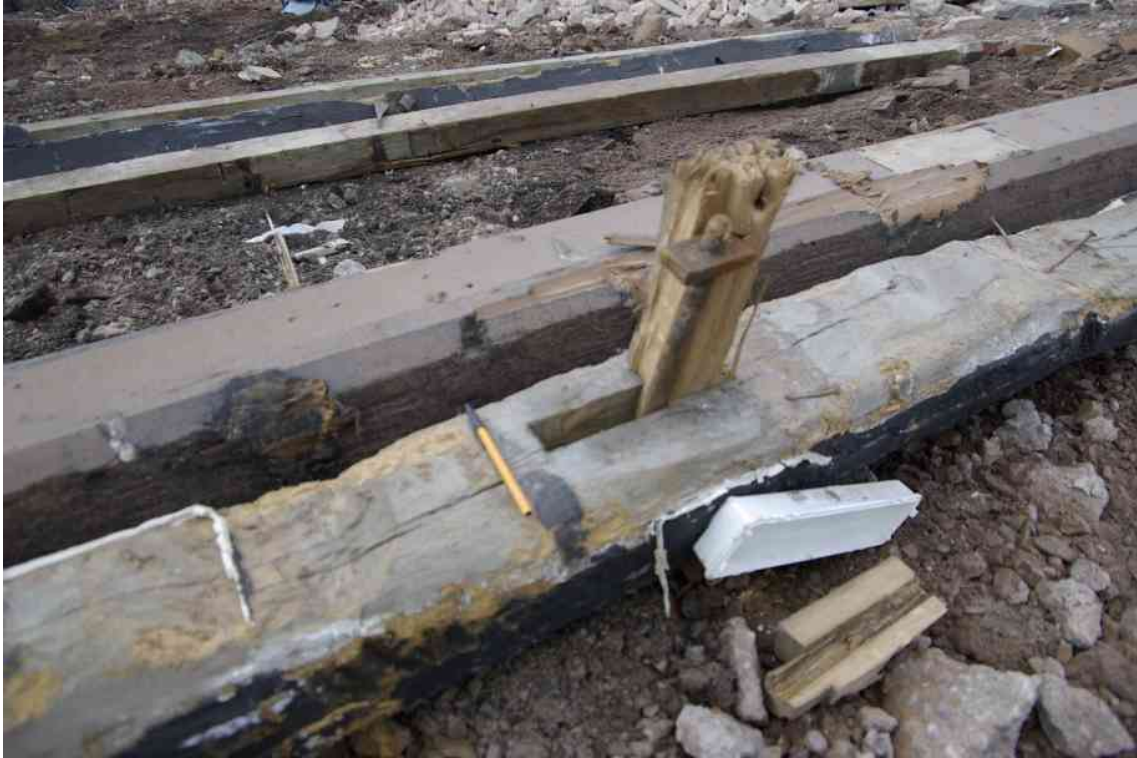
**Figure 14** Tie beams from Building 1b after removal

The exposed timbers within the southern part of the building are of greater significance and are clearly earlier in date. Again the four beams are the tie beams of concealed roof trusses; visible dimensions range between 240mm and 356mm (8-14 inches), and they appear to be hand-finished hardwood. Access to the attic space within this part of the building was possible which confirmed that the trusses were King Post trusses (*Figure 15*). The birds mouth openings visible on the both the rafters and the king post itself indicate that the timbers are re-used and were originally wall plates. The southernmost truss appeared to contain a trench for a wind brace on the inside face, suggesting that it too was not in its original position and is likely to be re-used. After demolition and removal from the building it could be seen that the large tie beams contained sockets for floor joists (*Figure 14*). The rafters were socketed and bolted into the tie beams.

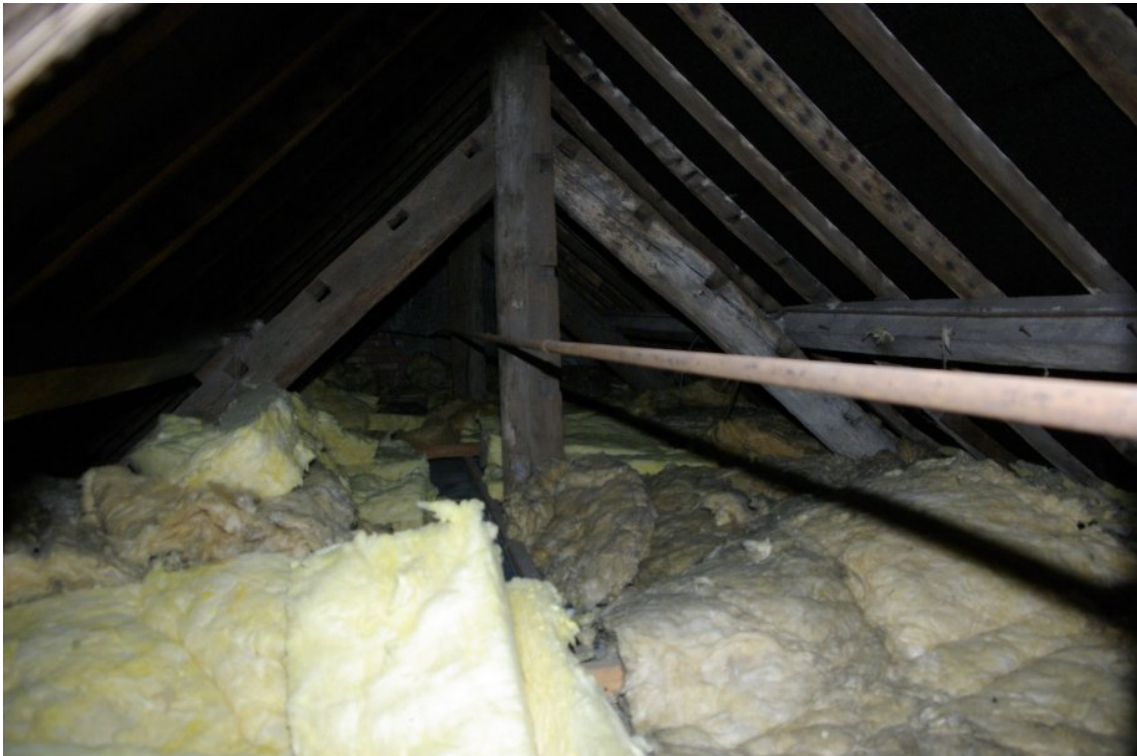
**Figure 15** Roof truss within building 1b.

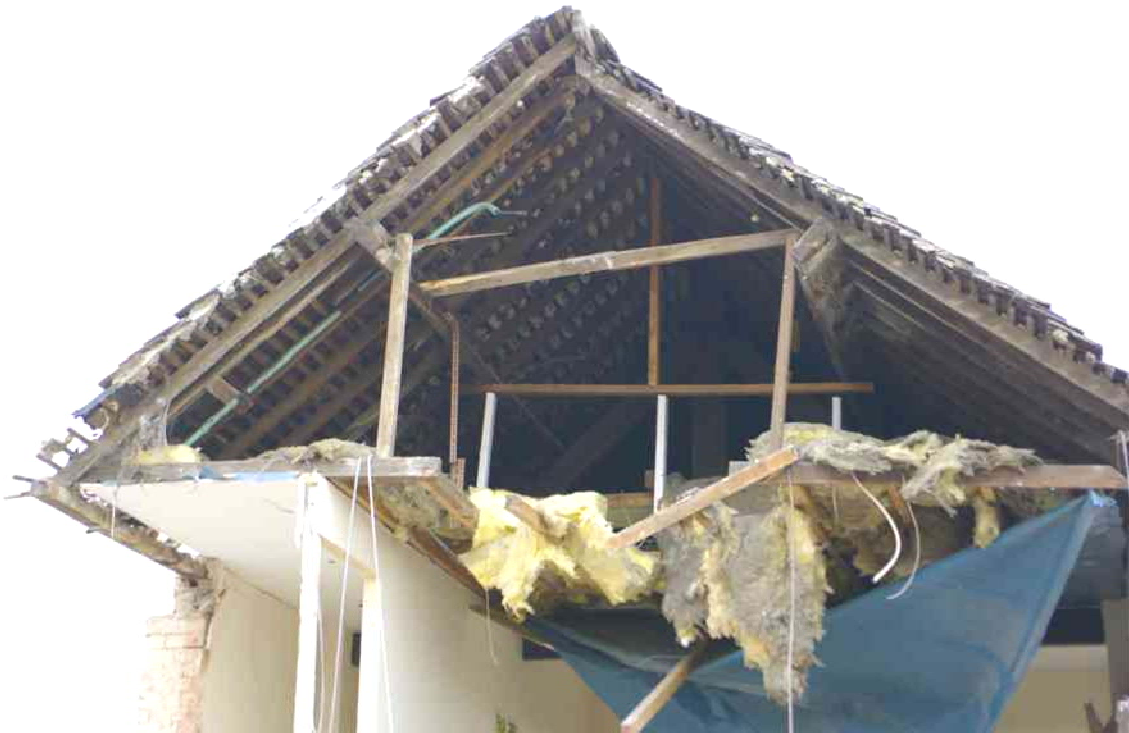
**Figure 16** Building 1b, northern end during demolition

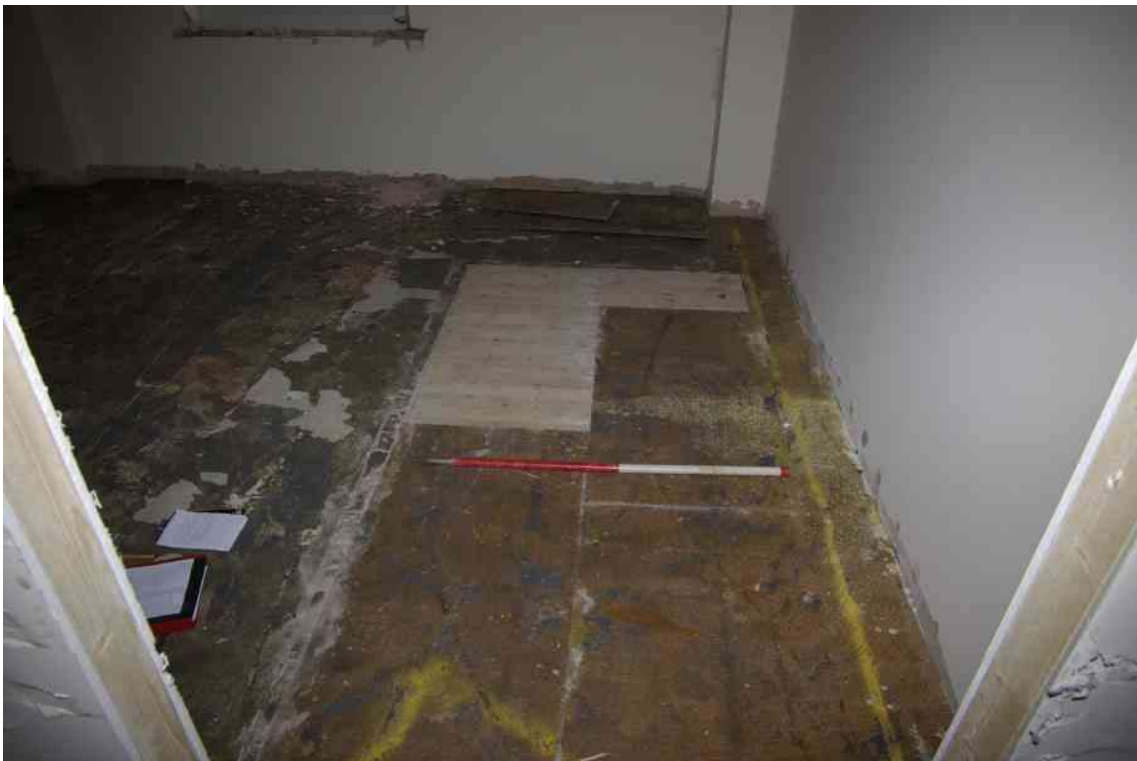
**Figure 17** Removed staircase Building 1b, south room northern end

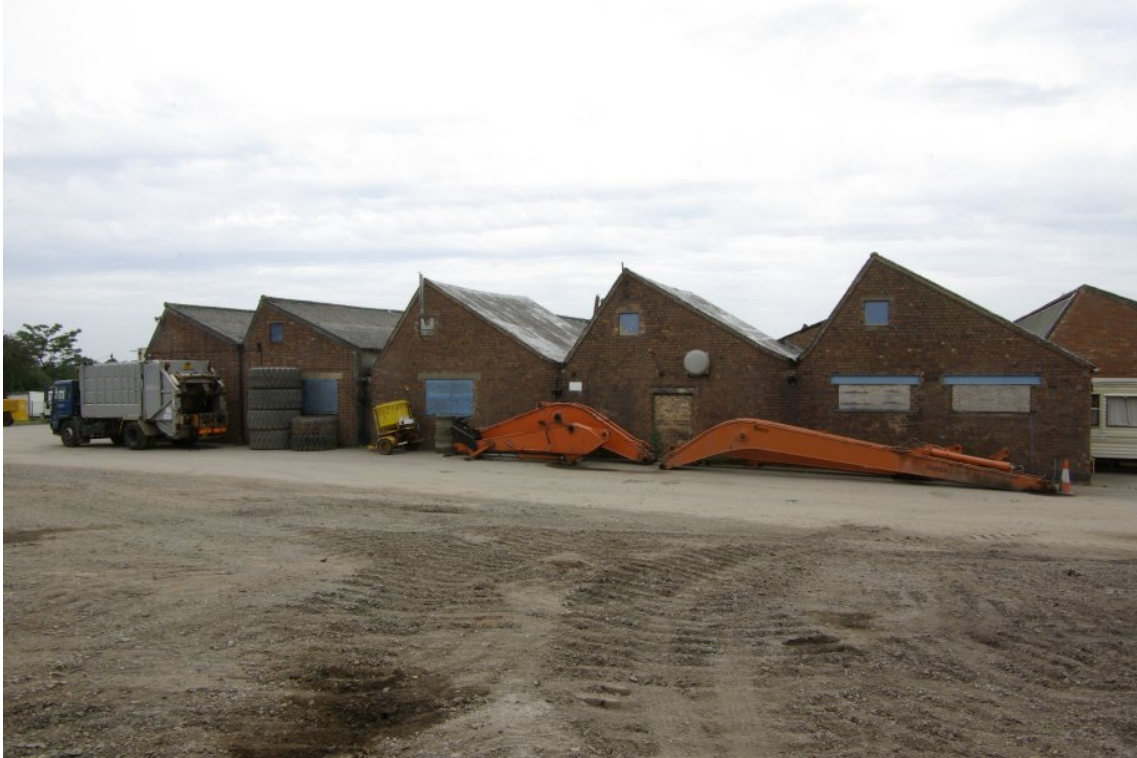
**Figure 18** Building 3b, west facing elevation.

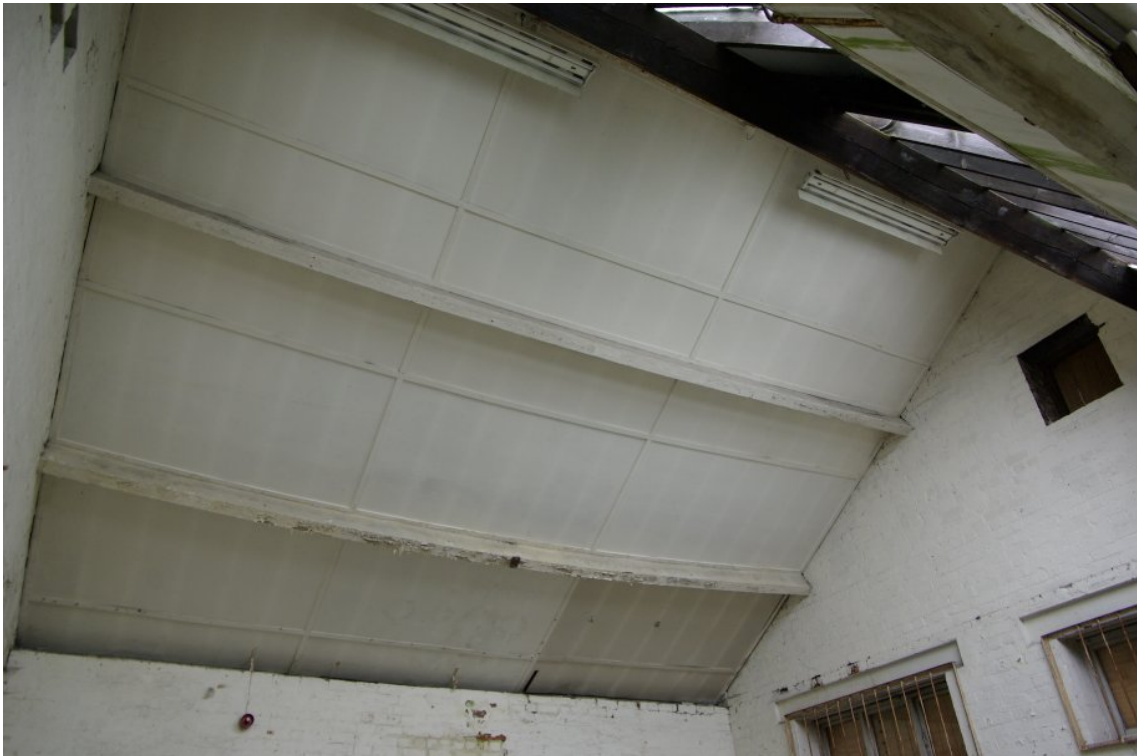
**Figure 19** Roof construction within building 3b.

The southernmost part (building 3b) has a much simpler roof design where the north-light roof is carried on only two purlins, as a result of which significant bowing has occurred (*Figure 19*). The lack of any significant architectural or historical features means the precise dating of Building 3b is uncertain; the brickwork is red brick (dimensions 8 x 2  $\frac{1}{2}$  x 4 inches) laid in a Flemish Garden Wall bond (three stretchers and one header in each course) with what appears to be a lime mortar containing ash or clinker, which has the appearance of a late 19th or very early 20th century build. Cartographic sources appear to support this with a building recorded on the second edition Ordnance Survey map of 1903 (*Figure 29*).

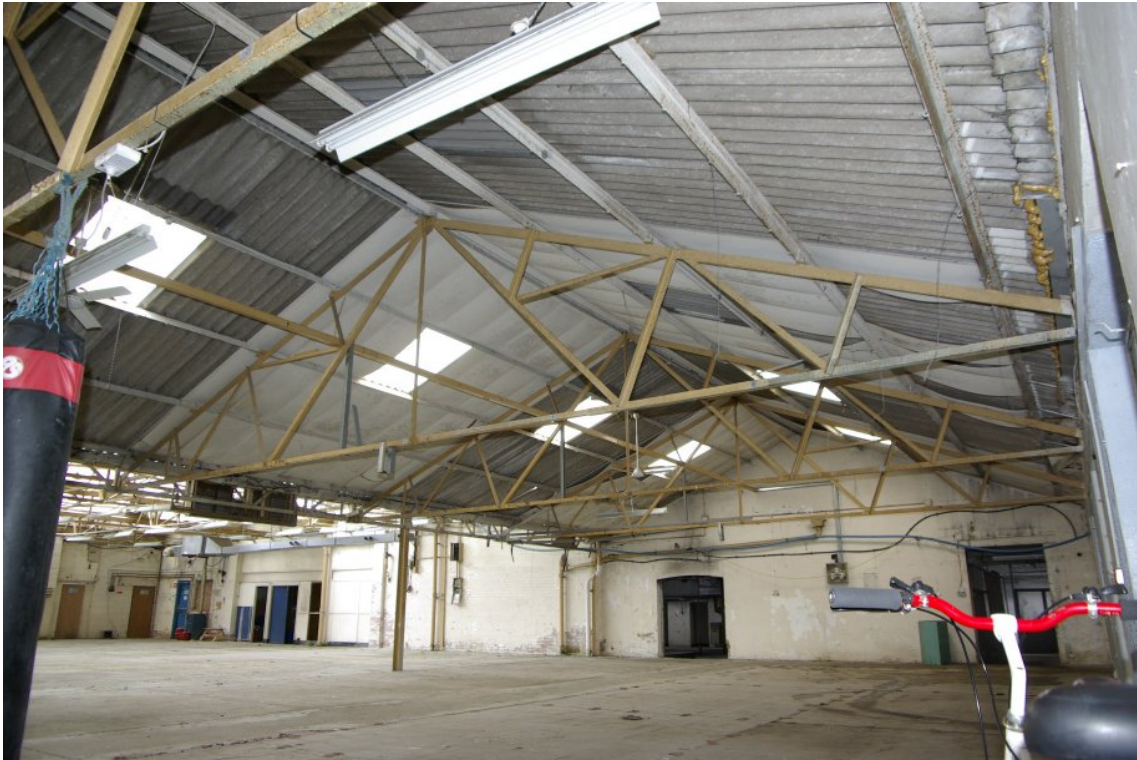
**Figure 20** Roof construction within building 3d.

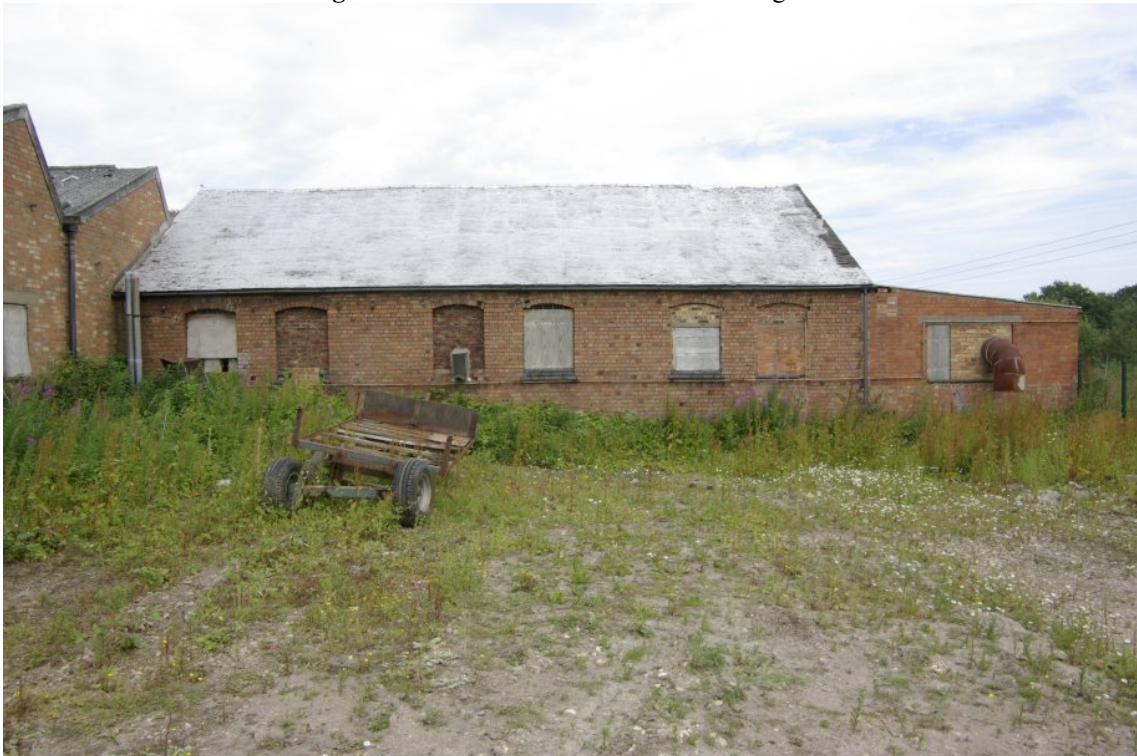
**Figure 21** South facing elevation of building 4.

Along the southern most wall there are six flat arched windows in pairs, two of which have been blocked (*Figure 21*). There is a single original steel-framed window surviving, while externally there are deep blue splay brick sills, an undoubted Victorian flourish.

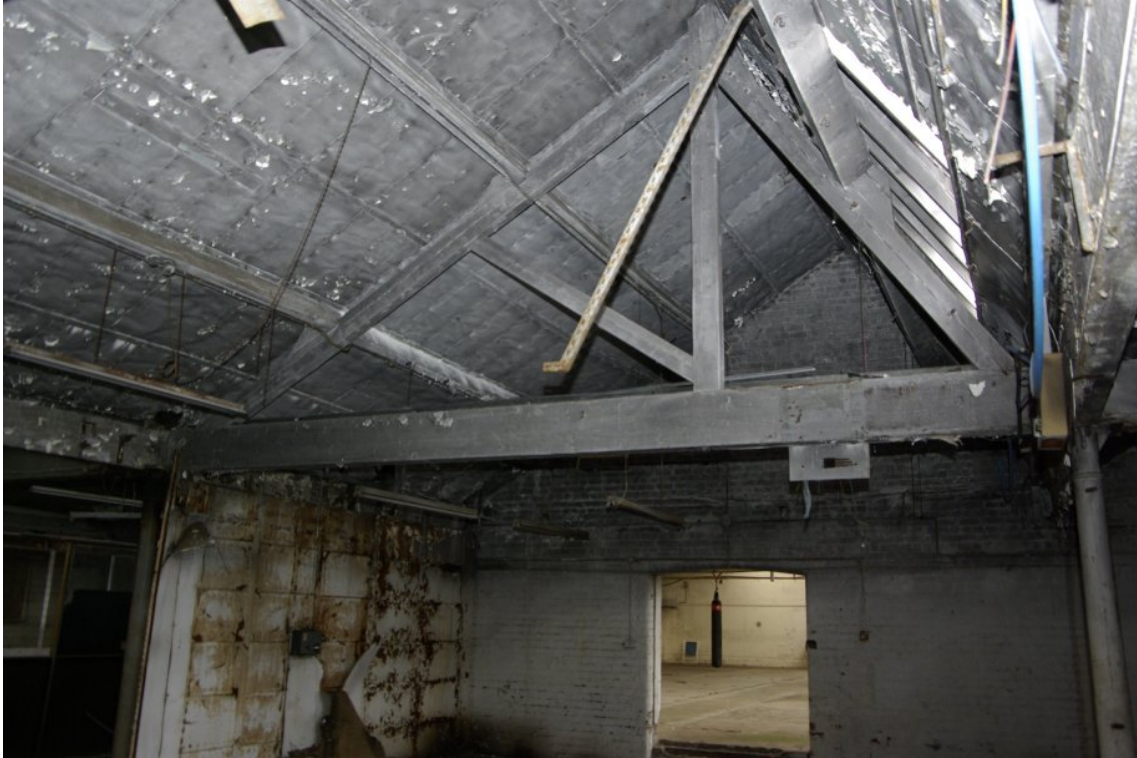
**Figure 22** Roof truss within building 4.

The building consists of three bays, 4a (in the centre) being the largest. It has a timber-built north light roof with four cast iron columns carrying the central gutter beams. The columns are 6 inch (145 mm) in diameter with a collar and although there are no identifying marks on the columns, they are likely to have been locally produced. The trusses are bolted deal (*Figure 22*) with clear circular saw marks visible on the tie beams and iron straps on the ridge. There appear to be two separate sets of marks incised in a number of the tie beams. One set is limited to the southern ends of the tie beams at the joint with the joist and are possibly carpenters marks. There are also a number of incised marks, almost certainly rase marks visible also (*Figure 23*). Such marks were incised into Baltic pine before being shipped to the United Kingdom. It is known that the port of Gdansk used the letters K (first quality), B (second quality) and BB (third quality); subsequently other marks were added by buyers (Atkinson 2007). Unfortunately with the exception of an inverted RM (*Figure 21*) none are clearly identifiable and match these known examples, but are however similar in form to examples identified at the warehouse at the Liverpool Road Station, the Manchester terminus of the Liverpool & Manchester Railway, which dates from 1830 and are likely to represent identification and denote the quality (Greene 1995).

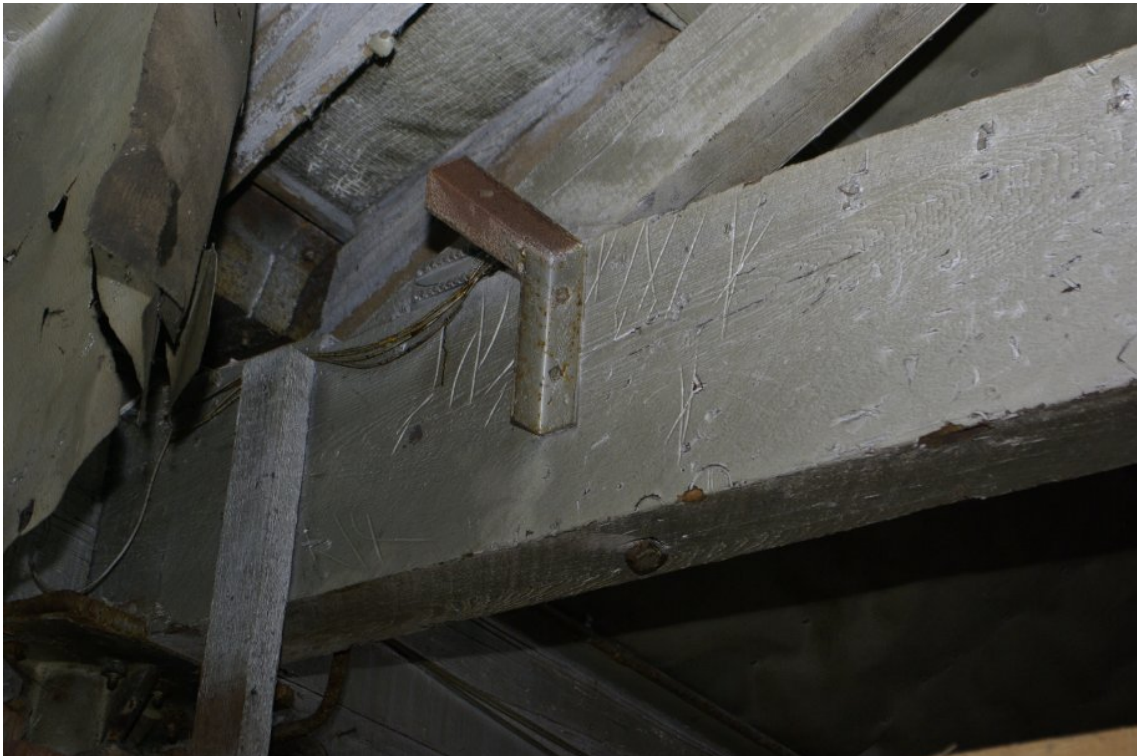
**Figure 23** Rase marks on tie beam, building 4.

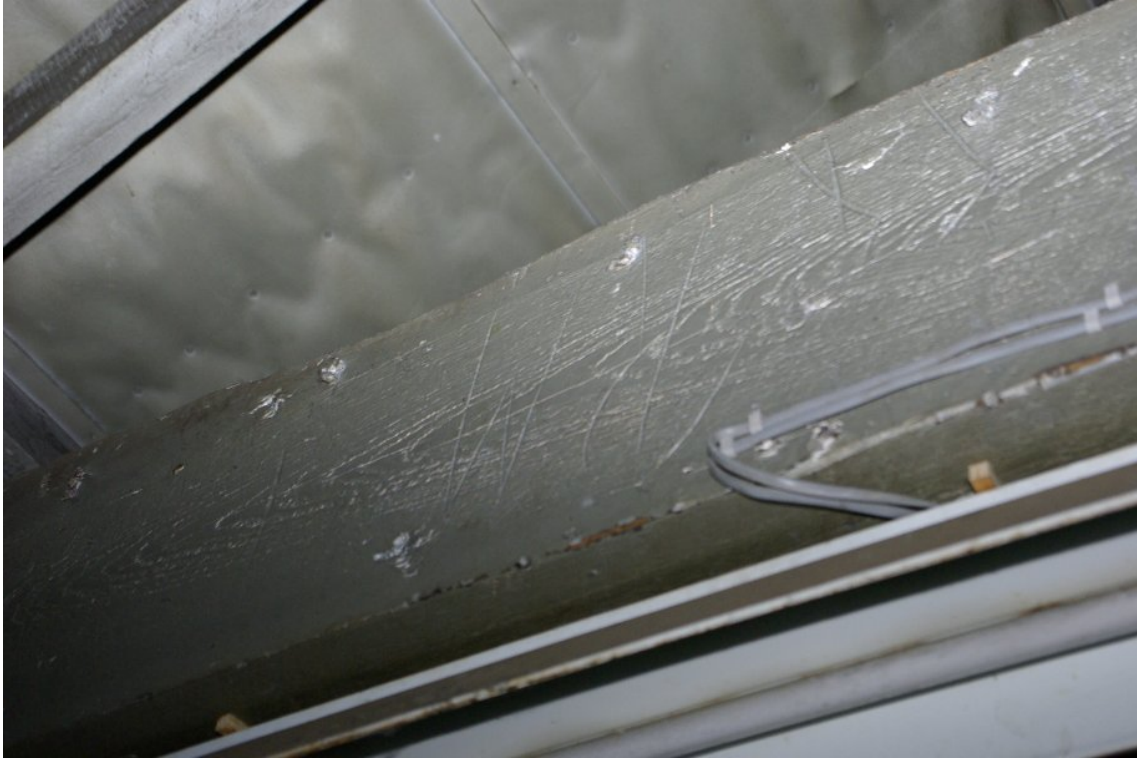
**Figure 24** Inverted RM on tie beam, building 4.

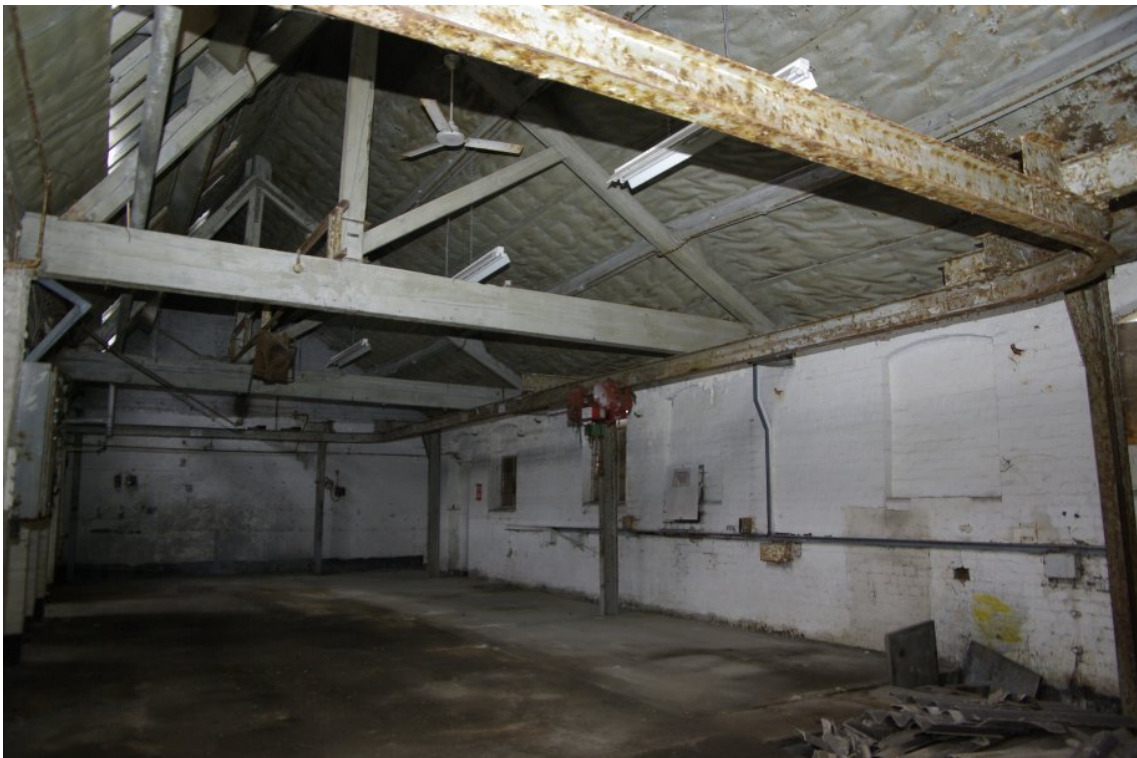
**Figure 25** Hoist & tracking mechanism, building 4.

The only evidence of the buildings previous use lies within 4c, where there is an overhead hoist on a semi-circular runner which circles the work space carried on Rolled Steel Joist (RSJ) columns (*Figure 25*), the exact purpose of which is unclear. Under the ownership of Lisk Controls this workspace is recorded as being the Phosphating Shop. Phosphating is used on steel for corrosion resistance and foundation for top coats or painting. A dilute solution of phosphoric acid and phosphate salts is applied by spraying or immersion which chemically reacts with the surface of the steel to form a layer of insoluble, crystalline phosphates, thereby inhibiting corrosion. It is likely that this overhead hoist, therefore, relates to this process rather than Coleorton Pottery. It is likely that the open sumps in the south-west corner of 4c also relate to this Phosphating process. There is also a second piece of overhead machinery, the exact identity and purpose of which is unknown.

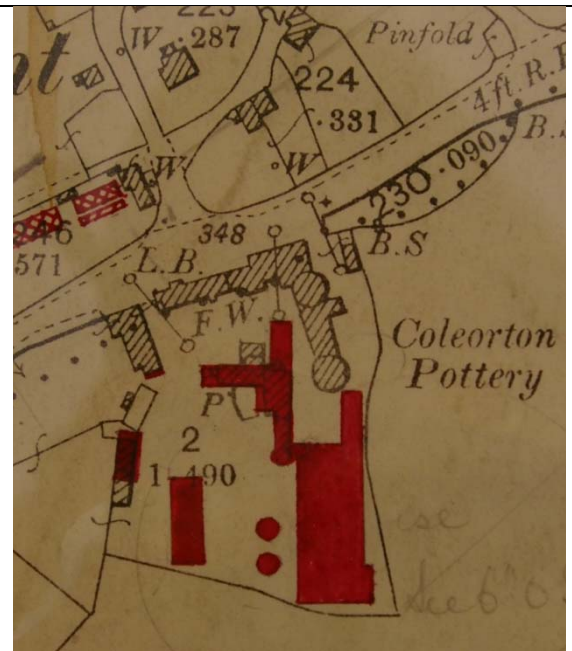
Figure 27 Second Edition Ordnance Survey (1903)

Despite initial doubt of the date of this building this additional work and a closer examination of the cartographic sources confirm that building 4 dates to the late 19th century and is recorded on the 1903 Ordnance Survey (*Figure 27*) and has remained largely un-altered since.
