**A Strip, Plan and Sample Excavation on
Land Adjacent to Church Farm House,
Church Lane, Cadeby,
Leicestershire.**

ULAS Report No. 2013-089
©2013

For: M & L Builders (Atherstone) Ltd

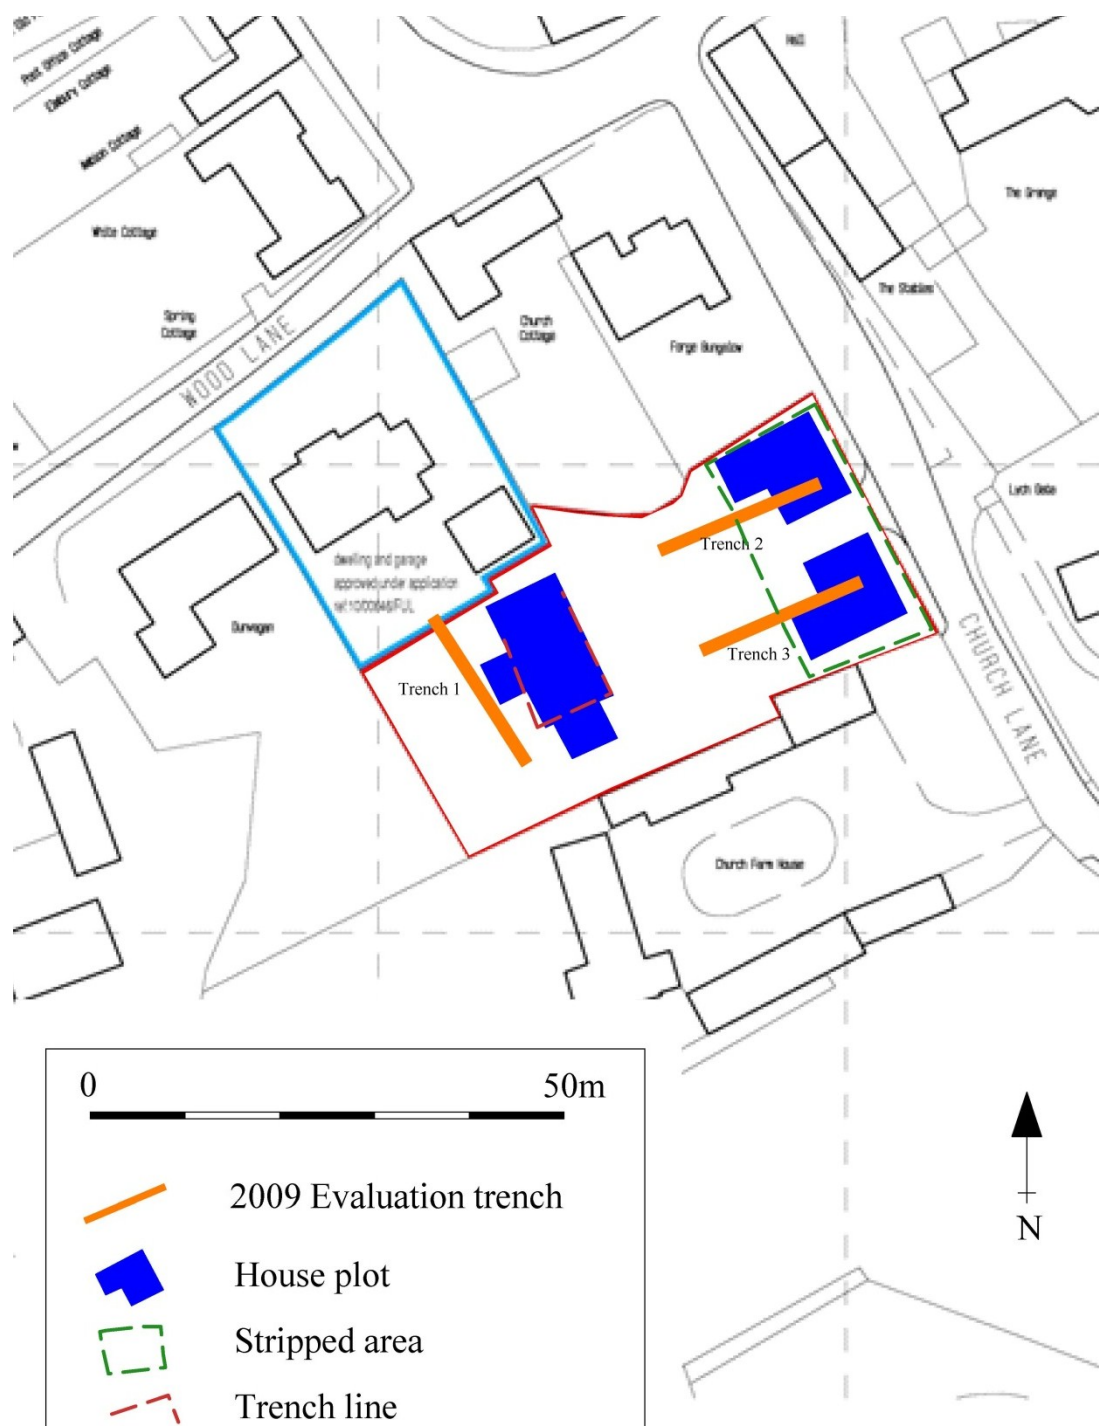
Figure 3 Site location and evaluation trenches
Modified from Haywards Architects plan

Three 20m trial evaluation trenches excavated on the site in 2009 revealed several archaeological features of uncertain date (Kipling 2009). However, the recovery of medieval pottery from subsoil overlying a possible quarry feature and ditch or gully in Trench 3, coupled with the similarity of their fills to the overlying material suggested that these features could be of medieval date. The 2009 trenches were placed to cover the footprints of an earlier proposed development, however since that time the plans have been changed and most of the trenches lay outside the footprint of the revised development (Fig. 3). Some levelling and landscaping of the site appears to have taken place since the time of the evaluation and much of the southern side of the site has been badly disturbed by heavy machinery tracking along the site.

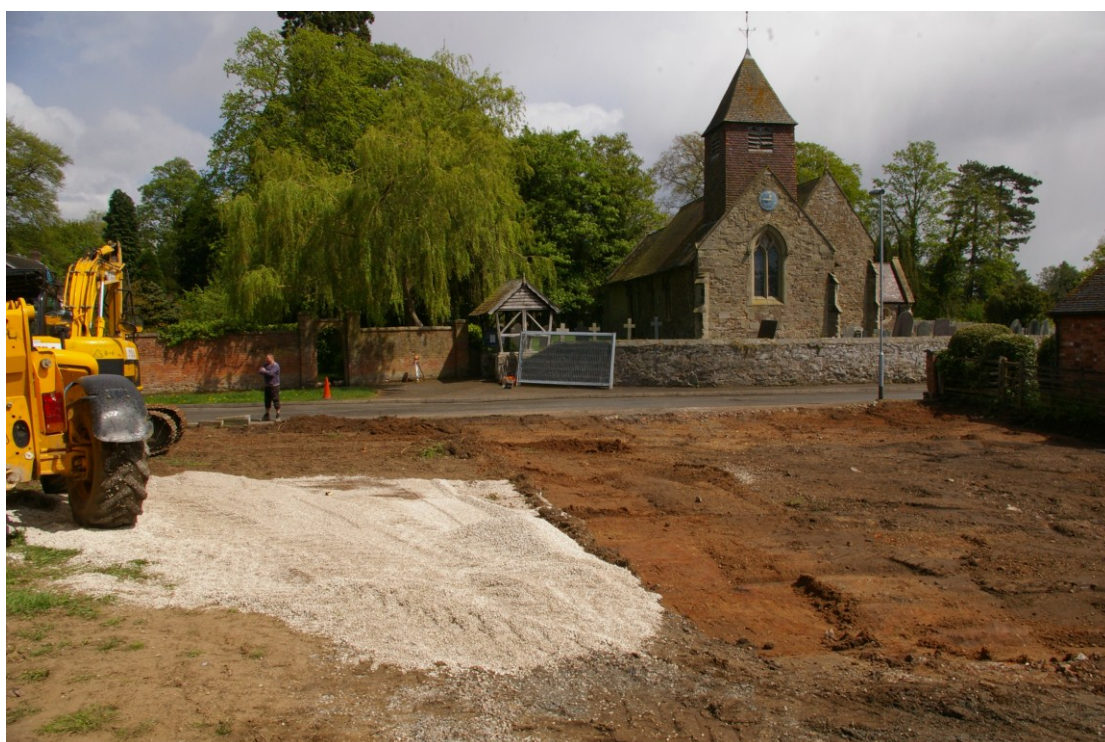
Figure 4 Stripped footprint of south-eastern house
Looking south-east

As noted in the methodology, the entire area around the two houses on the eastern side of the plot, fronting onto Church Lane, was stripped down to formation level. Approximately 0.1m of disturbed dark brown silty topsoil mixed with modern mill-waste was removed to reveal a layer of slightly less disturbed dark orange brown silty sand subsoil with a depth of between 0.15m and 0.3m. Beneath the subsoil was the undisturbed natural substratum of dark orange brown sand and sandy gravel (Figs. 4 and 5). The whole width of the plot was stripped from the pavement to approximately 3m beyond the western limits of the proposed houses. Both Trenches 2 and 3 from the 2009 evaluation were identified although the features seen in Trench 3 were further west than the current footprint strip. No archaeological features or deposits were observed during this area strip which covered approximately 350m².

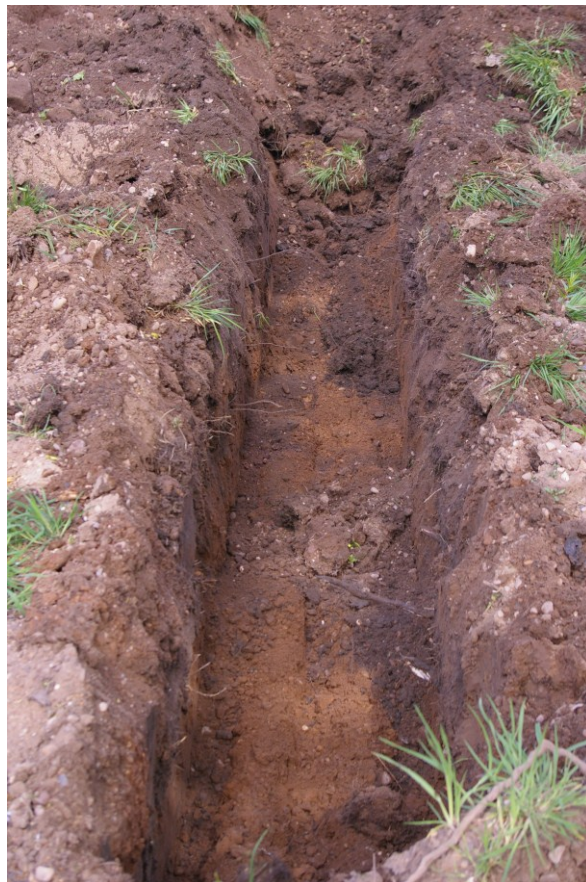
Figure 6 Trial trenching around south-west house
Working photograph of incomplete trench

On the location of the rear, westernmost, house plot a trial evaluation slot indicated that the natural substratum was at least 0.8m below current ground level. As the intended site reduction was only going to be 0.5m it was decided to run an evaluation trench around the wall lines of the proposed house (Fig. 6). This revealed a similar topsoil and subsoil to that seen in the earlier footprint strip. The dry and crumbly topsoil had an approximate depth of between 0.3 and 0.4m and was above between 0.4m and 0.5m of subsoil. The natural substratum again consisted of dark orange brown sand and sandy gravel. No features or deposits were observed within this area. The 2009 evaluation Trench 1 was located approximately 4m to the west of the proposed house.
