**An Historic Building Survey (Level 2)
and Archaeological Fieldwork at the
Former Jemsox Factory,
39-41 Welford Road,
Leicester**

**ULAS Report No. 2013-095
©2013**

For: Campbell Property (UK) Ltd

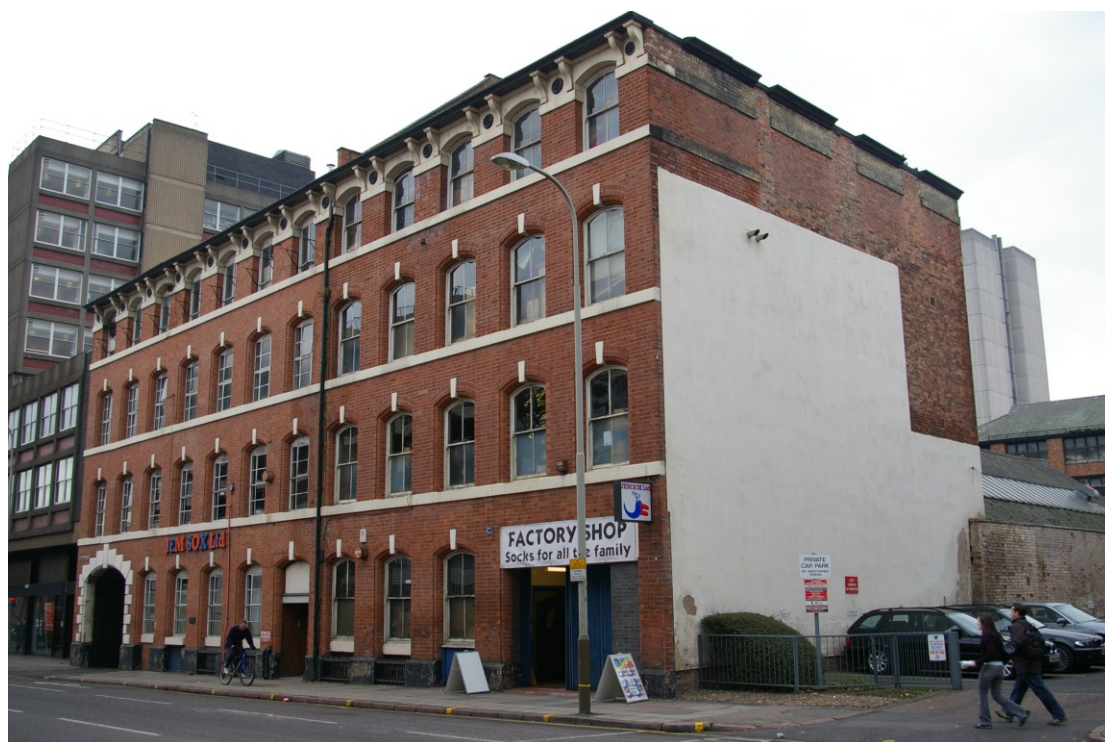
Figure 3 East facing elevation
Looking south-west. Photograph taken in 2007

The east facing street frontage range at 39-41 Welford Road is a late 19th century factory building of 12 window bays and 4 storeys, plus attic and basement (Fig. 3). It was constructed in two phases, these corresponding with the street numbering as shown on Ordnance Survey mapping. Number 39 constitutes the five bays on the northern side (the right as viewed from Welford Road) and Number 41 the 7 bays to the south. The two sections are executed in similar architectural style and materials, but with some differences in detail (e.g. window frames) but were clearly designed to match each other. It seems highly likely that both sections were built for the same firm probably within the space of a few years. It is built from red brick laid in Flemish bond on a stone plinth. Window and door openings have segmental arched heads with keystones, except for a goods entrance at the northern end, which looks to be an early opening but has been altered by the addition of a modern lintel. A goods entrance at the southern end, which provides access to a small service yard, has a segmental arch head with stone detailing. All window and door openings have quarter round brick detailing to the reveals. The principal pedestrian entrance is at the northern end bay of Number 41 (7th bay from the south end of the building) and matches the detailing around the other windows. There is a projecting painted stone band between each floor, and at the eaves there are paired brackets above a projecting stone band which is interrupted by the third floor windows. The roof covering is of slate with the south end gabled and the north end hipped. The party wall between Numbers 39 and 41 rises above roof level forming a clear separation between the two structural phases. The windows of Number 39 are two-over-two pane timber sashes with arched heads. Number 41 has metal framed windows. There are basements beneath both sections of the frontage range which are lit by glass blocks set immediately below the ground floor windows. The basement windows are protected from the street by low cast iron railings.

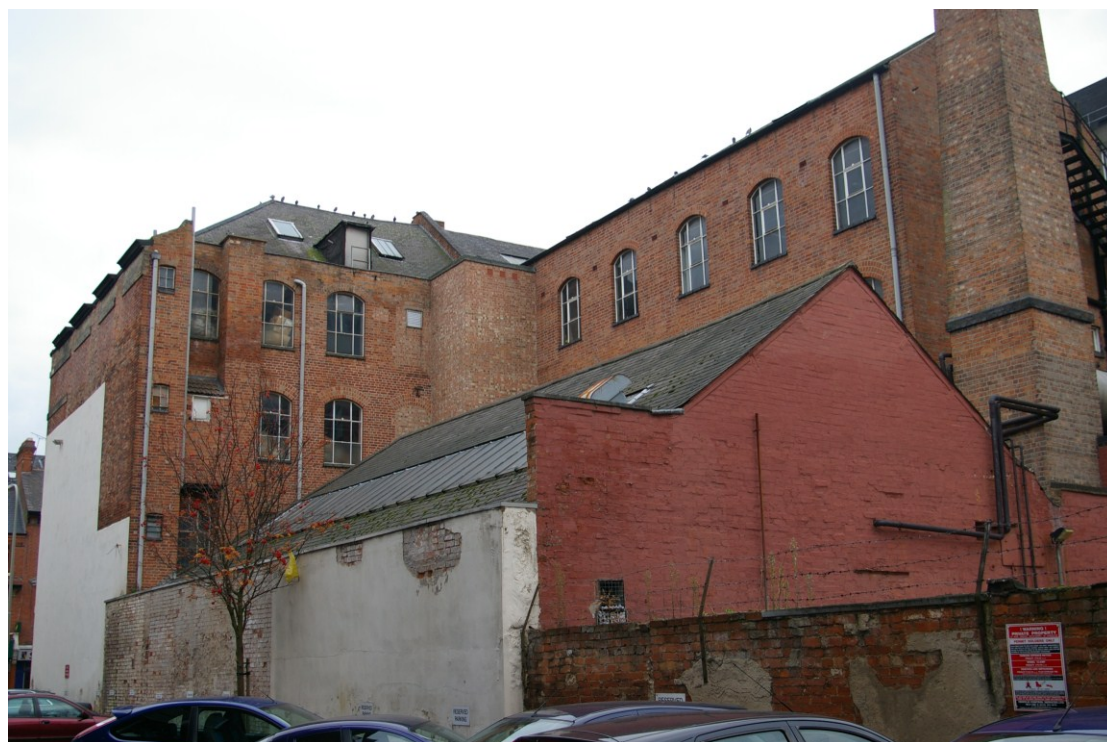
Figure 4 West facing elevation of Number 39 and east to west range
Looking south-east. Photographs taken in 2007 with single storey structure (red
painted brick) still present in courtyard

At the time of the Desk-Based Assessment the space to the rear of Number 39 was occupied by a large single-storey brick-built pitched roof structure which housed modern machinery (Fig. 4). By the time of this survey this structure had been removed leaving an open space. The windows on this elevation of Number 39 are metal framed, three over three panes which match the east to west rear range extending out from the main building. The ground floor windows on the rear (west) elevation have been removed and replaced with modern flat-headed openings. A projecting structure near to the northern end of the elevation houses a small toilet block which serves every floor. It is not clear from the outside whether this is part of the original design or a later addition. An obvious later addition is a modern lift shaft added into the corner angle of Number 39 and the east to west range extending from Number 41.

Most of the ground floor windows on the east to west range have been blocked by later brickwork. This was presumably done when the later single storey building was added to the rear courtyard. A modern double width entrance has been cut through two windows into the ground floor of the range.

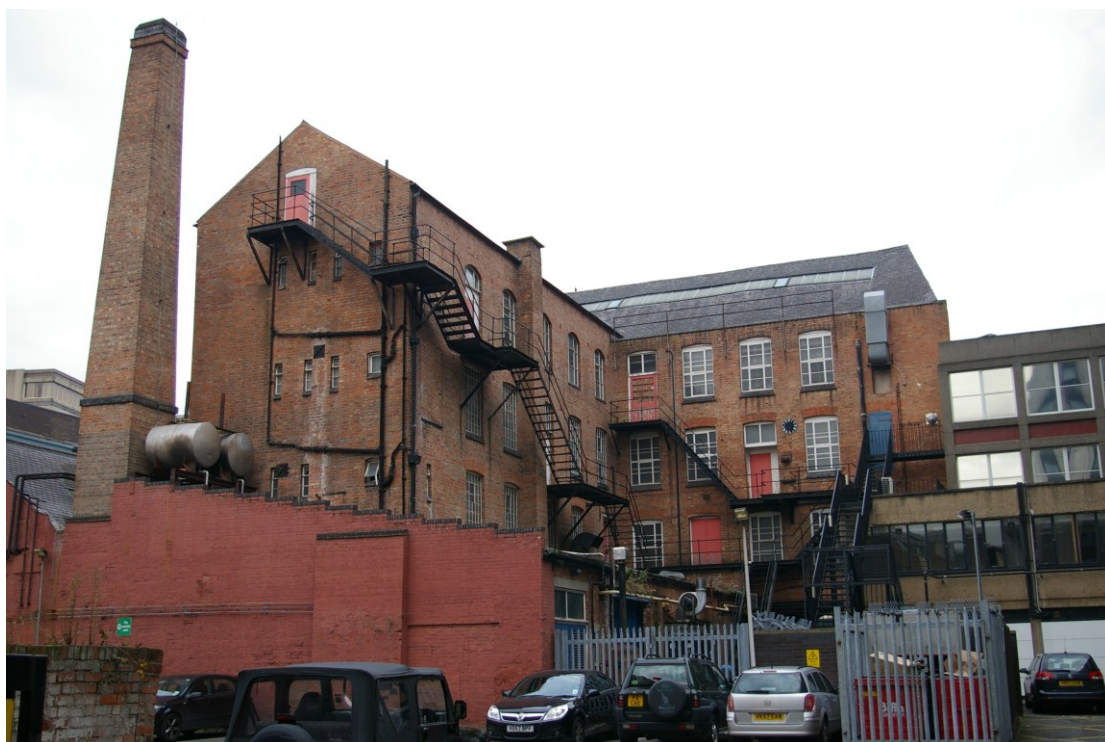
Figure 5 West facing elevation of Number 41 and rear range
Looking north-east. Photograph taken in 2007 with single storey structure (red painted brick) still present

The west facing elevation of Number 41 has a plain red brick façade with four storeys of windows of the same design as those used on the east facing elevation (Fig. 5). A number of these windows have been modified to provide access to a metal fire escape which had been removed shortly before this survey. This elevation faces into a small service yard which had been occupied by a single storey structure, later in date than the main buildings and this appeared to have been constructed in at least two separate

phases. It was brick built and the roof partly corrugated, probably with asbestos. The rear section housed modern plant equipment. By the time of this survey the building had been removed to expose the ground floor windows and modified openings around the service yard.

At the rear of the north end of Number 41 is a tall, narrow range of four storeys plus attic running on an east to west alignment (Fig. 5 and 6). This range has no basement and is brick built with a slate roof. The style suggests that it may be broadly contemporary with the construction of the Number 41 frontage range. Interestingly, although the north facing windows have three x three panes, the south facing windows have multiple panes to match the rear (west face) of Number 41. At ground floor level two large brick-built relieving arches spring from a central column towards each corner which suggests that the ground floor wall was used as a pair of wide doorways rather than as windows. This suggests that the ground floor was built as an open fronted structure. At the back of this range, is a square brick-built factory chimney, which presumably served an engine within the factory at some stage of its working life.

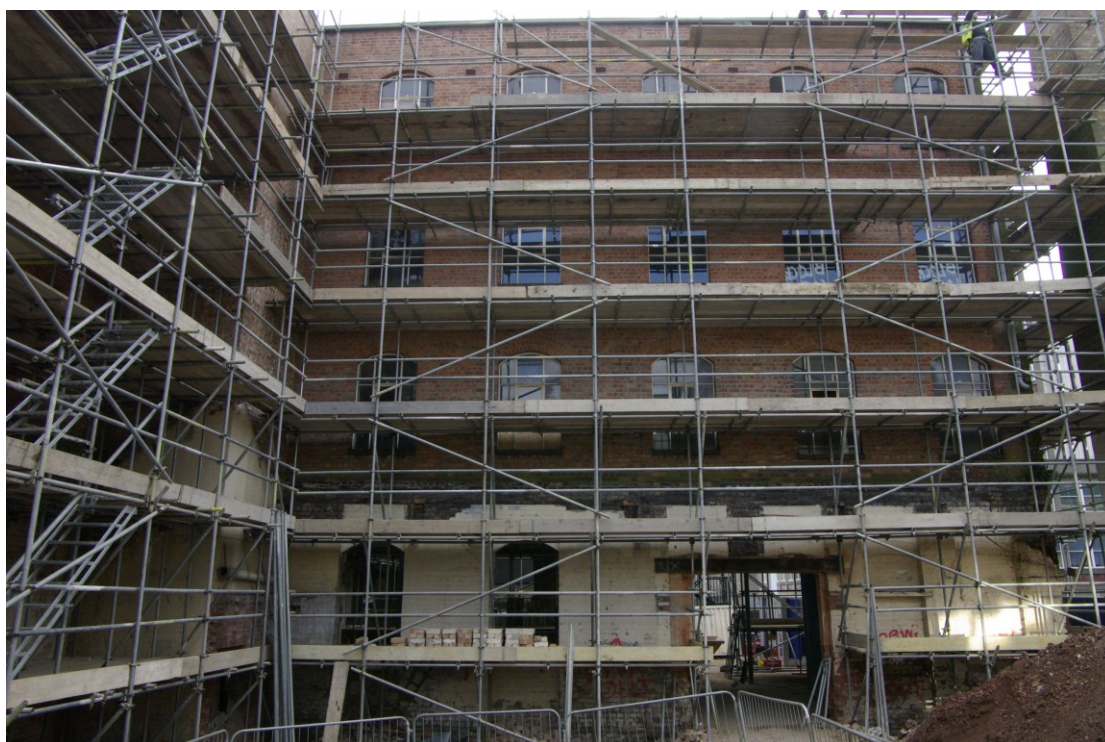
Figure 6 North facing elevation of rear east to west range
Looking south. Single storey structure removed

The north facing elevation is partially rendered suggesting that it masks some scarring caused by buildings which once butted up against it. Some decorative brickwork banding wraps around this elevation as a continuation from the front elevation. Breaks in this banding may indicate the location of former structures. The south facing elevation is obscured by a modern building.

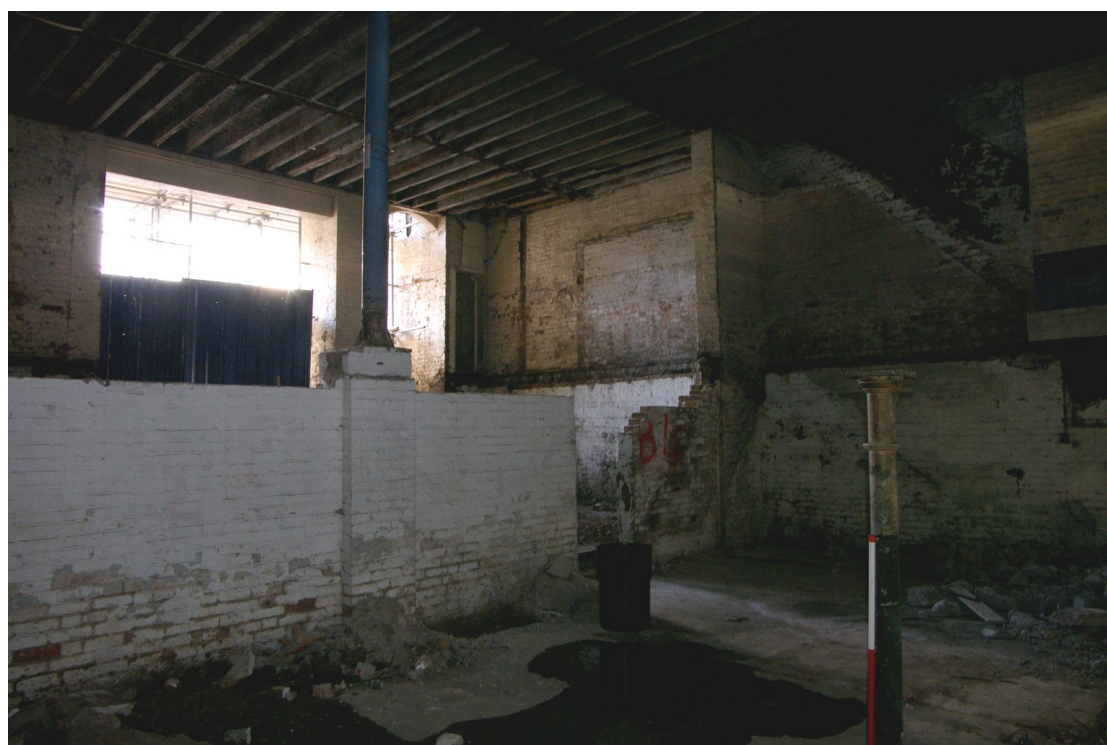
Figure 7 Basement of Number 39 with Ground floor removed
Looking north-west. 1m scale

The basement of Number 39 has had the ceiling removed to create a large open space up to the ground floor ceiling. A north to south low brick wall used to support the ground floor joists and a single cast iron column rests on this to support the floor above (Fig. 7). This floor appears to have been only recently removed as part of the conversion process. On the north wall is evidence of a timber staircase which once led up to the ground floor. A small hallway and stairwell at the base of a set of concrete replacement stairs separates the basements of Numbers 39 and 41. The stairwell forms part of the structure of Number 41. Number 41 basement has also had the ceiling removed to open up the space to include the ground floor room (Figs 8 and 9). As in Number 39 this split-level room is divided into two by a brick wall running from north to south. Two brick-arched alcoves extend below the covered entranceway from Welford Road. Four partially bricked-up metal-framed windows are located at basement level along the west wall. The two northern windows on this wall have been completely blocked due to the construction of the rear east to west range suggesting a slightly later date for this range. Rectangular blocked windows on the east wall at basement height show where light wells used to rise up to pavement level. Access to the rear courtyard is via a set of narrow external steps in the south-west corner. The rear, east to west, range has a solid ground floor with no basement.

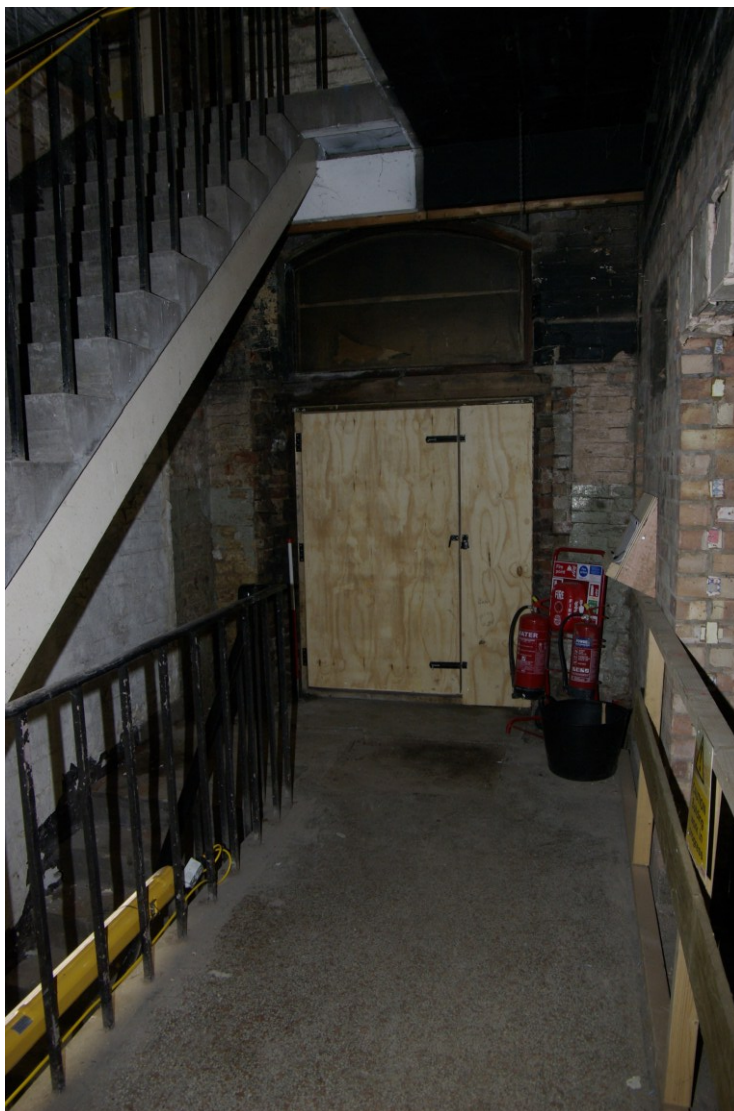
Figure 10 Main entrance and staircase
Looking east

As noted the original floor joists and floor boards have recently been removed leaving the empty shell of each ground floor and basement room. The east windows of Number 39 are as already described with a double width loading door in the north-east corner. Most of the windows on the western side have been modified to form larger openings, presumably to create easier access for goods and materials into the single-storey building which, until recently, stood in the courtyard. There is evidence in the paintwork on the northern wall of a staircase leading up to the next floor. There does not appear to be any access from this floor to the central staircase. The main pedestrian doorway out onto Welford Road leads in to the central staircase which ascends to the top floor. The remains of a terrazzo floor are evident on this floor but this area has seen a lot of alteration and the present stairs are relatively modern concrete ones (Fig. 10). Surviving paintwork on the walls indicates that the original staircase, although in the same position, was laid out in the opposite way to the current stairs. That is, the stairs to the floor above faced the outside doors rather than facing away as they do now.

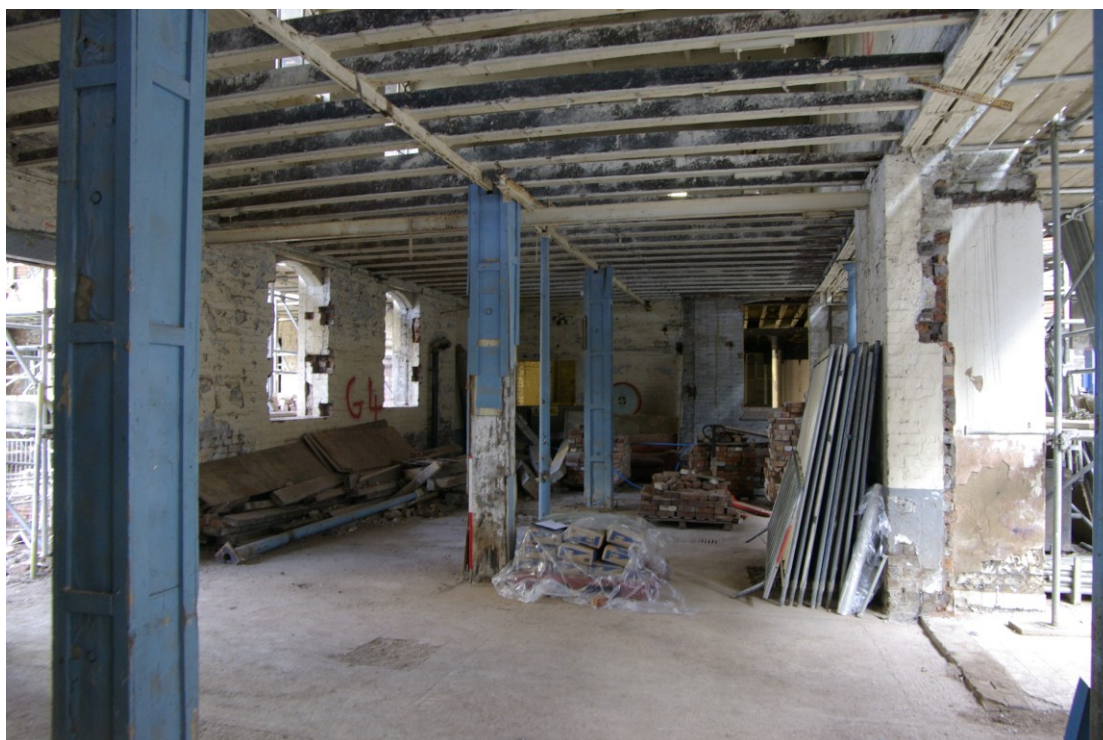
Figure 11 Ground floor of east to west range
Looking east. 1m scale

The east to west range has three central timber-clad posts supporting steel fireproof floor joists from which the masonry floor covering has been removed (Fig. 11). Three additional small circular diameter metal posts also support the roof. As noted, three of the windows on the north wall have been blocked with brickwork. A recent modification has cut through two of the blocked windows to create a large opening out to the northern courtyard.

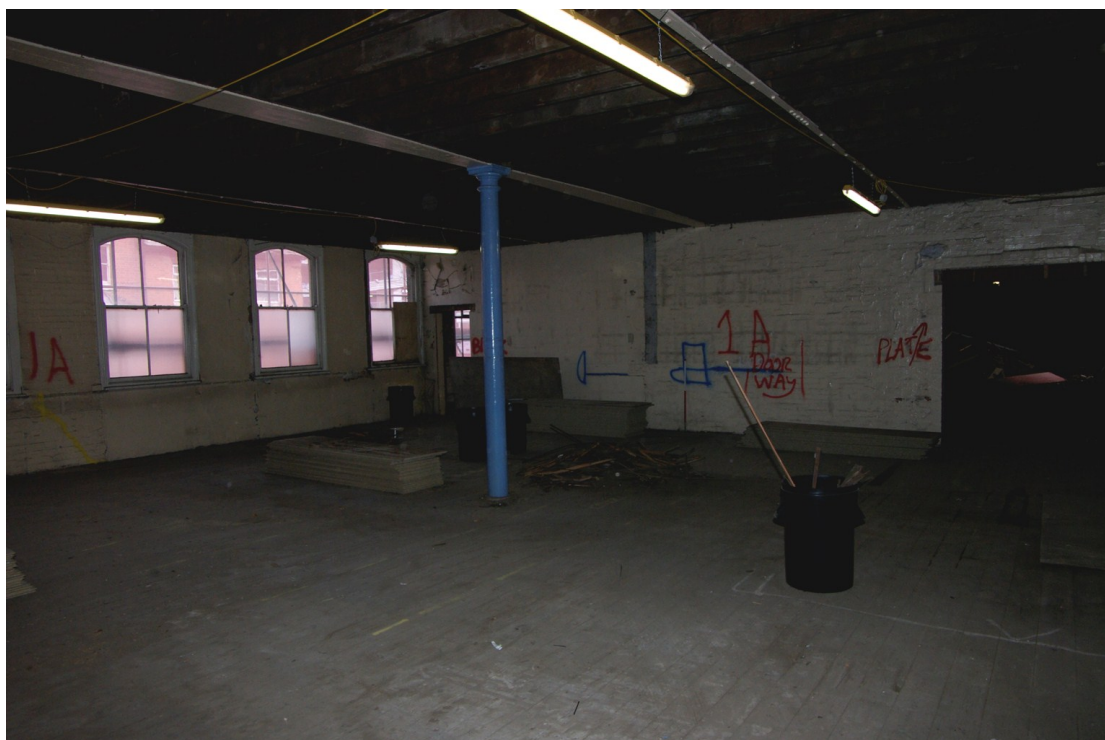
Figure 12 First floor of Number 39
Looking south-east

The first floor east facing windows of Number 39 are two-paned wooden sliding sashes (Fig. 12). The west facing windows are smaller paned metal-framed ones (Fig. 13). The small toilet block in the north-west corner of the room appears to be a later addition as the brickwork does not bond properly with the main wall. A blocked hole in the floor in the north-east corner marks where an earlier set of stairs came up from the floor below. A patched ceiling shows that the stairs continued upwards to the top floor. The later lift shaft, seen in the south-east corner of the north courtyard opens into the south-west corner of this room. A cast iron central column supports the floor above. There are no visible marks or attachments for machinery on this column.

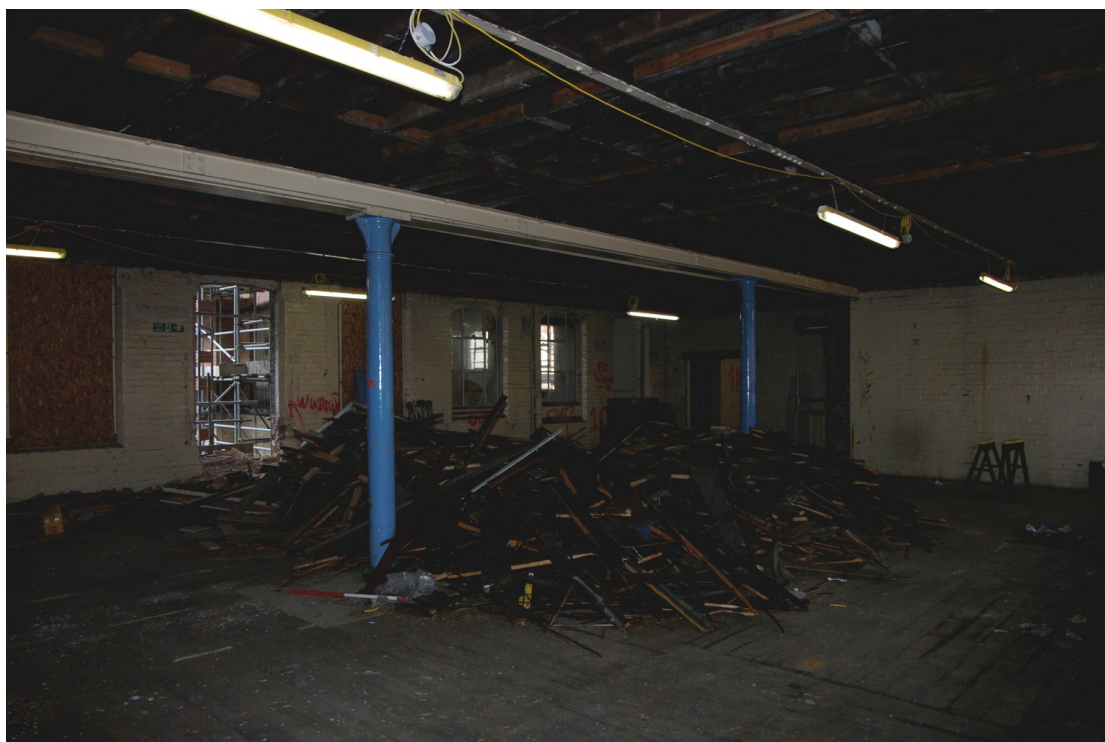
Figure 14 First floor of Number 41
Looking north-west

As well as connecting Numbers 39 and 41 by doors from the central staircase, a large double-width opening to the west of the stairs connects the two first floor rooms. This opening appears to be fairly late and has a steel joist lintel. A small internal goods lift is located behind the central staircase in Number 41 and reaches all floors. This floor extends southwards over the covered ground level entrance and has a south wall set at an obtuse angle to the east and west walls (Fig. 14). A doorway from Number 41 into the east to west range has been created by modifying a window. Two central cast-iron columns support the floor above.

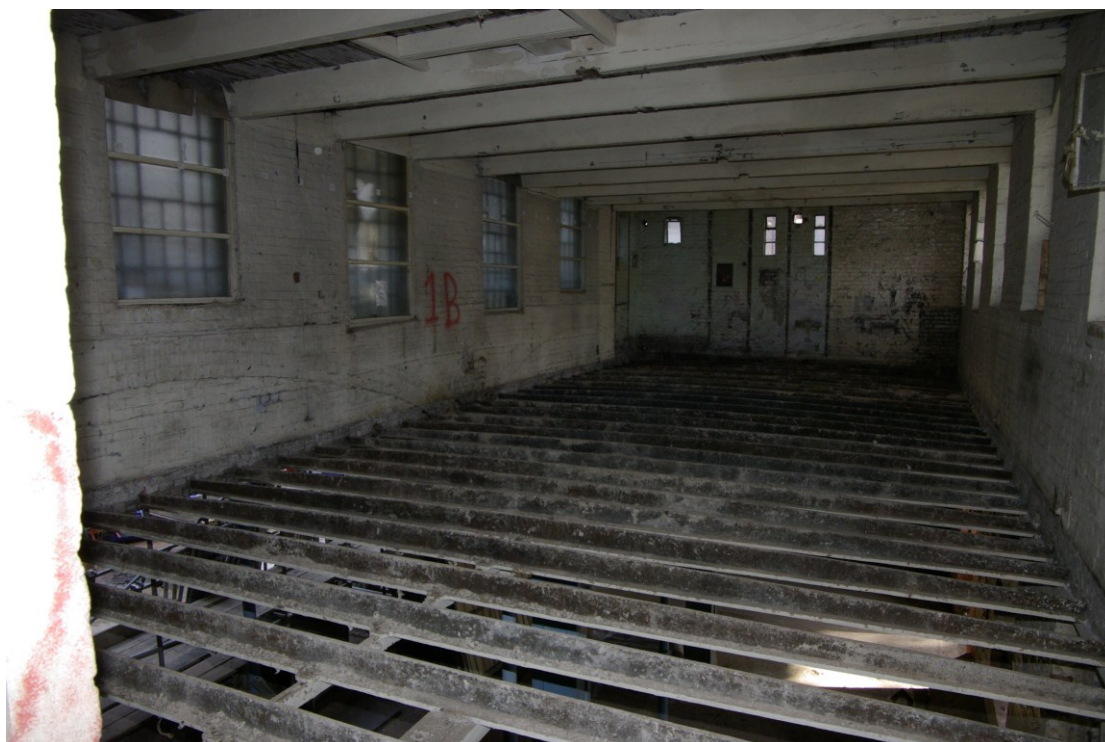
Figure 15 First floor of east to west range
Looking west. Note relieving arches under windows.

The rear east to west range at the time of the survey did not have a floor so could not be entered. The heads of two relieving arches, as noted above, can be seen on the south wall (Fig. 15). The two outermost windows have slightly higher sills to accommodate the head of the arches. The ceiling is made of conventional wooden floor joists rather than the metal joists used on the floor, which again would indicate that the ground floor was original designed as an open loading bay.

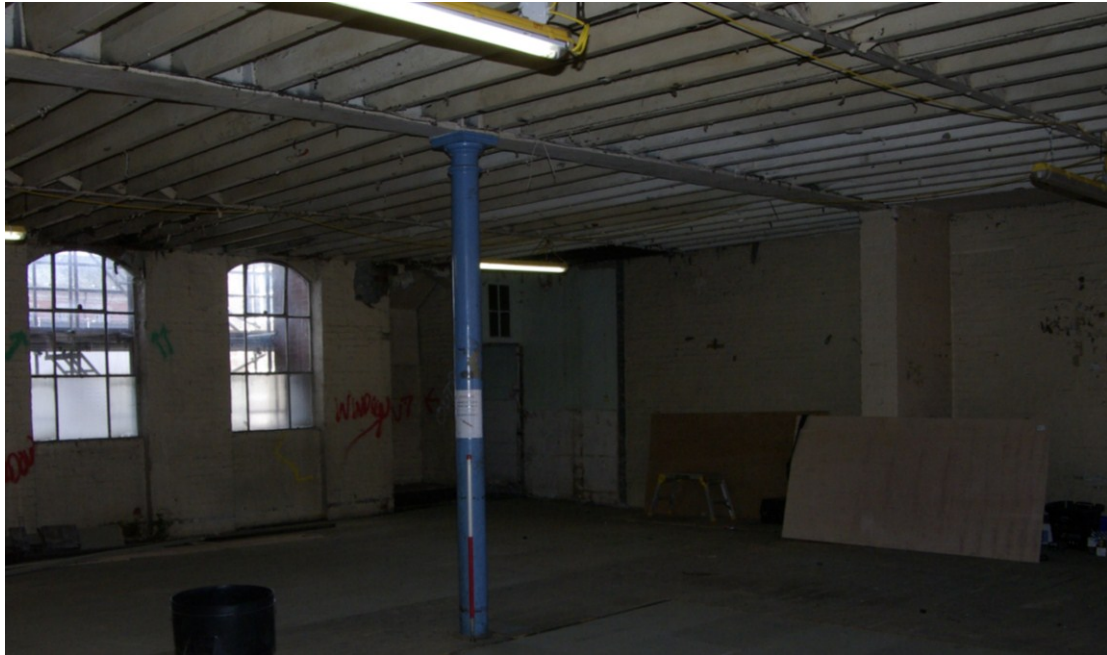
Figure 16 Support column detail, Second floor, Number 39
Looking north-west. 1m scale

The second floor of all ranges has been built to the same layout and design as that seen on the floor below. The supporting column details differ slightly (Figs 16 and 17). Three doorways have been made by opening up the original three windows leading from Number 41 into the east west range (Fig. 18). The main north to south floor joist in the ceiling has fractured and split possibly due to the weight of machinery suspended from it. The remaining floor/ceiling joists in this range have stop-chamfers.

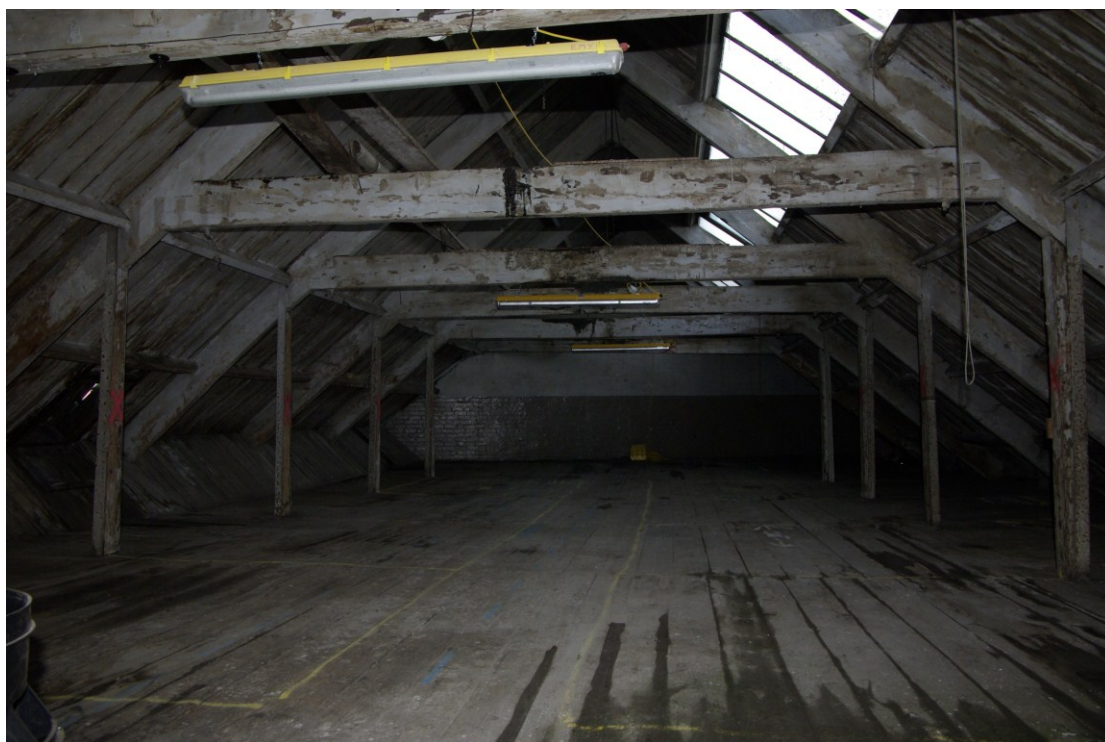
Figure 19 Fourth floor, Number 41 roof detail
Looking south

The fourth floor of Number 41 has been built into the roof space and is reached by the central staircase. The roof structure has clasped purlins sat on the backs of the principal rafters which join at their apex in a cast-iron socket (Fig. 19). Tie-beams are step lap jointed and bolted to the principals. The floor, which rises up along the eastern side to let in more light on the third floor, is suspended from timber posts which are attached by metal straps attached to the sides of the principals.

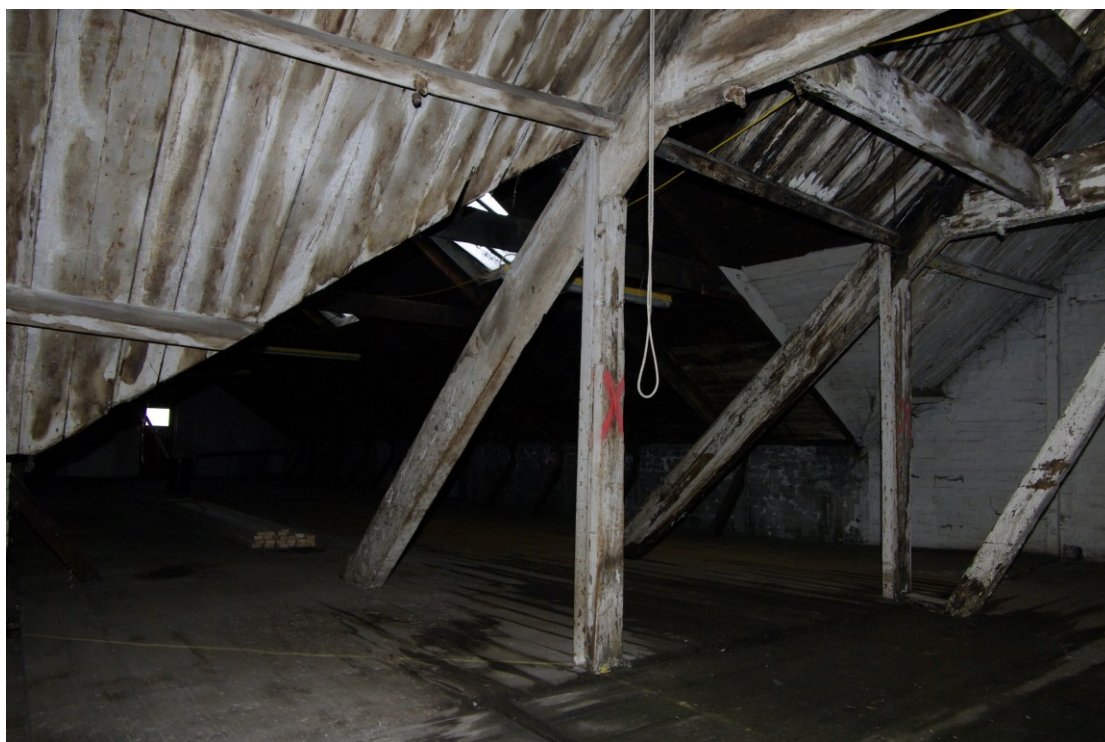
Figure 20 Fourth floor, junction of Number 41 and east to west range
Looking north-west

The east to west range is partially blocked by the roof timbers of Number 41 making access slightly awkward (Fig. 20). This range has a different method of construction possibly because the building is not as wide as the main building. Here, the principal rafters join at their apex and have small collars bolted near to the top. Raking L-section steel struts support the principals near to the floor (Fig.21).

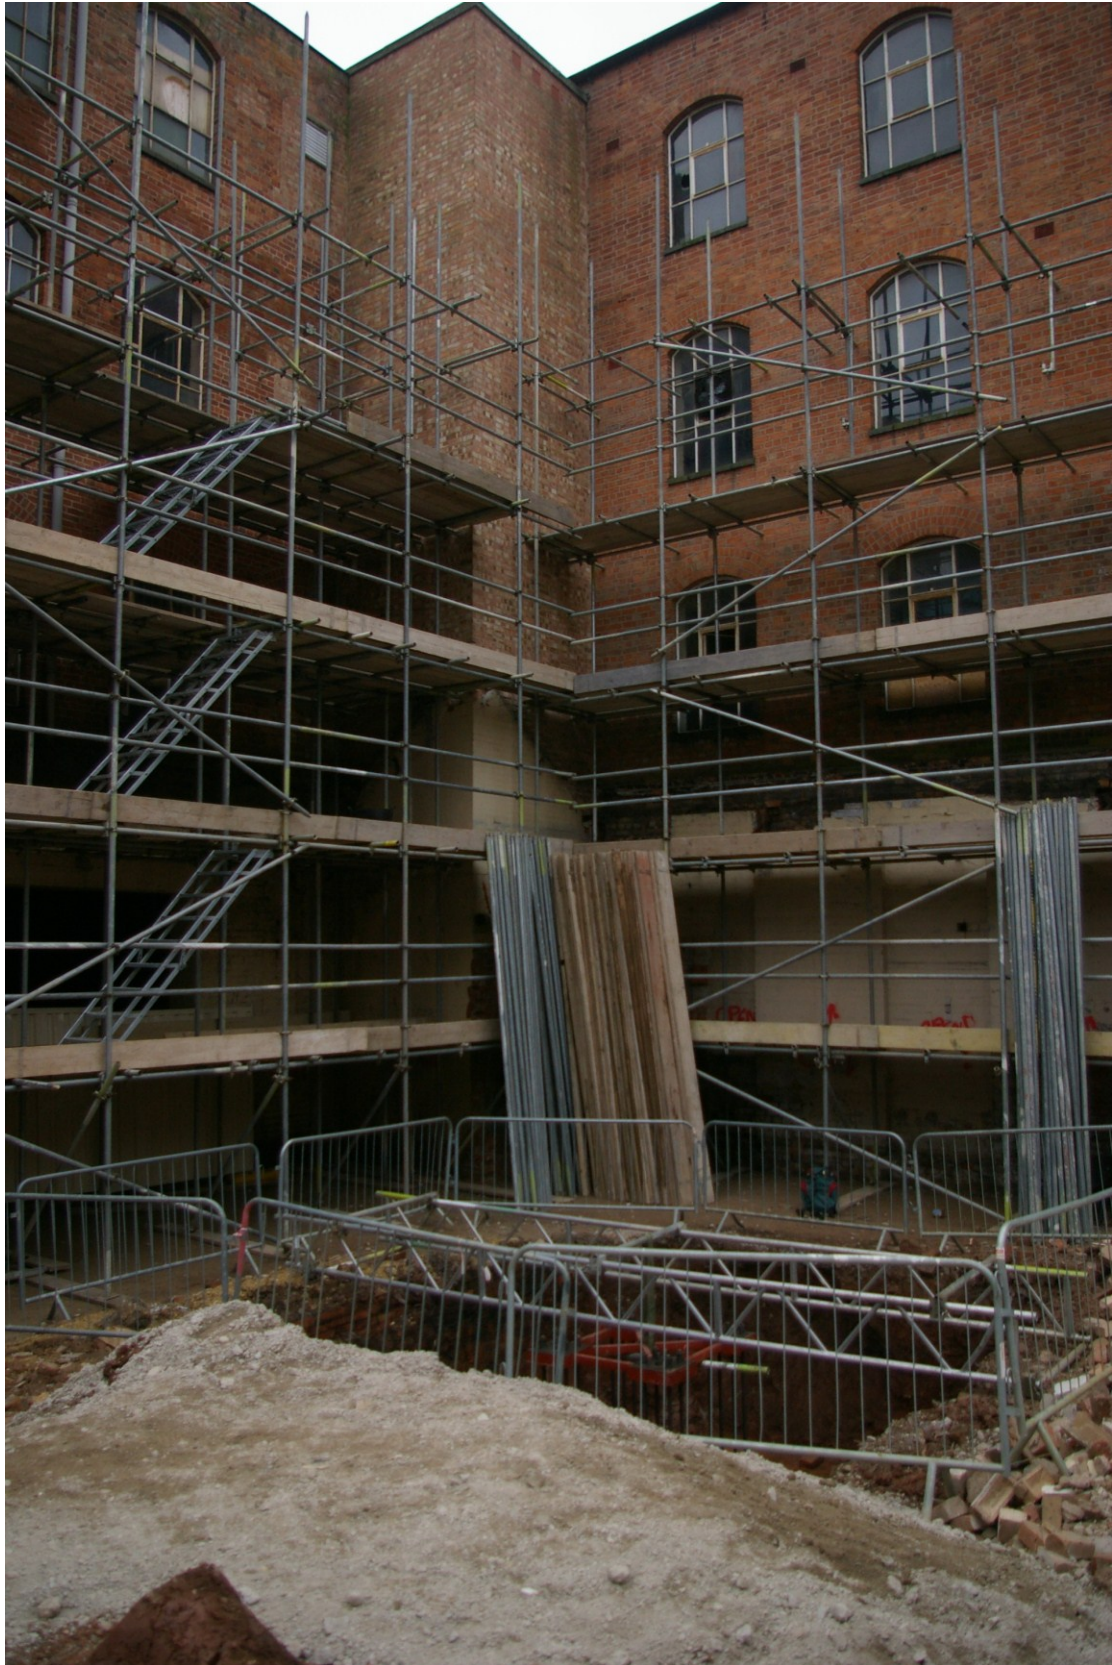
Figure 22 Location of crane base in northern courtyard
Looking south-east

The removal of the single storey buildings in both of the rear courtyards revealed a level but quite disturbed surface. The northern yard, at the time of the archaeological work, was covered in a thin layer of building demolition rubble. The southern yard retained a small concrete plinth on which part of the single storey building had recently stood. Around the plinth the ground had been heavily disturbed.

After clearing away most of the building debris within the angle created by Number 39 and the east to west range a 4.5m by 4.5m square crane base was excavated as part of the redevelopment construction programme (Fig. 22). Immediately below the demolition debris was the natural substratum consisting of reddish brown clay which continued down to the bottom of the crane base which was 1.7m below present ground level. Dug directly into the clay along the eastern edge of the trench were eight courses of unmortared bricks which appeared to be the foundations of a narrow wall. The bricks were of a typical early to mid-20th century factory-made style and seem likely to be part of the single storey extension which previously occupied this space (Fig. 23). Other small areas of cleared ground elsewhere in this courtyard indicate that the natural substratum is directly below the demolition overburden.
