**An Archaeological Watching Brief and
Historic Building Record at
22 High Street, Kibworth Beauchamp,
Leicestershire.**

NGR: SP 68267 93667

ULAS Report No. 2014-027
©2014

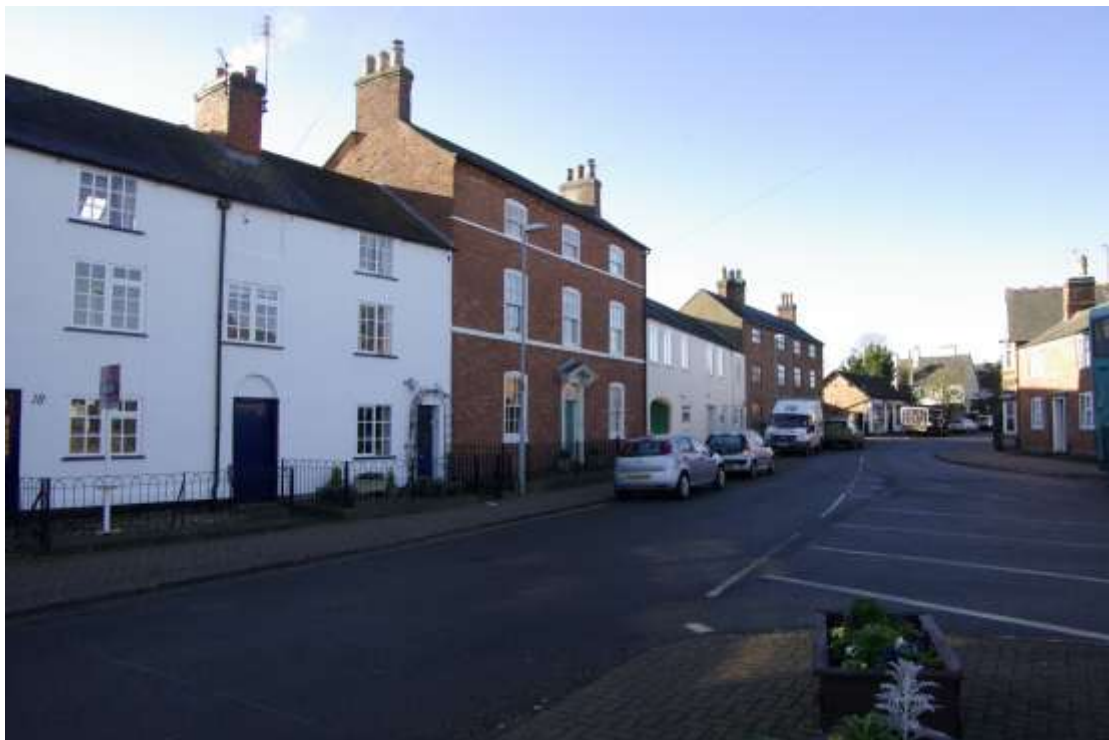
Figure 3 22 High Street
Looking south west. Site entrance between the two cars

To the rear (south) of Numbers 22 and 24 is a small yard area which leads to a pair of large two storey outbuildings. Access to the yard is presently from High Street through a covered entrance created when Number 24 was extended to join the west wall of Number 22 (Fig. 3). The buildings, which until recently belonged to Number 22, were formerly used as stables, stores and haylofts which, although not individually listed, form part of the curtilage of the property (Fig. 4). The focus of this programme of work is Building 1 which runs on an east to west alignment parallel to the rear of Number 24. Behind, to the south of, Building 1 is a large south-facing garden which has now been partially truncated by a new housing development covering a number of former rear gardens. Access to the redeveloped Building 1 will be from a service road running through the new housing development. Building 2, which runs north to south along the eastern boundary of the site, does not form part of this report.

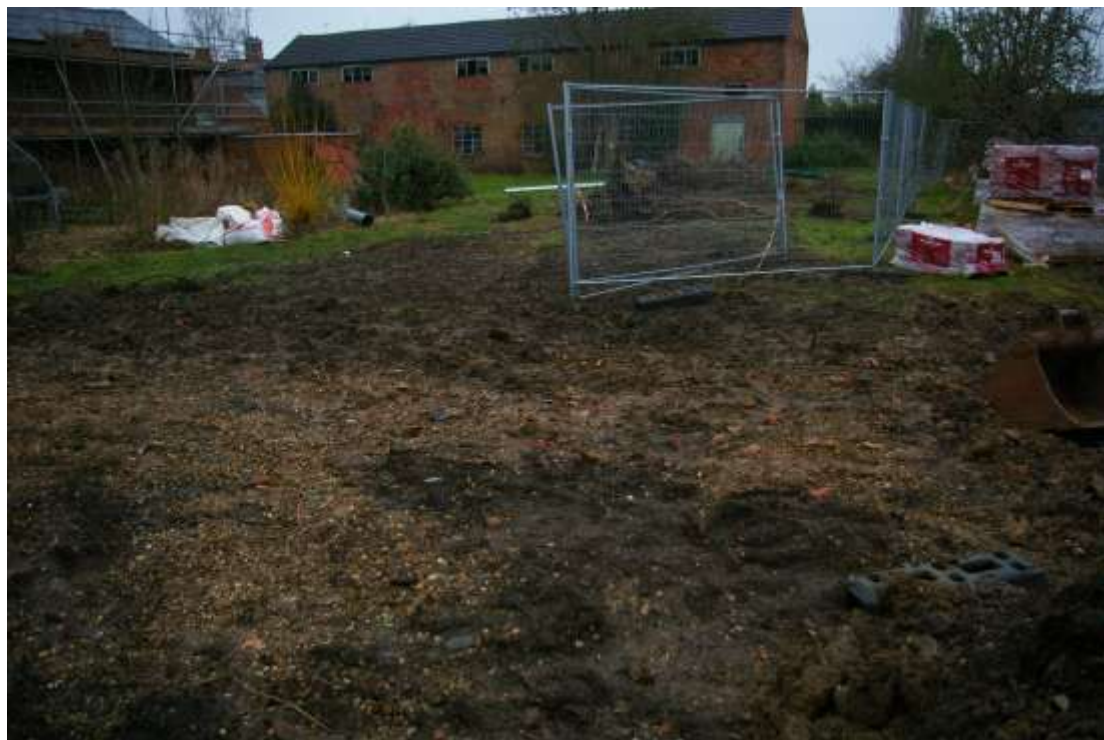
Prior to redevelopment, the site of the proposed drive formed part of a larger garden and was partially lawn and partially border (Fig. 6). The area had been heavily tracked on by plant and equipment belonging to the adjacent redevelopment which had caused a great deal of disturbance to the dark grey sandy silt topsoil which had an approximate thickness of between 0.1 and 0.15m. Removal of the topsoil revealed a subsoil consisting of a dark brown clayish silt with patches of mid orange brown clay silt. The subsoil contained a large amount of modern brick debris and extensive root disturbance was noted. Approximately 0.2 to 0.25m of subsoil was removed to expose areas of mid yellow-brown sandy clay natural substratum. The maximum depth of excavation for the drive was 0.4m below current ground level which was only deep enough to expose some areas of natural covering approximately 75% of the new drive (Fig. 7). However, the natural that could be seen was generally clean and undisturbed although there was a lot of evidence of tree and shrub root disturbance.

Figure 6 Location of drive before excavation
Looking north east. Building 1 on left of picture, Building 2 in centre

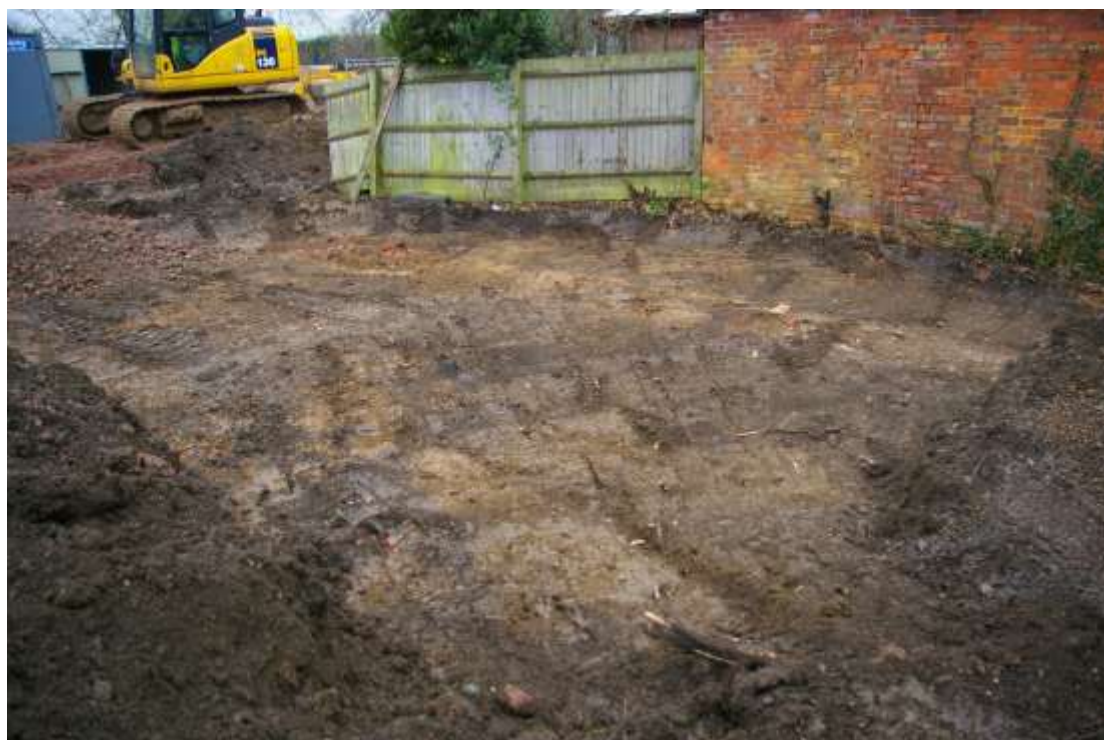
No archaeological features or deposits were seen during this small watching brief.

Figure 7 Stripped drive
Looking south west

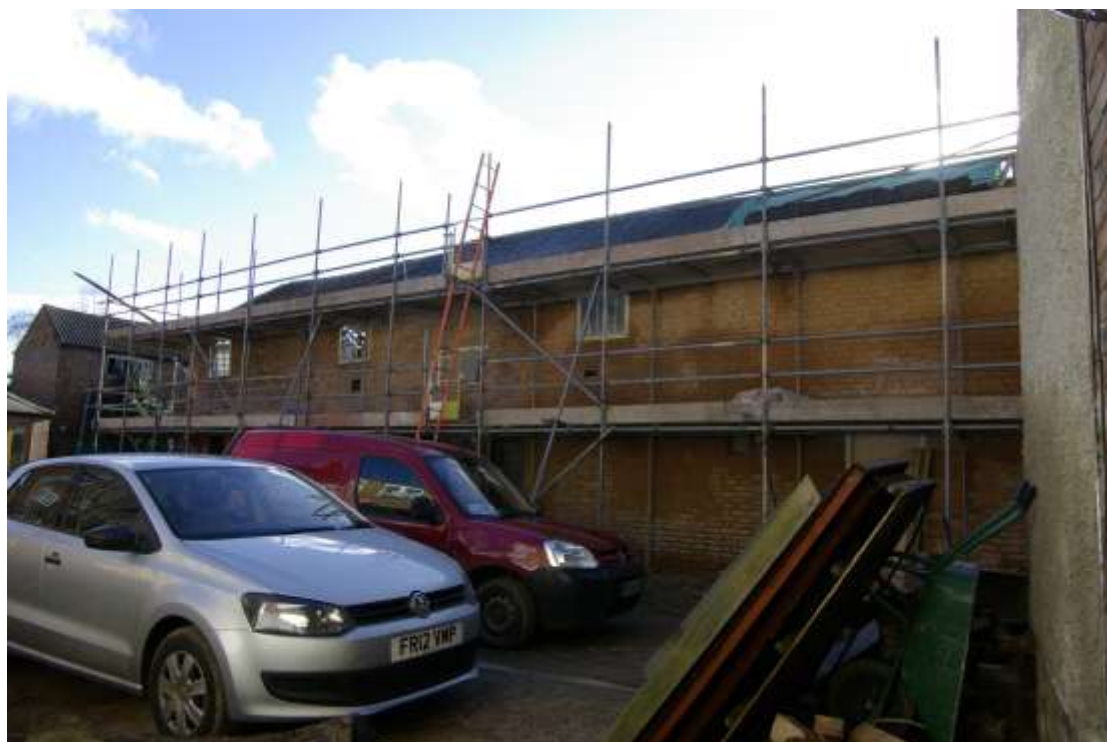
The north elevation is of a single phase of construction with no indication of brick joints suggesting any building extension (Figs. 8 and 9). The brickwork at the eastern end ground floor appears to be relatively fresh and may have been rebuilt quite recently. This may be the case as, currently, there is no doorway into the ground floor eastern room. A trace in the brickwork of possible flashing marks where a small lean-to type structure may have been, which would relate to the structure shown on current maps. No trace of this structure remains and the ground in front has been laid as a small lawn and border area. Access to the ground floor middle and western ground floor rooms is via two separate doors on this elevation. The middle room has a wide doorway into a small stable. The door for this room is a substantial four-panelled door, probably re-used from elsewhere (Fig. 10). The door into the western room is a plank-built door more in keeping with an agricultural building. No glazing survives in the ground floor windows, some of which have been blocked using imperial sized bricks, suggesting that they were blocked some time ago. The windows have flat-headed brick arches whilst the doorways have simple flat lintels made of timber. Some of the first floor windows have also been blocked with bricks. Where the first floor glazing survives it can be seen to consist of thin vertical metal glazing bars with

Figure 8 North facing elevation
Looking south east

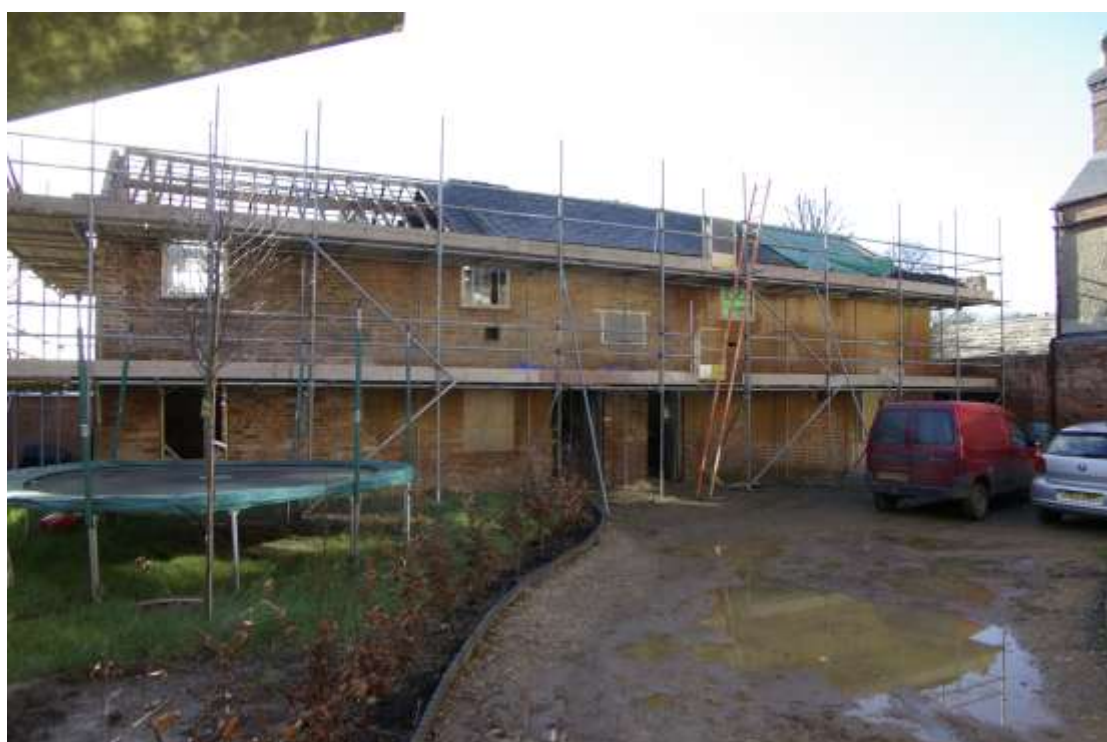
Figure 9 North facing elevation
Facing south west

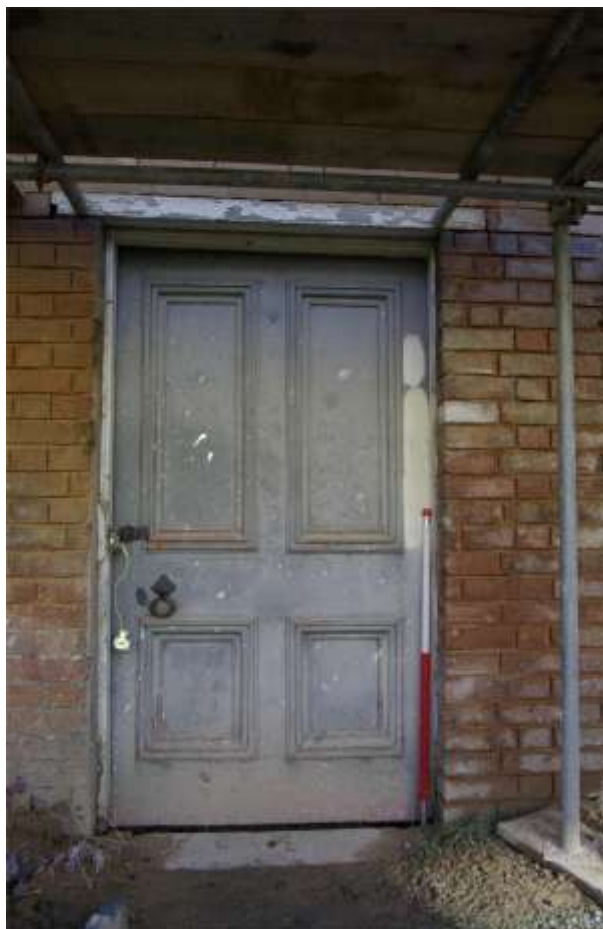
Figure 10 North elevation stable door

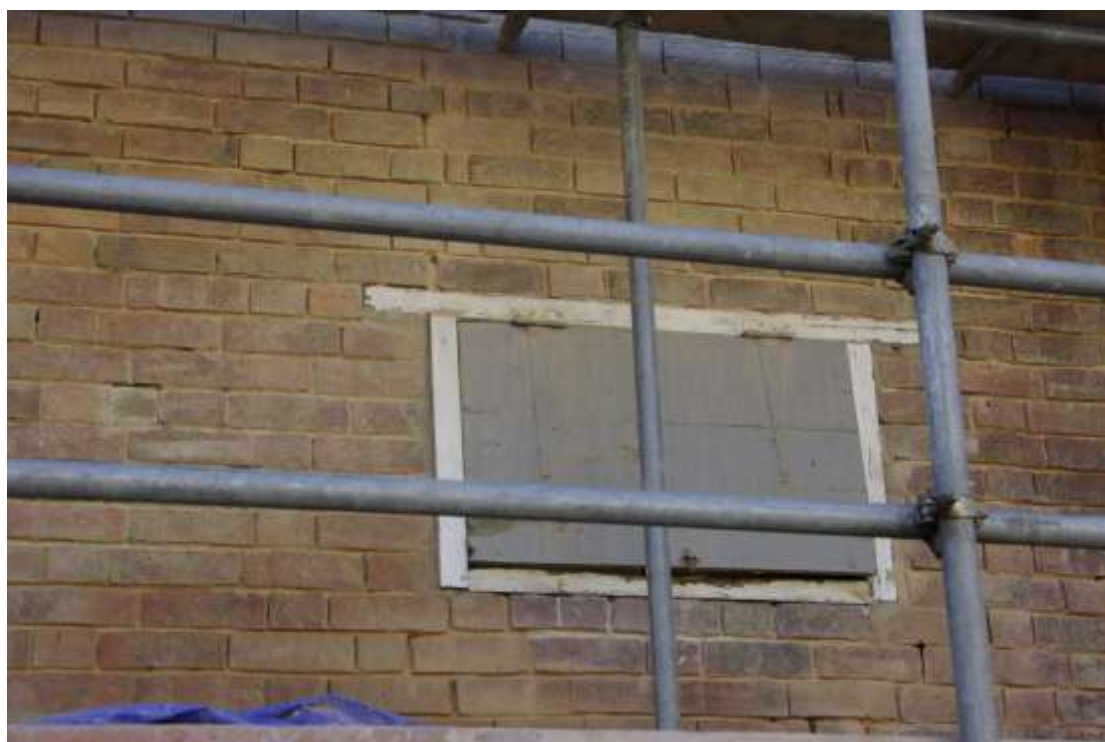
small rectangular panes of glass (Fig. 11). The central first floor window has a horizontal wooden hatch door set below the brick blocking (Fig. 12).

Figure 12 Modified window on north facing elevation
Looking south west

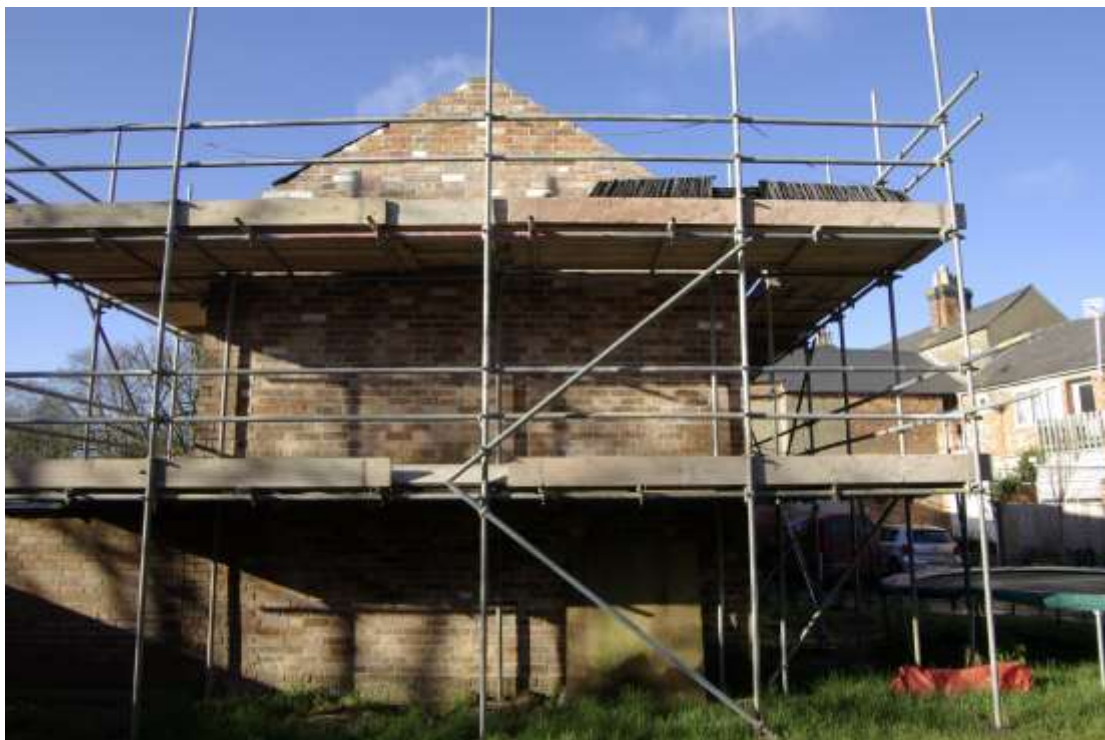
The east facing elevation faces towards the north west corner of Building 2 and is separated from it by approximately 9 metres. The plain brick-built gable end matches that of the west facing elevation and has no obvious blocked doors or windows (Fig. 13).

Figure 13 East-facing elevation
Looking west

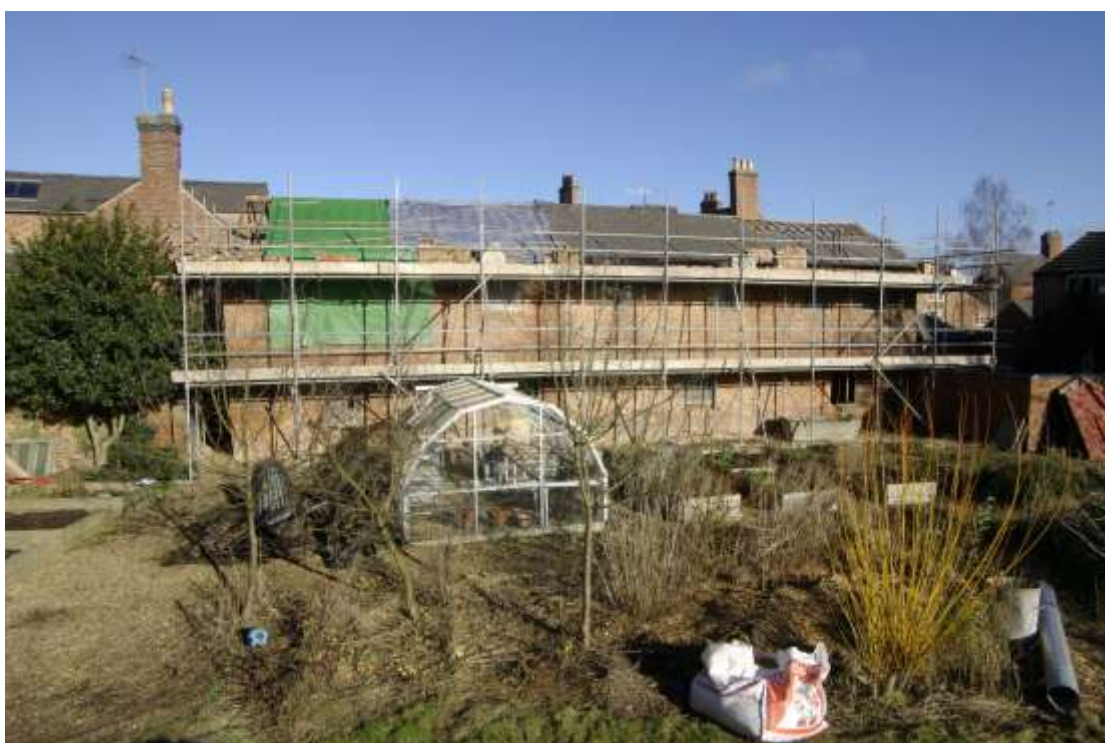
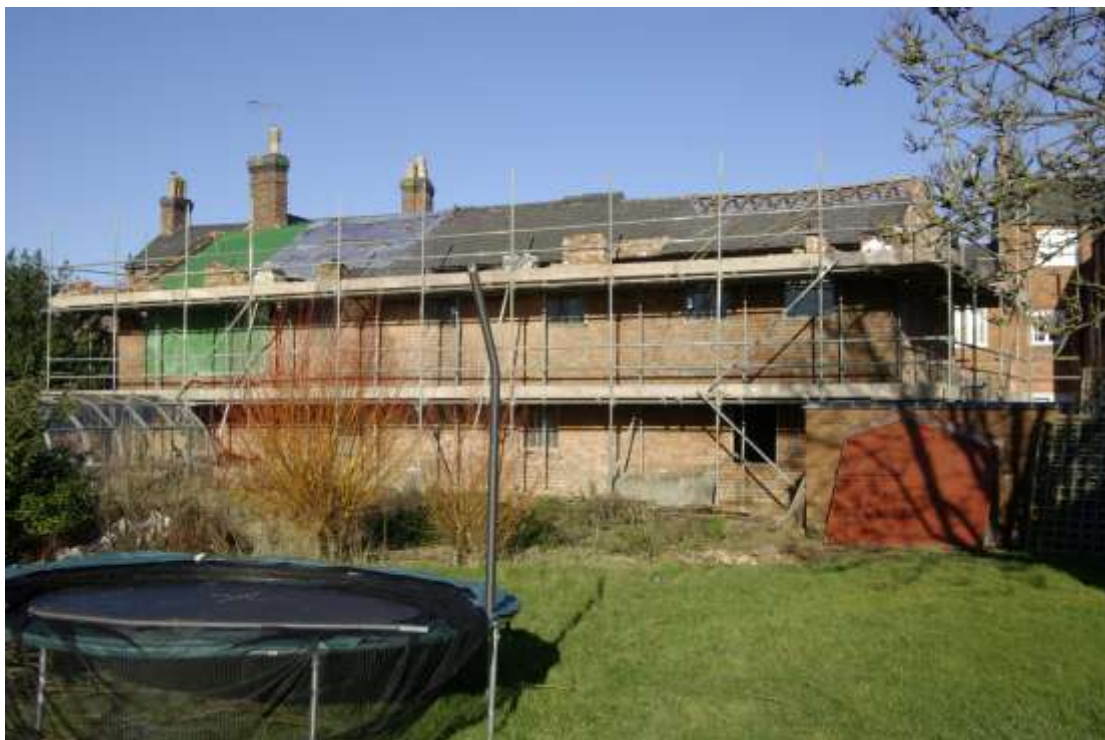
The south facing elevation follows a similar pattern of irregularly spaced windows at ground and first floor level (Figs. 14 and 15). At the time of the survey the brickwork was being repointed and the first floor western corner had been demolished prior to rebuilding. Two rebuilt chimney stacks had also been removed down to eaves height as they had been causing serious structural problems (Fig. 16). Both the ground floor and first floor windows are a mix of vertically glazed windows, as seen on the north facing elevation, and similar windows but with an opening top third (Fig. 17).

Figure 14 South facing elevation
Looking north east

Figure 15 South-facing elevation
Looking north west

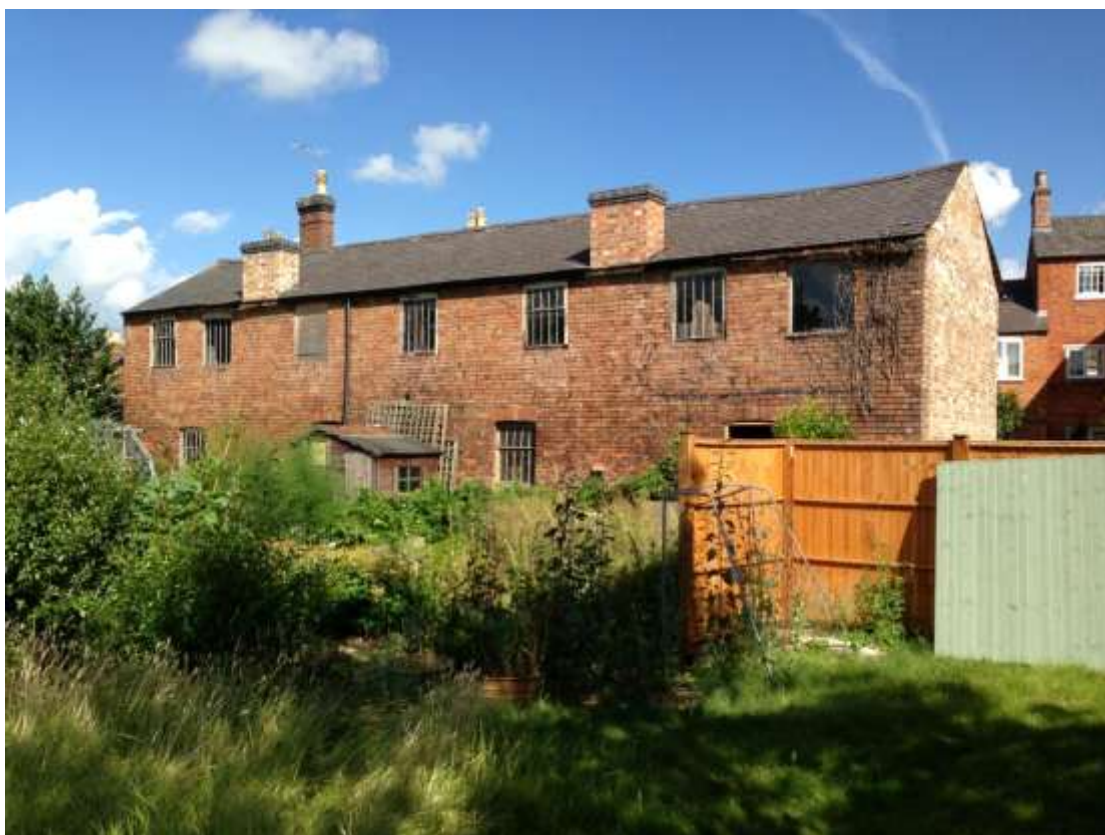
Figure 16 South-facing elevation
Photograph taken by Mr R Gamble prior to remedial works.

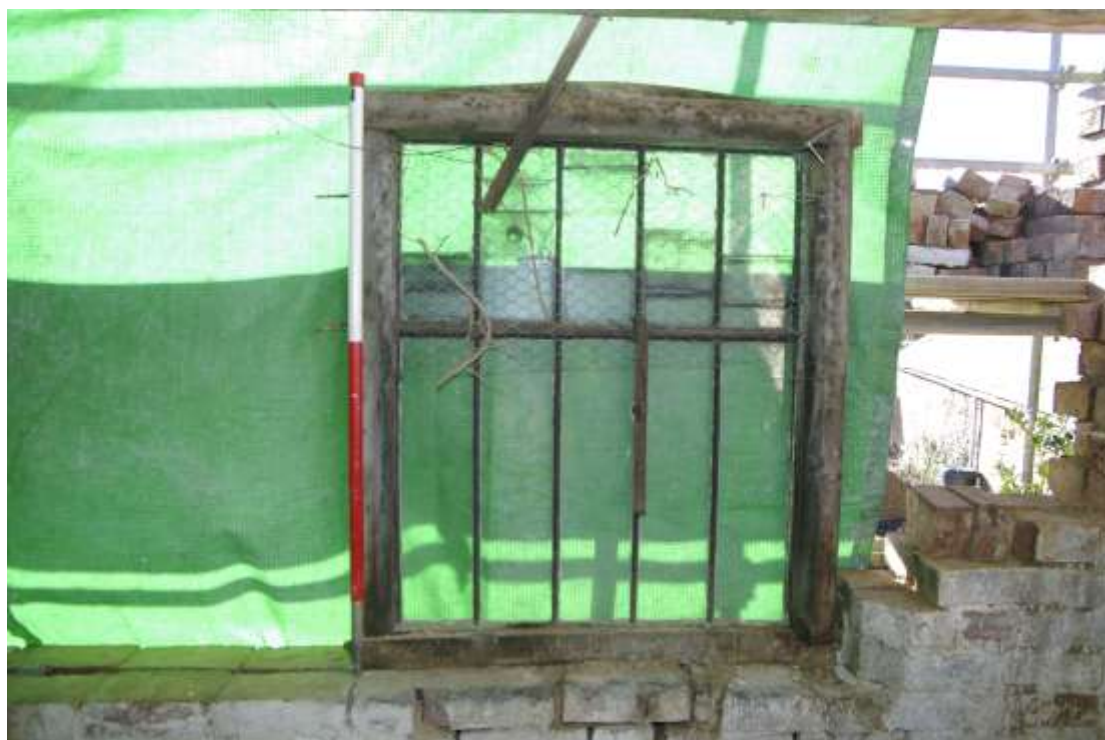
Figure 17 South-facing elevation first floor window
Looking south, 1 m scale

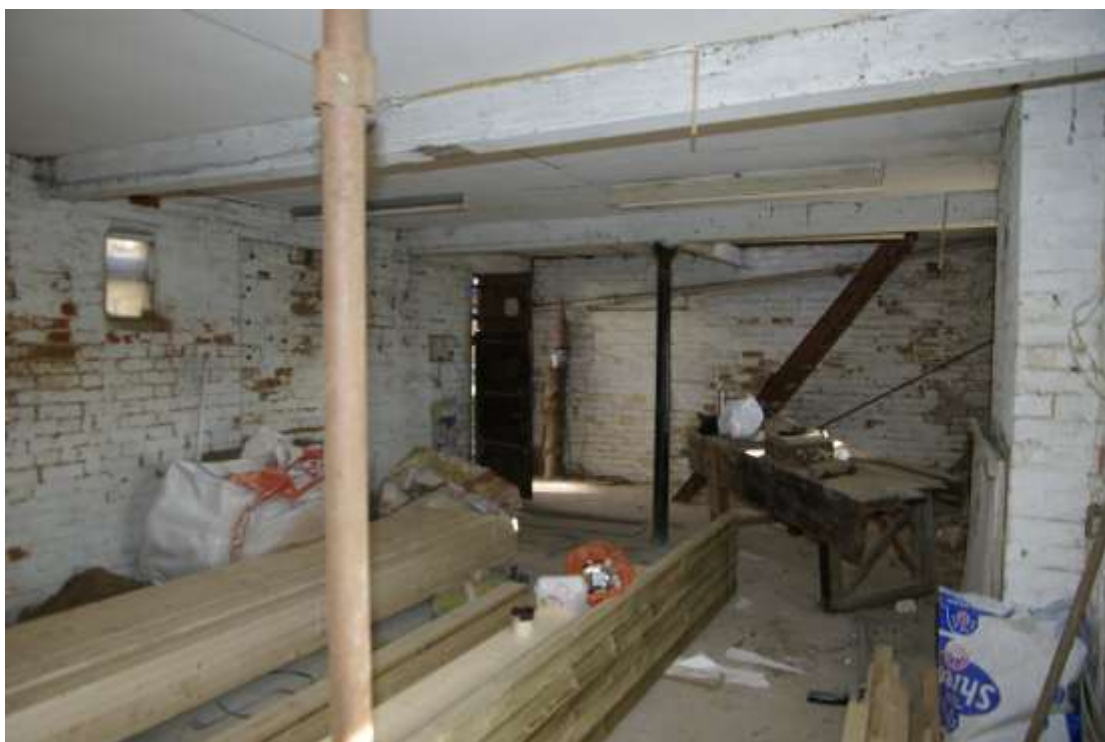
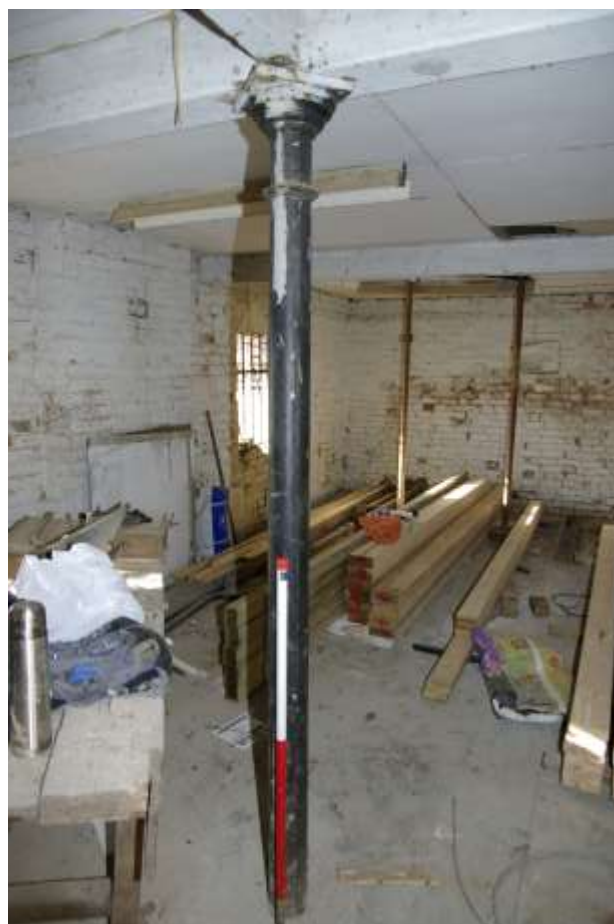
The westernmost room is the largest of the three ground-floor rooms (Figs. 18 and 19). The room has a modern concrete floor which covers the base of a cast-iron post. The post supports one of two north to south oriented stop-chamfered beams. This post appears to be a later addition, probably added because the beam is supported over a window lintel. A 0.76m (30 inch) wide fireplace has been boarded over on the south wall (Fig. 20). Open wooden stairs on the east wall lead up to the first floor. A doorway in the north east corner of the room used to lead into the middle room but has been blocked with relatively old brickwork.

Figure 18 Ground floor, west room
Looking north east

Figure 19 Ground floor, west room, post detail
Looking south west, 1m scale

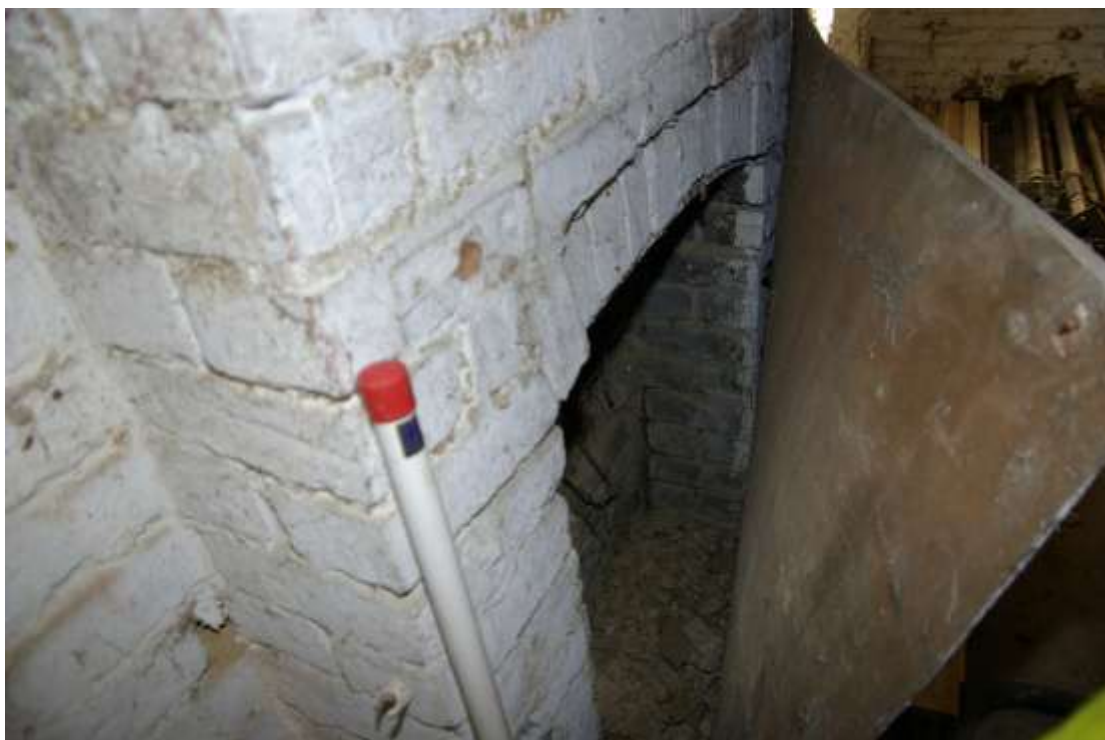
Figure 20 Ground floor, west room fireplace
Looking south west

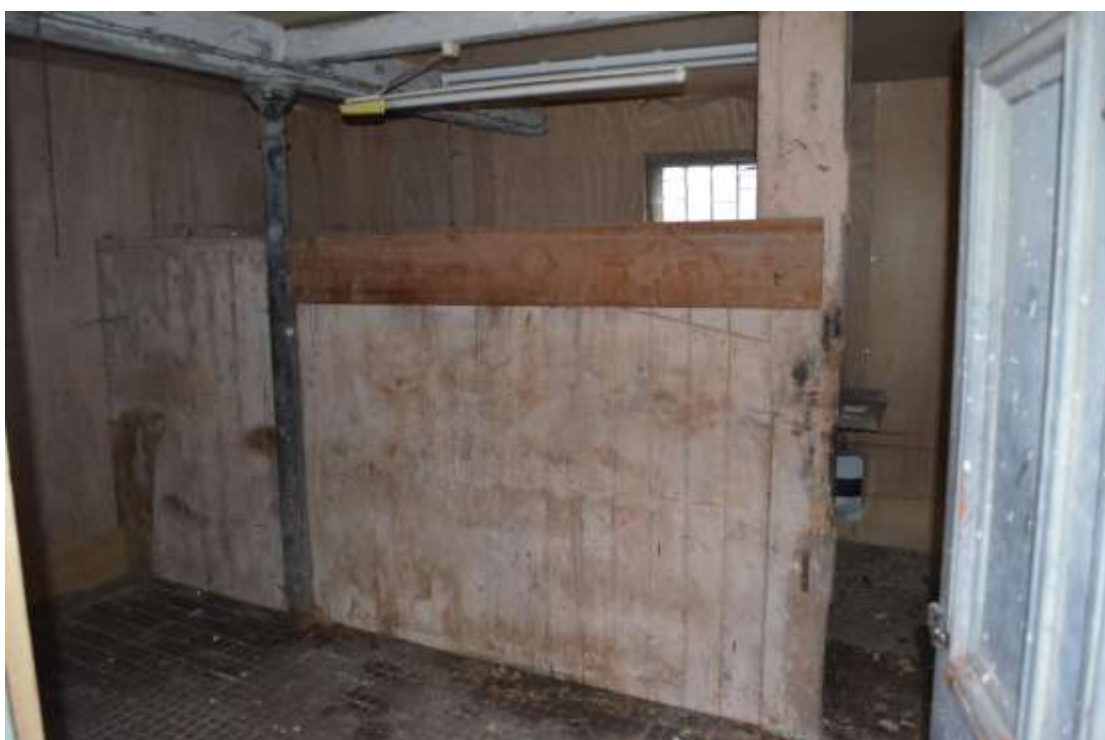
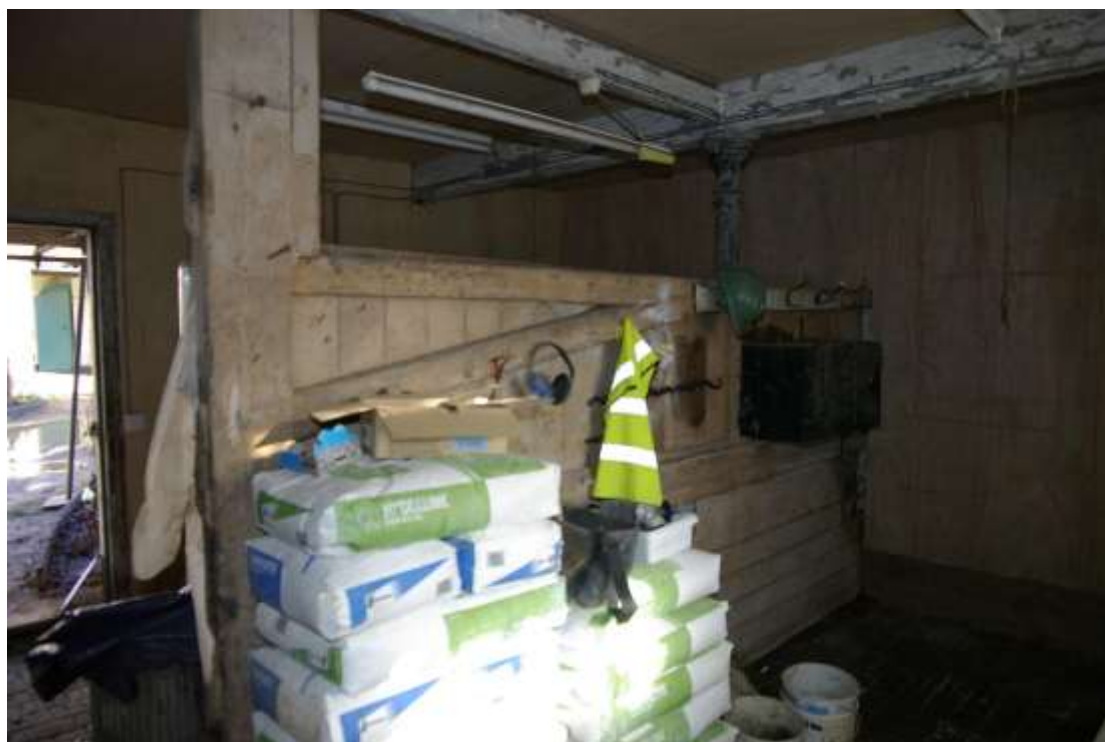
The middle room has clearly been used as a small stable and has stable paviours on the floor (Fig. 21 and 22). A wooden partition runs from east to west across the centre of the room to create two stalls. A cast-iron post, which matches that seen in the west room, supports a stop-chamfered beam. The south and east walls have recently been panelled with plywood which has also boxed in a fireplace in the south east corner.

Figure 21 Ground floor, middle room
Looking south east

Figure 22 Ground floor, middle room
Looking north east

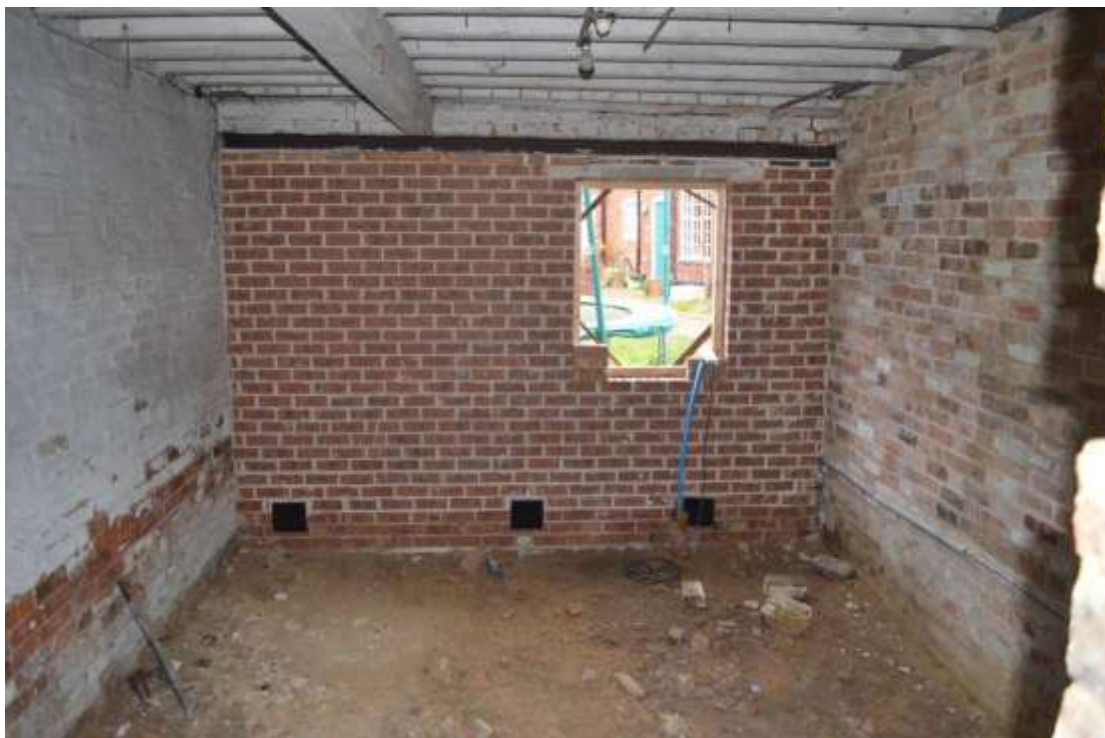
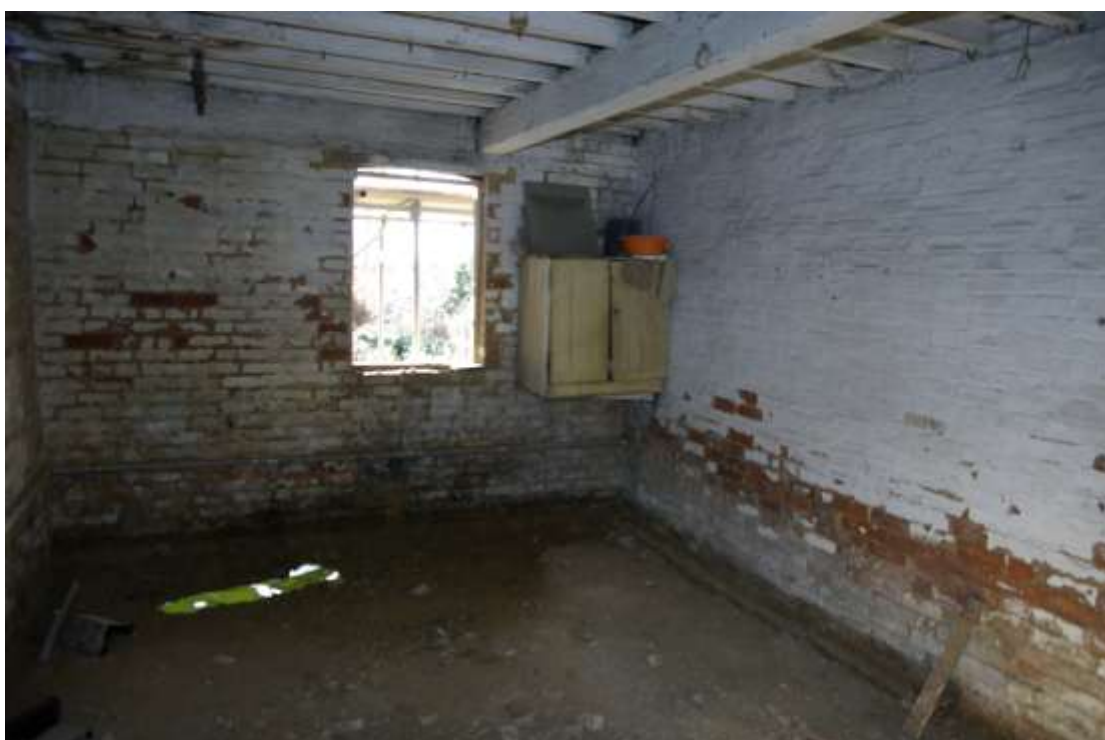
There is currently no doorway into the eastern room, so an inspection had to be made through the windows (Figs. 23 and 24). None of the original flooring remains as this has been removed to rebuild and re-skin the south wall. The original bricks have been re-used on the outside and modern ones used internally.

Figure 23 Ground floor, east room
Looking south

Figure 24 Ground floor, east room
Looking north

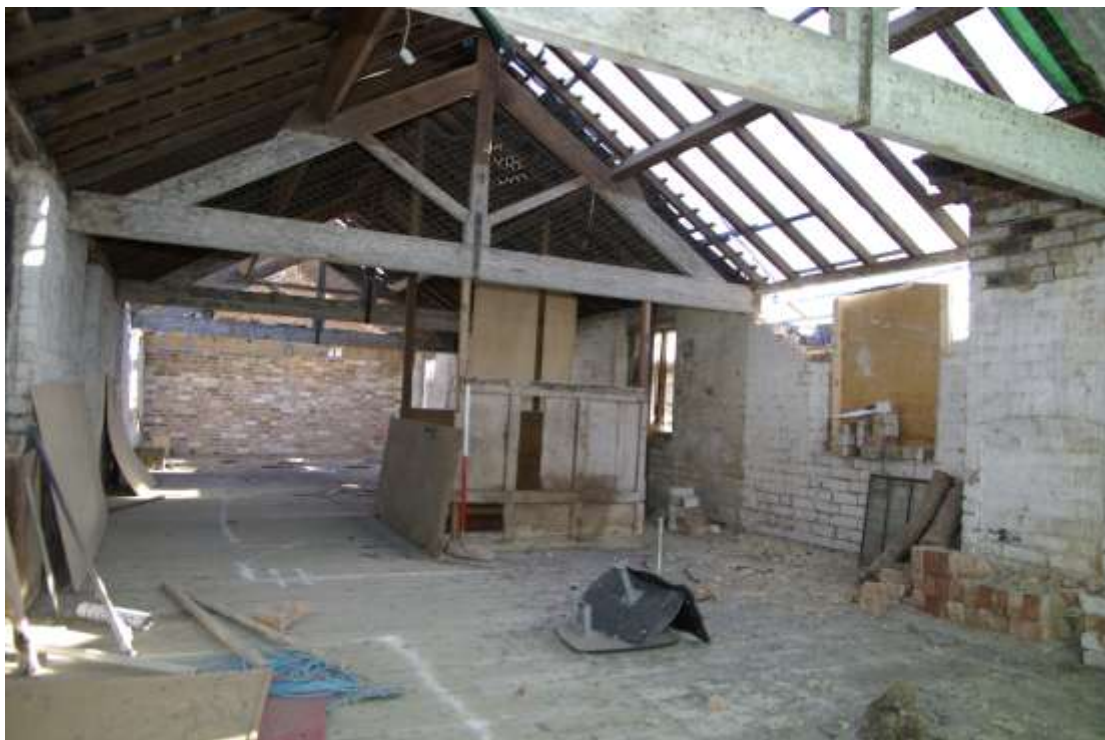
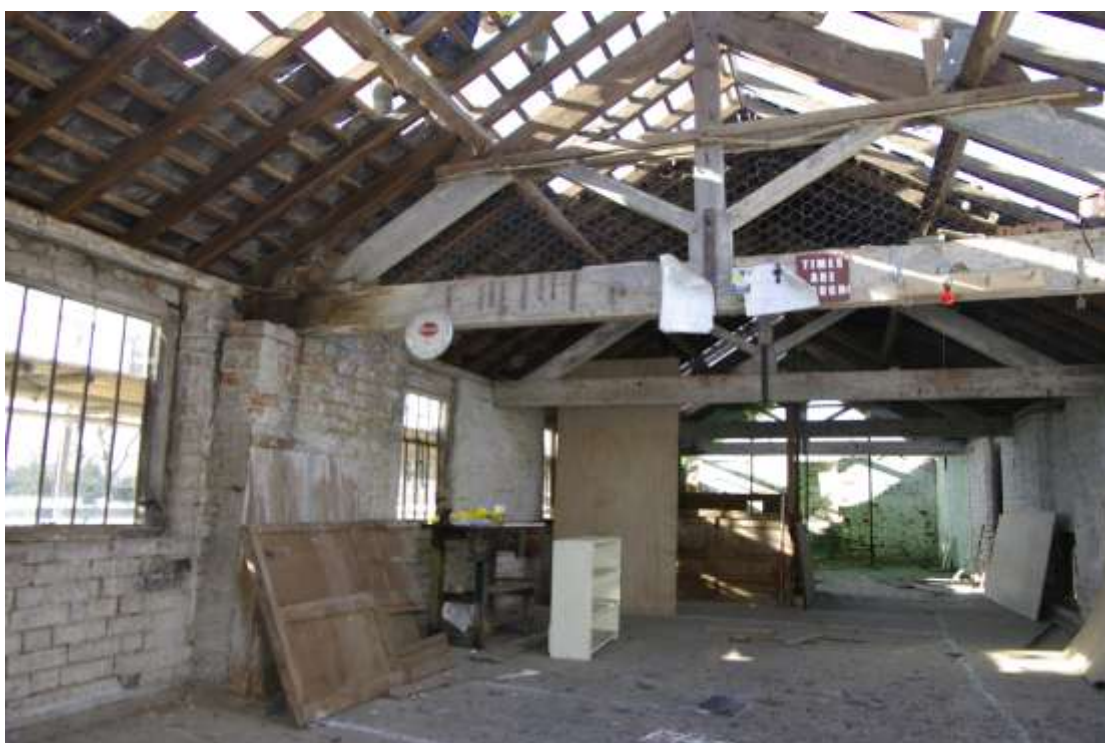
The first floor of Building 1 forms a single long room partially divided by the stairs leading up from the ground floor (Figs. 25 and 26). Four roof trusses support the roof structure, a fifth new truss has been added for additional structural support at the east end of the building. The original trusses consist of a king post with raking struts and cleated purlins supported on the backs of the principal rafters (Fig. 27). The socketed king post is held onto the horizontal truss with a metal stirrup which is pegged using an iron peg (Fig. 28). Both fireplaces on the south wall have been blocked and the chimney stacks removed at eaves height. Rebuilding work in the past has caused significant structural damage to the outside walls and stacks. This is in the process of being remedied by rebuilding the stacks and parts of the walls. The western gable end has been removed as has much of the wall around the south-west corner which has left some windows temporarily isolated.

Figure 25 First floor
Looking south east, 1m scale

Figure 26 First floor
Looking west, 1m scale

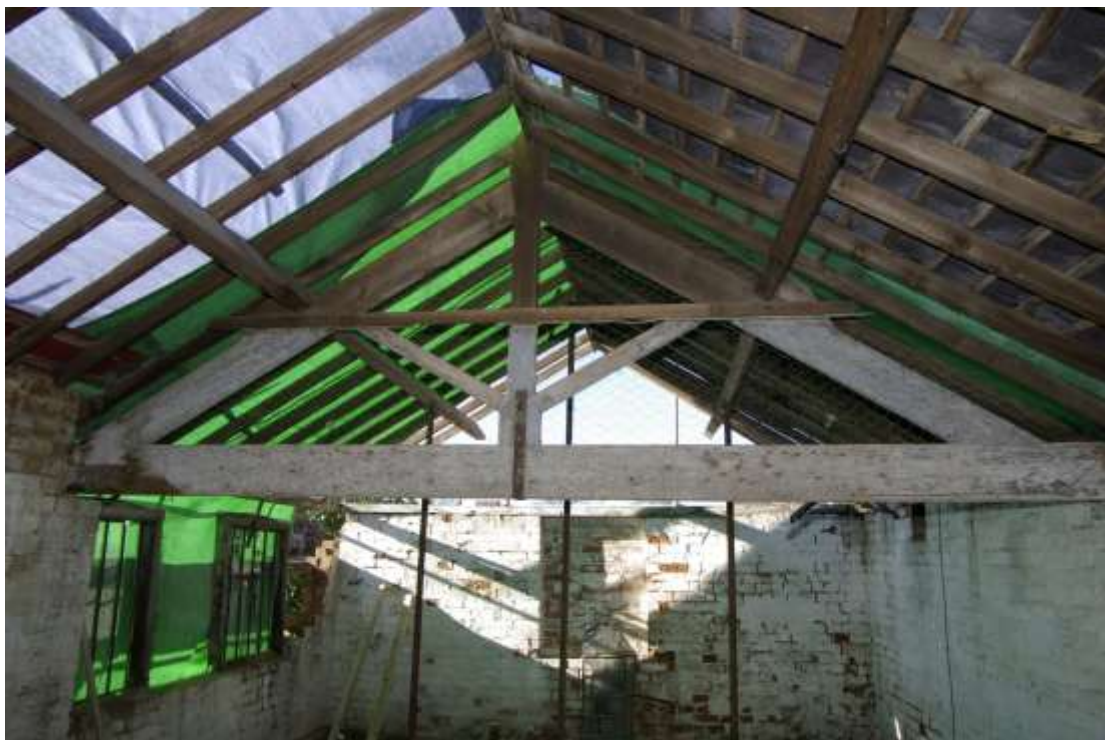
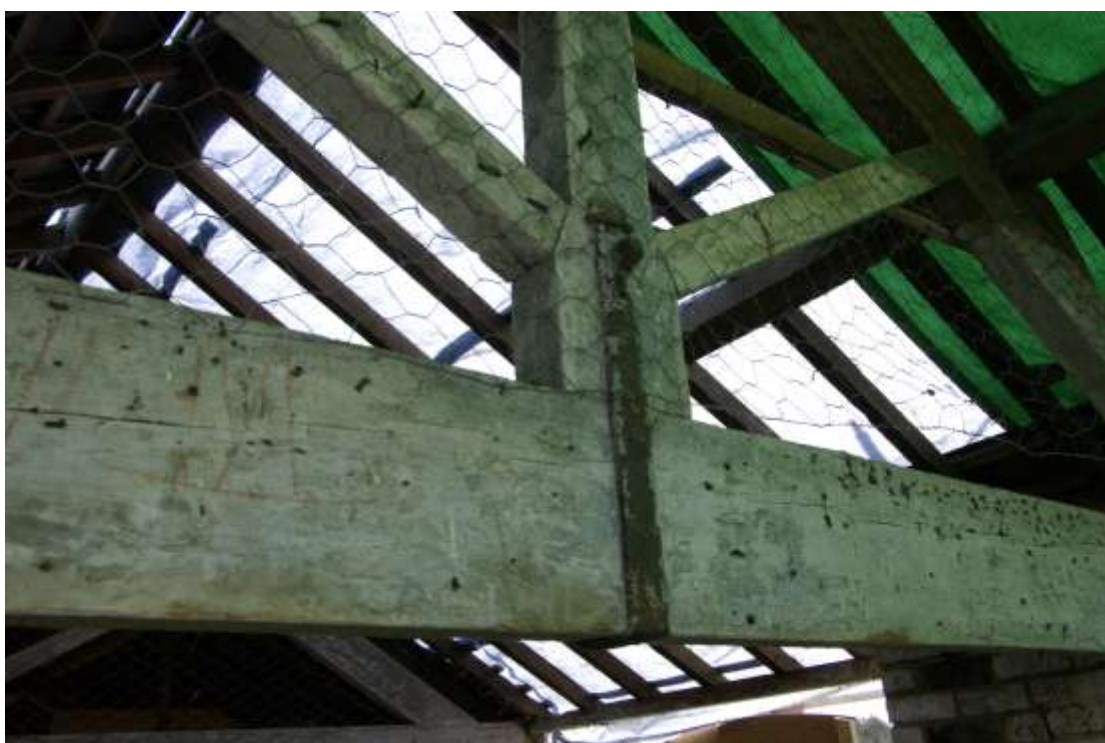
Figure 27 First-floor roof truss
Looking west

Figure 28 First-floor roof truss detail

The building recording shows that Building 1 is a mid to late 19th-century structure which was constructed in a single phase. The style of building and materials used would narrow down the construction date to well into the second half of the 19th century at the earliest but, at the same time, pre-dates the first edition OS map of 1886. The use of metal stirrups supporting the timberwork of the roof trusses also suggests a mid to late 19th-century origin.
