**A Strip, Plan and Sample Excavation at  
Rose Cottage, 10 Main Street, Saltby,  
Leicestershire.**

ULAS Report No. 2013-087  
©2013

*An archaeological strip, map and sample excavation was undertaken by the University of Leicester Archaeological Services (ULAS) at Rose Cottage, 10 Main street, Saltby, Leicestershire. The work took place on the 9th of May 2013 during the excavation of foundation trenches and ground works for a proposed new triple garage and attached hobby room. The site lies within the medieval settlement core of the village.*

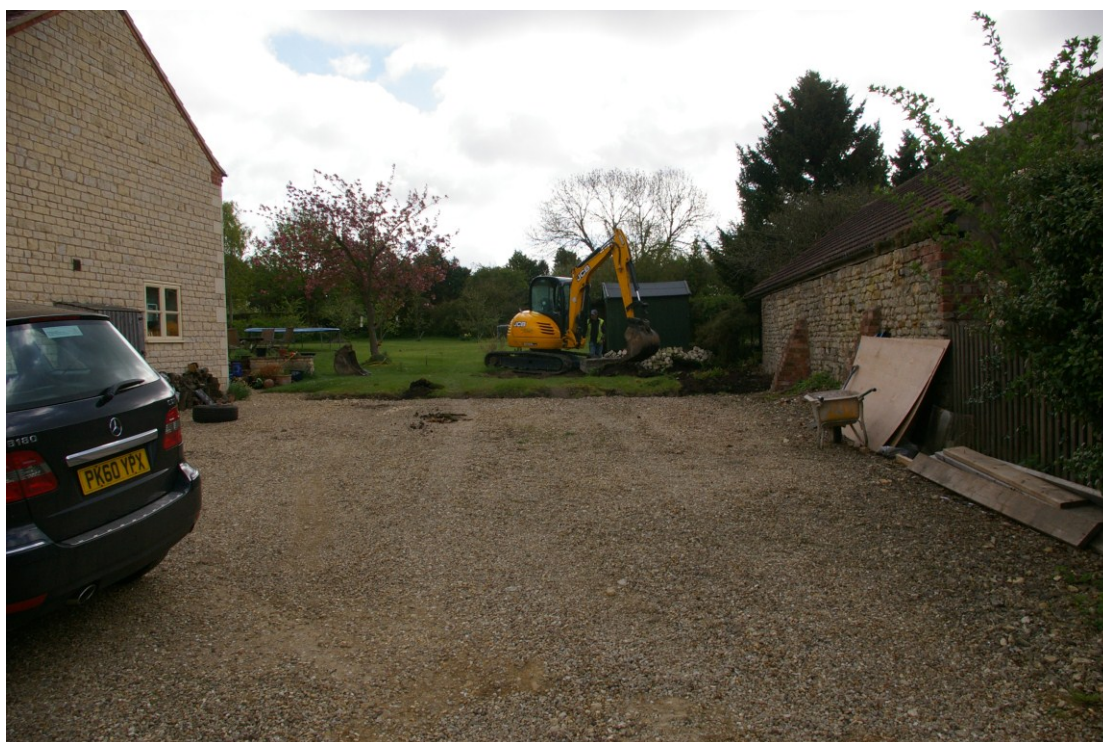
Figure 4: Proposed site of garage  
Looking east

The village of Saltby lies midway between Melton Mowbray and Grantham (Figs 1 and 2). Rose Cottage lies on the eastern side of Main Street and is centred on National Grid Reference SK85010 26290. The present house forms an L-shaped building plan created from the original cottage along with a later two-storey extension which does not show on any of the more recent maps (Fig. 3). The rear garden slopes up to the east and has a row of assorted outbuildings along the northern boundary. The proposed garage is to be located to the south-east of the house and is partially set on an existing gravel driveway and partially on a lawn (Figs 4 and 5). Prior to the

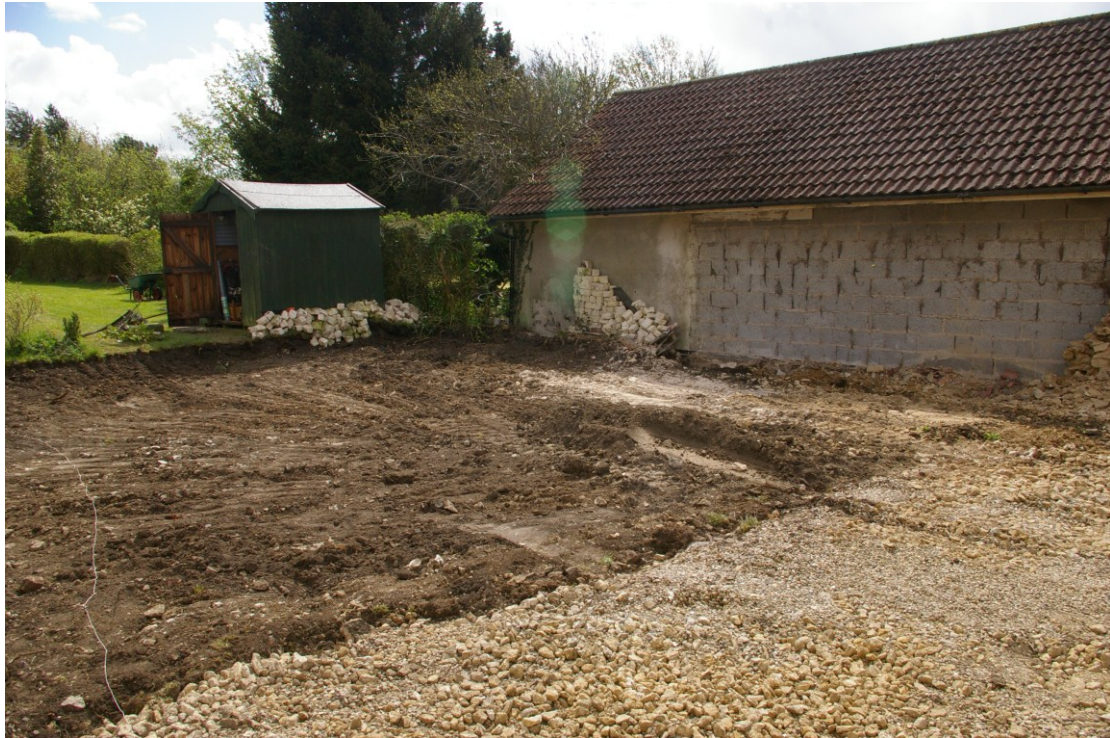
Figure 6 Proposed garage area during site reduction  
Looking south-east

As a first phase, the entire footprint of the garage was reduced down to formation level. Because of the slight slope up to the east approximately 0.3m of turf, topsoil and subsoil was removed in the grassed area. The topsoil consisted of a dark brown silty sand with occasional limestone fragments. The subsoil was a mid-grey brown silty sand with a high proportion of limestone fragments. In order to achieve the same level on the driveway area, only the gravel and a thin skim of modern overburden measuring approximately 0.2m in total depth was removed (Fig. 6). The footprint strip revealed large areas of dirty natural substratum consisting of fragmented limestone brash. The lack of subsoil and the very flat driveway suggests that this area had been landscaped before the start of this development. This may have taken place during the construction of the extension to the house. The spoil and exposed ground were scanned by the client with his own metal detector. Only a George III farthing, a late post-medieval buckle and the base of a shotgun cartridge were found in the spoil. These items were retained by the owner.

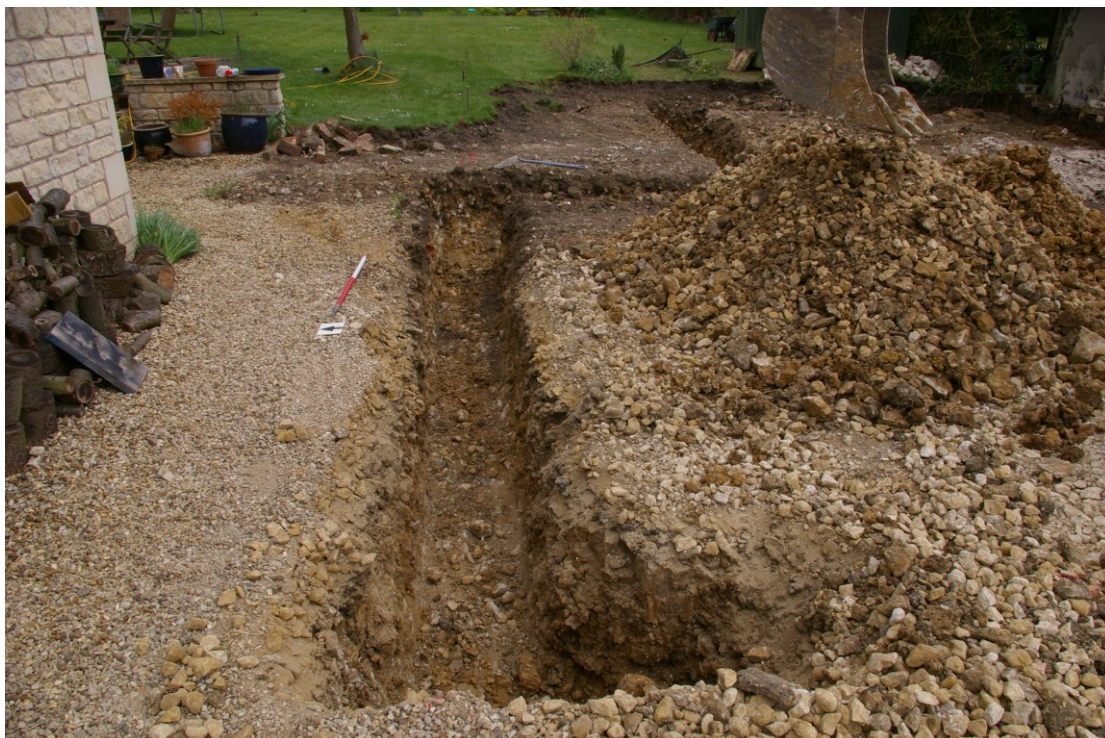
Figure 7 Northern foundation trench  
Looking east

The 0.6m wide and 0.75m deep foundation trenches were then excavated down to the required building depth. A trench around the perimeter of the garage and a central

north to south trench was excavated (Figs 7 and 8). The southernmost foundation trench was badly disturbed by the construction of a single storey house and garage on the adjacent property. None of the other trenches revealed any archaeological features or deposits. All of the service connections will be made within the former gravelled driveway area where the subsoil has already been removed by the earlier landscaping work. This indicates that no other features will be revealed during this work.
