**An Archaeological Watching Brief
during restoration works at
Abbey Grounds,
Abbey Park,
Leicester.**

ULAS Report No. 2014-058
©2014

Scheduled Monument No. 17131

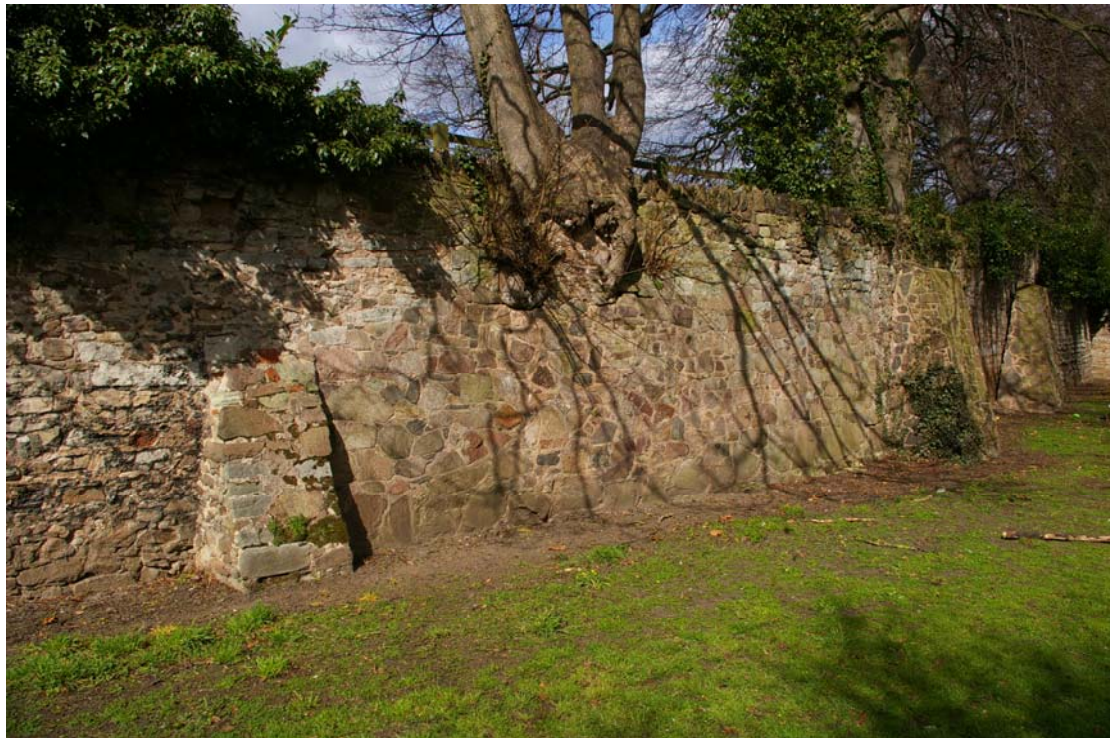
Figure 3 Eastern face of precinct wall
Looking north west. Trench and boreholes on opposite side of wall

The eastern precinct wall of Leicester Abbey has a pronounced lean to it due to the configuration of surrounding mature trees and the difference in ground levels on both sides of wall – that to the west being much higher than to the east. This wall has no weep holes for ground water to discharge and it is also retaining soil beyond its strength and design capacity (the soil being too heavy for the structure, the water

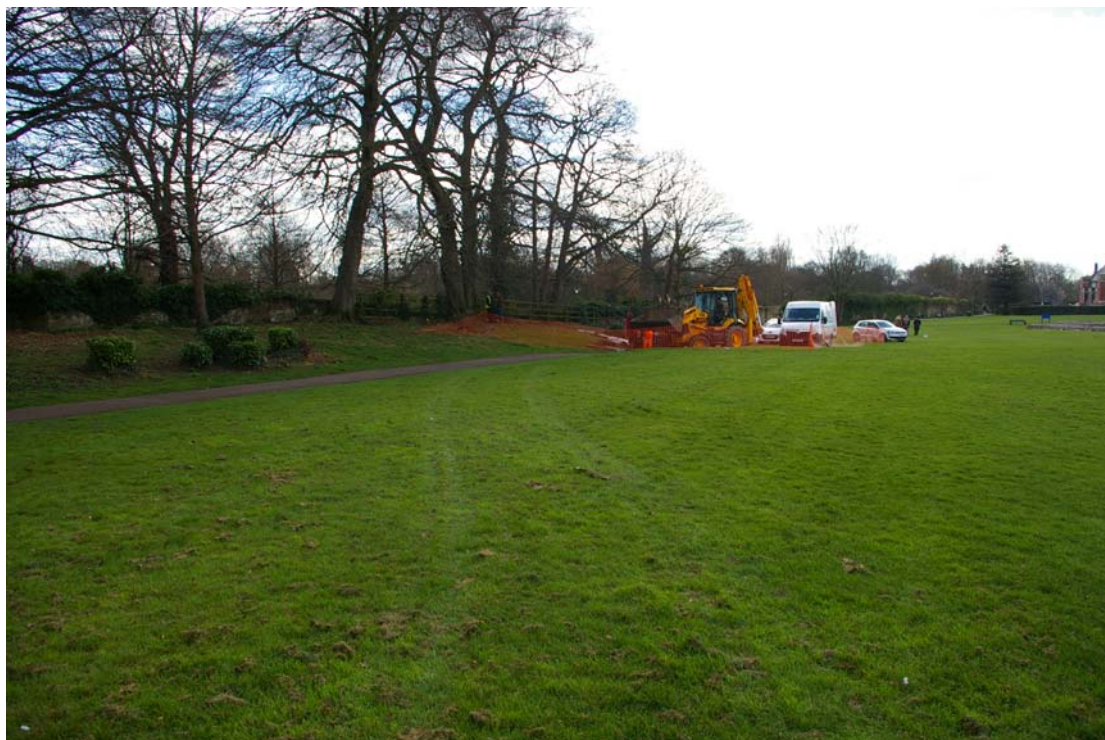
Figure 4 Earth bank against western face of precinct wall
Looking south east

At present there is a bank of earth rising from the pathway up to the top of the surviving wall (Fig. 4). At the top of this bank are a number of semi-mature trees which are very close to the precinct wall. At least one tree has broken through the stonework and its roots appear to be growing within the wall structure. The trees are thought to be approximately 100 years old (pers comm M Sharif) giving an indication of the minimum age of the earth bank.

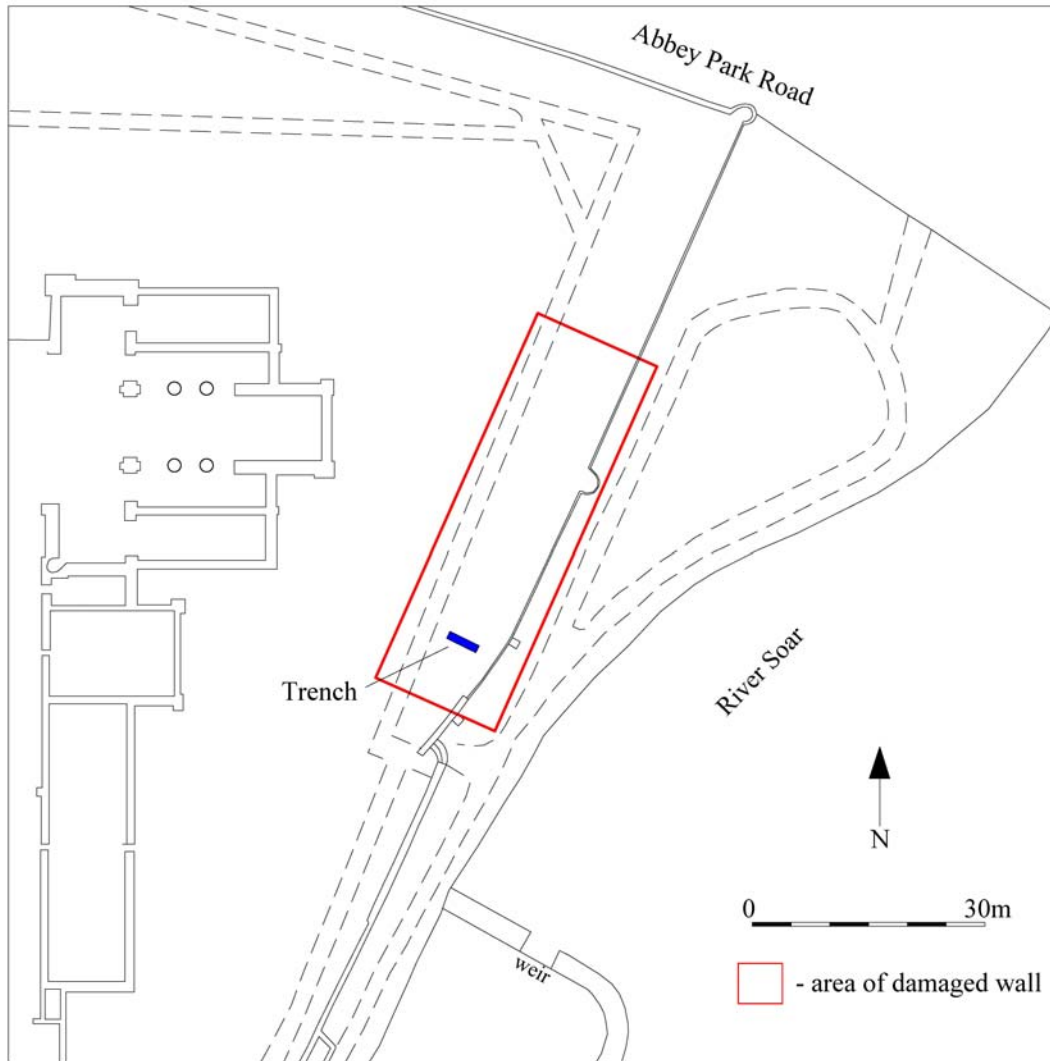
Figure 5 Location of trench

After discussions with the Senior Building Surveyor for Leicester City Council and the borehole contractor it was decided to place the trial trench and boreholes at the southern end of the area identified for stabilisation work (Fig. 5). This area contained most of the larger trees including those which were growing through the walls. To avoid a wooden fence and causing root damage to the existing trees the eastern edge of the trench was excavated 3 metres to the west of the wall (Fig. 6). The trench was laid out on an east to west orientation to cut across the proposed location of the tie-beam.

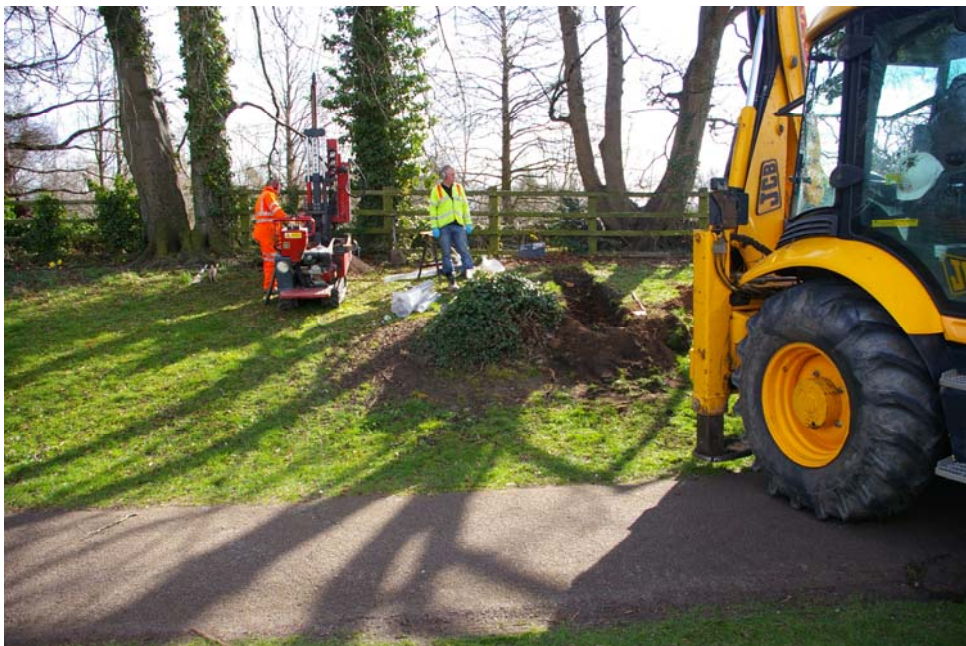
Figure 6 Location of trench
Trench partially excavated. Looking east

An average thickness of 0.3m of mid grey-brown sandy silt topsoil (1) was removed in level spits. This layer was full of reasonably sized tree roots indicating a significant level of disturbance. Below the topsoil was a mid orange-brown sandy silt layer full of Dane Hills sandstone fragments, mortar and slate roof tile fragments (2). The whole of this deposit was quite compact but appeared to be relatively free-draining and may not be causing as much of a drainage problem as first thought. Four fragments of 14th-century floor tile and one fragment of post-medieval pancheon ware were recovered from this layer. The tiles were all broken and quite worn with some still having mortar attached to the underside. No very modern material was observed. Layer (2) had an average depth of between 0.9 and 1.0m. Removal of (2) exposed a dark red brown sandy silt layer (3) which had a frequent occurrence of charcoal but only a small amount of Dane Hills sandstone. No artefacts were recovered from this 0.2m thick layer. A similar layer, but with significantly more Dane Hills sandstone (4), was exposed below layer (3) (Fig. 7). This layer, from which no finds were recovered, had an average thickness of 0.15m and appeared to be an interface layer between (3) and a layer of compacted Dane Hills sandstone rubble (5). The top of layer (5) was below the expected excavation depth of the tie-beam so, after a small exploratory box had been dug, no further excavation took place during this phase of work (Fig. 8). The final excavated base of the trench was at the same height of the pathway running parallel to the wall and to the church ruins.

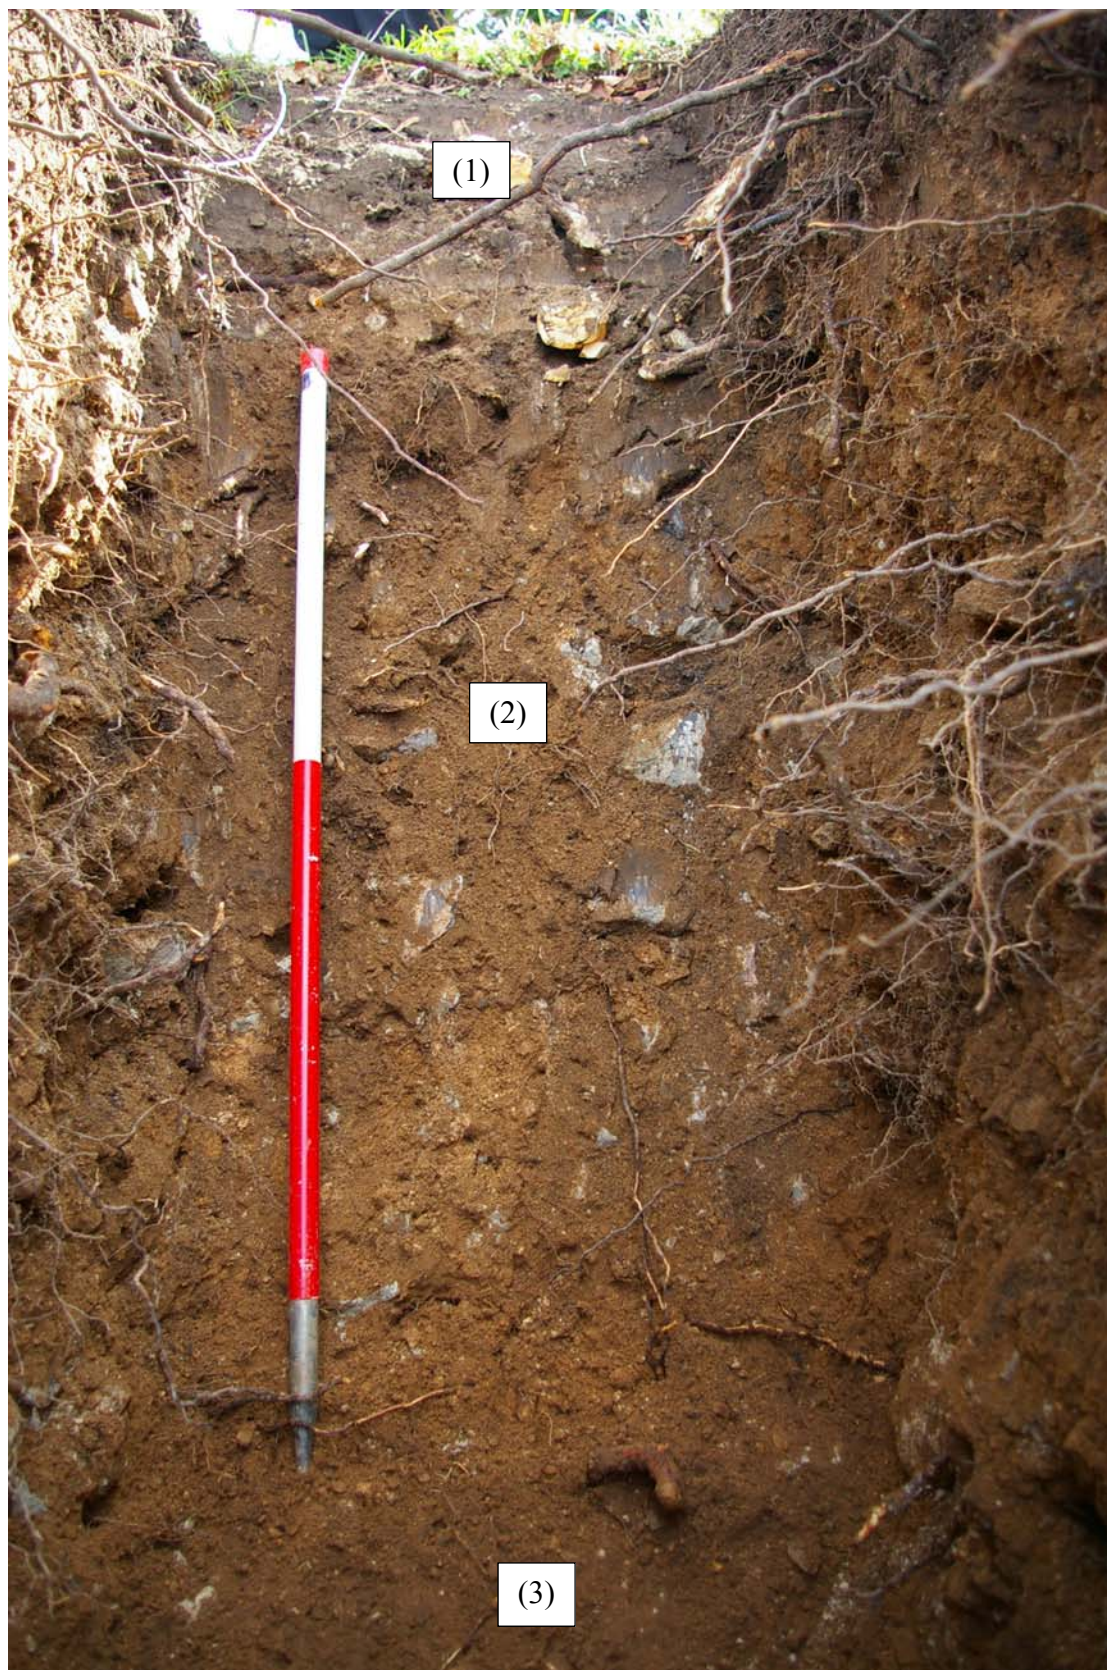
Figure 7 Upper levels of trench stratigraphy
Looking east

The different layers containing demolition debris suggest phases of clearance or dumping over a number of years. Layer (2) was the only layer from which any dateable finds were recovered, the floor tiles being from the abbey demolition phase but the pottery clearly post-dating the mansion phase. The quantity of Dane Hills sandstone rubble, one of the more commonly used stones found in the abbey, and slates might be from a period of salvage whereby good quality stone was being recovered and cleaned ready for re-use. The resulting spoil and debris might then have been disposed of against the precinct wall. Similar rubble layers have been found elsewhere on the site. However, the late date of the post-medieval pottery from this context seems likely to post-date any salvage work which presumably took place very soon after the Dissolution in 1538. The bank could be part of Bedingfield's excavation spoil from the 1920s and 1930s although, when found elsewhere on site, his spoil is often characterised by a large quantity of modern rubbish which was not seen during this watching brief. More accurate dating of the trees sitting on top of this layer might help to provide the latest possible date. From the limited work the best date that can be estimated would be between the late 17th to early 20th centuries.

The layers (3) and (4) below the rubble layer could be the remnants of a trample layer laid down when the precinct wall was still working as an effective high wall. These layers, which contain very little building rubble, may sit on an abbey phase stone dressing layer or post Dissolution rubble layer which layer (5) might well prove to be.

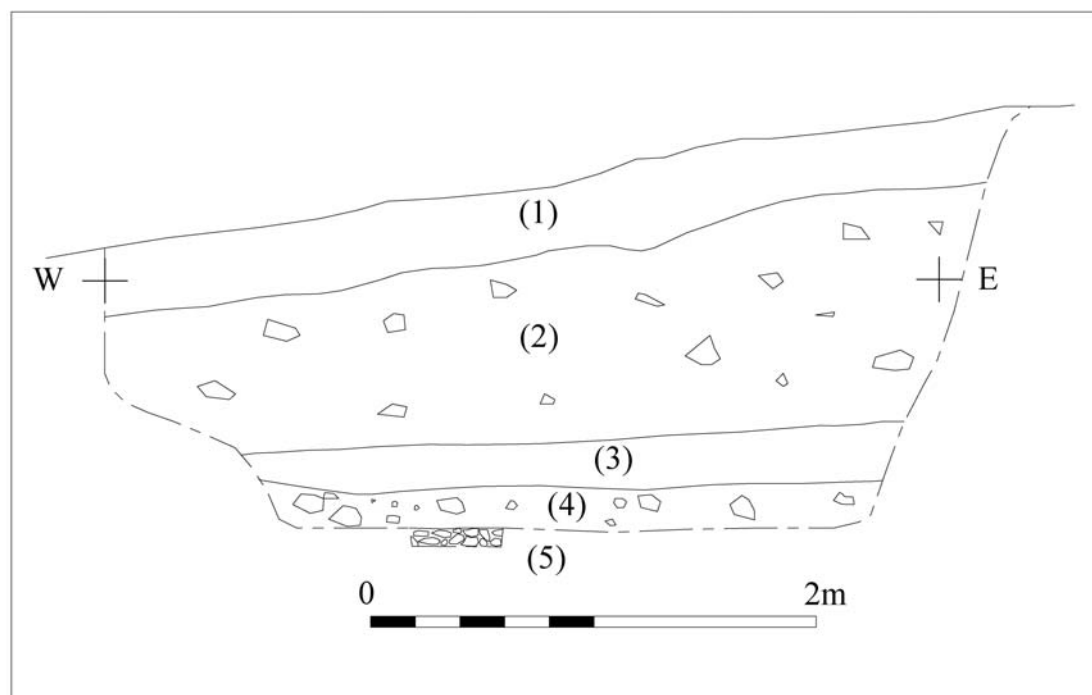
Figure 8 Section

The four bore holes confirmed the relatively simple stratigraphy seen in the trench. Layer (5) continued down to a dirty clay silt layer which was on top of the clay/marl natural substratum at between 3.5 and 4.1m below current ground level, dependent upon the borehole position on the bank.
