**A Programme of Archaeological
Attendance, Inspection and Recording
(watching brief) at
Holly Tree Farmhouse,
51 Bolton Lane, Hose
Leicestershire.**

ULAS Report No. 2013-075
©2013

A R Hyam

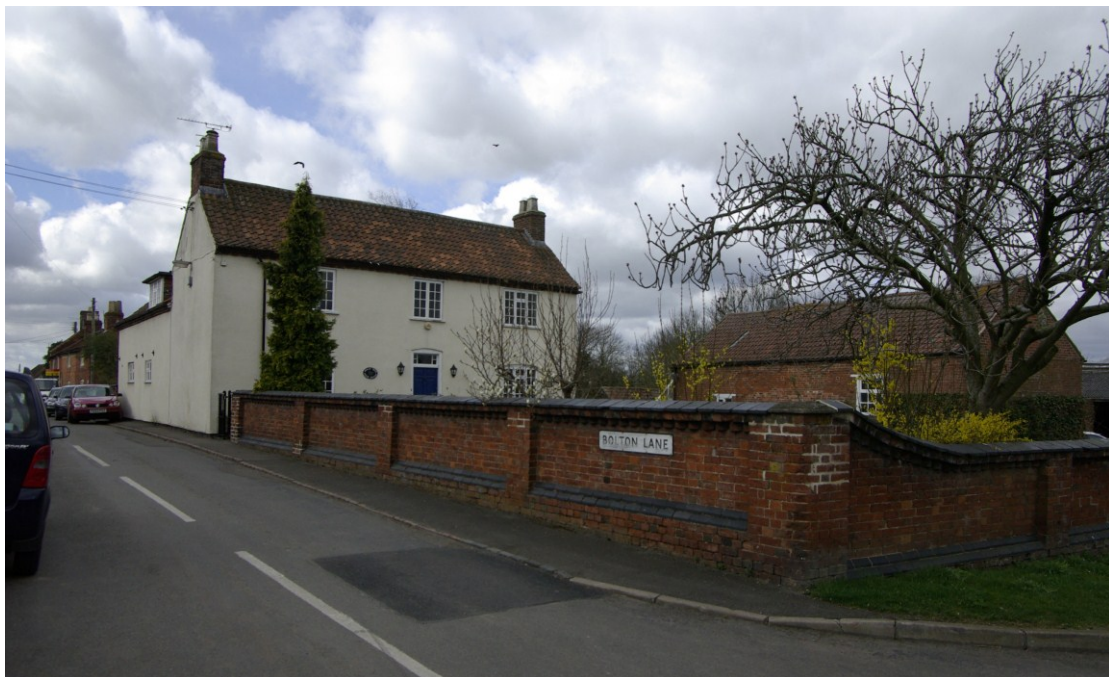
Figure 3 Holly Tree Farmhouse
Seen from the junction of Bolton Lane and Meadow Lane, looking south-west

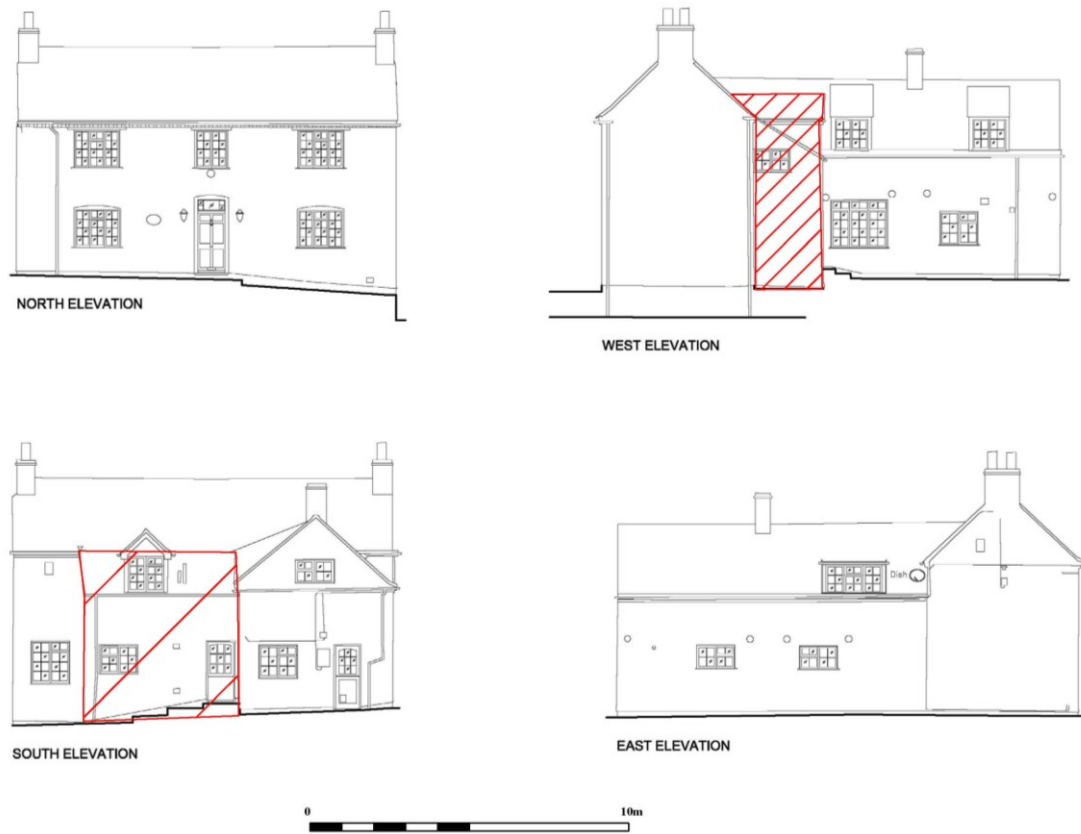
Figure 4 Existing elevations
Demolished extension highlighted in red.
Source: HSSP Architects/Mr and Mrs Cheetham

Prior to the watching brief a small two-storey extension, located within the angle created by the two ranges, had been demolished (Figs. 4 and 5). This will be replaced by a much larger extension extending out from the north-east facing elevation of the single storey range. It is intended that the existing staircase will be removed and re-sited in the new extension. The development work also entails underpinning of the remaining structures, modification of the single storey range roof and ground reduction over the proposed footprint of the new extension.

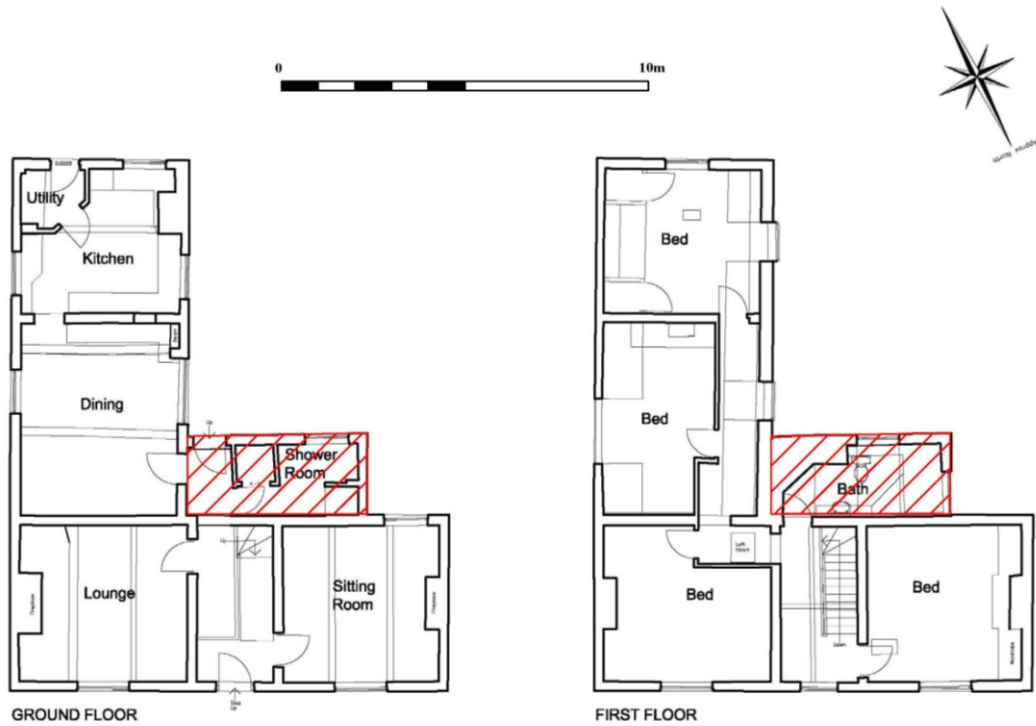
Figure 5 Existing plans
Demolished extension highlighted in red.
Source: HSSP Architects/Mr and Mrs Cheetham

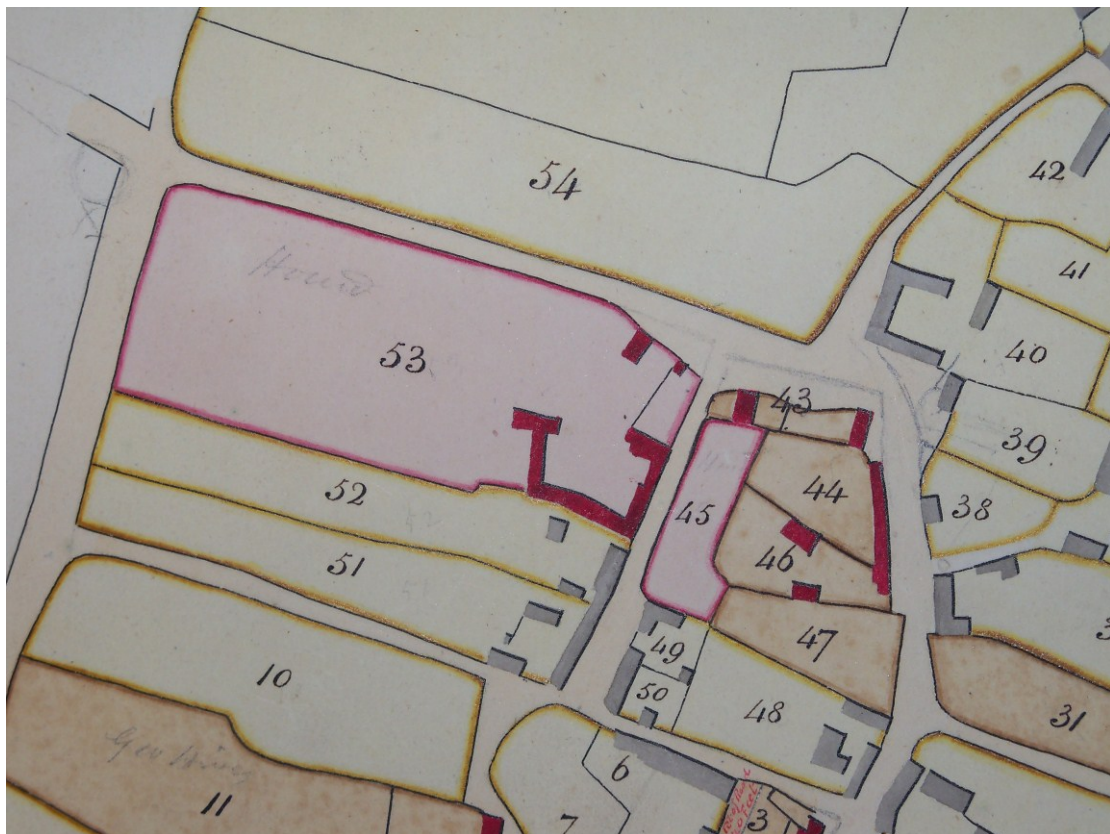
Figure 6 Detail from William King survey 1797
Source: Belvoir Castle Estate Archives/Mr and Mrs Cheetham

from 1797 when William King carried out a complete village survey (Fig. 6). At that time the farmhouse had the same recognisable footprint as now but a long range of buildings extended from the south-west facing gable end of the single storey range. The set of buildings appears to form an early courtyard style farm.

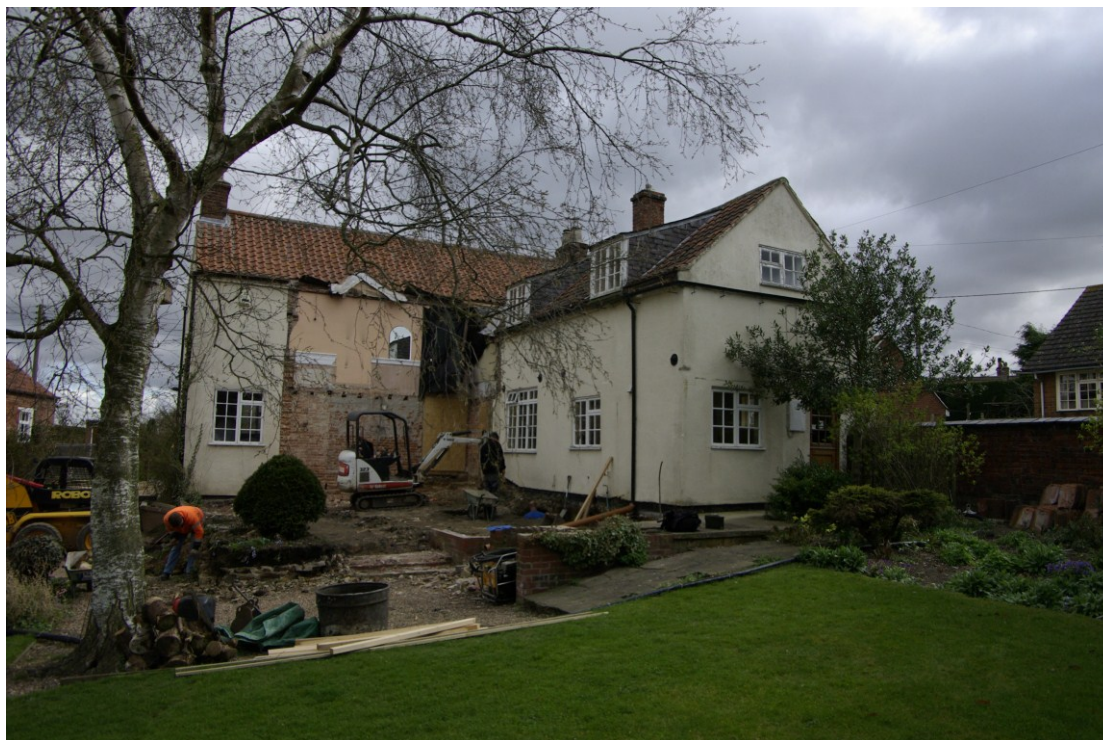
At the time of the watching brief the existing extension had been removed along with the patio surface (Fig. 7). The removal of the patio and other modern disturbance had reduced the site level to that required by the proposed extension. Underpinning was also taking place under the single storey range.

Figure 7 General view of alterations during watching brief
Looking north-east

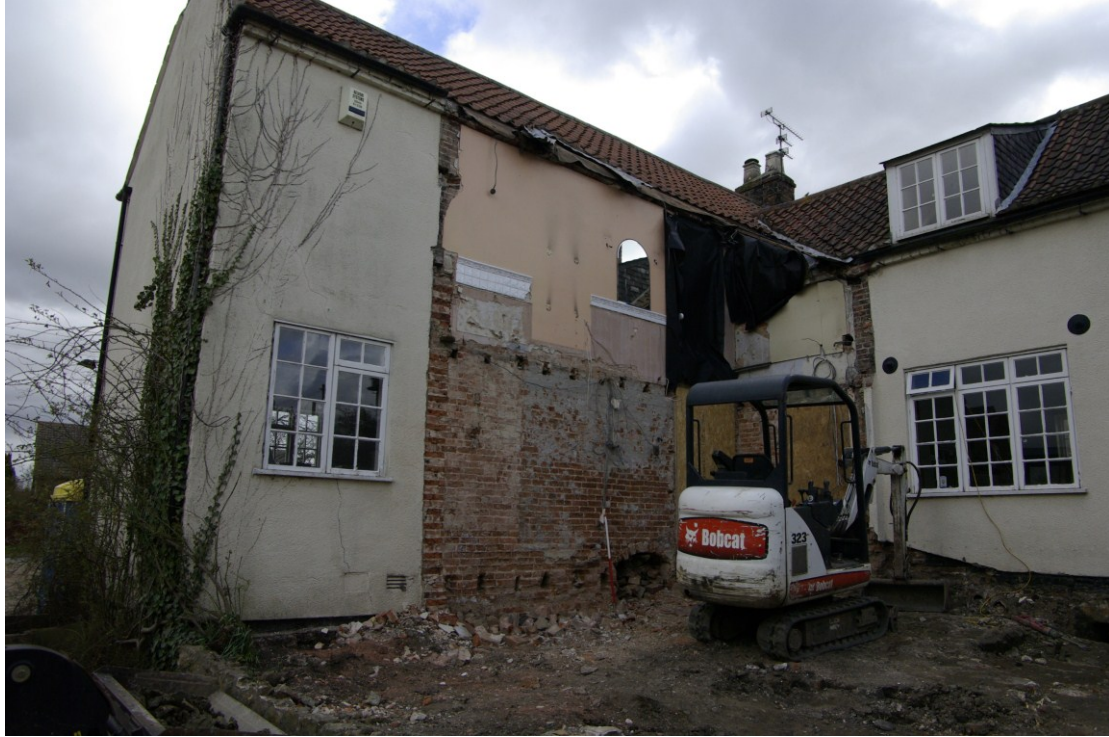
Removal of the two-storey extension revealed it to be made up of two distinct phases; the ground floor and first floor. The ground floor was brick-built using the same thin red bricks as the farmhouse and had been keyed into both the north-west to south-east range and the north-east to south-west range. The first floor, which had been used as a bathroom, appears to have been made of modern materials and was not keyed into the farmhouse walls (Fig. 8). Internal access to this extension was from a doorway in the angle of the two ranges at ground floor level and through a knocked through doorway at first floor level. Access to the outside was through a single width door on the south-west facing elevation of the extension. The south-west facing elevation of the main farmhouse showed evidence of holes for floor and ceiling joists which appear to be part of the original farmhouse design. The foundation wall of the extension was still in situ and was seen to be surrounding a backfilled brick-lined cellar. The double thickness cellar wall was built using the same sized bricks as in the farmhouse walls. The cellar was full of broken bricks, pan tiles and other building material which may belong to the original extension roof which was removed when it was extended to become a two storey structure. Measurement of a sample assortment of the backfilled bricks indicated that they were of similar size to those used on the main farmhouse. As the new extension floor will span the area of the cellar it is not intended to empty it as part of the redevelopment plan. The head of an arch leading out of the farmhouse, below the present staircase, could be seen at the base of the south-west facing

Figure 8 Demolished extension
Looking north-east.

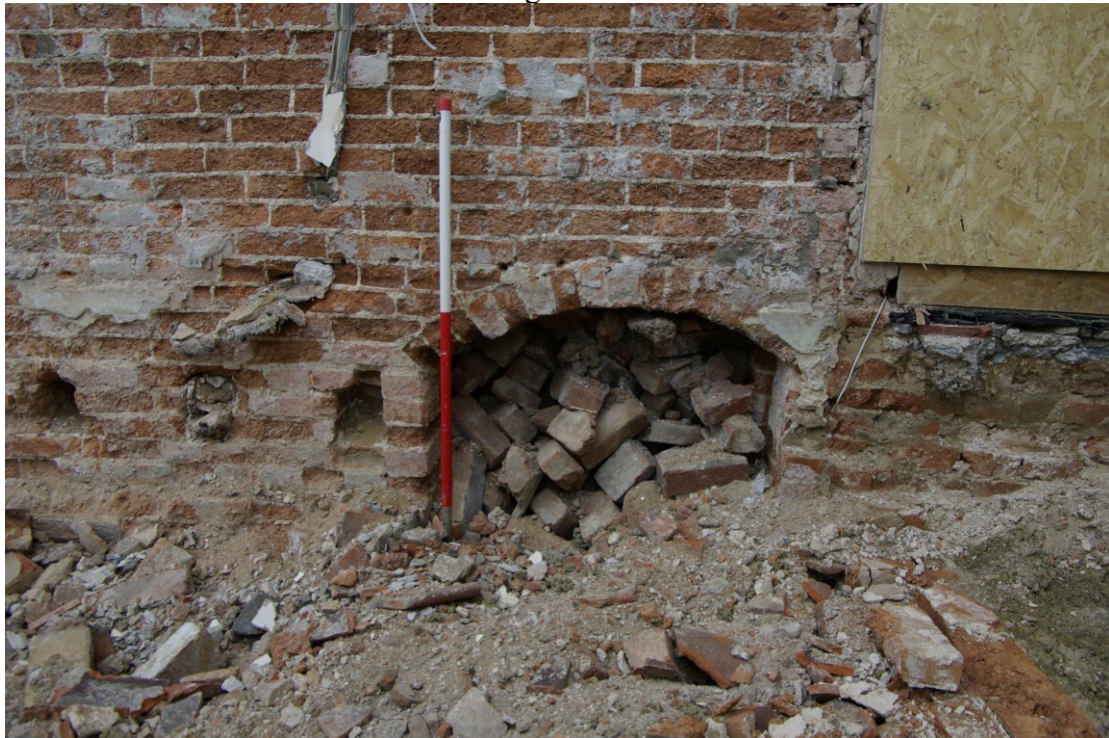
elevation (Fig. 9). There is no evidence of this arch on the other side of the wall in the hallway which has plaster covered walls. Probably to avoid undermining the north-east to south-west range, the cellar did not extend underneath the whole of the extension but only reached as far as the eastern side of the cellar doorway (Figs. 10 and 11).

Figure 9 Head of archway leading into cellar
Looking north-east

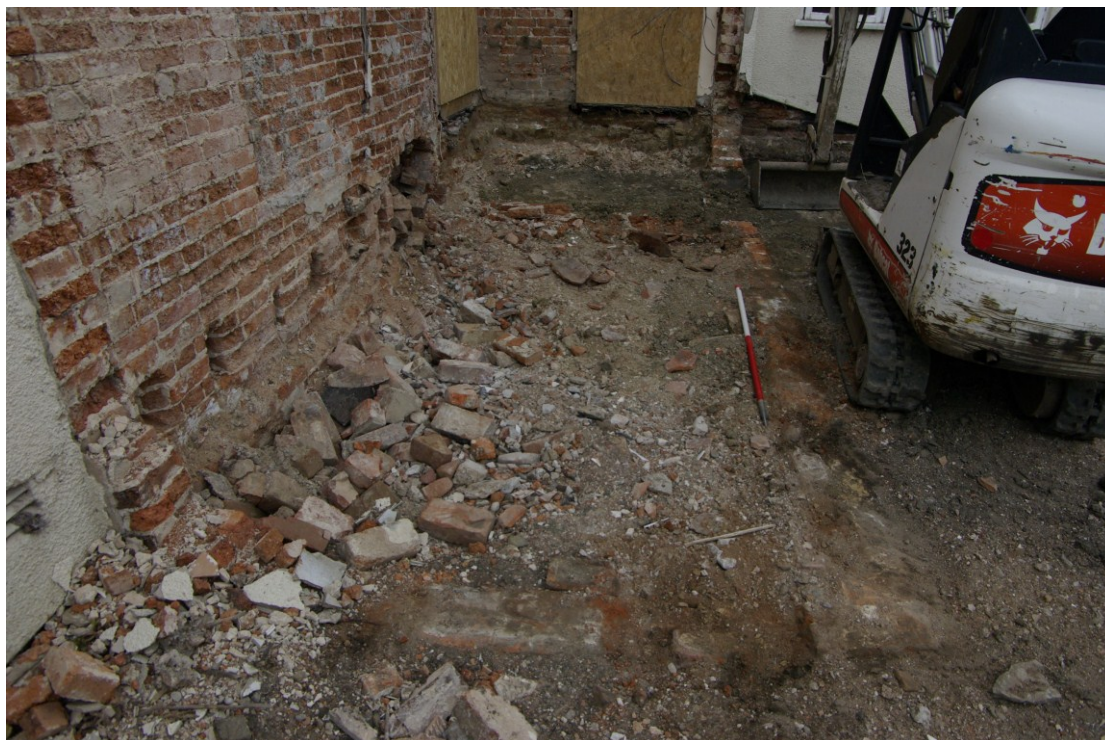
Figure 10 Limits of cellar
Looking east. 1m scale

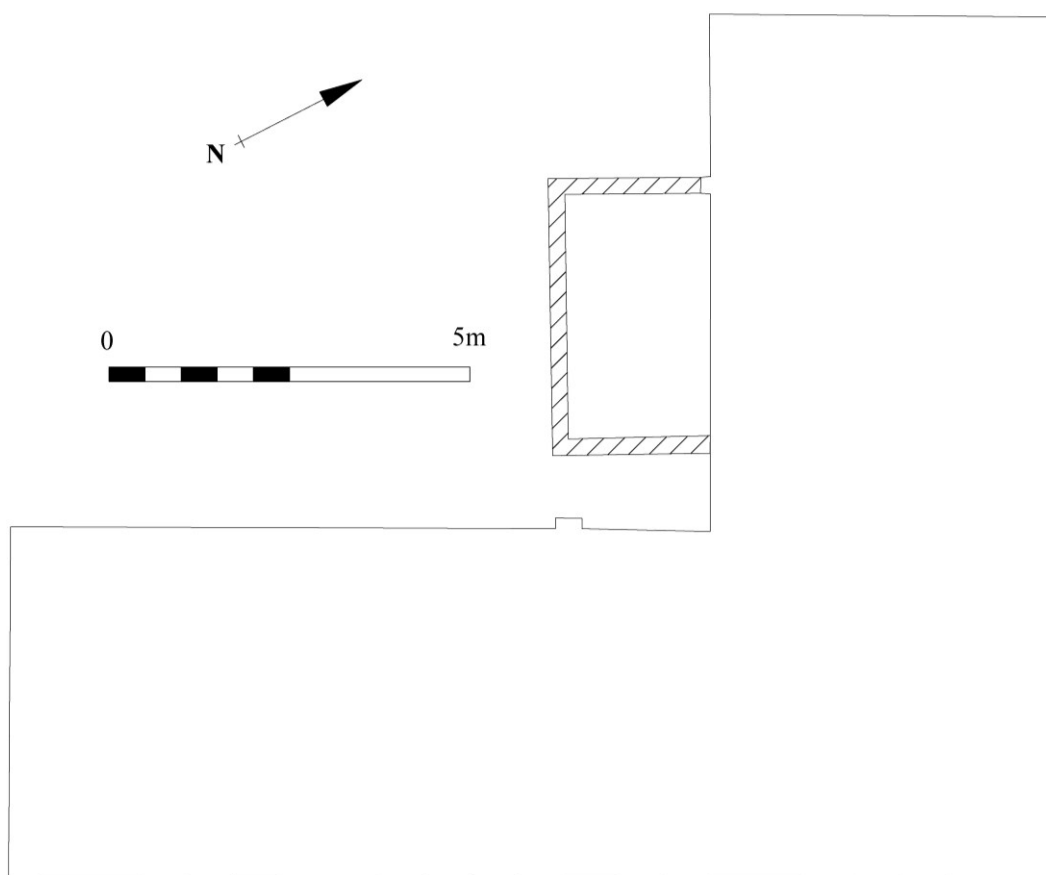
Figure 11 Footprint of cellar

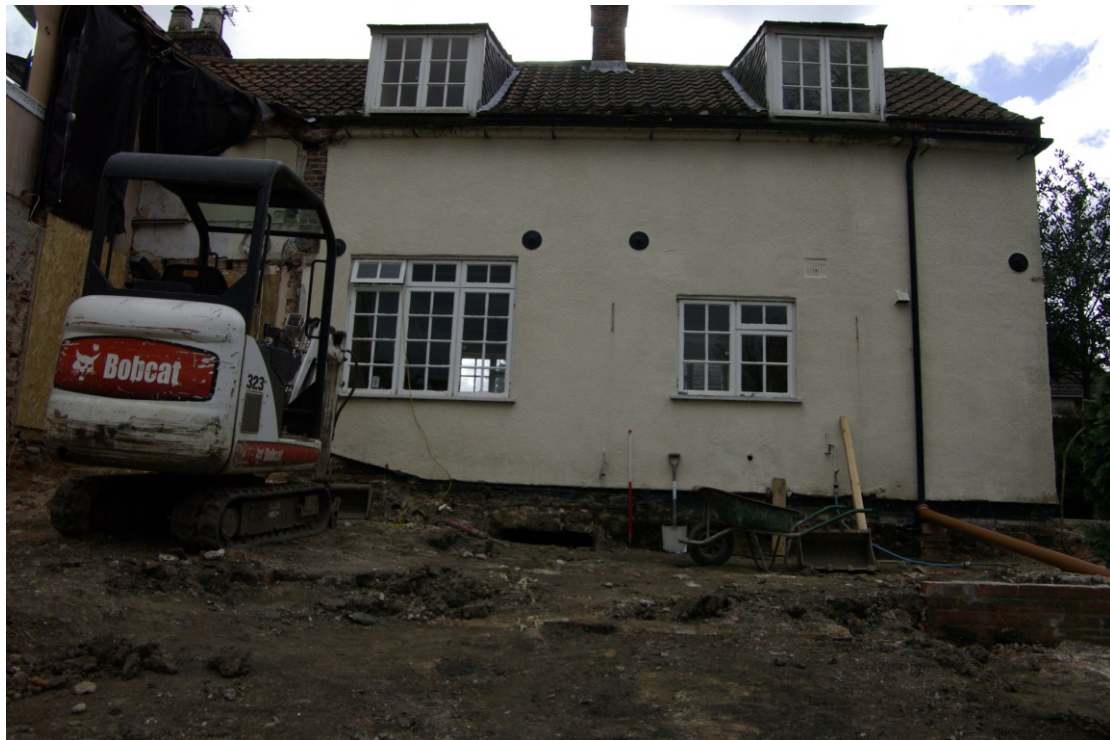
Parts of the single-storey north-east to south-west range are to be underpinned to support the new extension. At the time of the survey an approximately one metre wide hole had been excavated beneath the central part of the north-west facing elevation. The shallow foundations consist of one or two courses of ferruginous limestone only just set into the natural substratum (Figs 12 and 13). This wall will eventually form an internal wall within the redesigned house.

Figure 12 Underpinning of north-west facing elevation
Looking south-east. 1m scale

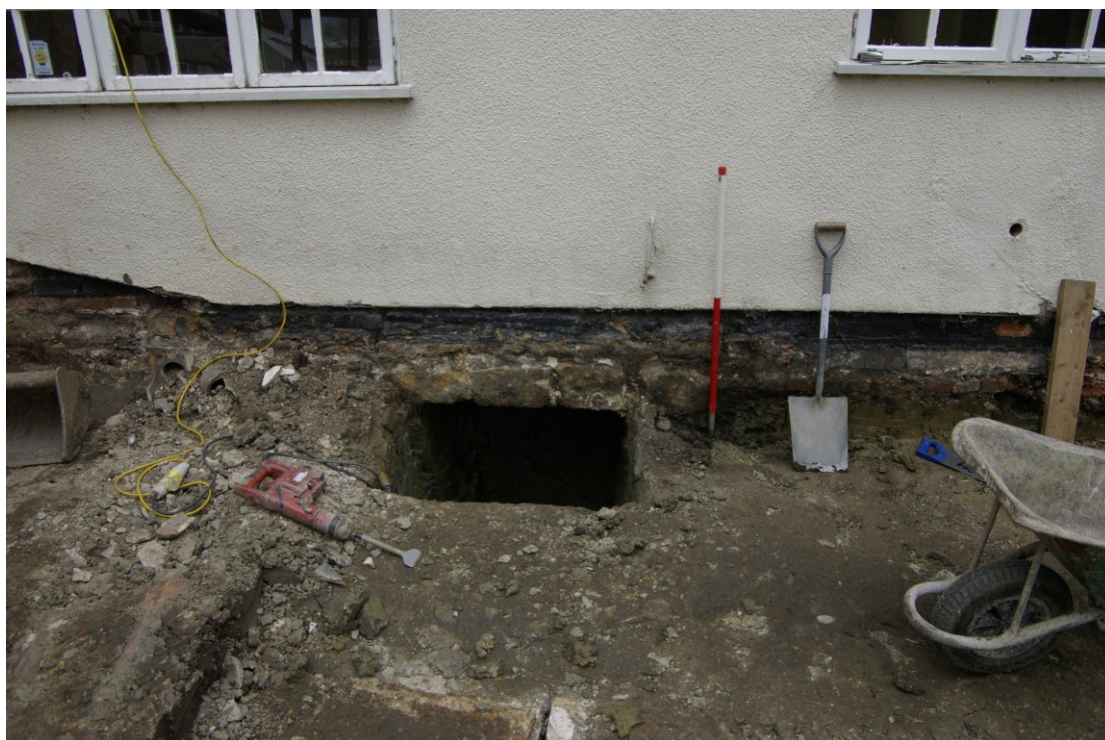
Figure 13 Underpinning close-up
Looking south-east. 1m scale

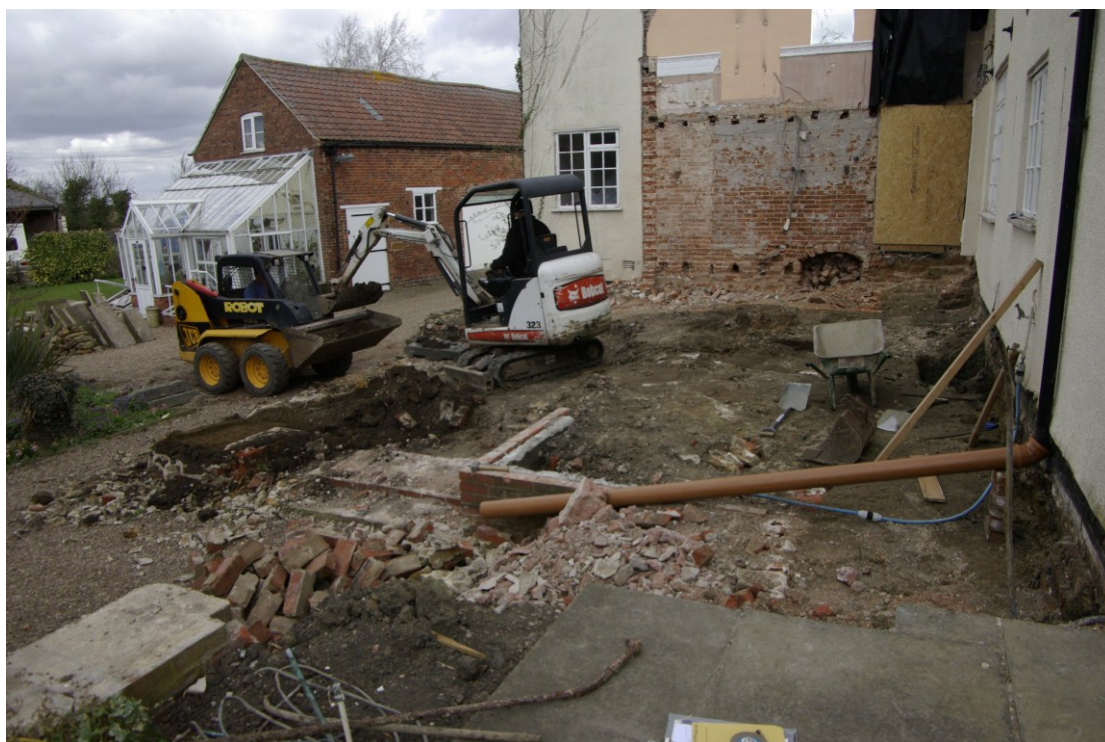
As noted above, much of the area within the corner angle of the two ranges appears to have been quite heavily landscaped, possibly when the garden was created after the demolition of some of the outbuildings. Removal of the modern surface and low retaining brick walls exposed a disturbed layer of topsoil and dark grey brown clay silt which covered the natural substratum (Fig. 14). The natural substrata consisted of a firm dark grey brown clay into which no archaeological features or deposits appeared to cut.

Figure 14 Yard, patio area
Looking north
