**An Archaeological Field Investigation
on the site of the former
North Derbyshire Tertiary College,
Rectory Road,
Clowne,
Derbyshire**

ULAS Report No. 2012-152
©2012

For: Bellway Homes East Midlands Limited

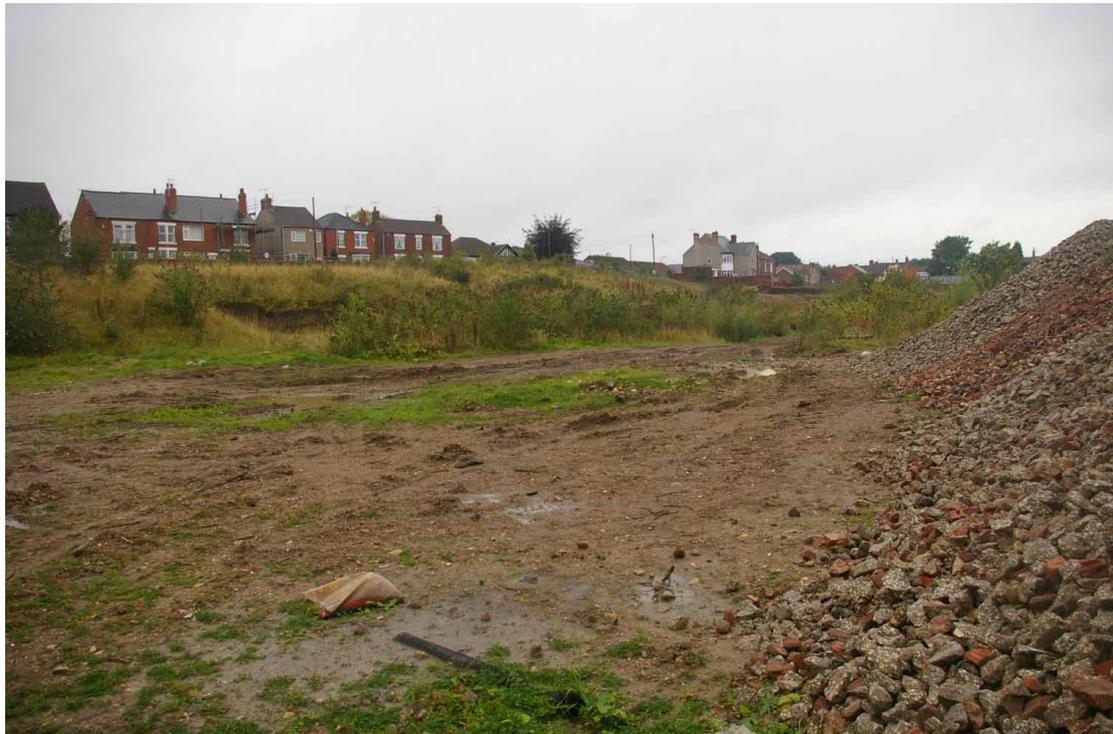
Figure 3. General view of site looking south-west

side of the railway which divides the settlement on an east to west axis (Fig. 1). The development site is roughly rectangular and lies at the bottom of a shallow valley with the ground rising towards the northern and southern borders (Figs. 2, 3 and 4). Rectory Road runs along the northern and eastern boundaries of the site, Church Street forms its southern boundary and a number of other properties run along the western side. Although not very clear it would appear that both Rectory Road and Church Street are present on the First Series 1840 Ordnance Survey map (Sheet 82). The culverted Millswood Brook runs from west to east across the centre of the site although this is not visible above ground. As noted in the WSI the site has until recently been occupied by a number of buildings belonging to the North Derbyshire Tertiary College, most of which have now been demolished leaving a number of large spoil heaps across the site (Fig. 5). Before the construction of the Tertiary College buildings the site underwent a gradual process of development culminating into three separate and distinct schools and a cinema.

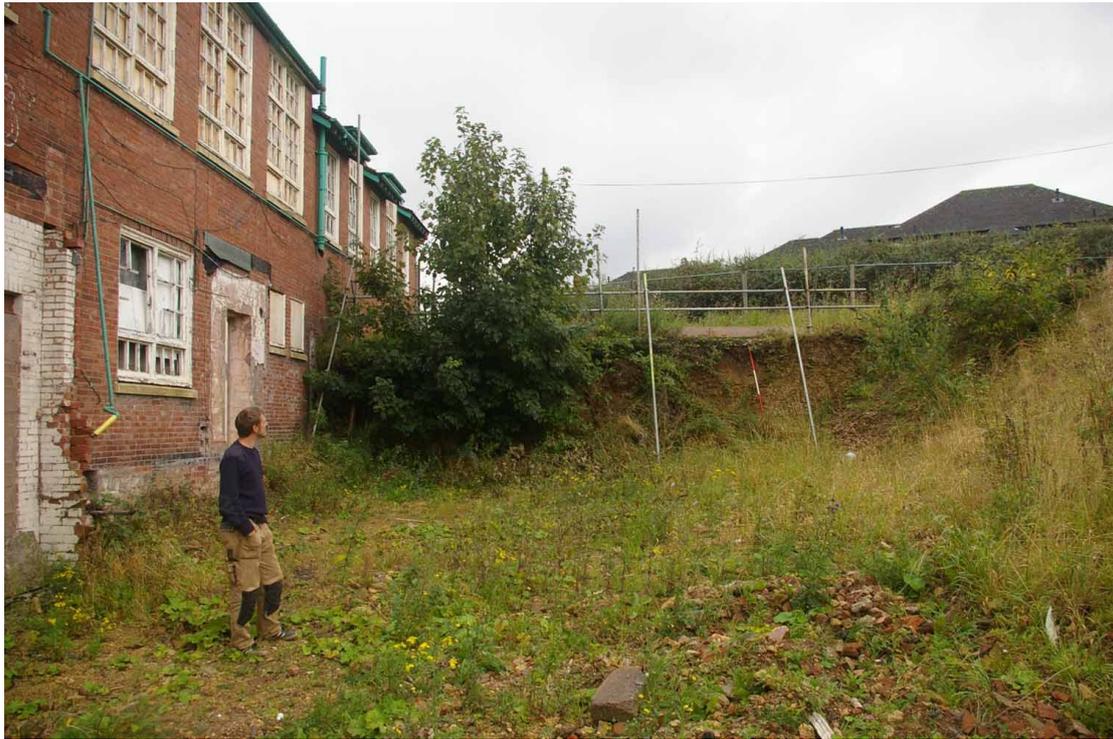
Figure 6. Evidence of reduced ground level in south-east corner of the site.
Looking south. 2m scale

It would appear that the construction of the Tertiary College buildings involved a significant amount of landscaping to create a large flat central area to the site leaving a narrow raised border of land along Rectory Road and Church Street. Evidence of this can be seen in an exposed cliff face of limestone bedrock seen in the south-east corner of the site (Fig. 6). This suggests that at this point, at least, the ground has been reduced in height by over 2m.

The southern area of potentially undamaged natural substratum is very narrow but could be up to 90m in length. It runs along the edge of the site and is tucked between this and a large demolished building. In places this finger of natural may be no more than two or three metres wide but towards the south-west could be up to a maximum of ten or eleven metres. The exposed cliff face, visible in Figure 6, in the south-eastern corner of the site shows that at this point more than two metres of ground had been removed.

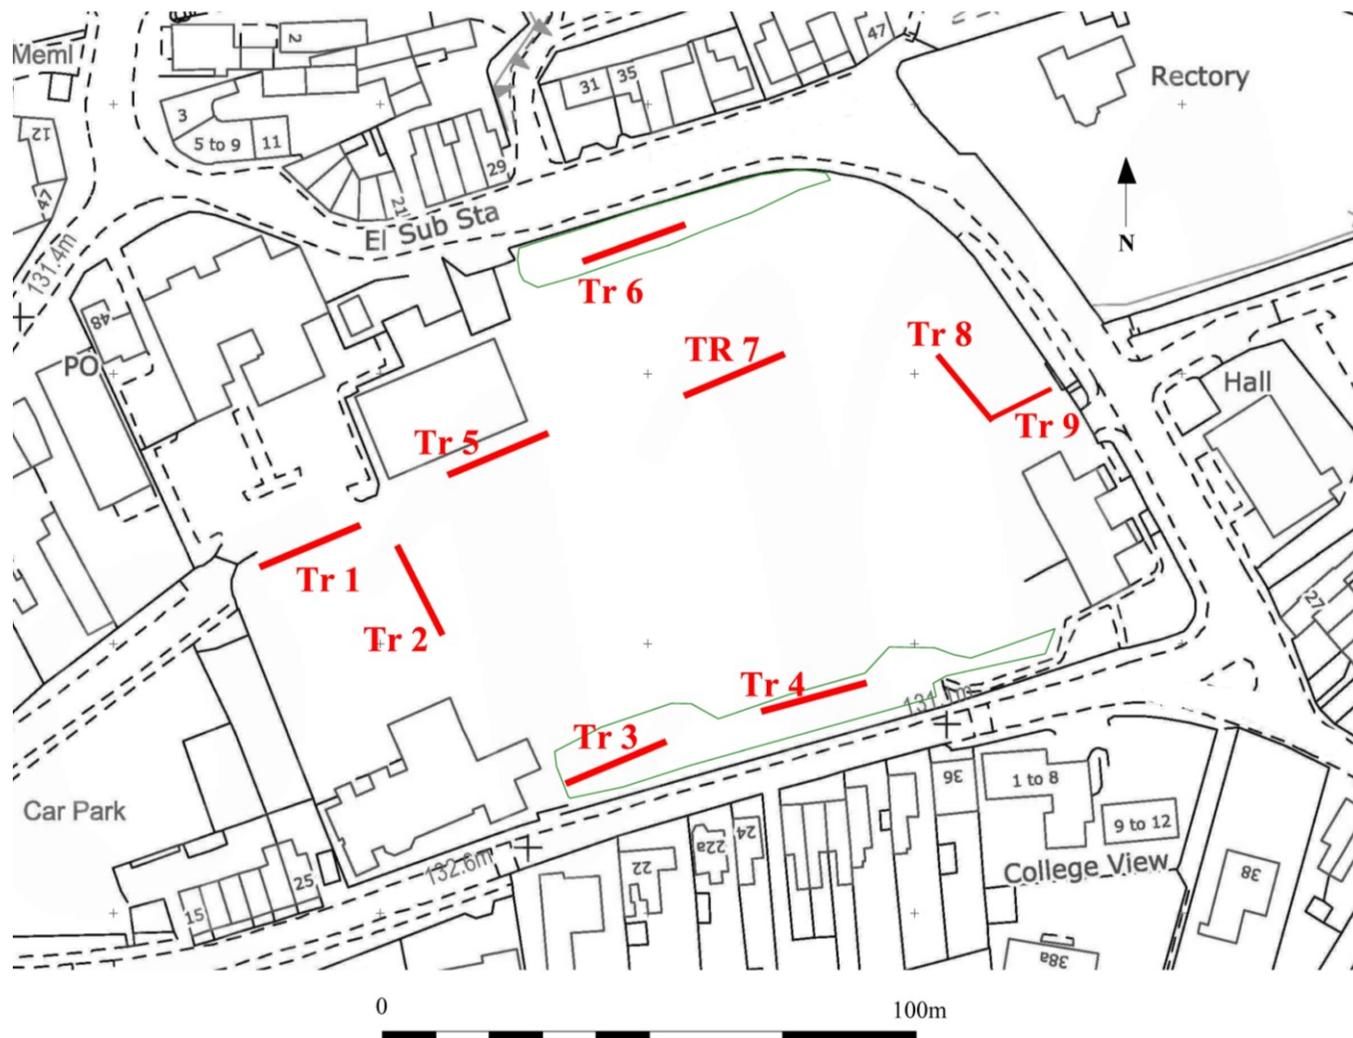
Figure 7. Trench locations
The green lines indicate where there is a possibility of surviving undisturbed natural substrata.

Nine 20m long by 1.8m wide trenches were proposed and located to target areas which may not have been disturbed by modern building work and services. Due to the presence of the culverted brook and apparently live sewers and drains some of the trenches had to be moved slightly from that specified in the WSI (Fig. 7).

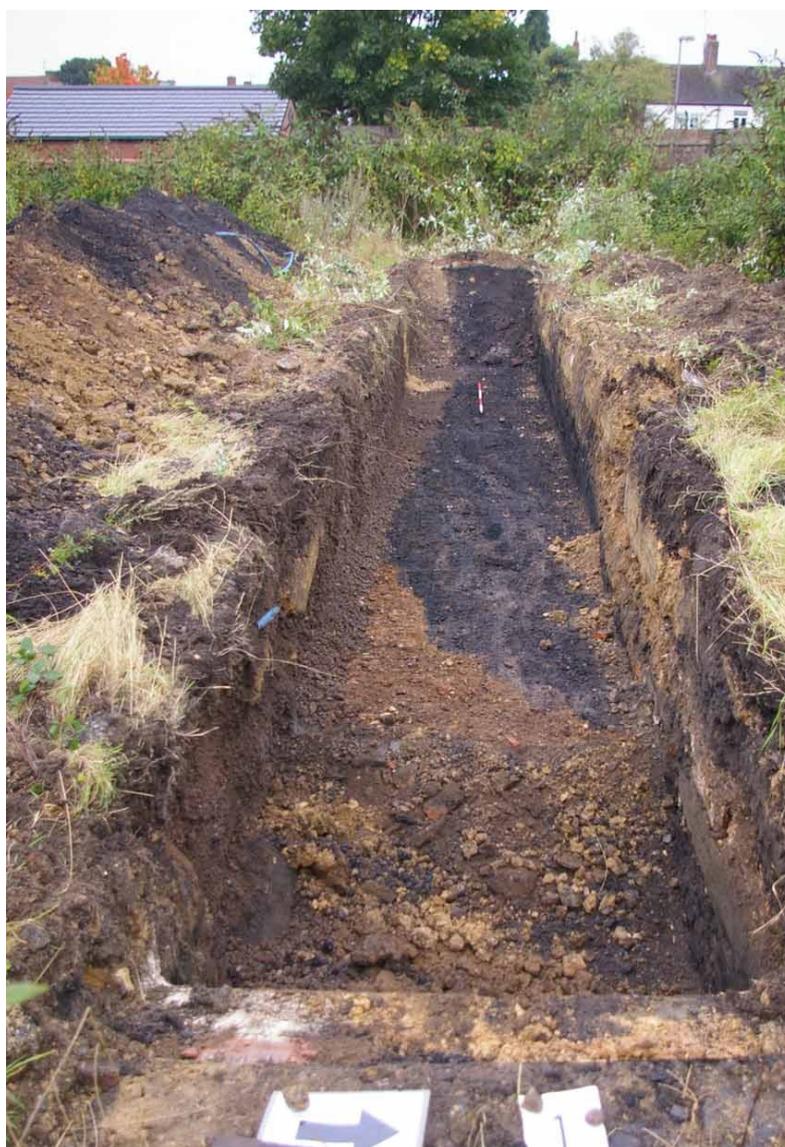
Figure 8. Trench 1
Looking west. 1m scale

Trench 1 was located in the north-west corner of the site to the south of one of the original school buildings. The trench had a maximum depth of 1.7m with numerous layers of modern building rubble down to, and including, the base of the trench. Later 20th century building materials and rubbish layers were located lying on top of late 19th or early 20th century coal ash, building material and rubbish deposits including a number of bottles (Fig. 8). One bottle bore the trademark of Henry Powell of Clumber Street, Mansfield and appears to date to around 1915. The trench edges were extremely loose and were collapsing during excavation and subsequent recording. Stepping or sloping the sides of the trench was not an option due to the proximity of a parallel foul sewer. The natural substratum was not reached and the trench was immediately backfilled following recording. No archaeological features or deposits were present in this trench.

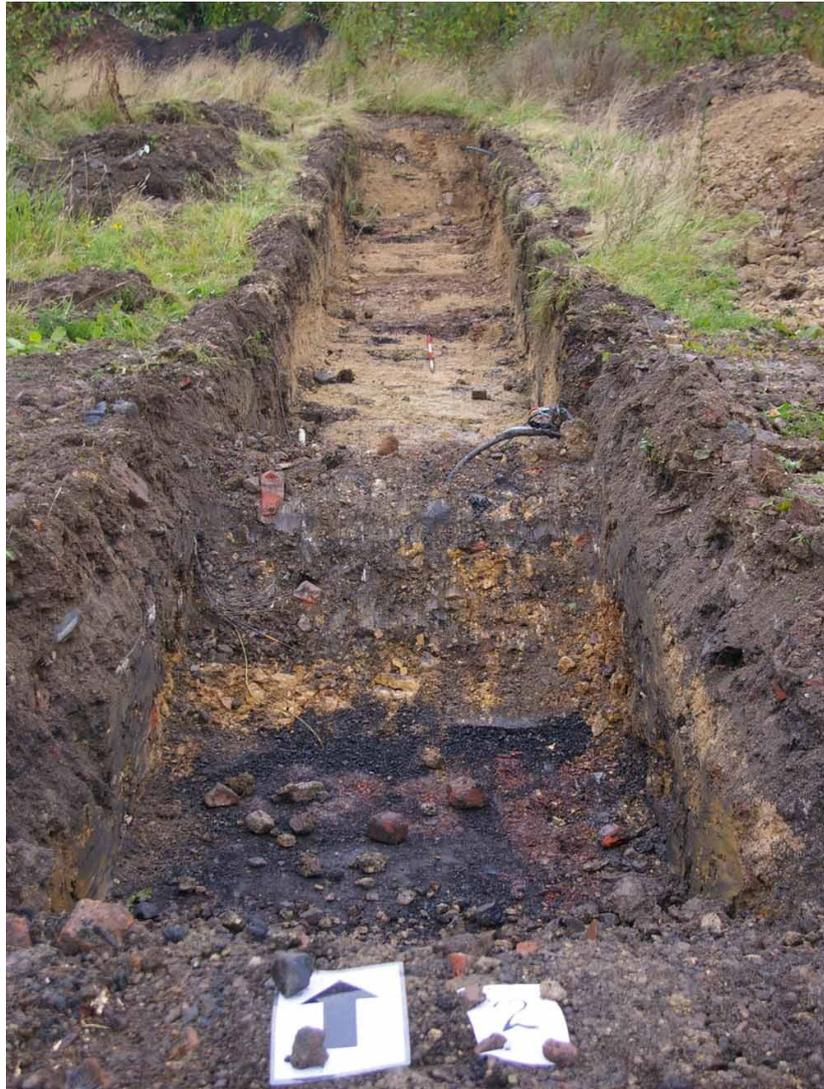
Figure 9. Trench 2
Looking north. 2m scale

Trench 2 was placed at a right angle to the eastern end of Trench 1 and had a maximum depth of 1.6m. Modern (mid/late 20th century) building rubble and loose limestone mill waste was observed from the current ground level down to and beyond the base of the trench (Fig. 9). An adjacent parallel sewer and a demolished building again prevented stepping or sloping the sides.

No archaeological features or deposits were present in this trench.

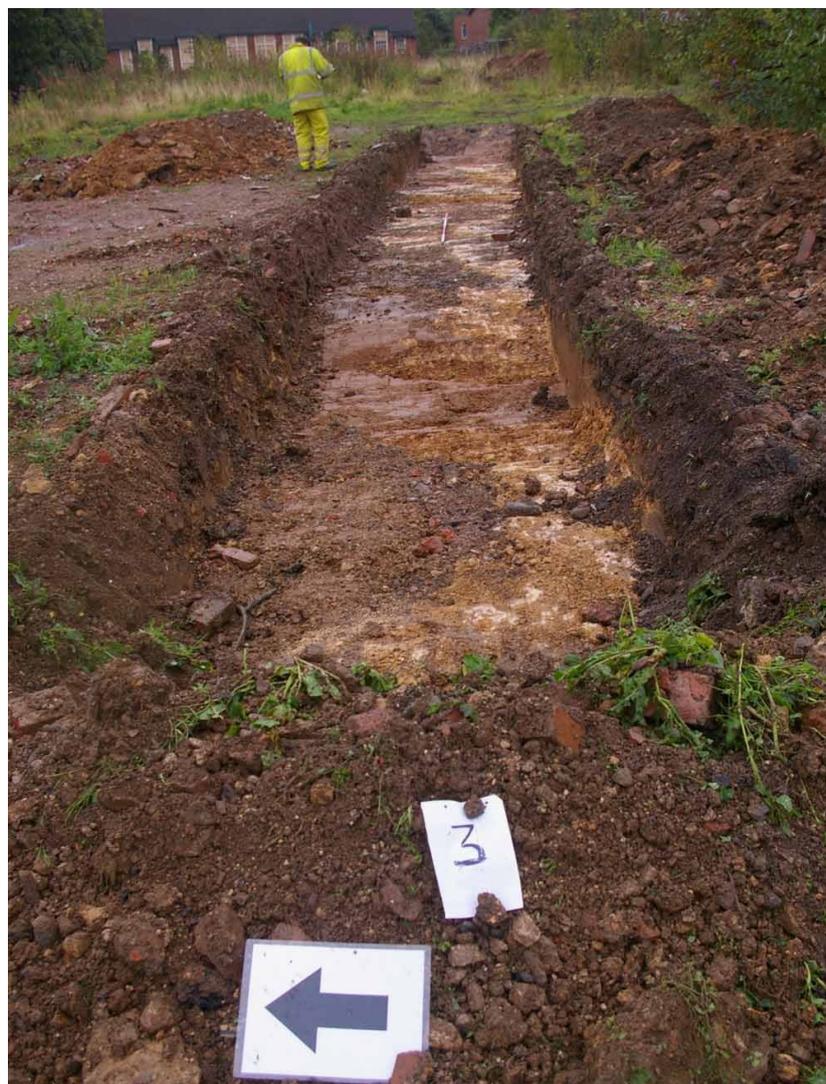
Figure 10. Trench 3
Looking east. 2m scale

This trench was one of two placed alongside Church Street at the highest part of the proposed development site. The ground level can be seen to rise to the south following the natural slope of the land. A mid greyish brown silty loam topsoil extended from present ground level down to the top of the natural substratum without any apparent subsoil division being present for most of the trench length. Only a thin skim of mid orange brown clayish silty sand subsoil measuring approximately 10-15mm in depth was present at the eastern end. The natural substratum consisted of a yellowish cream coloured limestone which was undisturbed by any archaeological activity (Fig. 10). The trench had a maximum depth of 0.56m. A modern area of intrusion disturbed part of the west end of the trench.

No archaeological features or deposits were seen in this trench.

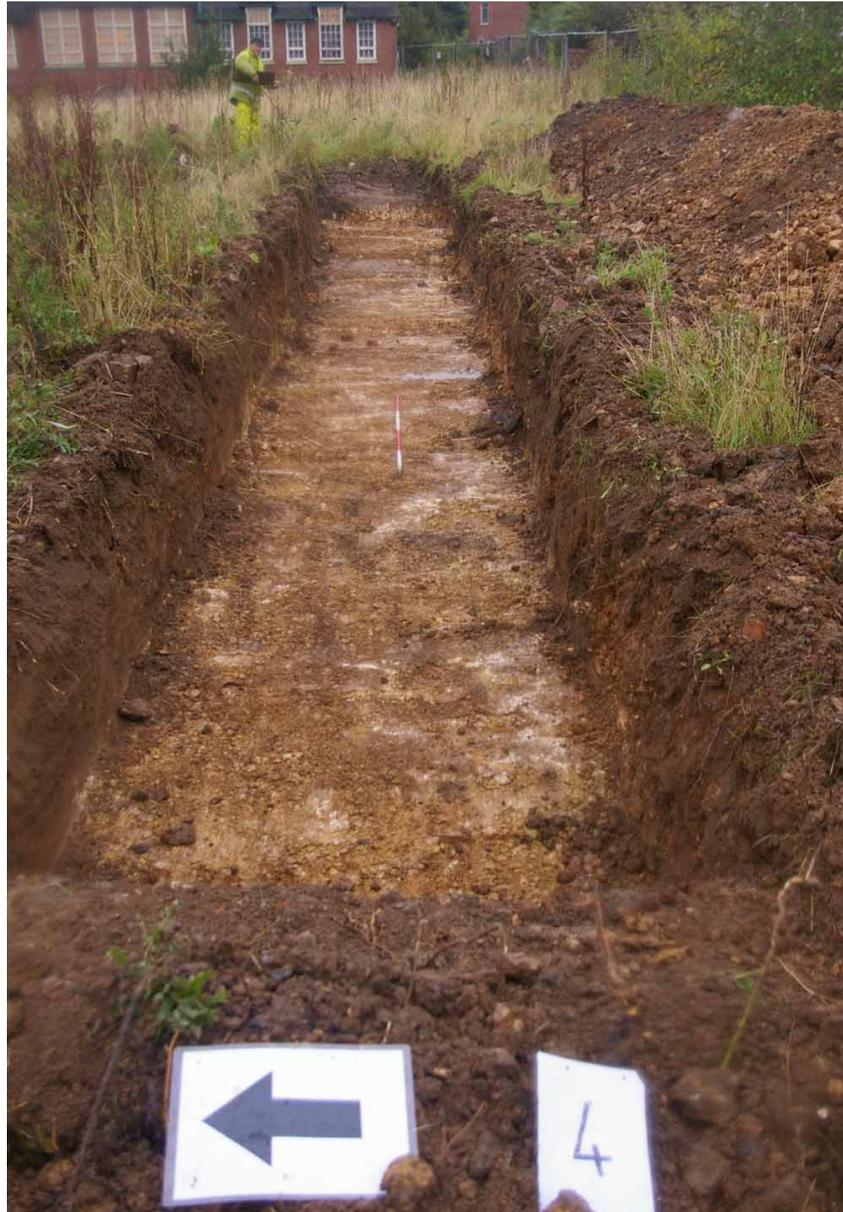
Figure 11. Trench 4
Looking east. 2m scale

Trench 4 was placed on the same area of higher ground as Trench 3 with similar results although a thin layer of subsoil survived to a maximum depth of 30mm across most of this trench. An undisturbed limestone natural substratum was exposed along the whole of the trench base after removal of the subsoil (Fig. 11). The trench had a maximum depth of 0.92m

No archaeological features or deposits were observed in this trench.

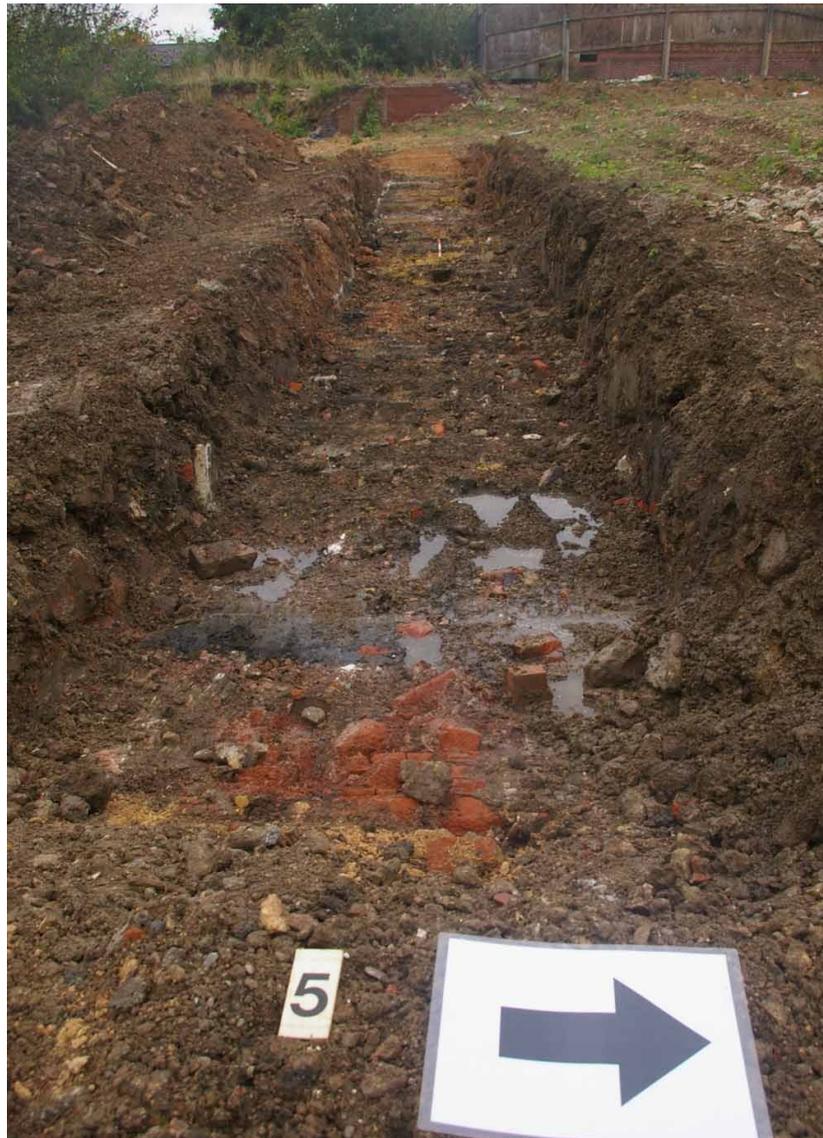
Figure 12. Trench 5
Looking west. 2m scale

This trench was placed between the foundations of a demolished building to the north and a probable drain or live culvert to the south. Highly compacted building rubble was present from the current ground level and concrete foundations were encountered at a shallow depth making it impossible to excavate the trench any deeper than 0.89m at its maximum depth (Fig. 12). The natural substratum was not reached in the trench base.

No archaeological features or deposits were present in this trench.

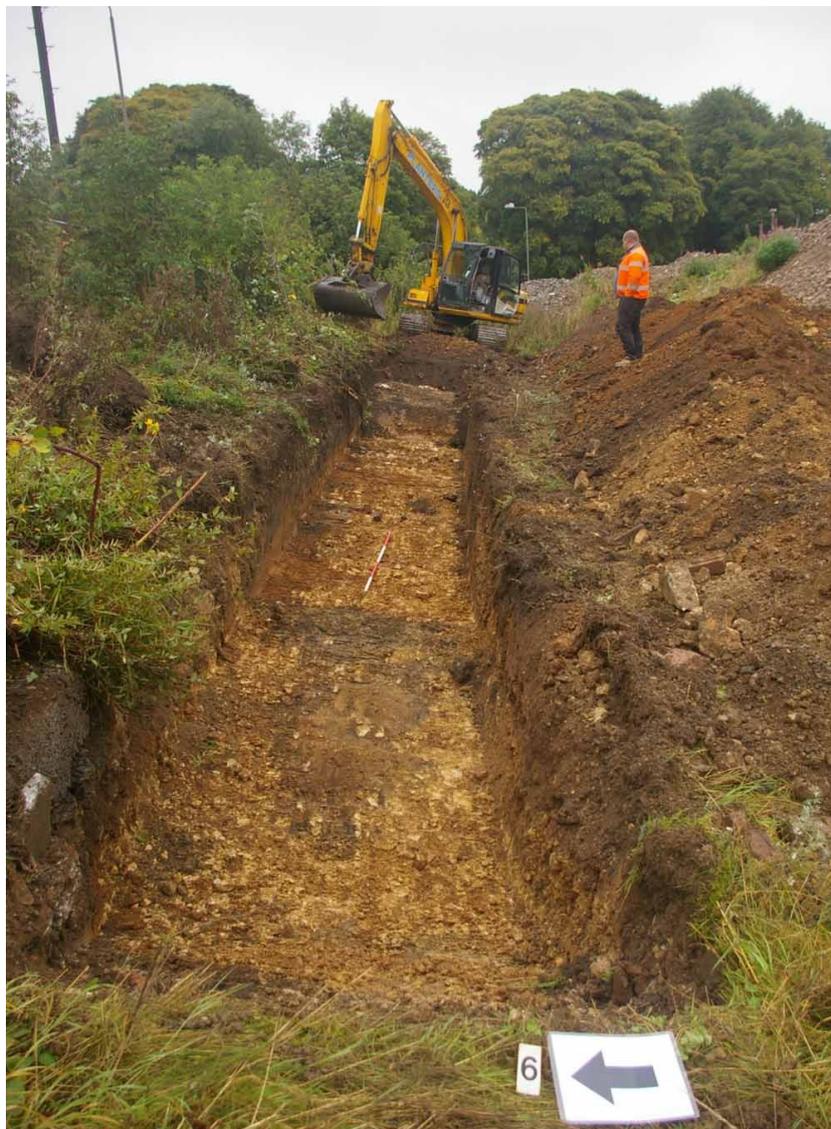
Figure 13. Trench 6
Looking east. 2m scale

Trench 6 was excavated along the northern boundary of the site parallel to Rectory Road. The ground at this point slopes down quite sharply from the road towards a large spoil heap filling most of this area. After removal of the undergrowth up to 1m of loose and disturbed made ground and topsoil were removed to reveal a layer of dark brownish grey silty-sand topsoil between 0.2m and 0.25m thick. Beneath this was a layer of mid orange brown clayish silty sand subsoil which was very similar to that seen in Trenches 3 and 4. The subsoil layer varied in thickness from 0.1m to 0.2m. Removal of the subsoil revealed an undisturbed, but fairly fragmentary, yellowish cream coloured limestone natural substratum (Fig. 13).

No archaeological features or deposits were present in this trench.

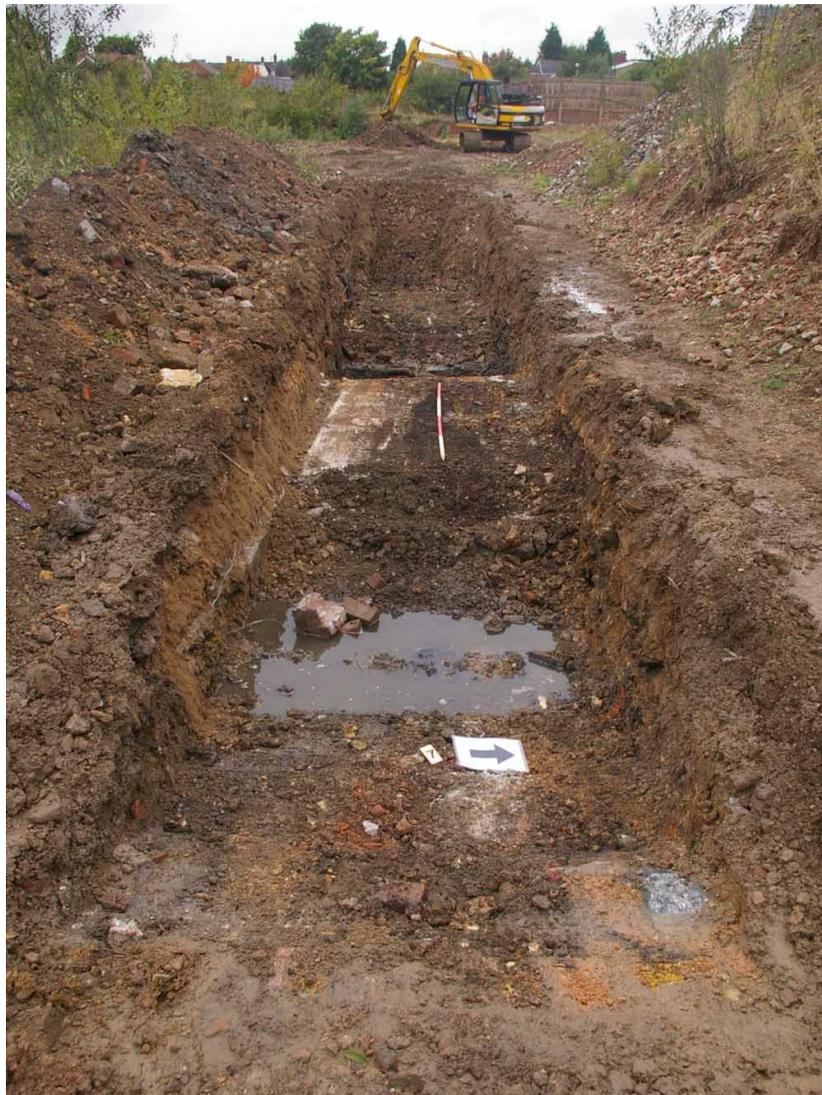
Figure 14. Trench 7
Looking west. 2m scale

Trench 7 was placed close to the centre of the site whilst avoiding the footprints of the demolished buildings. The ground was heavily disturbed and compacted layers of building rubble and debris were present down to a maximum depth of 1.4m below current ground level with no indication of the natural substratum. At one point towards the eastern end of the trench a solid concrete base was encountered which prevented excavation below 0.55m. Ground water conditions around this trench meant that the base showed signs of filling with water so it was backfilled immediately after recording.

No archaeological features or deposits were present in this trench.

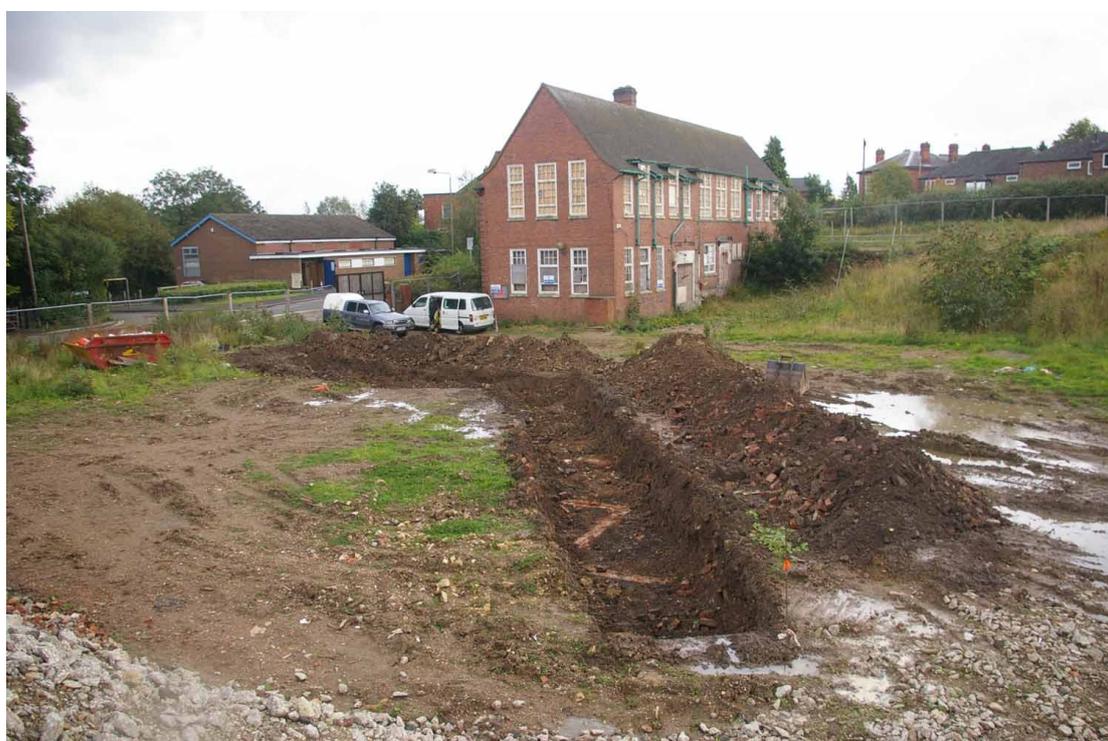
Figure 15. Trenches 8 and 9
Trench 8 in foreground, Trench 9 on left. Looking south-east

Due to a number of sewer pipes or culverts running across the proposed location of Trench 8 it was decided to move it to the east to avoid potential damage. This however did mean that the trench had to be placed within the footprint of a flat roofed building. As with Trench 7 a significant quantity of disturbed building rubble was present which extended down to the base of the trench and also between a number of L-shaped brick foundations running along the centre of the trench. The bricks appeared to be of late 20th century origin. The proximity of the sewer pipes again meant that stepping the trench was not possible and a maximum depth of 1.2m was reached. The natural substratum was not visible at this depth.

To achieve the maximum length possible Trench 9 formed an extension to Trench 8 at a right-angle to the east (Fig. 15). A similar mix of alternate loose and compacted building rubble as was present in Trench 8 was observed although there was no evidence of any brick structures.
