**An Historic Building Survey (Level 2)
of Gardens Cottage, Home Farm,
Rockingham Castle, Northamptonshire.**

NGR: SP 8689 9105

ULAS Report No. 2012-166
©2012

For: Corporate Architecture Limited

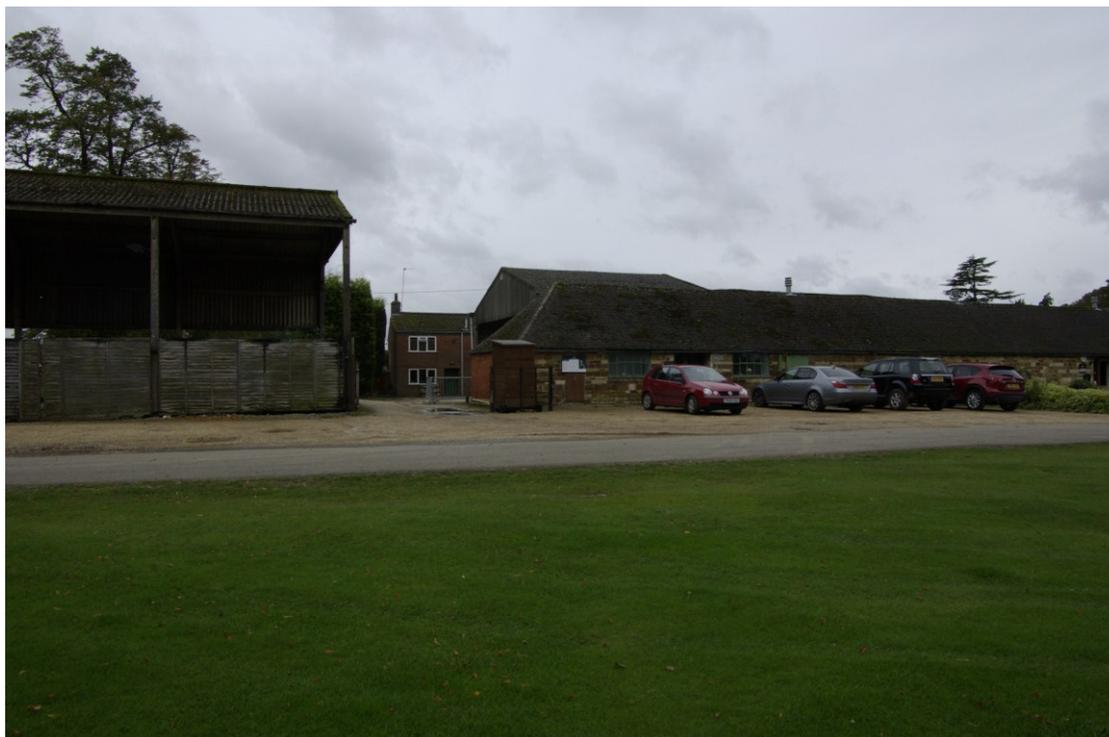
Figure 5. Gardens Cottage seen from the east
Looking south-west

The cottage, as noted, lies at the north-east corner of the walled garden which slopes downwards towards the south-west. The garden has a large tennis court near to the centre and is currently being remodelled to include a swimming pool close to the south-west of Gardens Cottage. Because of the slope the garden has evidence of a number of shallow terraces separated by linear paths. To the north-west are a number of ironstone built stables and cottages of early 19th century origin. To the north and north-east of the cottage are a modern, concrete-built, open barn and a number of other agricultural buildings (Fig. 5).

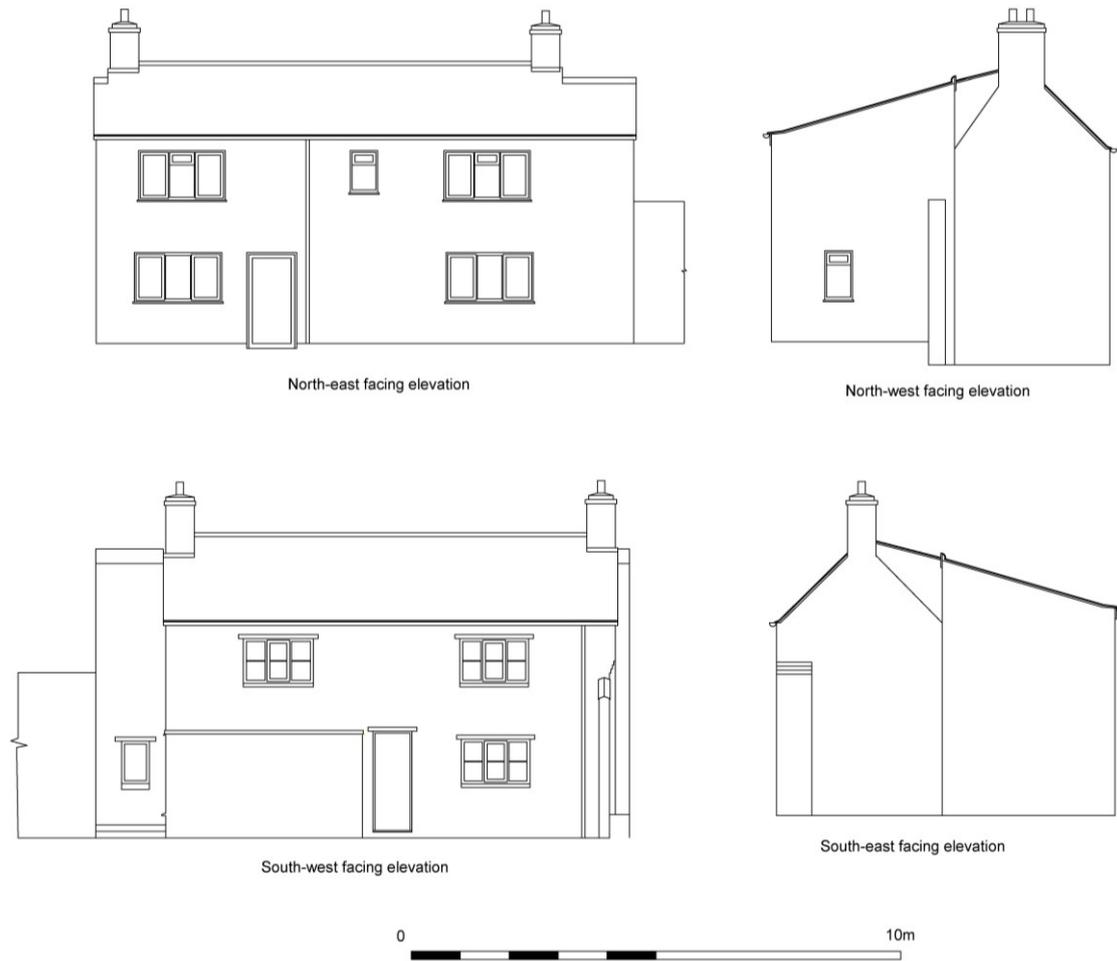
Figure 6. Elevations of Gardens Cottage.
Modified from Corporate Architecture Ltd drawing 3380.RC.12.004

Gardens Cottage is a two-storey brick-built house with gable ends to the north-west and south-east elevations. The roof has a shallow pitch on the north-east elevation and a steeper, shorter, pitch on the south-west side. Initial inspection clearly shows two main phases of construction with the northern half of the building being built of bricks which appear to date from the second half of the 20th century. The southern half of the building appears to have used an earlier 20th century brick. This is discussed in more detail below. Corporate Architecture Limited has produced a set of elevations and plans of the cottage and has designated names for each room which this survey has continued to use (Figs. 6 and 7).

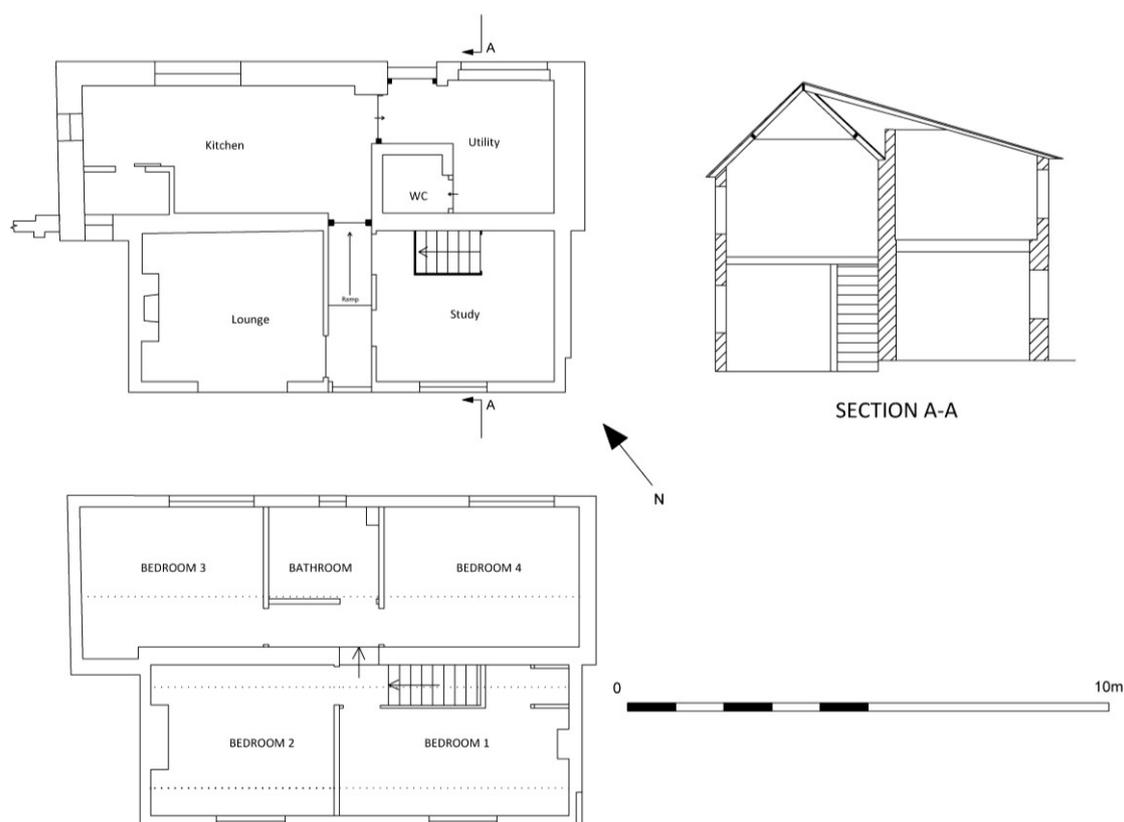
Figure 7. Plans of Gardens Cottage
Modified from Corporate Architecture Ltd drawing 3380.RC.12.002

As mentioned, the names of each room are those used in the original architectural drawings (see Fig. 7).

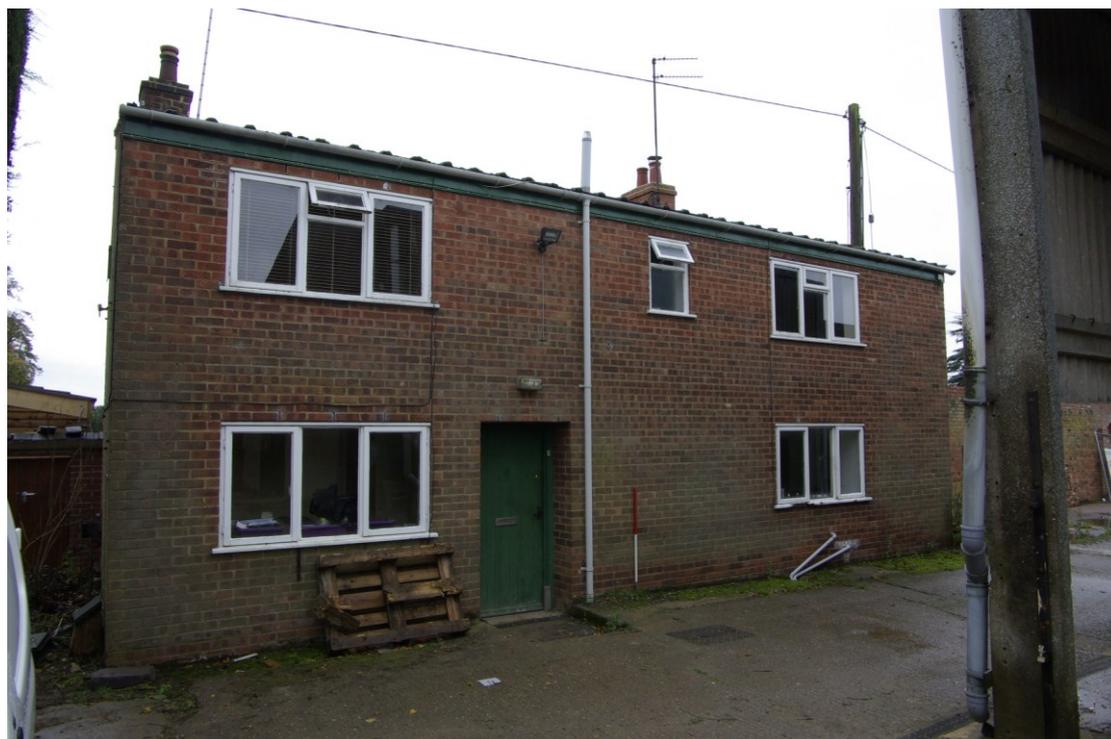
Figure 8. North-east facing elevation
Looking south-west. 1m scale

The north-east facing elevation faces towards the modern barn and is partially obscured by it. Dark purple-red bricks which appear to date to the later 20th century are laid in a stretcher bond on this elevation (Fig. 8). The bricks measure 215mm long by 64mm high by 104mm wide. Cement roof tiles which also date to the later 20th century cover the shallow (approximately 15° slope). The rainwater goods are all of grey plastic and are consistent with the age of the brickwork and roof. The windows are plain undecorated wooden framed with flat lintels which presumably hide RSJs. The deeply recessed front door is off-centre to match the internal room layout and is made from plain wooden boards. The chimney stacks set at each gable end are brick built and are of an early 20th century brick. There is no evidence of any blocked or modified openings on this elevation.

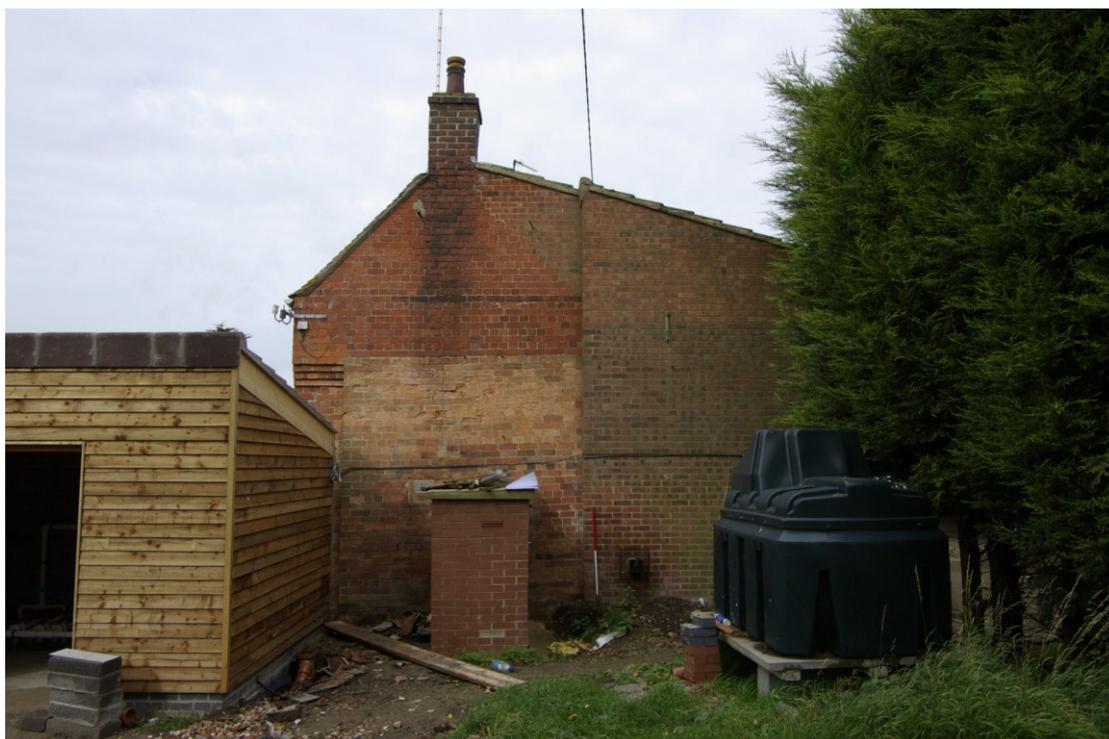
Figure 9. South-east facing elevation
Looking north-west. 1m scale

The division between the two types of brick can clearly be seen on this and on the north-west facing elevation (Fig 9). On the south side the bricks appear to date to the first half of the 20th century and are laid in an English bond in the gable end and halfway down the first floor level. The bricks measure 230mm long by 75mm high by 102mm wide. Below this the brickwork has been disturbed and is built in a partial English bond with courses of headers at random courses rather than alternating with courses of stretchers. This area also appears to have been previously covered by another structure and may relate to the building shown on the 1938 OS map in Figure 3. A recessed and corbelled corner at the top of ground floor level on the southern corner may also be associated with this now removed structure.

The northern half of this elevation is built from the same later 20th century bricks as found on the north-east facing elevation. There are no apparent modifications to this part of the wall although the upper courses are of a slightly redder brick than on the lower courses. This portion of the building steps out from the southern half by 0.29m. The gable end between the two building phases has been filled in with modern brickwork to continue the new and shallow roofline of the northern half of the building. As noted, the chimney stack dates to the earlier phase of building.

The garden wall extended from the southern corner of the elevation although part of this has been temporarily removed for rebuilding due to stability issues. The heights of the cottage brickwork courses do not quite match those of the garden wall although some attempt has been made to key the two structures together.

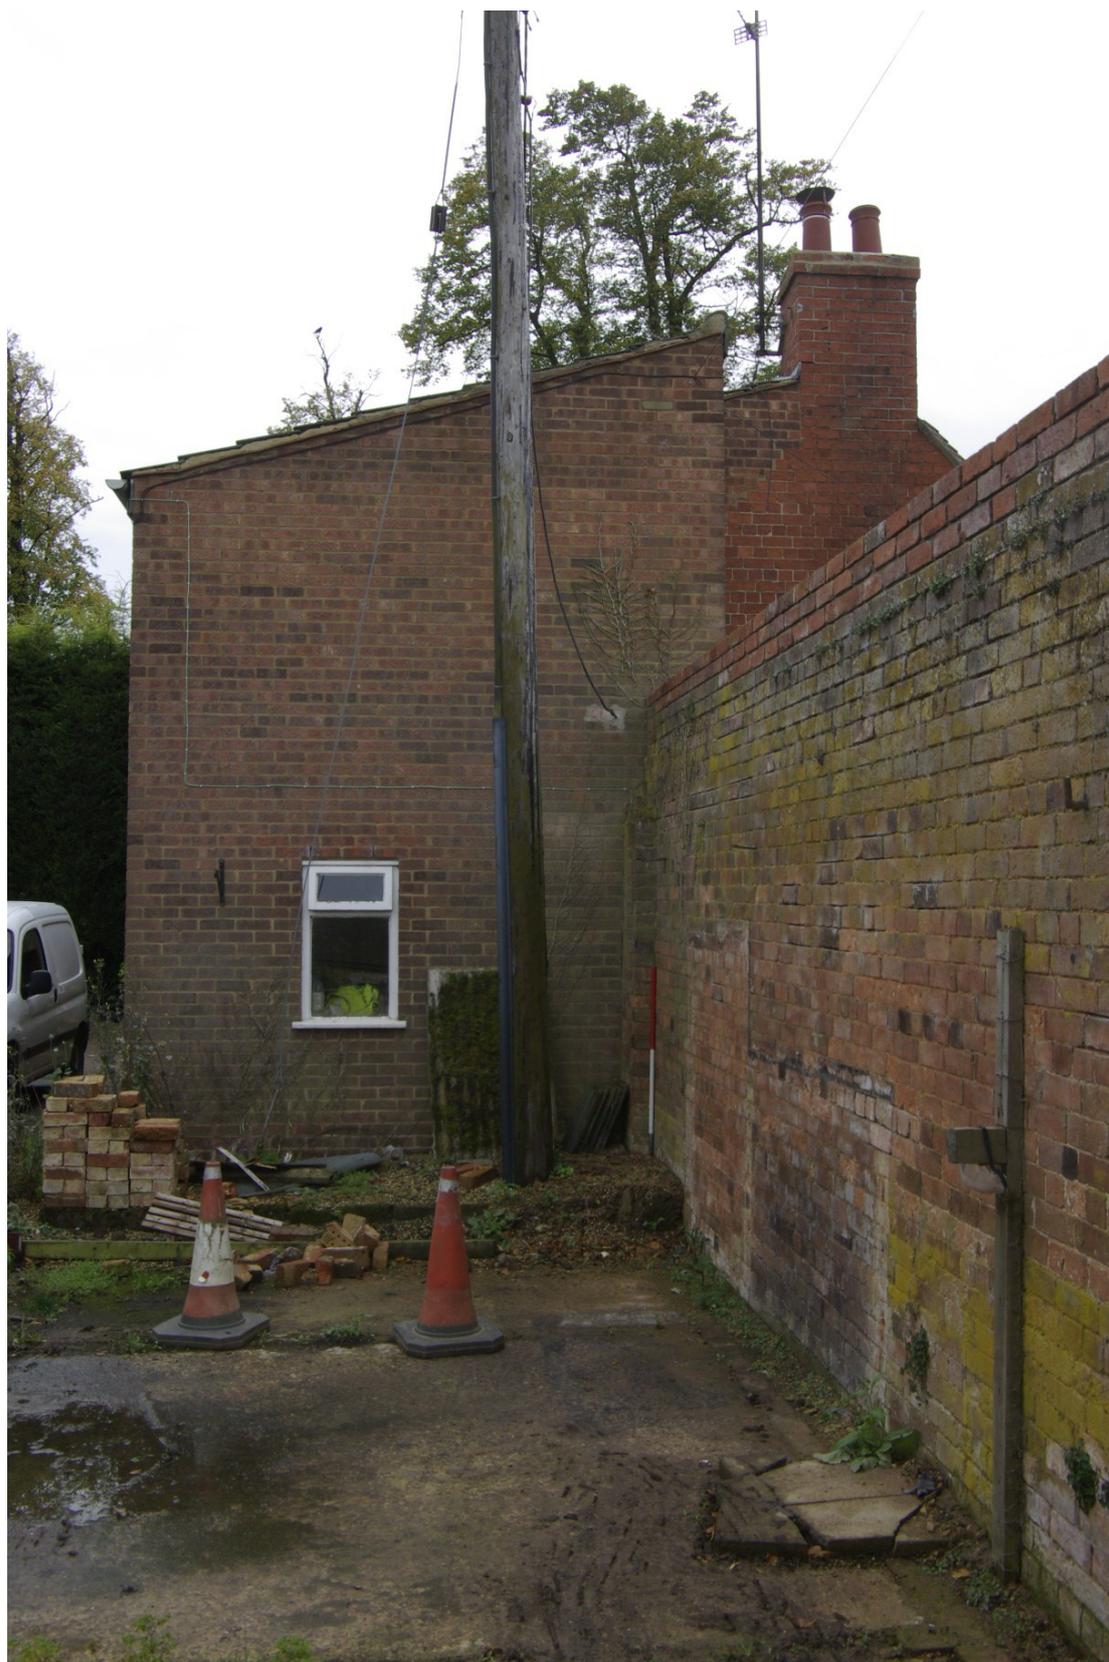
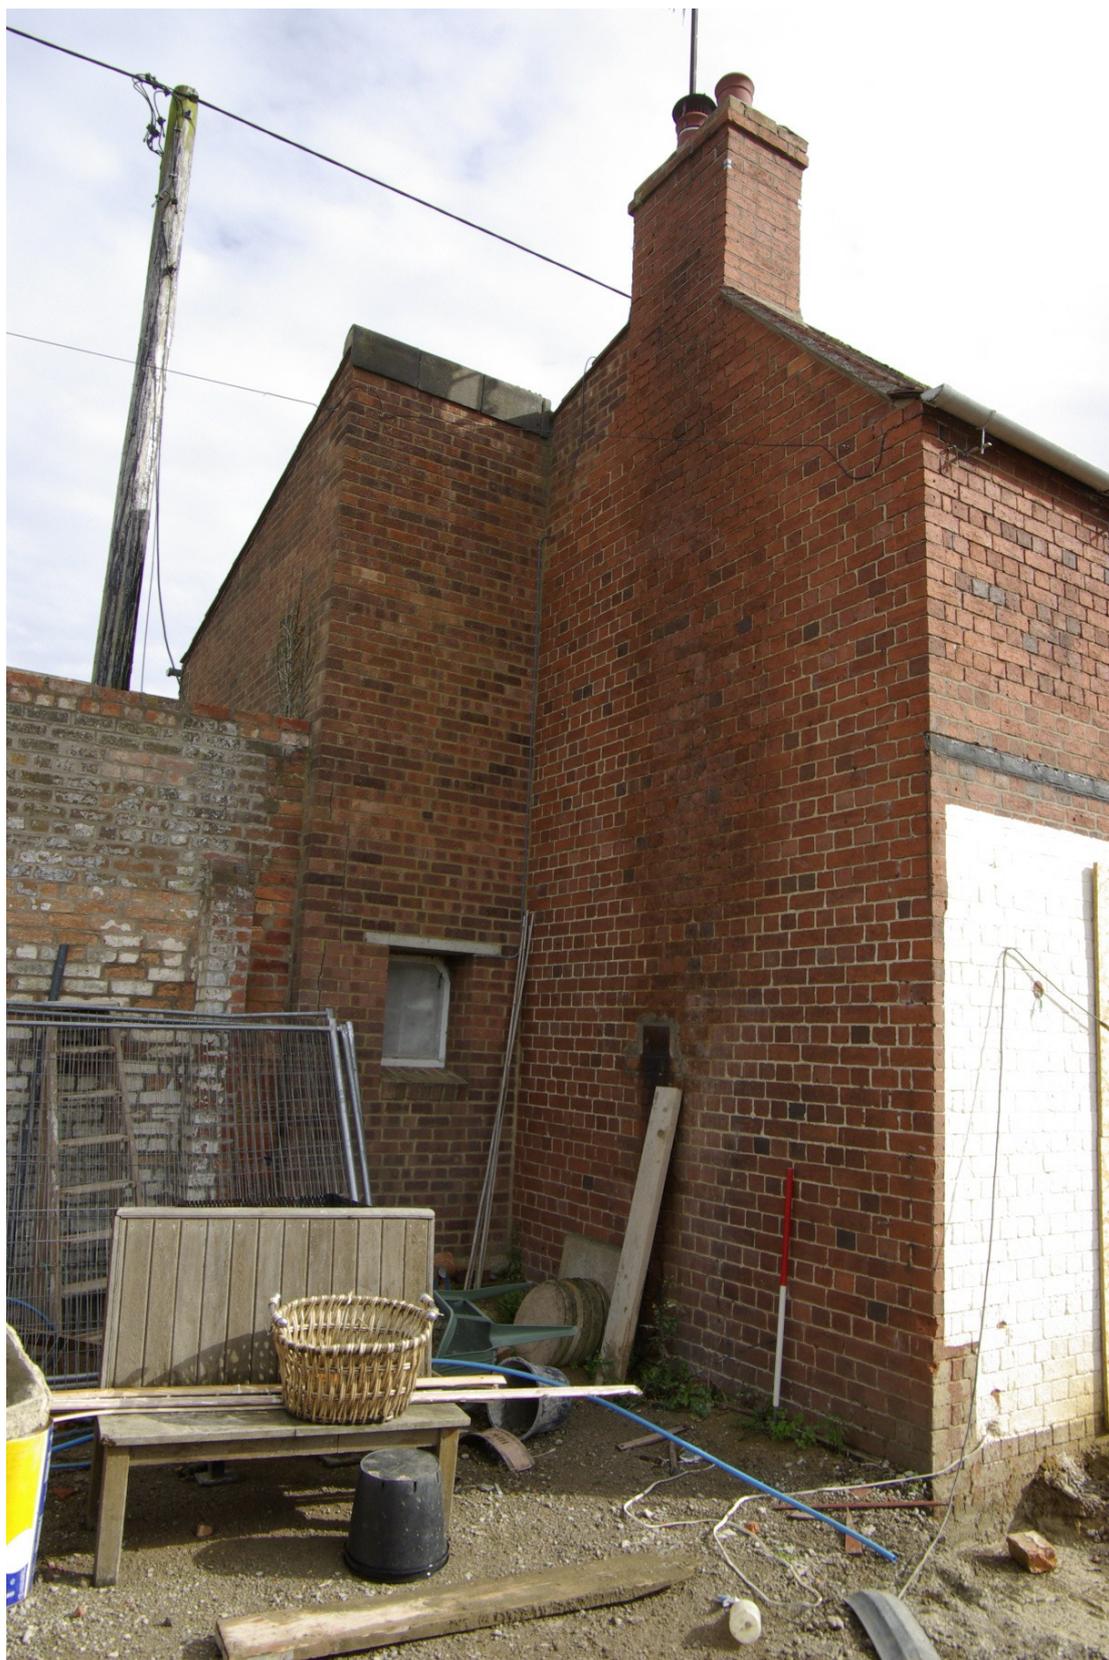
The north-west facing elevation exhibits the same two building phases as located on the south-east facing elevation although in this case the later build extends out beyond the earlier phase by approximately 1.5m (Figs. 10 and 11). The garden wall butts up against the later phase of cottage wall. A small wooden-framed window at ground floor level matches those on the north-eastern facing elevation.

Figure 10. North-west facing elevation to north of garden wall
Looking south-east. 1m scale

Figure 11. North-west facing elevation to south of garden wall
Looking east. 1m scale

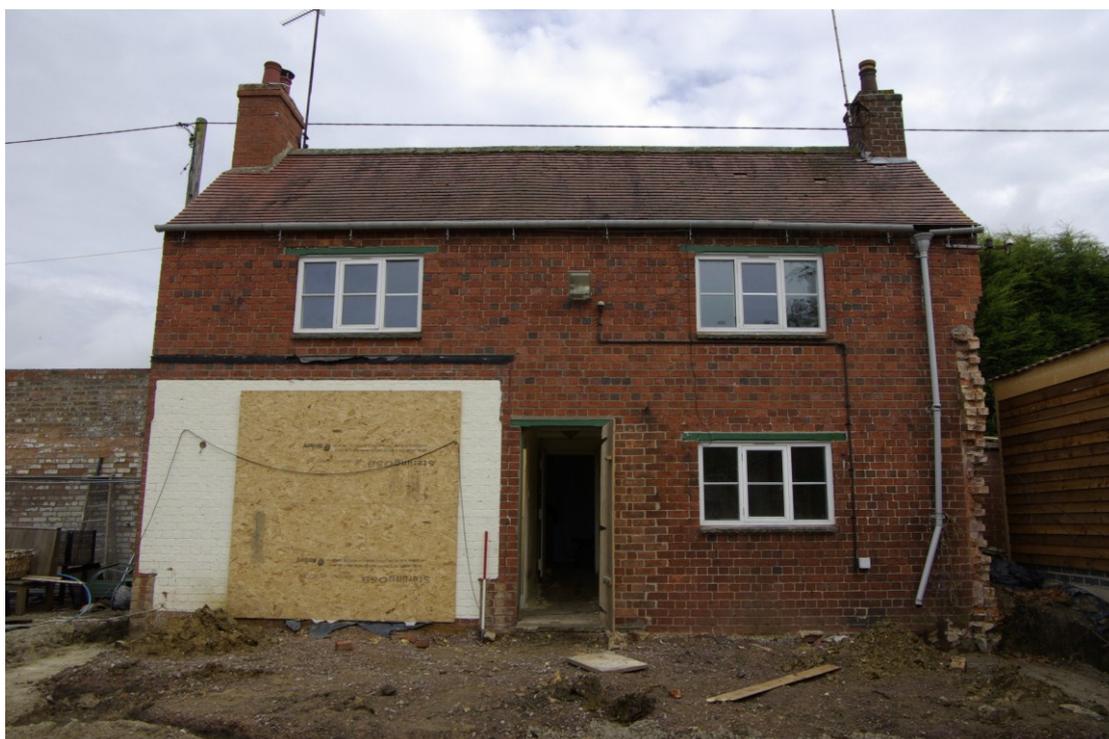
Figure 12. South-west facing elevation
Looking north-east. 1m scale

The south-west facing elevation looks out down the slope into the walled garden. It is built using early 20th century red bricks laid in an English Bond to match that found on the older phases of the north-west and south-east elevations and on the garden wall (Fig. 12). It has ceramic roof tiles which do not appear to be as old as the brickwork. Later internal inspection of the roof structure shows that the tiles bear the stamped name of ROSEMARY which is a make of tile which continues to be used to the present day. The windows are modern double-glazed and have wooden frames but retain their original flat wooden lintels which have a stop chamfer on each. A recently removed conservatory has left a large opening on the western side which has a temporary board covering the hole. The door has also been replaced by a temporary board.

The later phase extension extends north-westwards by approximately 1.5m as noted above. It has a single deeply recessed metal framed window at ground floor level which lights a small pantry in the kitchen.

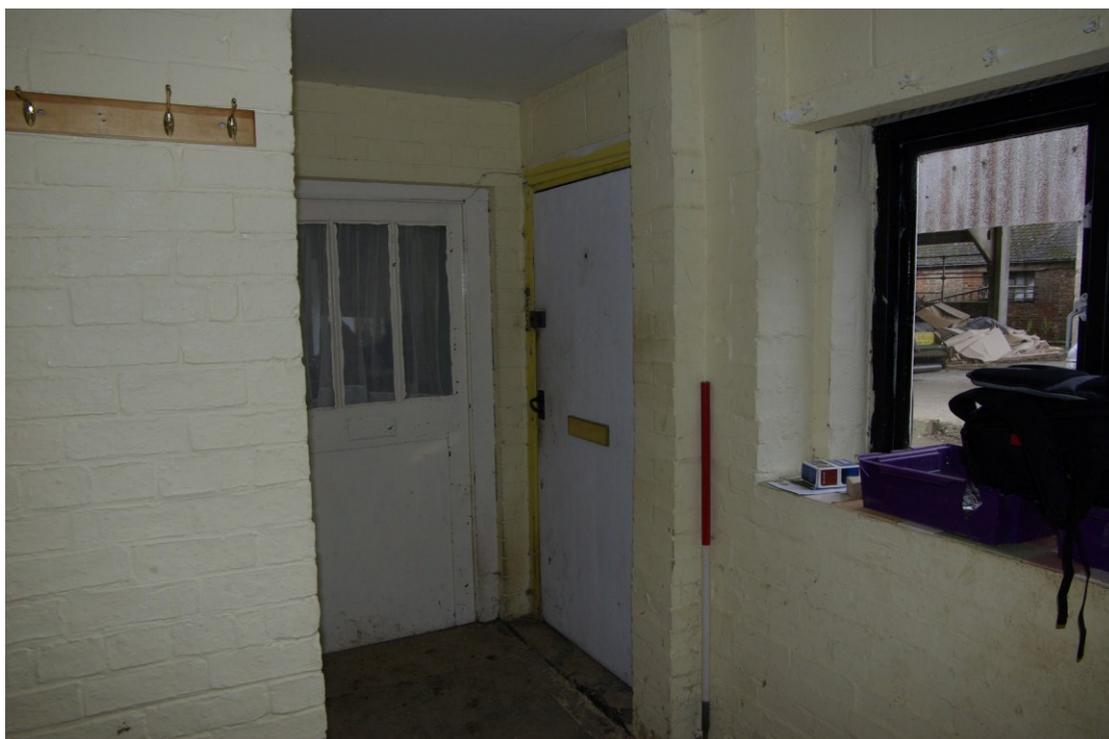
Figure 13. Utility Room
Looking north. 1m scale

The utility room is entered from the outside doorway on the north-east facing elevation or from a doorway leading from the kitchen. It has a concrete-floor with exposed lime-washed bricks which are of the same size as those used in the earlier phase portion of the cottage (Fig.13). There is a small brick-built structure, currently used as a toilet, in the south-west corner made of the same bricks and which has a chamfered lintel. There are no signs of any blocked windows or openings on the south-west wall. Around the window on the north-eastern wall is a step which shows that the wall consists of an inner skin of original bricks with an outer skin of new bricks and breezeblocks. This would account for the unusually thick wall on this phase of the cottage.

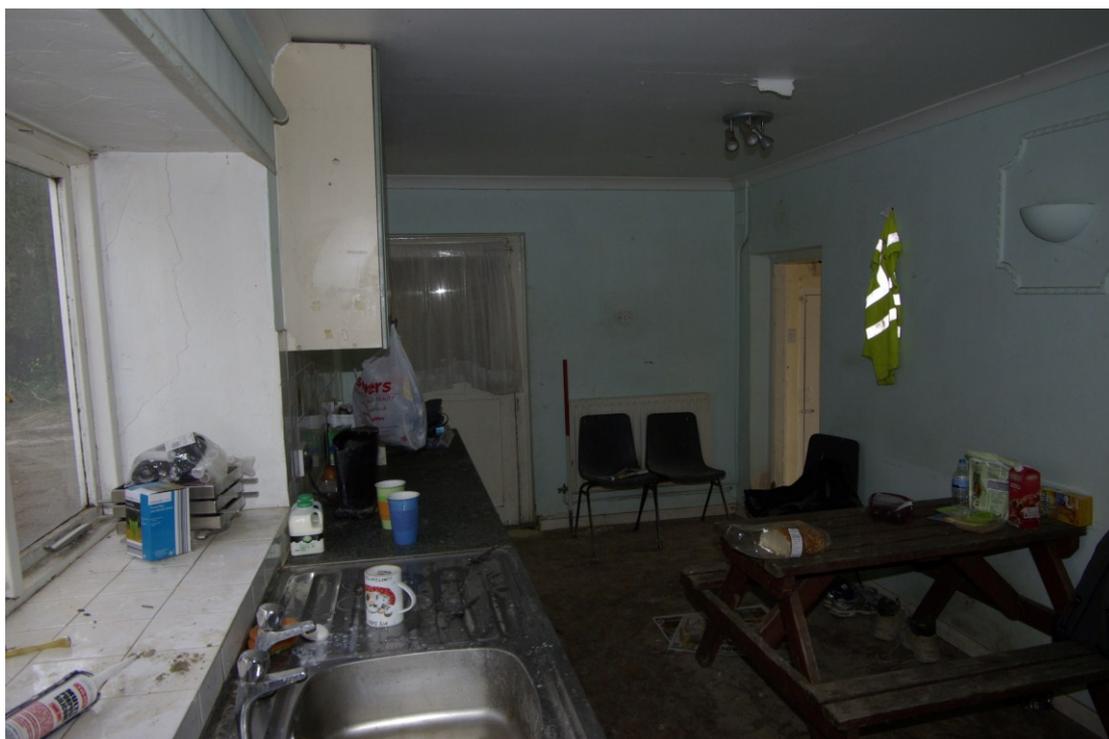
Figure 14. Kitchen
Looking south-east. 1m scale

As with the Utility Room the kitchen has very thick outer walls although there is no telltale stepping around the windows to indicate that an earlier wall has been re-skinned (Fig. 14). Again there is no evidence of any blocked windows into the earlier phased part of the cottage although the kitchen walls are plastered so that this evidence would be obscured. A pantry built from breeze-blocks fills the western corner.

A doorway in the south corner leads out of the kitchen to a small ramp and central corridor running between the lounge and study of the southern rooms. A door, constructed from 6¹/₂ inch (166mm) wide boards, on the east side leads into a small storage space under the stairs. This space has since been opened out to make the study slightly larger. Two other doors lead to the east and west lead to the lounge and study.

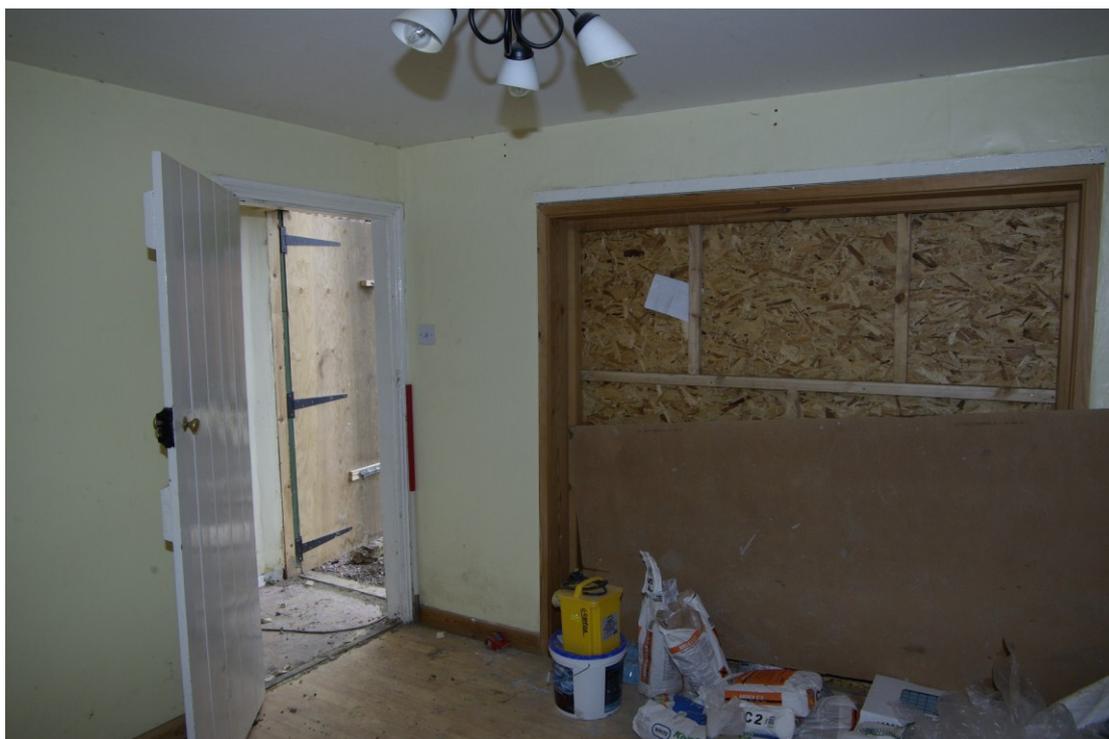
Figure 15. Lounge
Looking south. 1m scale

The lounge is a small rectangular room with plastered and wallpapered walls and a boarded over entrance on the south-west wall where a conservatory was recently demolished (Fig. 15). The chimney breast is plain with opening a 0.54m wide opening but no traces of any internal fireplace fittings remain. The door to the centre corridor appears to be original and is made from 6¹/₂ inch wide tongue and groove boards. The floor covering is modern laminate flooring which appears to be laid on concrete.

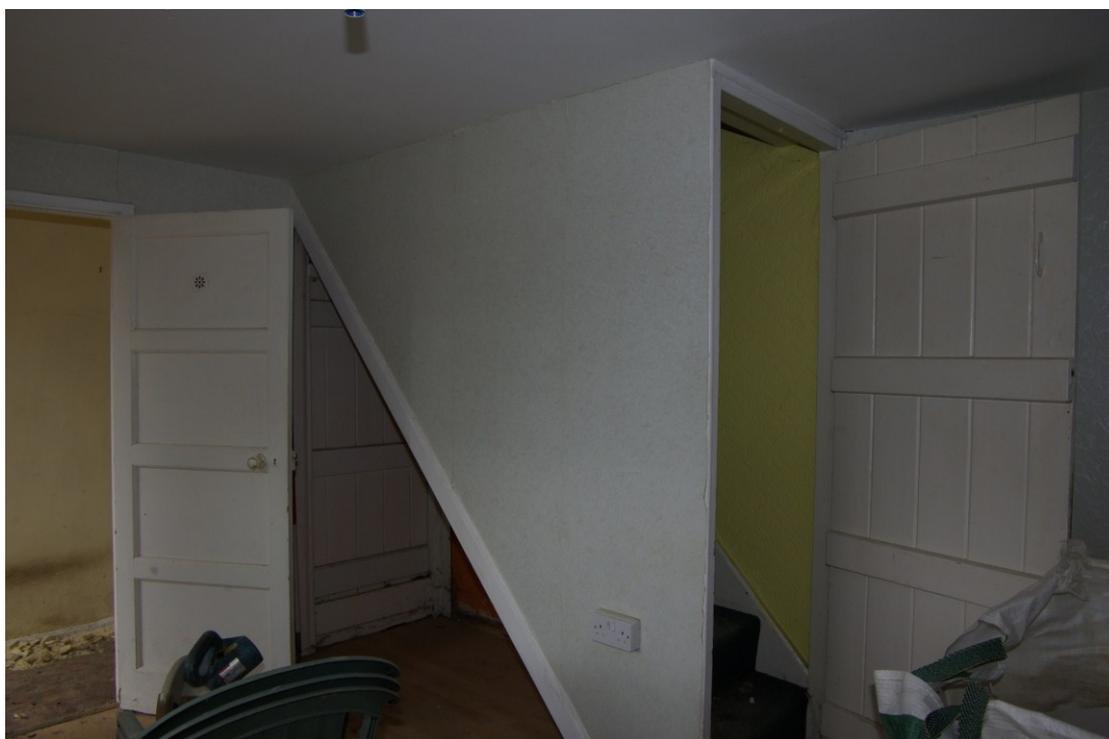
Figure 16. Study
Looking north

The study is the same size as the lounge but has the enclosed staircase in the north corner (Figs. 16 and 17). The main doorway into the room from the corridor appears to be of 1940s or 1950s origin but the doorway underneath the stairs, as noted above, is made from tongue and groove boards and is probably original. The stairs are enclosed by the same style of tongue and groove boards and would have run from floor to ceiling when first built. At some stage the boards below stair height have been removed to create a slightly larger room. There is a board door at the bottom of the staircase.

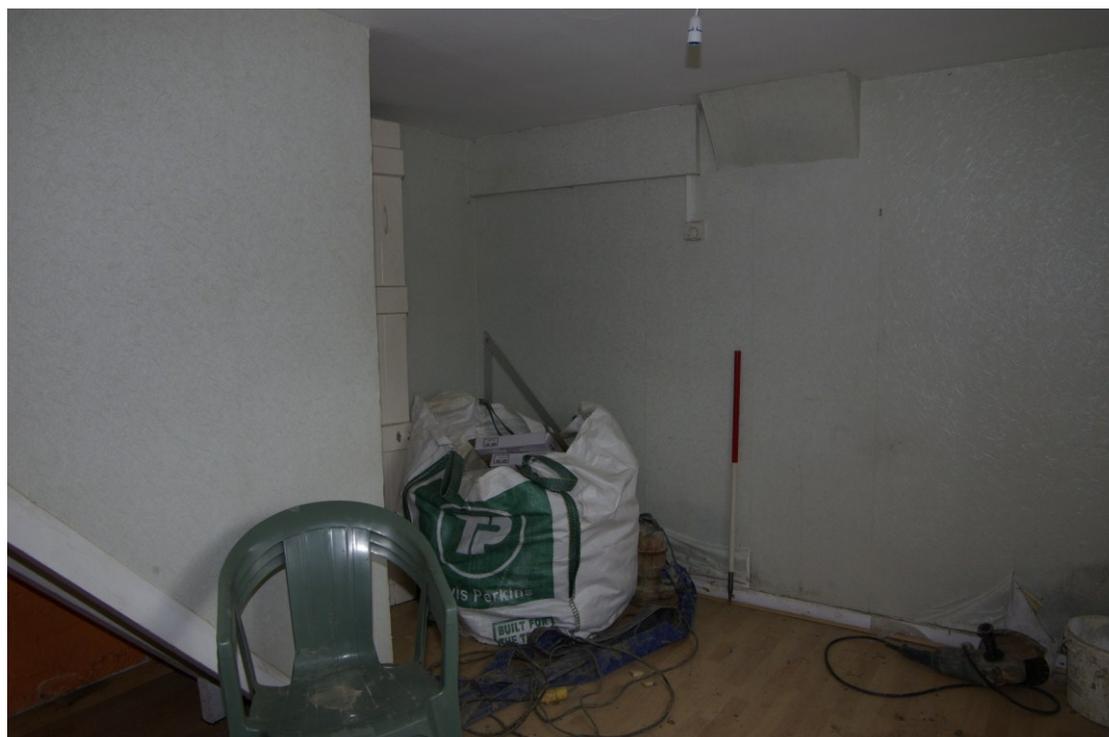
Figure 17. Study and truncated chimney
Looking east. 1m scale

On the east wall is a sloping masonry projection at ceiling height (Fig. 17). This acts as a support for the single flue chimney breast in the first floor bedroom. It seems likely that this used to continue down to floor level and would also have had a fireplace.

Other modifications to the house, which might be contemporary with the second phase redesign, include the removal of the fireplace and chimneybreast in the ground floor room now used as the study. The opening out of the space under the stairs probably happened at this time too.

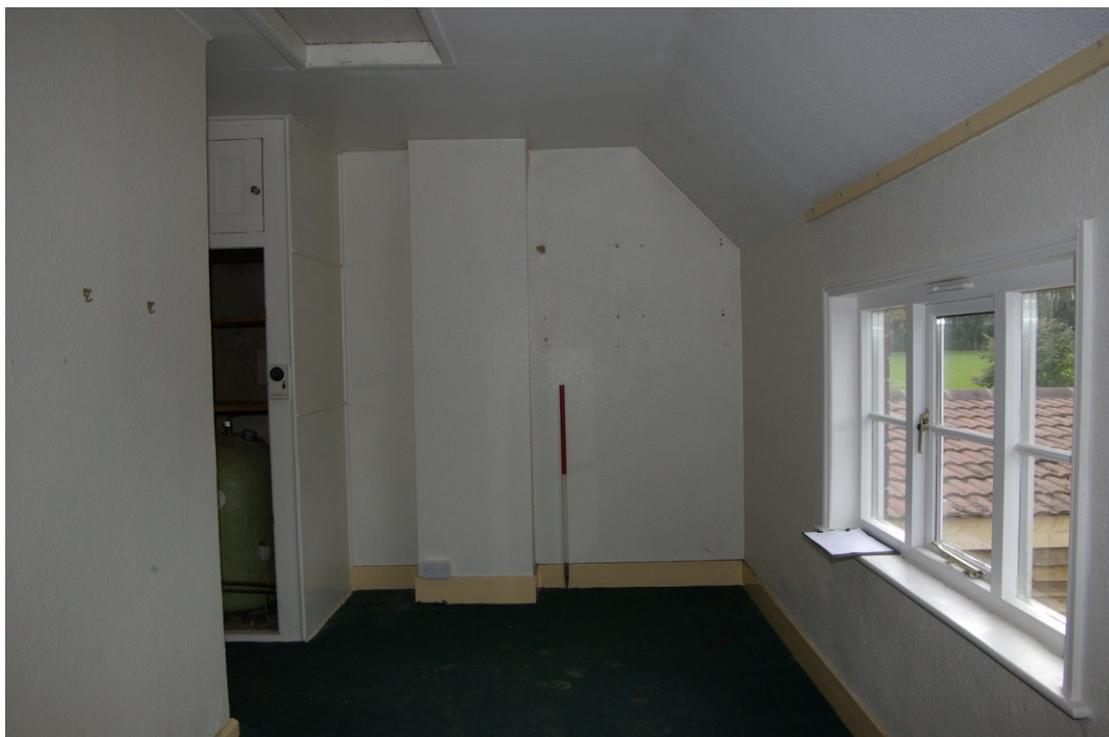
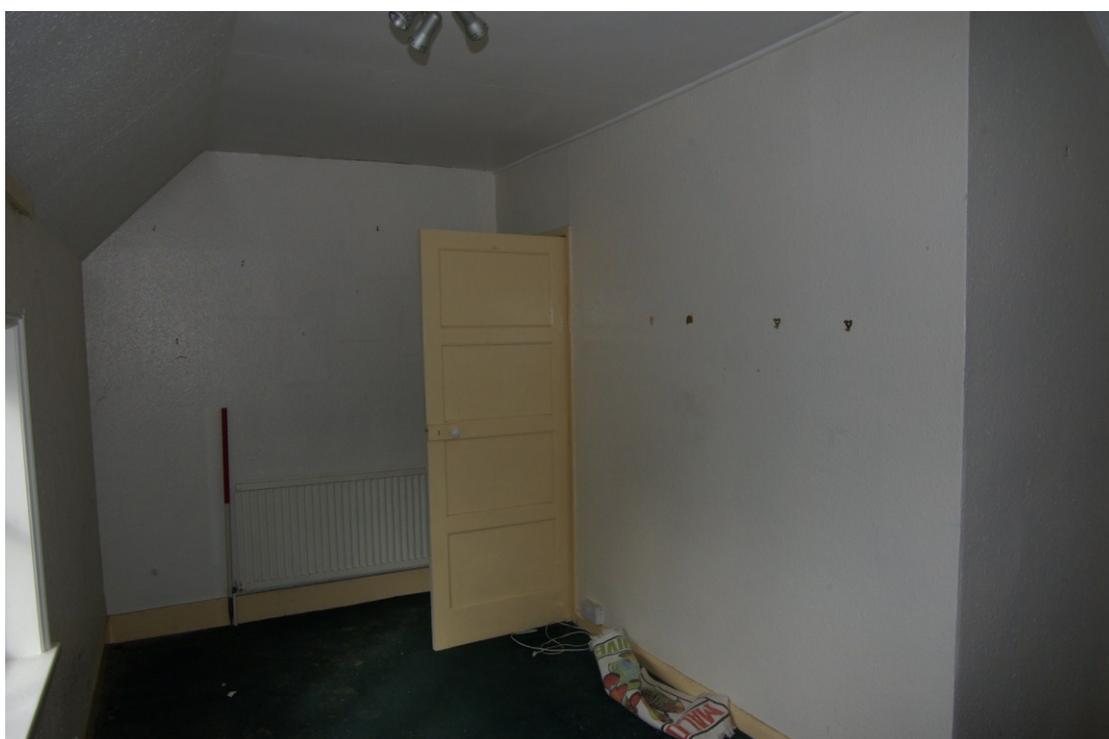
The stairs along the north-east wall of Bedroom 1 make this room a slightly awkward shape (Figs. 18 and 19). In order to gain more height the ceiling is built against the first purlin height creating a sloping angle against both outside walls. To compensate for the loss of space caused by the staircase this bedroom is slightly longer than Bedroom 2. The chimney breast has no evidence of a blocked fireplace which suggests that it once extended down to ground floor level and to a ground floor fireplace. The windows are modern replacements and look out into the walled garden (Fig. 20). The door to the small landing is a replacement and matches that seen in the ground floor study.

Figure 18. Bedroom 1
Looking south-east. 1m scale

Figure 19. Bedroom 1
Looking north. 1m scale

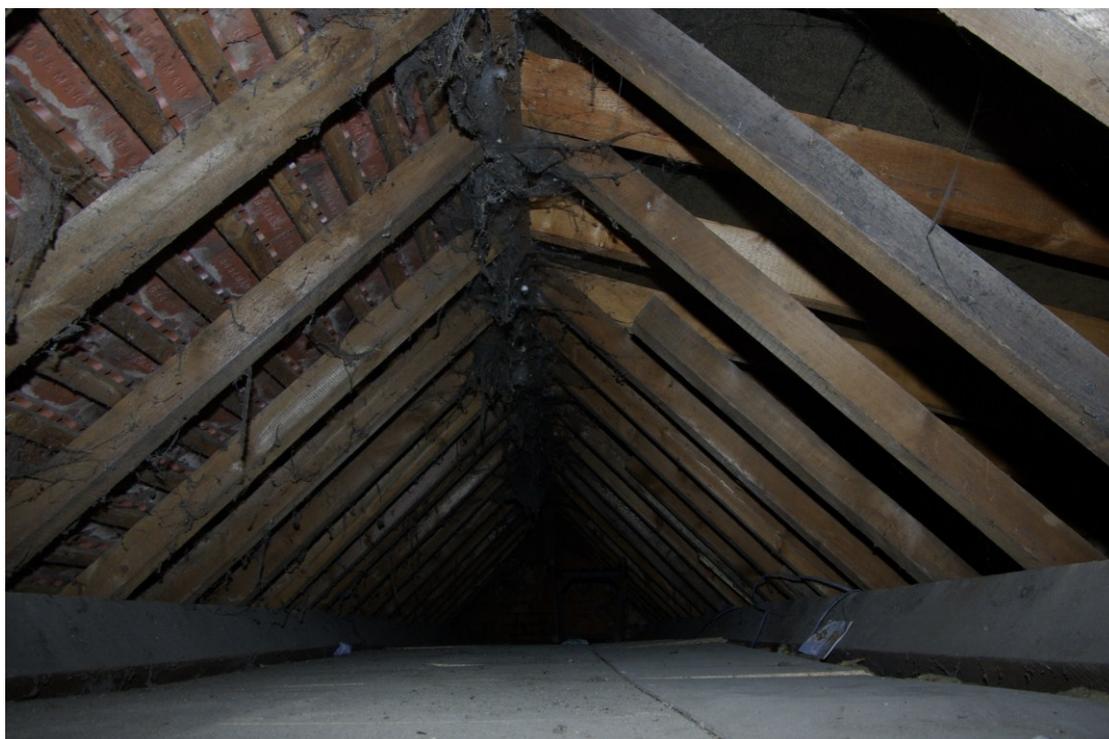
Figure 21. Roof structure
Looking north-west. Original phase on left, later extension roof on right

A small hatch in the ceiling gives limited access into the roof space. The first phase of roof structure is relatively simple with the purlins being attached to the underside of the common rafters which join at the top against a narrow ridge. When the new extension was added to the north-east side of the cottage it would appear that the tiles on the north-east side were removed and replaced by new common rafters set at a new and shallow angle to cover the new build (Fig. 21).

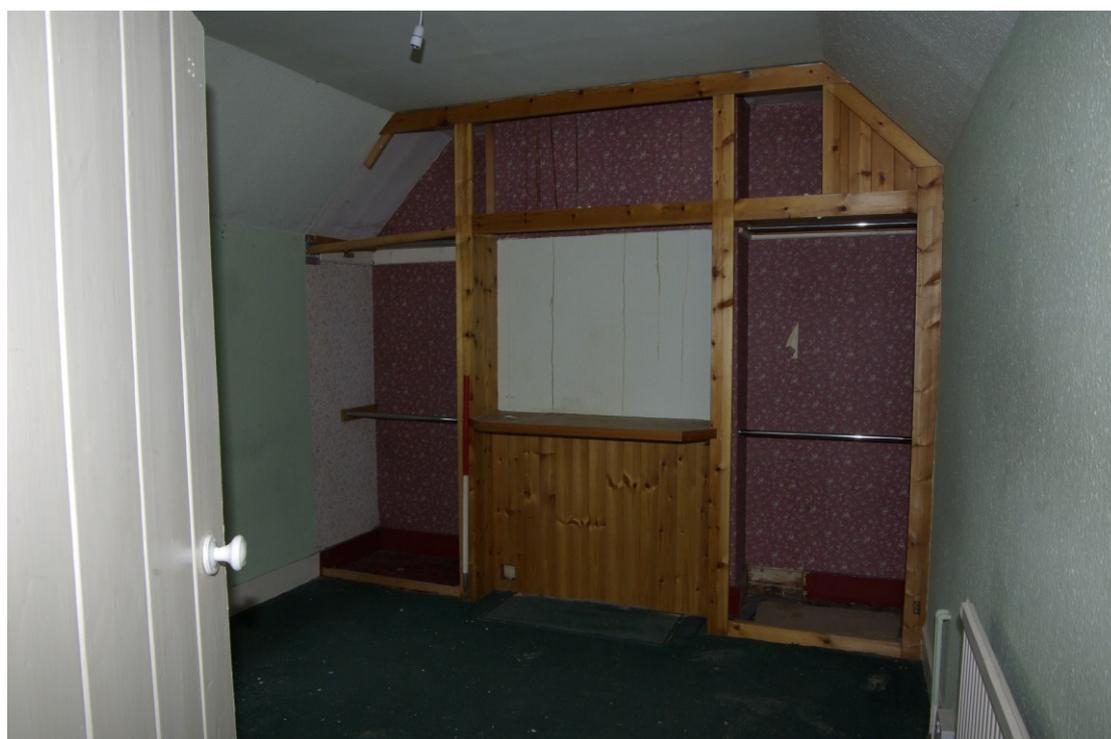
Figure 22. Bedroom 2
Looking west. 1m scale

Bedroom 2 was the principal bedroom of the original cottage and as such has a fireplace on the north-west wall which is currently partially covered by modern wardrobes (Fig. 22). It has plastered and papered walls making it difficult to see any evidence of any blocked windows on the north-east wall. The door is still the original 6¹/₂ inch (166mm) board door and the floorboards are flat boards of approximately 170mm width.

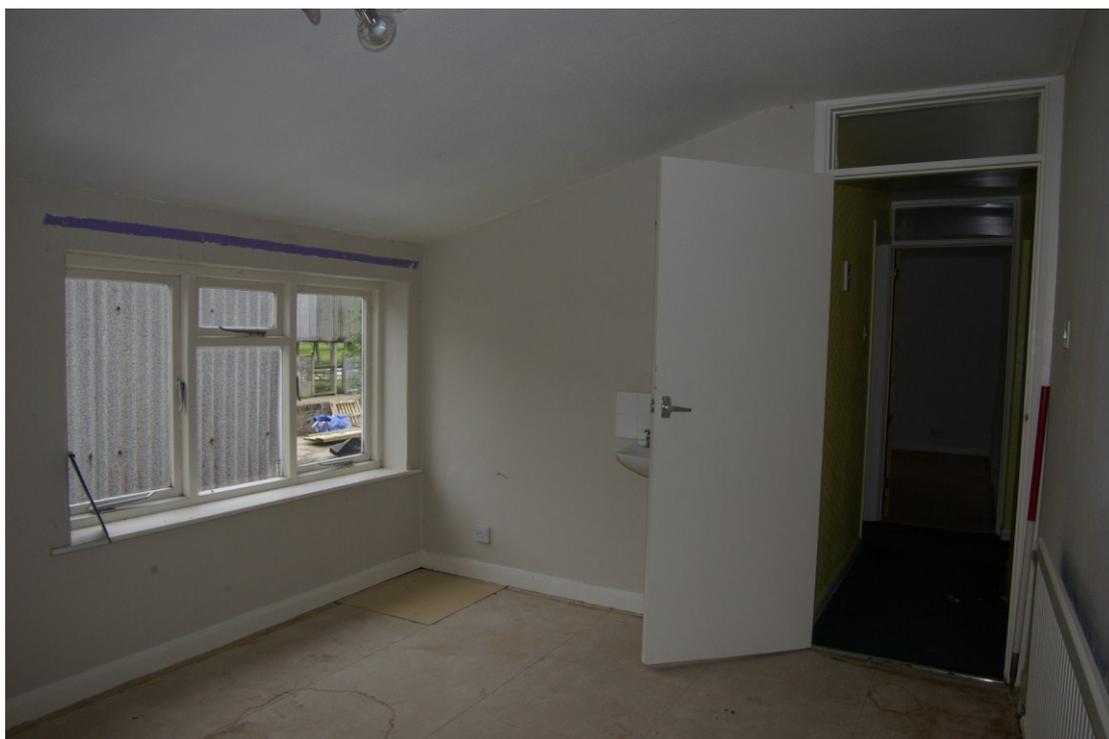
Figure 23. Bedroom 3
Looking south-east. 1m scale

Bedroom 3 is quite plain in detail with a modern wood-framed window and a modern hardboard covered door which has a glass door light over it to light an otherwise unlit landing (Fig. 23). The floor is covered in chipboard sheet which may or may not cover earlier boards. The walls on this floor are only a single skin of brickwork rather than the very thick walls seen on the ground floor. Because of this, and because the new brickwork sits outside the earlier brickwork, there is a small step in the south-west wall in the corner where the later extension extends beyond the edge of the original cottage (see plan in Figure 7).

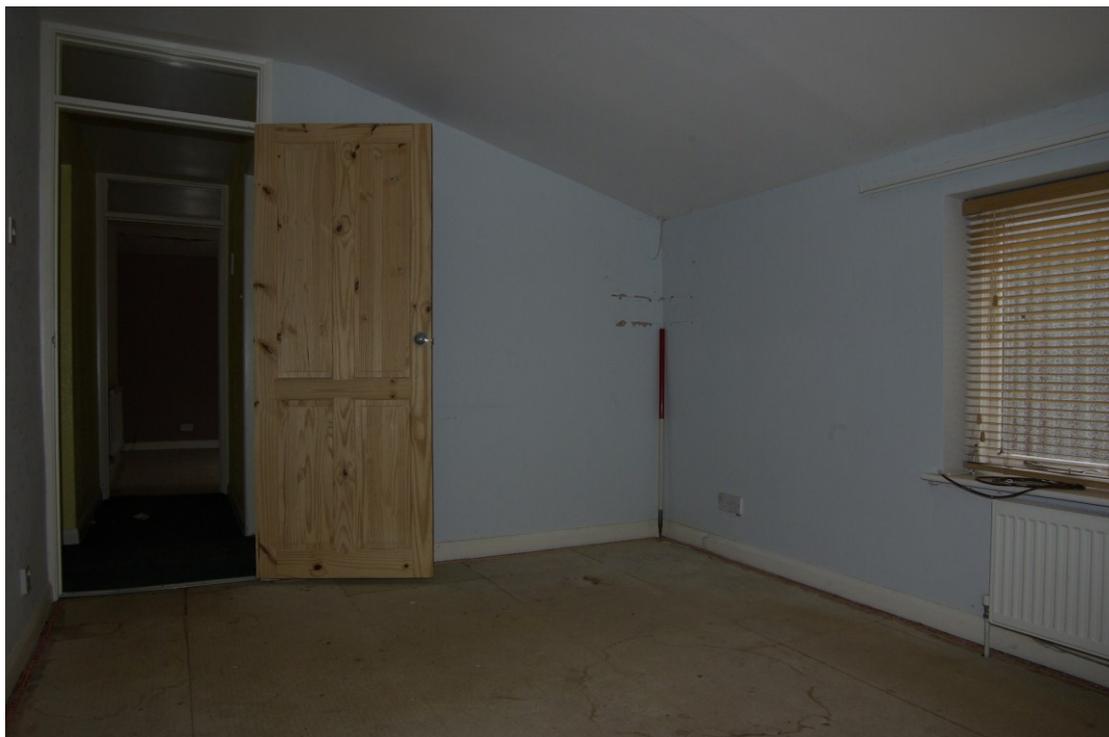
Figure 24. Bedroom 4
Looking north-west towards landing. 1m scale

Bedroom 4 is identical in shape and style to Bedroom 3 with the exception of the small step in the south-west wall (Fig. 24). The only exception being that this room has a modern stripped pine door.

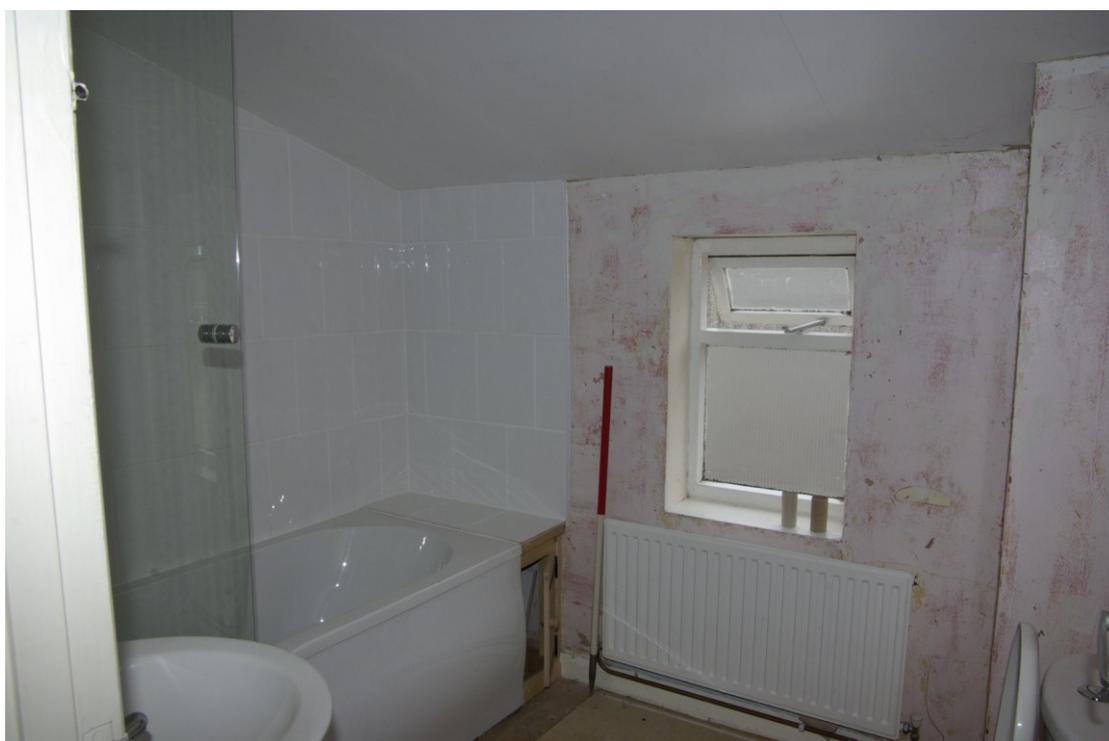
Figure 25. Bathroom
Looking north. 1m scale

As noted the modern bathroom is located between Bedrooms 3 and 4 (Fig. 25). It is tiled and plastered making close inspection of the construction details difficult.
