**An Archaeological Watching Brief and  
Building Record at the air-raid shelter,  
Regent College, Regent Road,  
Leicester**

**NGR: SK 5944 0346**

**ULAS Report Number 2014-012**

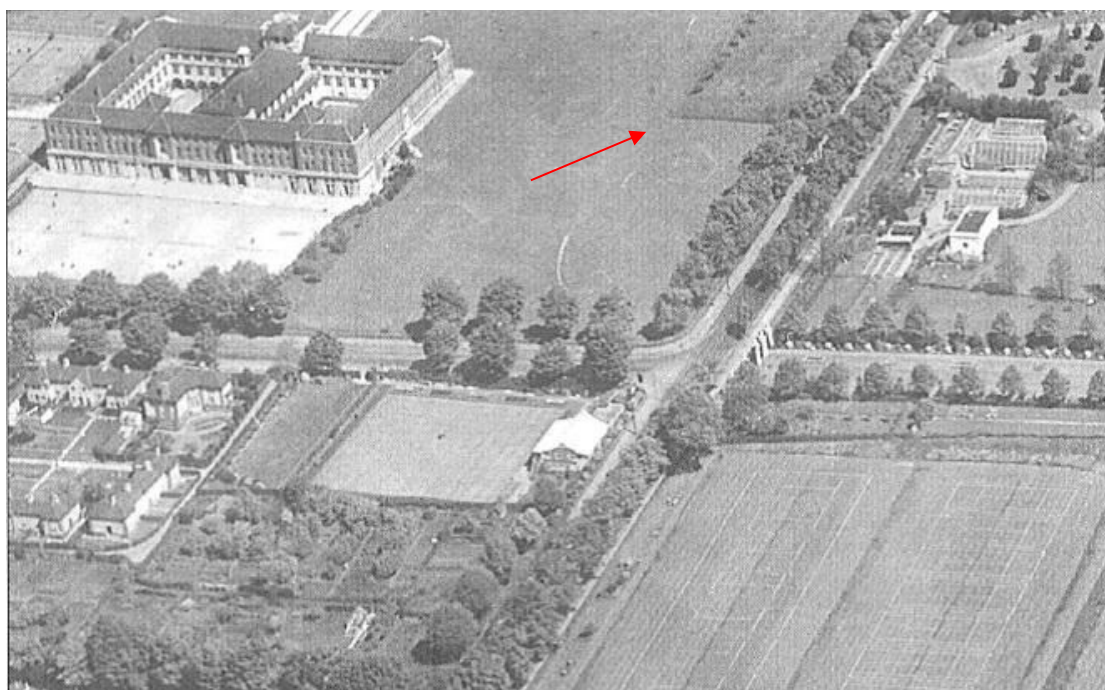
Figure 3 Aerial photograph of Wyggeston Girls School and air-raid shelter  
(Photograph taken in the 1950s. Shelter is marked with arrow)  
(from H. Boynton 2000)

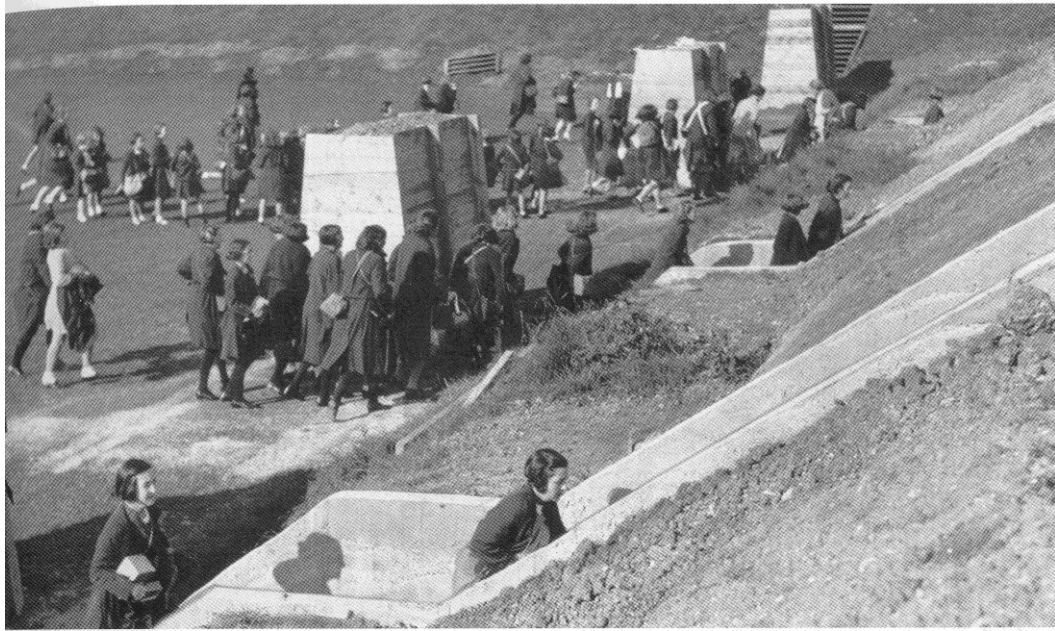
Figure 4 Wyggeston School shelter during a practice drill  
Note steps in background leading up to Regent Road

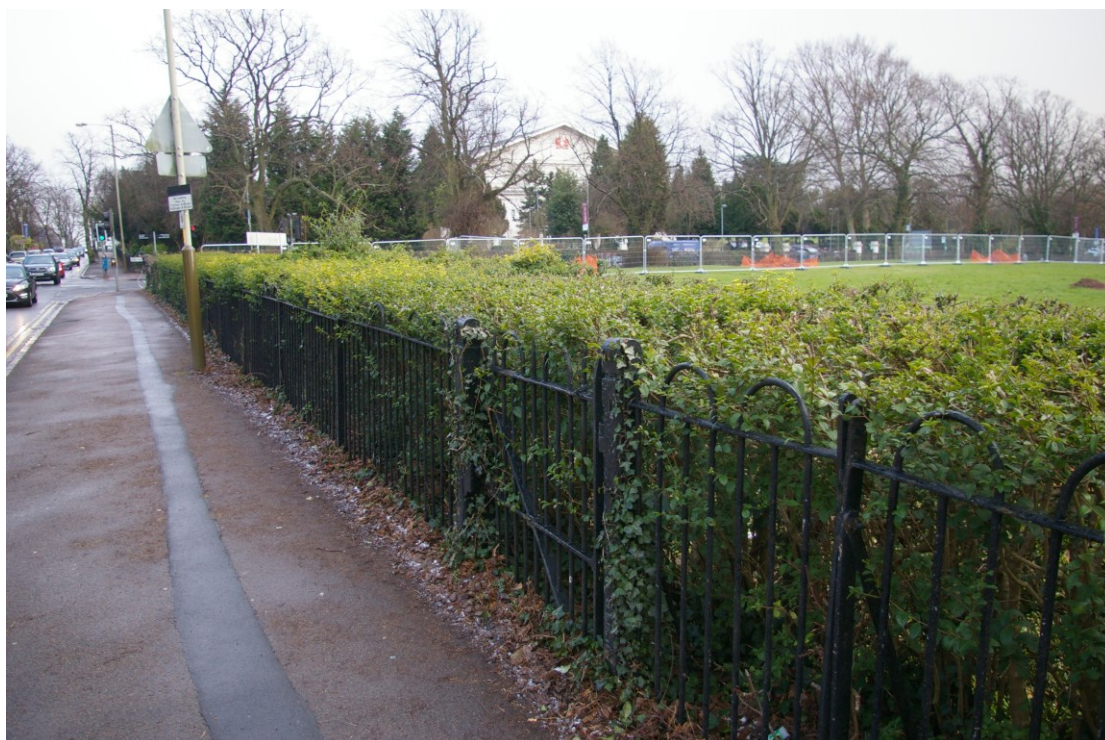
Figure 6 Gateway leading from Regent Road to shelter  
Looking south east

Prior to the commencement of the development the air-raid shelter consisted of an approximately rectangular turfed earth mound. The western and southern faces had similar sloping sides of approximately 20 to 30 degrees with a narrow terrace approximately half way up the face. At its eastern end the southern face swept outwards in a gentle curve to the south where it joined University Road. The eastern and northern side were on the same level as the adjacent Regent and University Roads. The top of the mound was generally flat although high points and ridges indicated the outline of the buried trenches below. On the western face were 7 concrete entrances, some of which were blocked with modern breeze blocks and others with plywood doors. There was no indication of any original doors or frames. The wooden framed blast walls which protected the doorways were no longer present. A gateway in the perimeter railings survives on Regent Road. Figure 4 shows a set of steps leading down from Regent Road which were, presumably, used for civilian access to the shelter out of school hours (Fig. 6).

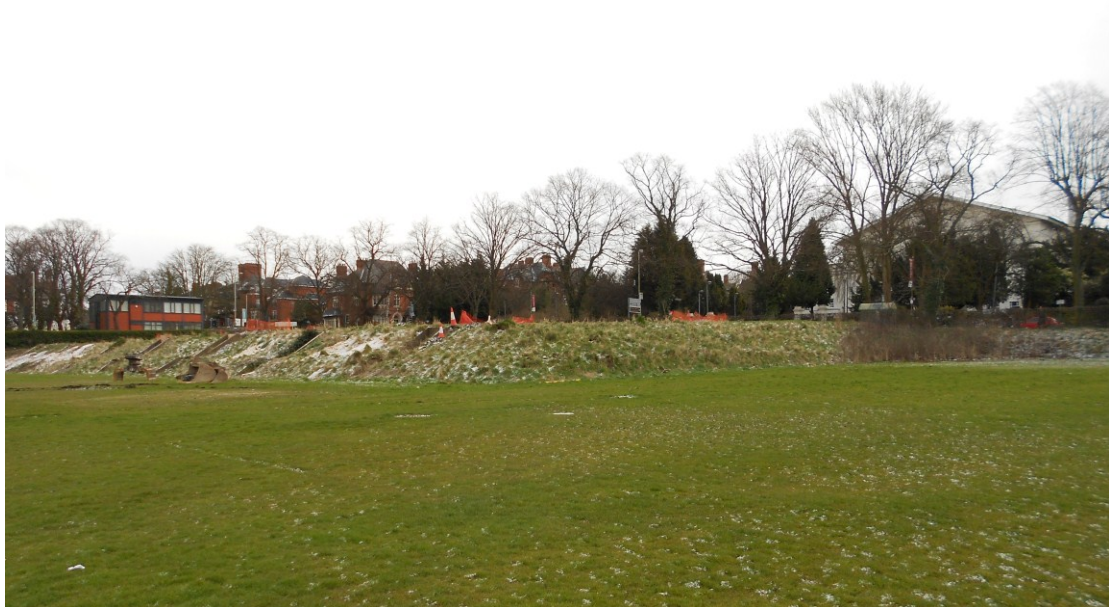
Figure 7 General view of the south and west elevations  
Looking north east

As noted above, the Regent College air-raid shelter forms a rectangular platform in the north east corner of the Regent College site (Figs. 7 and 8). Seven concrete-faced entrances are set at regular intervals along the west face of the shelter (Fig. 9). Shortly before demolition commenced a number of trial holes were hand excavated across the top of the earthwork to assess how far the roof of the shelter was below current ground level. This appeared to be surprisingly shallow with an average depth between 0.35 and 0.55m.

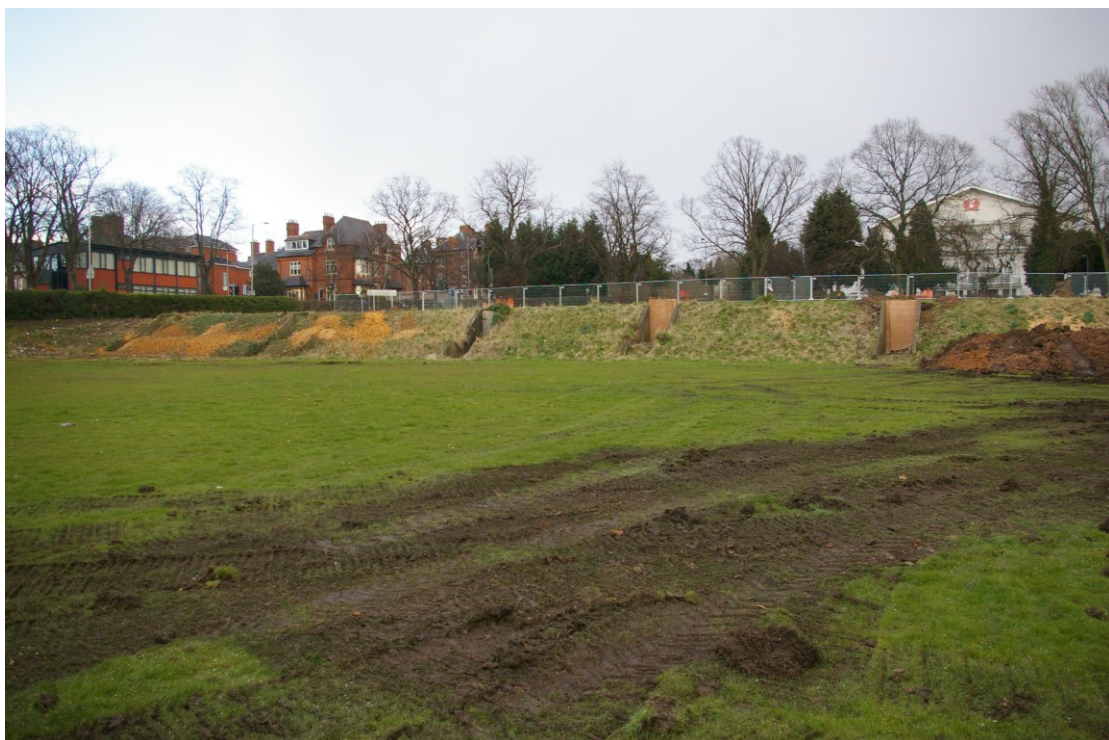
Figure 8 Shelter entrances  
Looking east

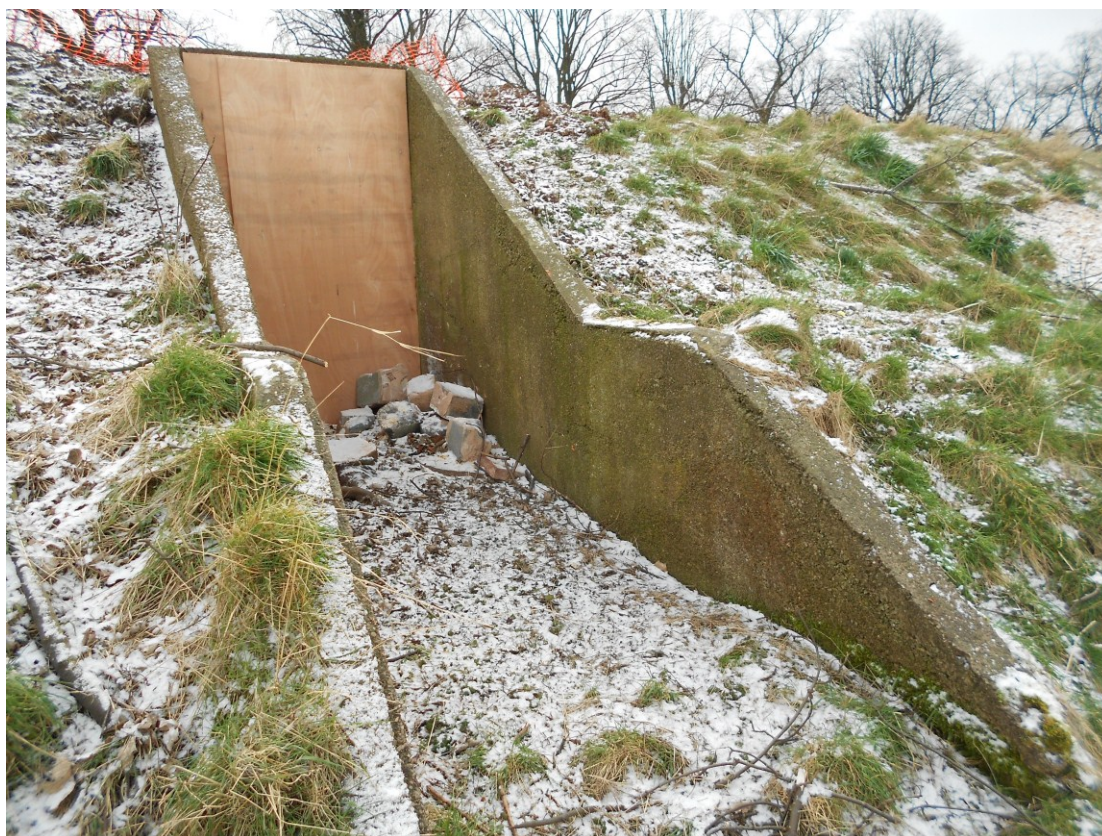
Figure 9 Detail of entrance

The seven entrances were set at regular intervals along the eastern edge of the shelter facing downhill towards the school. The flanking concrete retaining walls are stepped to follow the slope of the earthwork and have been cast in-situ as clear lines between each pour of concrete could be seen in places. There appeared to be no form of flooring within the entrances until the actual start of each tunnel.

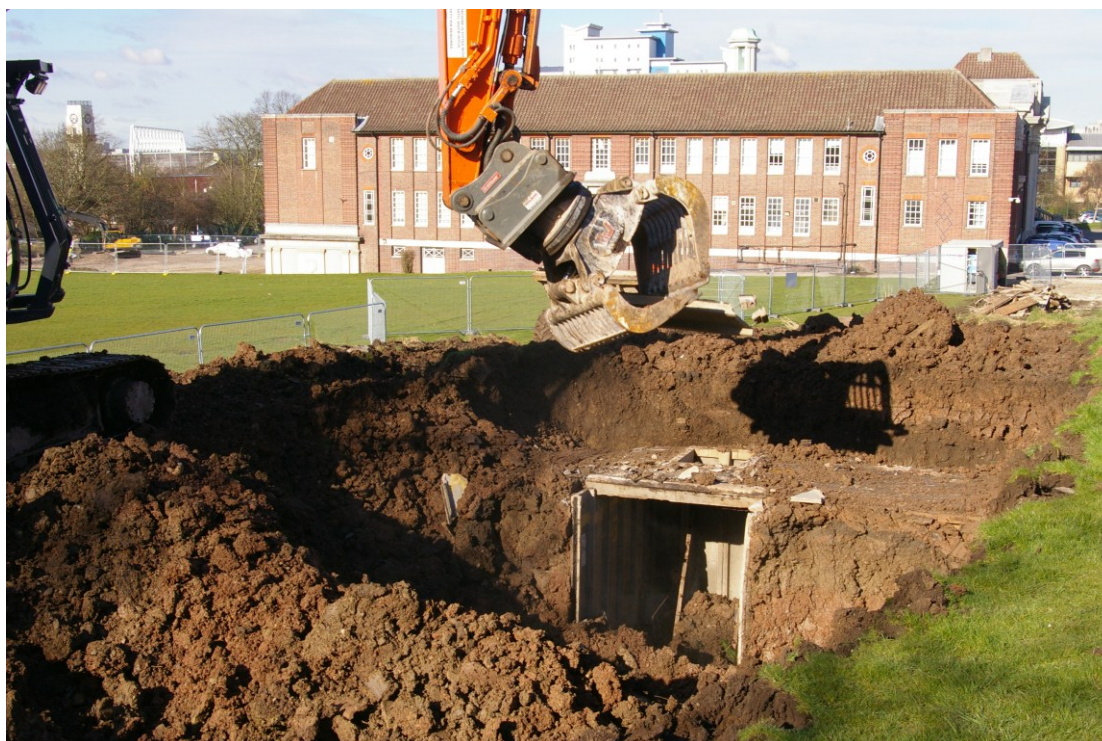
Figure 10 Demolition of Tunnel A  
Looking west

Demolition began at the southern edge by removing the earth bank to reveal the edge of the southernmost shelter tunnel (Fig. 10). The exposed structures were then photographed and surveyed before further demolition continued. The anti-blast zig-zag pattern suggested by the lumps in the turf and from the brief inspection in 2010 was clearly visible during demolition. As demolition progressed it could be seen that, although each tunnel followed the same overall pattern of right-angled bends and dead

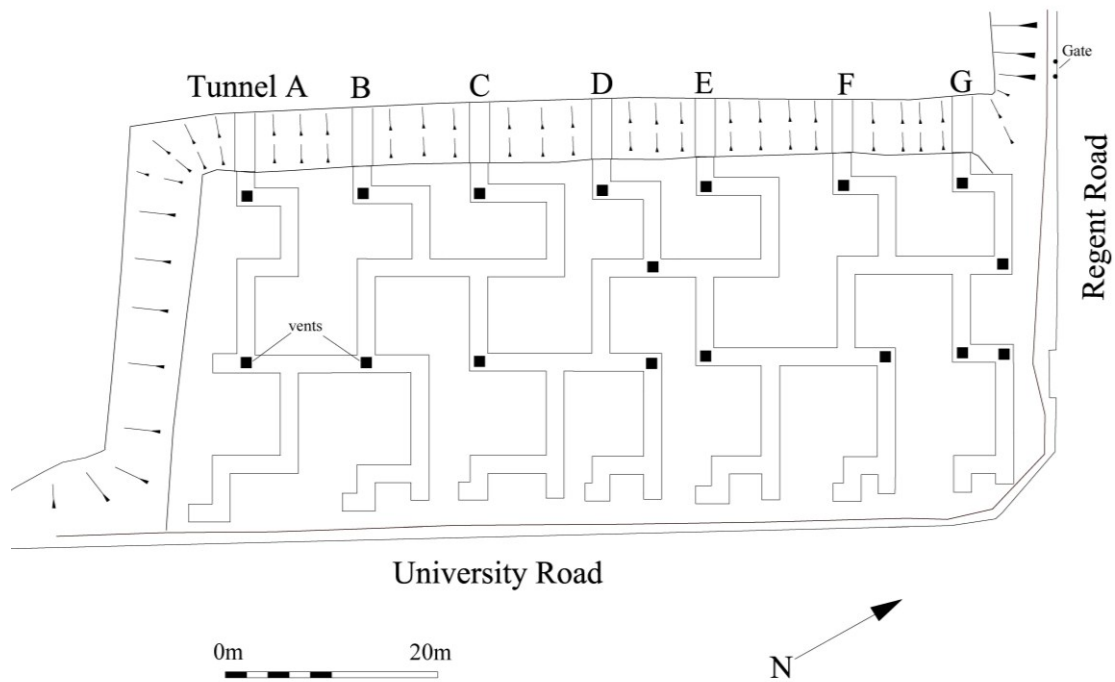
Figure 11 Overall tunnel layout as surveyed during demolition

ends, some tunnels were longer than others (Fig. 11). Although the shelter is made up of seven distinct tunnels they do interconnect at a number of points so that any part of the system can be reached, albeit in a circuitous fashion.

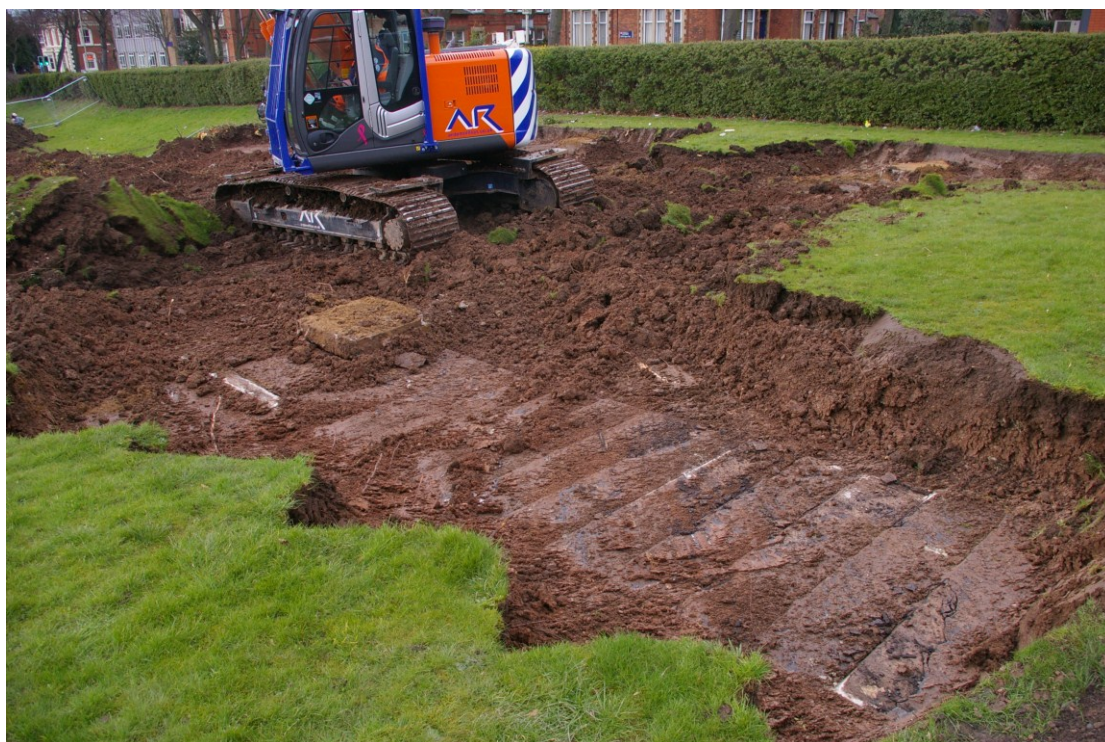
Initial inspection of the tunnel roof showed it to be built of sectional pre-cast concrete slabs sealed at each joint with tar which appeared to have been poured in when hot (Figs. 12 and 13). A 7-8mm (1/4 inch) thick layer of tar had also been poured over the entire roof to create a waterproof membrane. Rectangular holes in the roof indicated where air vents had been placed. These had been blocked, presumably soon after the war, to create a level ground surface. Seventeen ventilation holes were recorded (as in Fig. 11) but, as the final 7 or 8 metres of tunnels at the east end were left in-situ, it is probable that some holes remained unrecorded at the furthest extremities.

Figure 12 Exposed shelter roof, Tunnel F  
Looking north. Note capped ventilator shaft near to vehicle track.

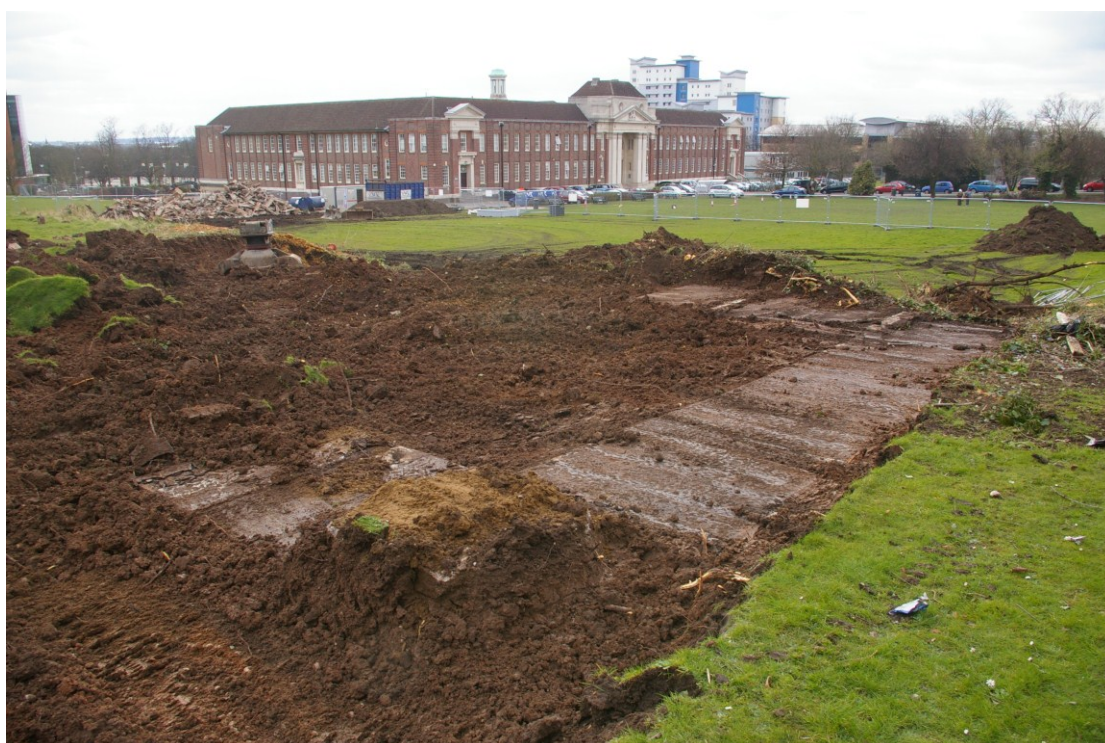
Figure 13 Tunnel D roof being exposed  
Looking west

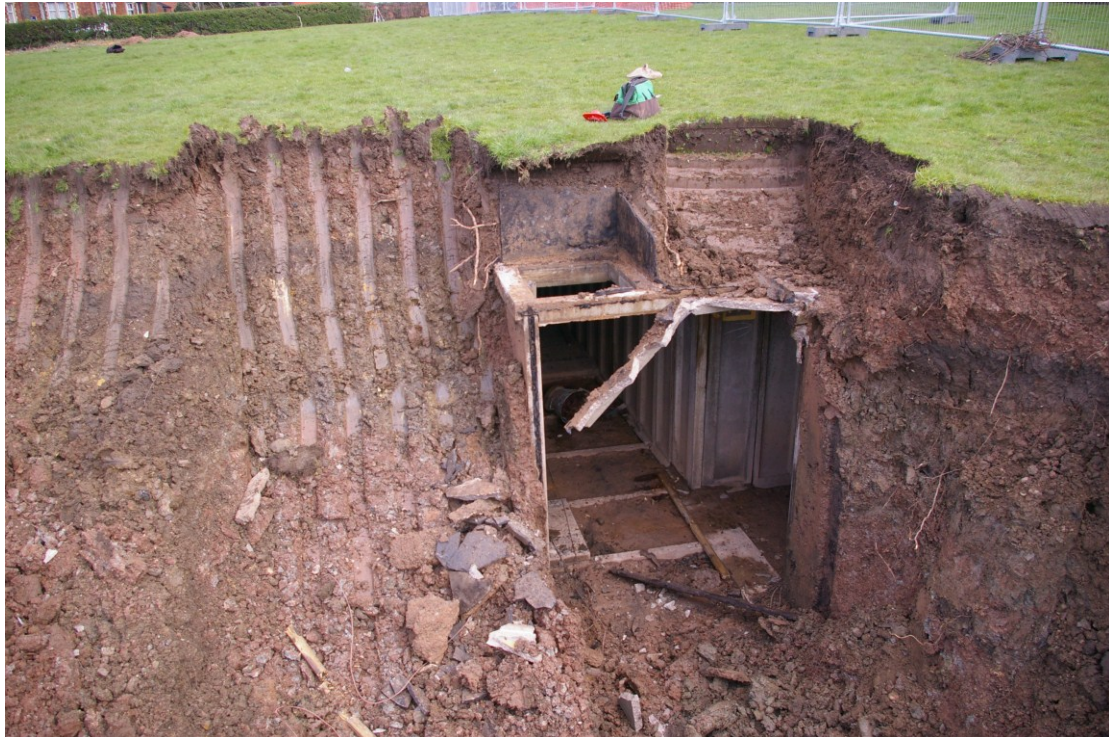
Removal of the roof showed it to have been located onto the wall using an interference fit with the upper edges of the wall panels. This was achieved using pre-cast channels in the roof panels slotting over the top edges of each wall panel (Figs. 14 and 15). The roof panels measured 1.52m in overall width (5 feet) which gave an approximate internal tunnel width of 1.42m. Once the roof slabs had been removed it was possible to see into the tunnel structure which was remarkably dry and intact (Fig. 16).

Figure 14 Roof structure and vent  
Note original turf line running across the section at ceiling height

The shelter appears to have been built by the cut and cover method as seen by the buried turf line showing the height of the original ground level. It is probable that rather than this area being a mound in the corner of the school grounds, it is actually the original ground surface and that the ground to the east and south was reduced for a cricket pitch. Certainly the top of the shelter structure was at a similar level as the adjacent roads. Such a readily available earthwork would have been viewed in 1939 as an ideal basis for a large school shelter which needed to be built as close to the school and as quickly as possible.

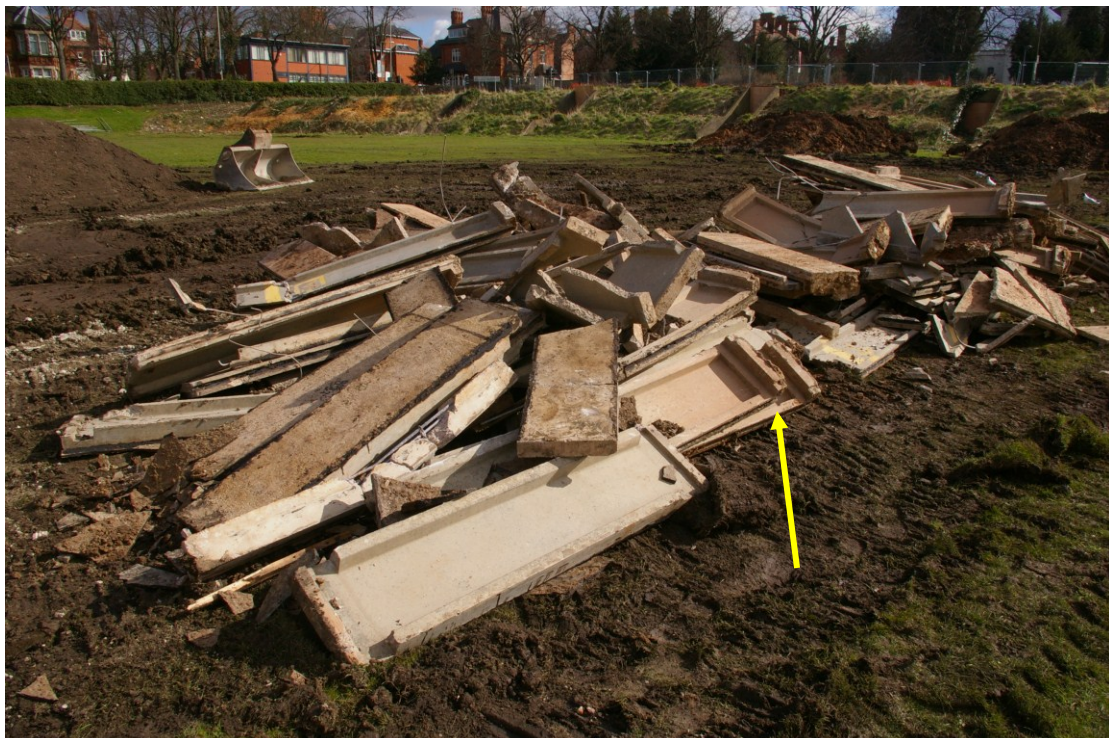
Figure 15 Removed roof and wall panels  
Roof panel in foreground. Arrow the shows foot of a wall panel

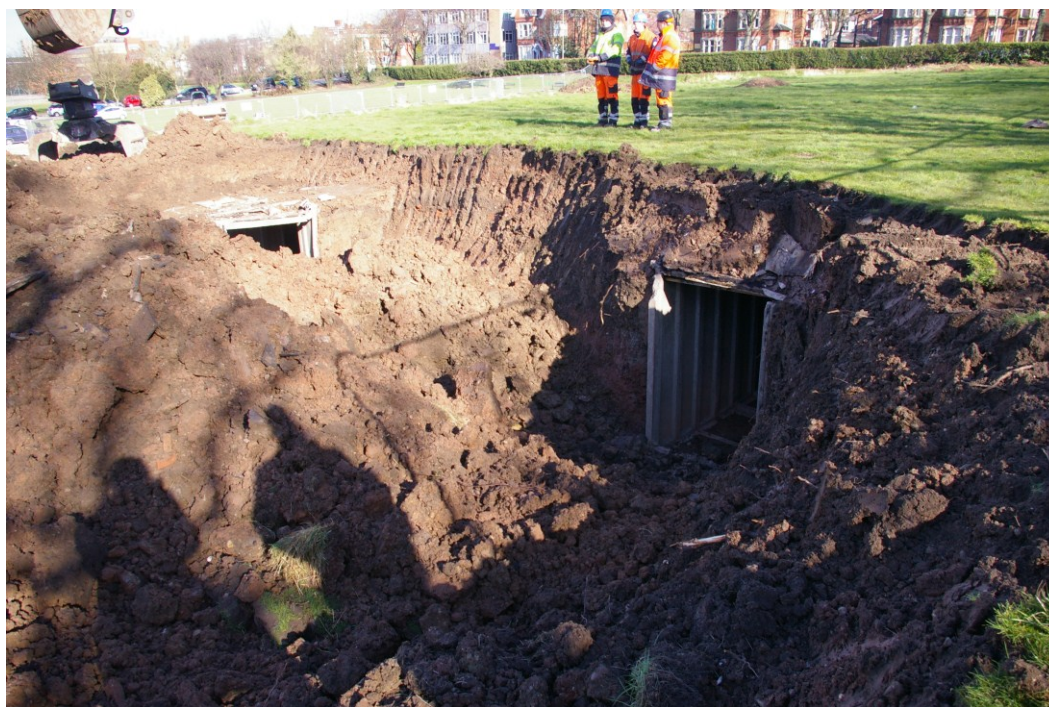
Figure 16 Partial demolition of Tunnel B  
Looking north

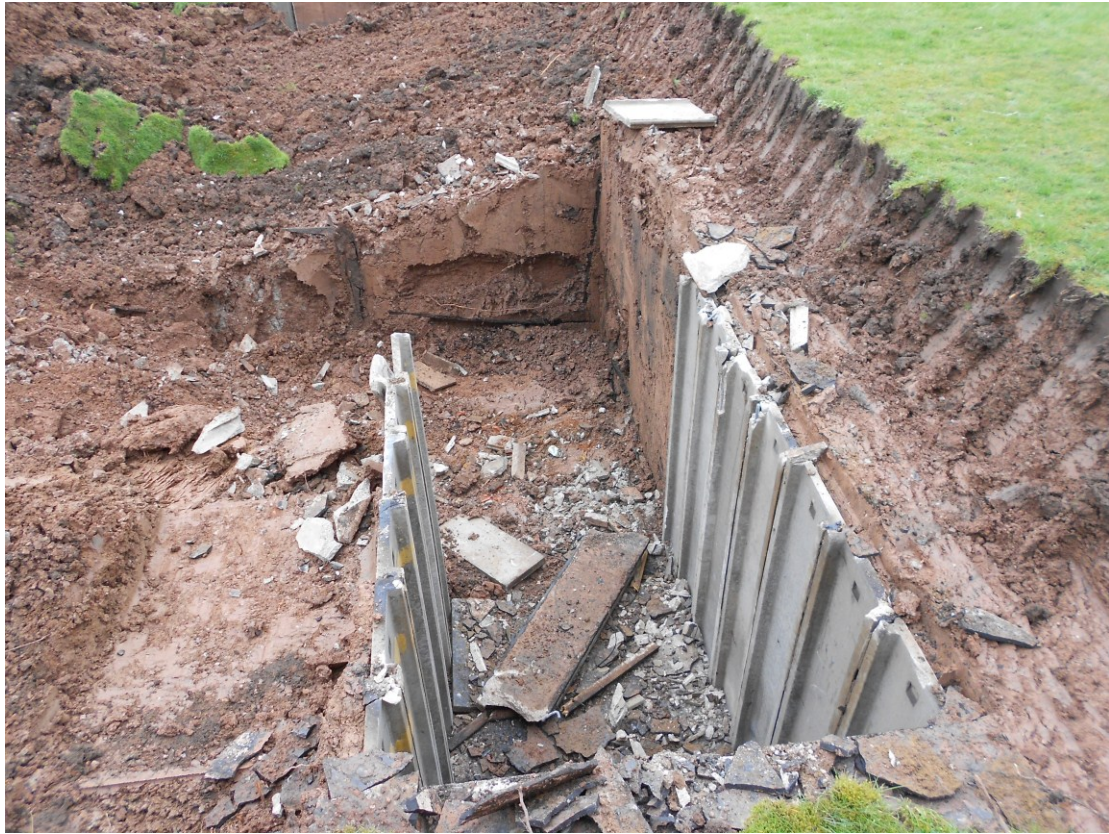
Each identical wall panel was joined to its neighbour using a simple tongue and groove system, with each joint being filled with tar. Small recesses at the top of each wall panel could be seen where a hoist or clip could be located to assist in manoeuvring the panel into position either during manufacture or on site during construction (Fig. 17). The 385mm wide (15 inches) panels had an I-shaped cross-section when viewed in plan. They had steel reinforcing bars running down each side where they were thicker to create the tongue and groove. Some steel rods had begun to rust and cause some spalling, but overall the condition of the panels was remarkably good. Each wall panel had a distinctive foot (see Fig. 15) which, as well as identifying top from bottom, presumably assisted stability during construction. The foot also supported the floor slabs as is discussed below. No cross-bracing had been used to prevent the whole structure from twisting out of alignment and it would appear that the overlapping joints and weight of surrounding earth were sufficient to maintain the structural integrity.

Figure 17 Tongue and groove joints on wall panels

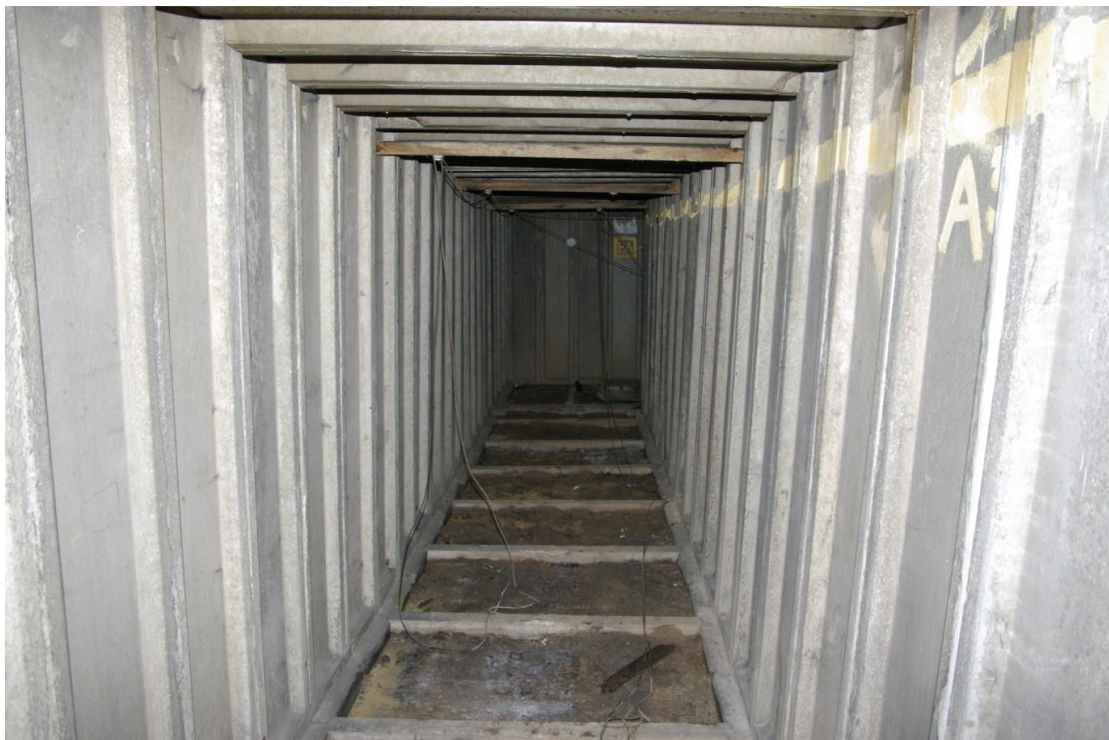
The floor was laid on bare earth with concrete spacers set at regular intervals to prevent the base of the wall panels from slumping inwards (Fig. 18). The tunnels nearest to the entrances had exposed earth floors, but deeper into the system remnants of the concrete slab flooring could be seen in places. The last few metres of tunnel nearest to University Road were almost completely slabbed (Fig. 19). The slabs were laid, apparently without mortar, onto the top of the concrete floor spacers leaving a small drainage gap beneath. Presumably after the war these rectangular slabs were sufficiently easy to remove and would be useful elsewhere. Below the floor and partially dug into the earth was a single ceramic circular section land drain running down the centre of each tunnel (Fig. 20). This would appear to be the drainage system added shortly after construction. No evidence of any pumping equipment was in evidence although it is possible that drainage relied on the natural slope of the land down to the north.

Figure 18 Tunnel A  
Looking south east. Note concrete spacers on floor

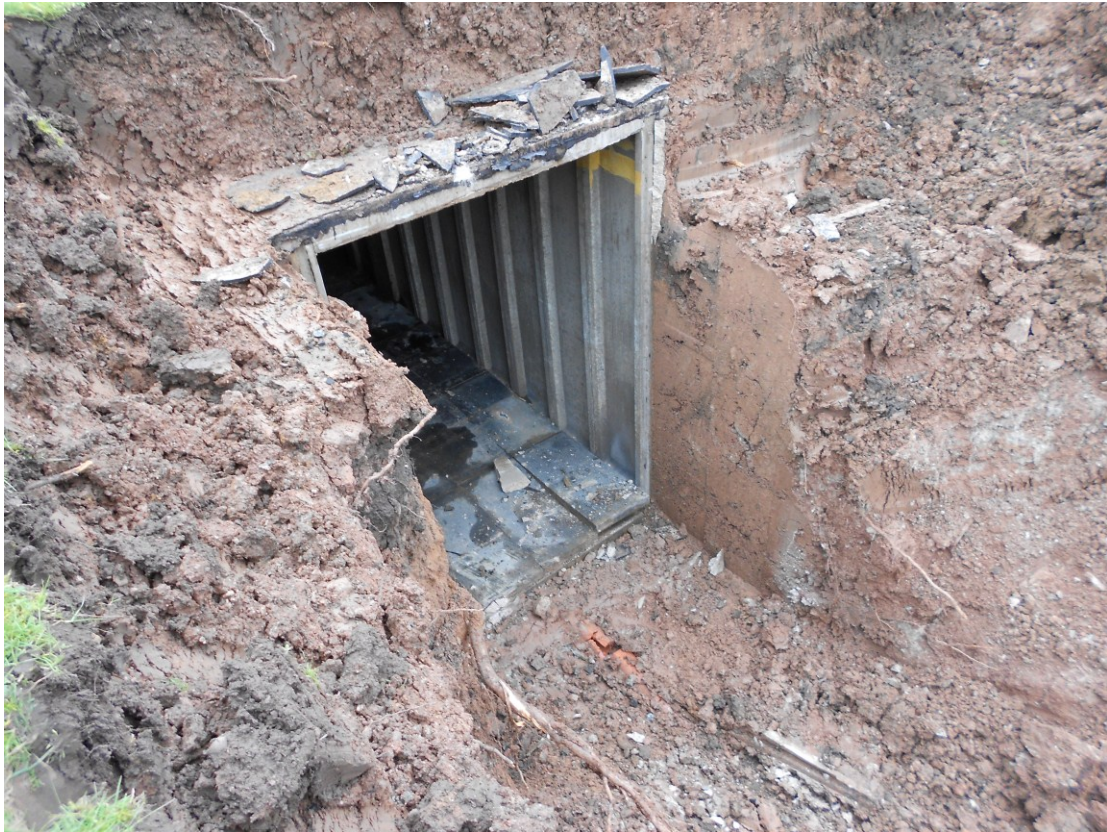
Figure 19 Tunnel E floor slabs near to University Road  
Looking south

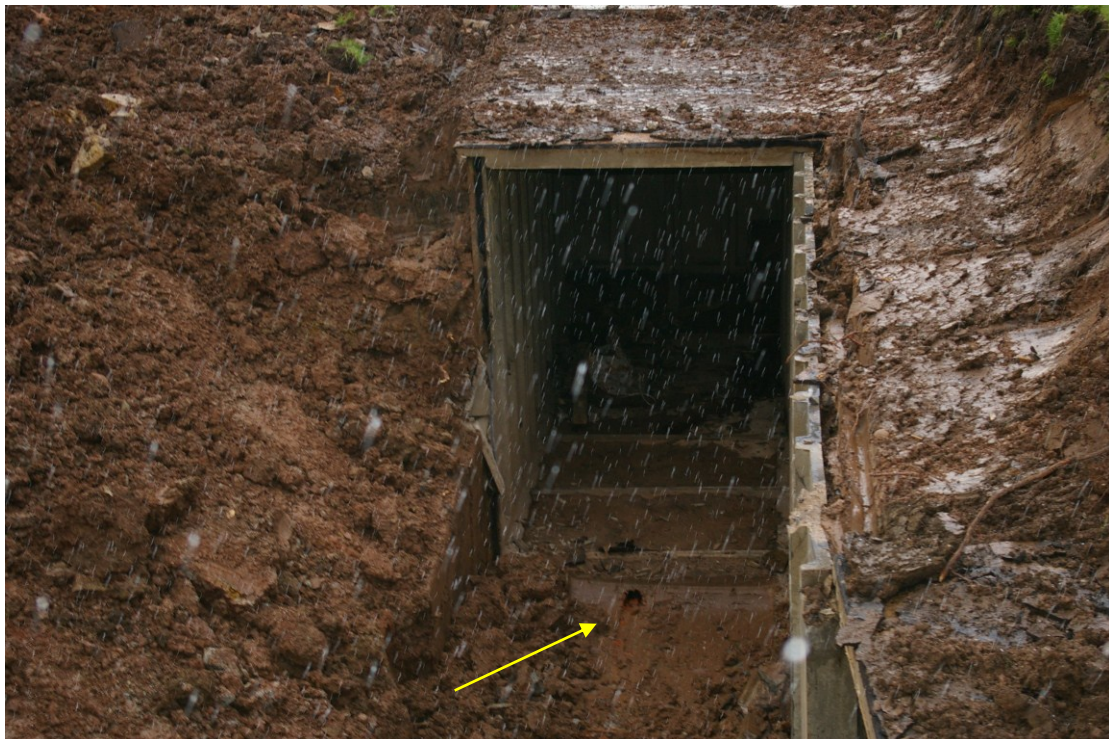
Figure 20 Drain in Tunnel F/G  
Looking north east

The fact that the ground drops away to the south and east should have helped drainage, however the presence of the land drain and the ROLLR records concerning drains would indicate that all was not well. Demolition took place during a cold but particularly dry period so that only condensation and slightly damp floors was seen. It would be easy to imagine significantly wetter floors in poor weather.

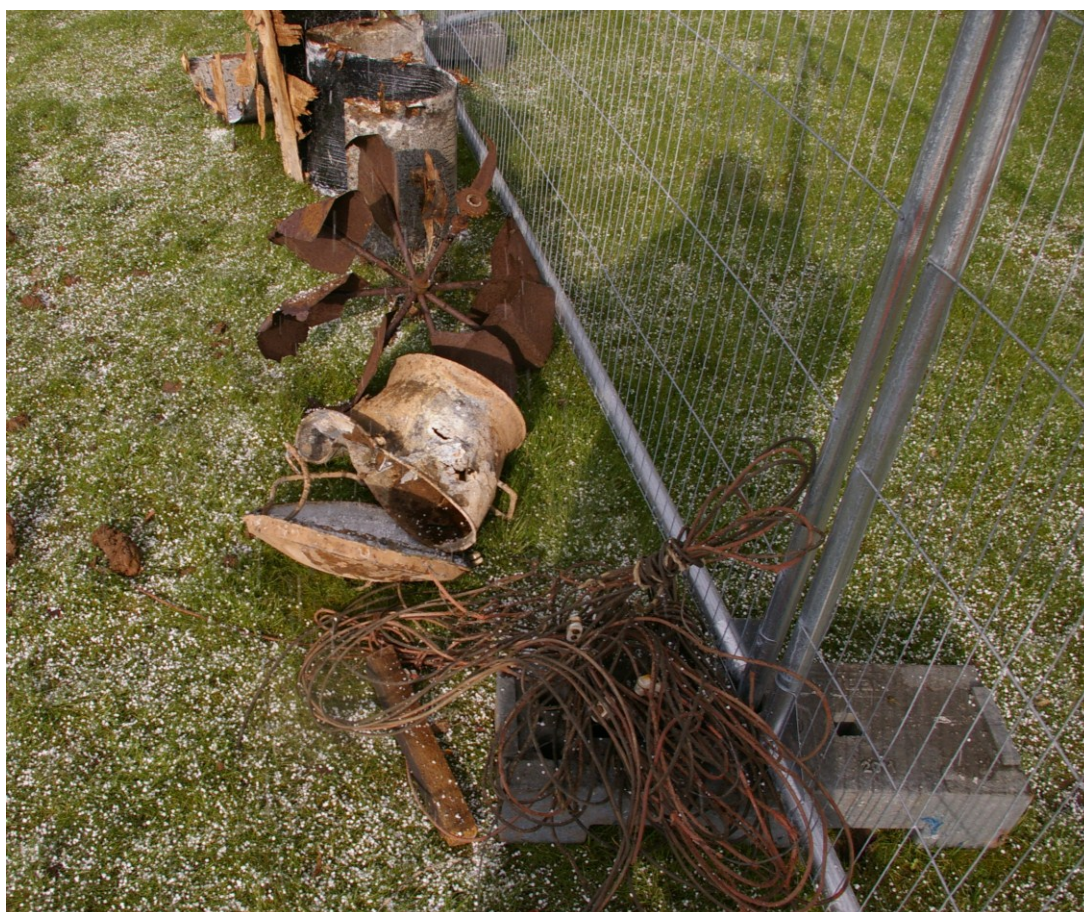
Internally a number of fittings survived, although in poor condition. Near to many of the 17 ventilation shafts which were identified during demolition were the remains of large hand-operated paddle-like fans. They had hand cranks attached to a chain and gear wheel (Fig. 21) and were, apparently, housed within a simple metal, plywood and chicken wire structure. None of the fans survived in-situ and it would seem that the fans were simply pushed down into the tunnels when the ventilation shafts were removed and covered over. A variety of wooden and metal ladders were also seen near to the ventilators which might suggest that they could also be used as escape routes should the entrances become blocked. A simple electrical cable system with Bakelite fittings ran along the roof of each tunnel and was attached to timber cross members. The timbers were wedged at ceiling height into the recessed slots in the wall panels which were noted earlier (Fig. 22). The cables and fittings appeared to be the remains of the lighting system but no bulbs remained – possibly removed for use elsewhere during the post-war austerity period. A number of galvanised steel buckets were noted, some having perforated covers, and are likely to be soil buckets. No evidence of any form of seating was seen but as these would have been easily moved it would seem probable that they were taken away for use elsewhere.

Figure 21 Recovered fittings  
From top; ventilator housing, fan, soil bucket and lid, lighting cable

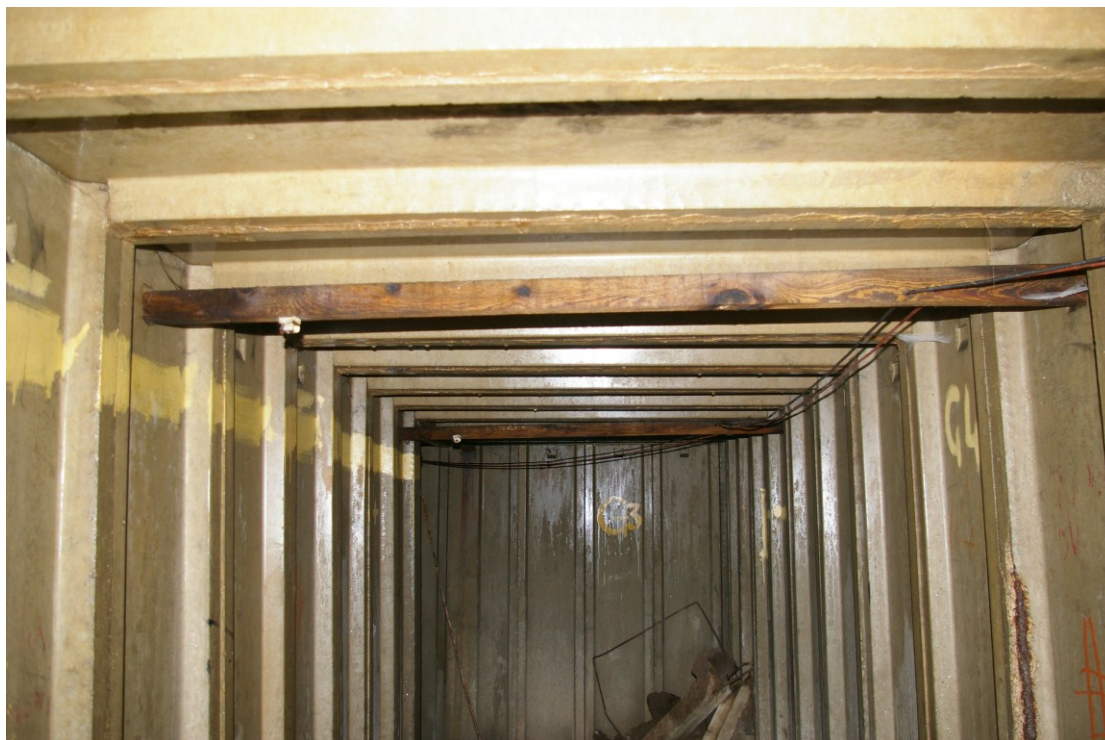
Figure 22 Lighting system in-situ, Tunnel G  
Looking north east. Note wooden cross members held in pre-cast slots

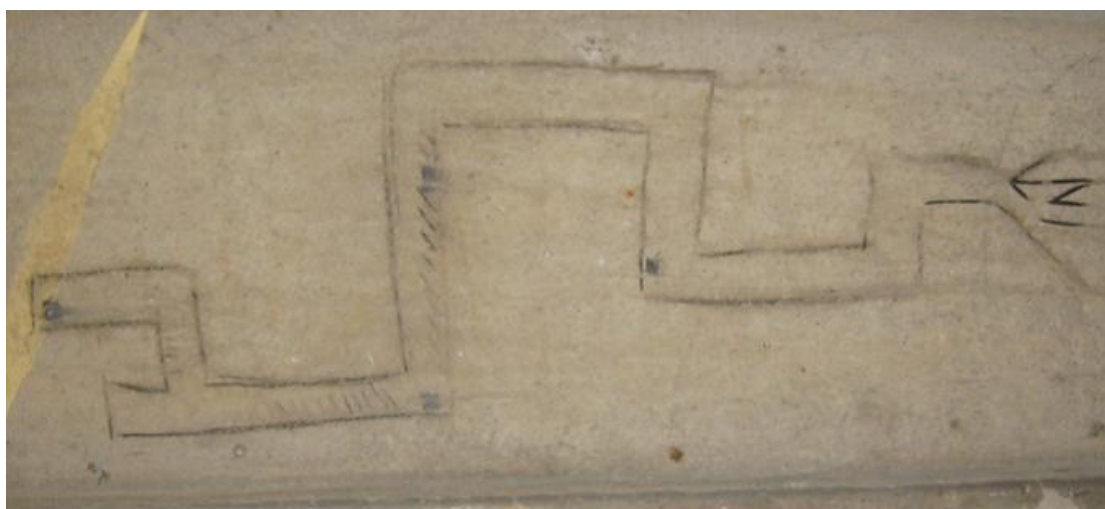
During demolition a number of wall markings were evident. The most prominent of these was a system of crudely painted yellow lines with numbers and letters identifying each segment of tunnel. These were noted during the visit for the heritage statement and it was suggested that these dated to the post war period when it was used for Fire Brigade practice. There is no reason to dispute this idea as in places it could be seen that they were painted over earlier red markings. The letter designations have been used for the purposes of this survey and are shown in Figure 11. Pencil-drawn maps appear on the walls in various places, one appears to show a complete length of tunnel with annotations suggesting the location of ventilator shafts and, possibly, benches (Fig. 23). Interestingly, if the interpretation is correct, there do appear to be ventilators at the extreme ends of each tunnel. The maps are quite crude and do not show any of the interconnecting passages which link each tunnel. It is possible that these are a much later addition as one would assume that rather more permanent and visible maps would be used during the war.

Figure 23 Sketch map on wall of Tunnel D  
Black squares probably indicate vents, hatching might show location of benches

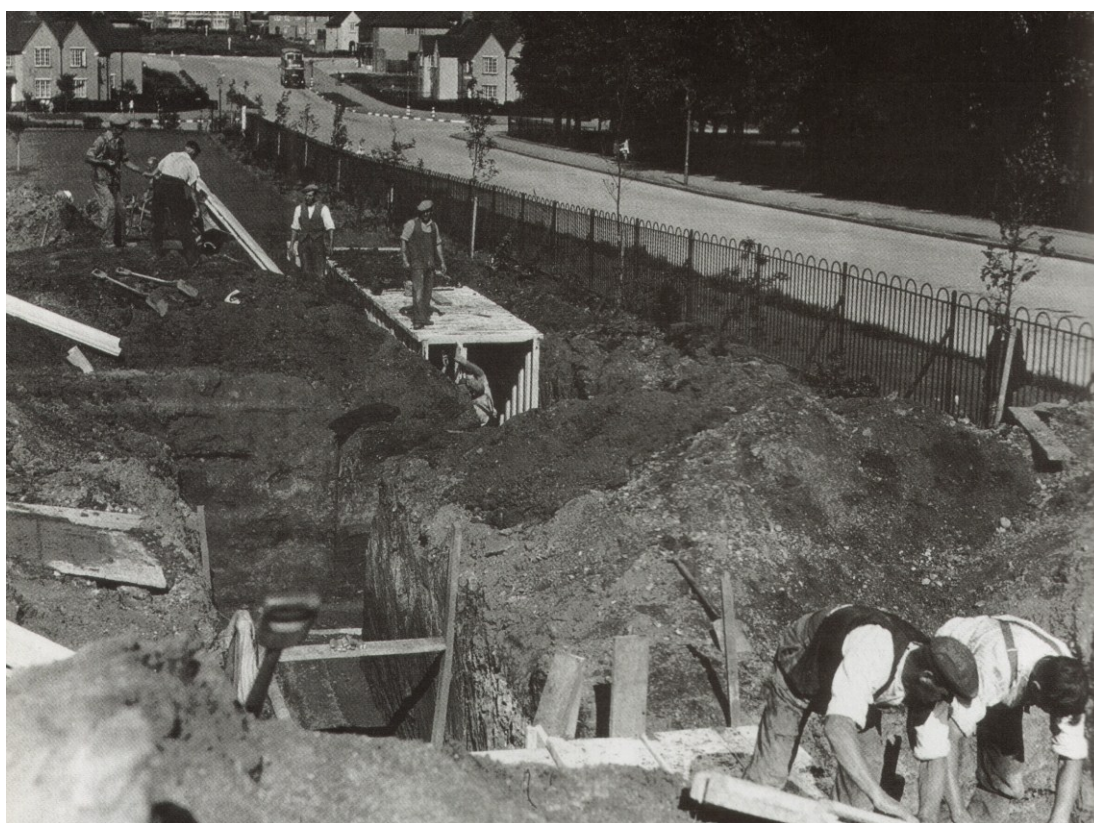
As demolition progressed it could be seen that the surrounding earth mound consisted of a homogenous mid orange brown silty clay. Despite map evidence indicating that this feature dates back at least to 1902 there was nothing to indicate any former uses. Also, the tunnels must have been built using a cut and cover method but no difference could be seen in the main mound material and any potential back-filled material against the outer walls of the shelter. There was however a clear band of darker material at about roof height where the original turf line was and which was then buried by upcast from the excavated tunnels. Figure 14 most clearly shows this. The cut and cover method would seem to be the preferred method of construction for such a shelter as photographs exist of other structures being built elsewhere in Leicester (Fig. 24).

Figure 24 Construction of an air-raid shelter  
Fullhurst Community College (formerly Newarke Girls School)  
(Record office for Leicestershire, Leicester and Rutland)
