**Archaeological Attendance, Inspection and Recording
at the Church of St. Simon and St. Jude
Church Street/Almeys Lane,
Earl Shilton, Leicestershire,
NGR SP 4711 9819**

ULAS Report No 2014-059
©2014

**For:
Architects LE1 LLP**

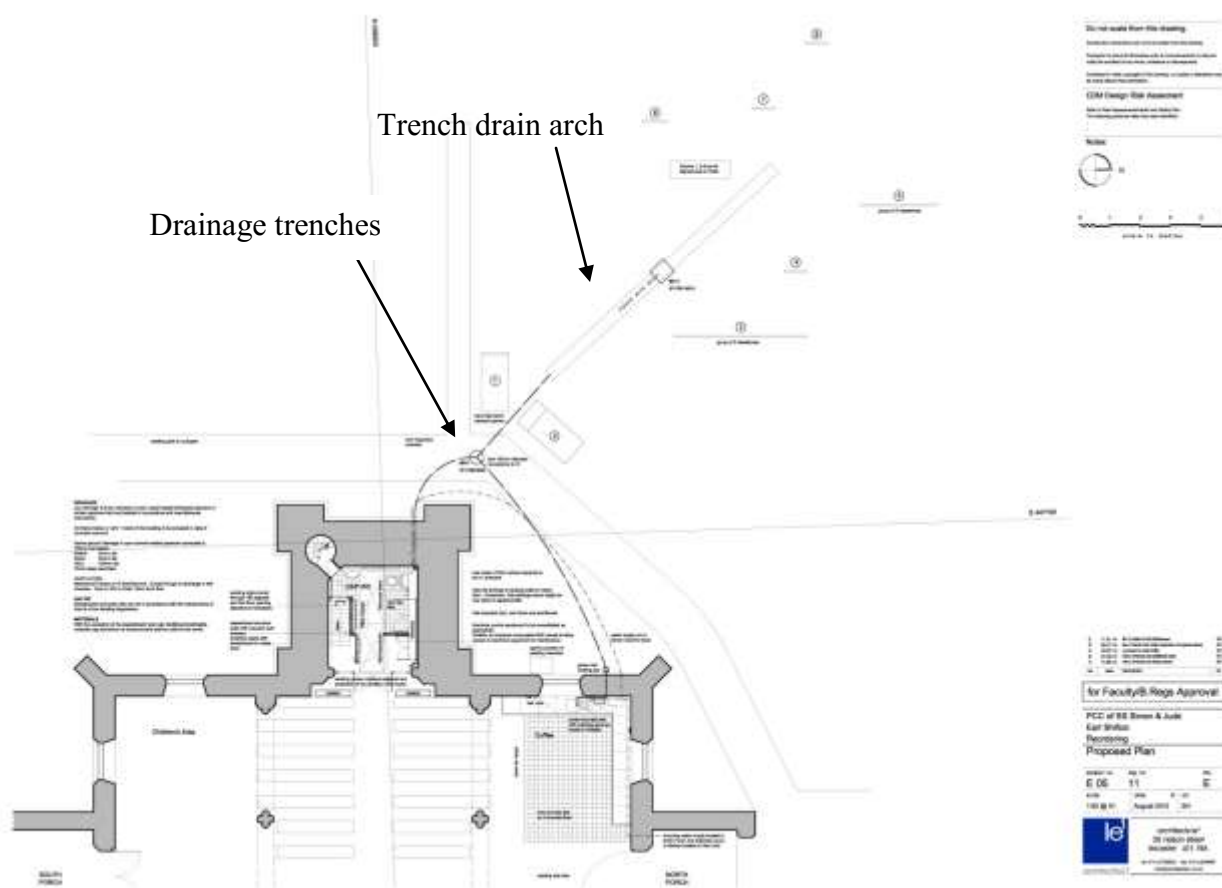
Figure 2: Plan of west end of church showing areas watched (plan supplied by client)

The site was visited on 19th March 2014 during the groundworks for the new drainage trenches and trench arch drain. The sides of the trenches were inspected and the spoil heaps checked for artefacts. A trench, 0.25m wide, had been excavated from the west wall of the north aisle towards the north-west corner of the tower. The trench varied in depth, measuring 0.6m at its deepest point and 0.3m at its most shallow, close to the wall of the church where it exposed the foundations of the north aisle (Fig. 5). The topsoil consisted of dark brown clayey sand 0.15m thick, overlying reddish brown, slightly clayey sand with frequent medium sized rounded pebbles and occasional fragments of mortar, brick, tile and slate.

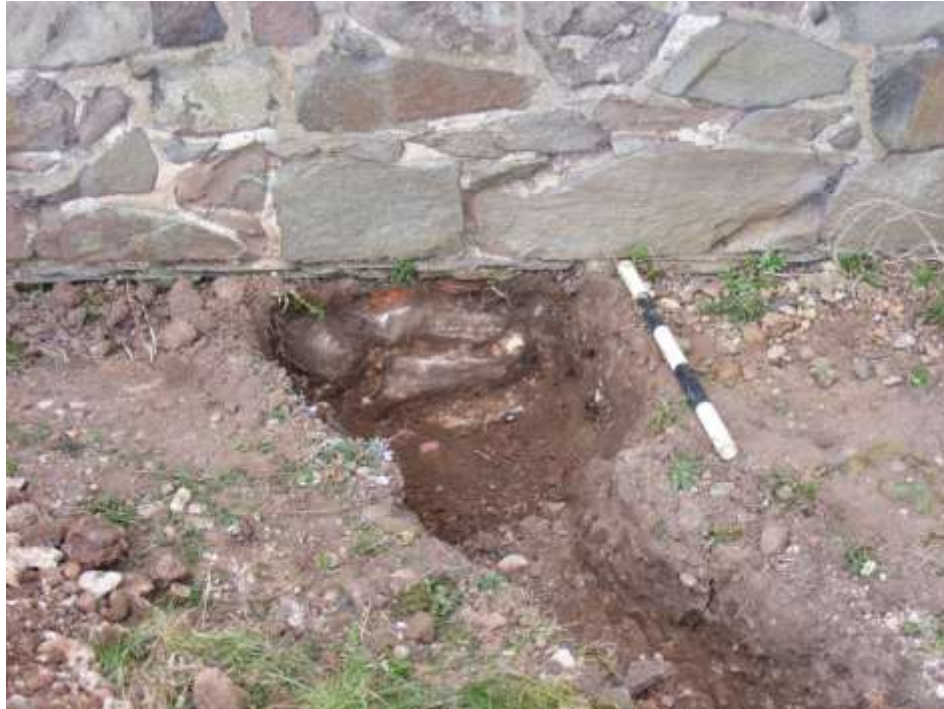
The foundations of the western wall of the tower were also exposed by the work (Figs 3-4). The tower is the only part of the church that was not rebuilt in the 19th century. However, the mortar and arrangement of the stones appeared different to the rest of the tower wall, more closely resembling the foundations of the north aisle. It is therefore possible that the tower was 'shored up' or underpinned during the rebuilding of the church or the 1874 restoration of the tower.

Figure 3: The western wall of the north aisle showing foundations

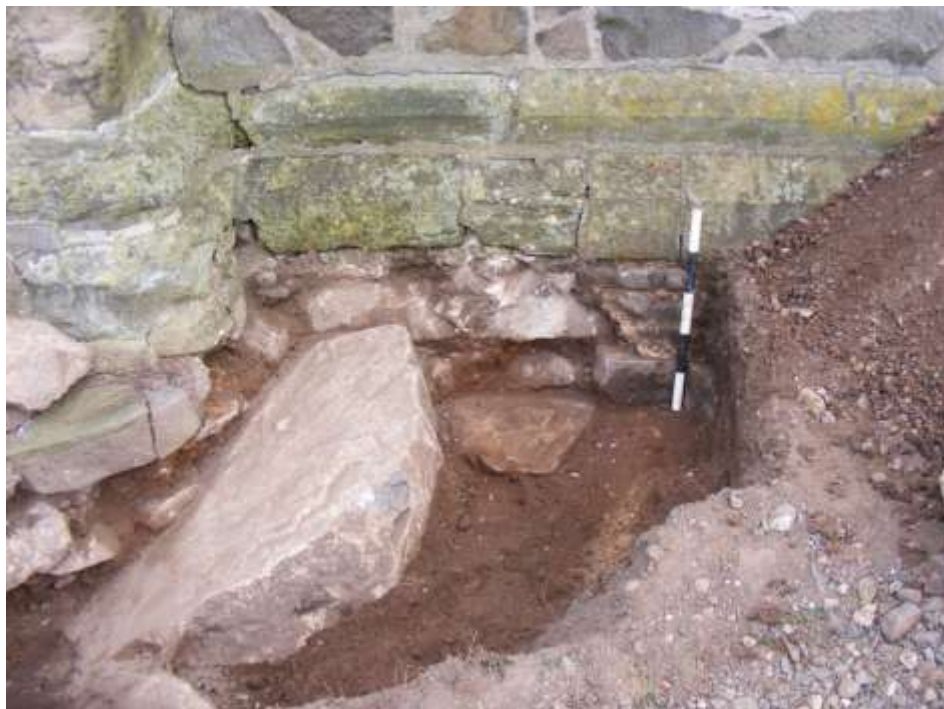
Figure 4: The exposed foundations of the tower wall, looking east

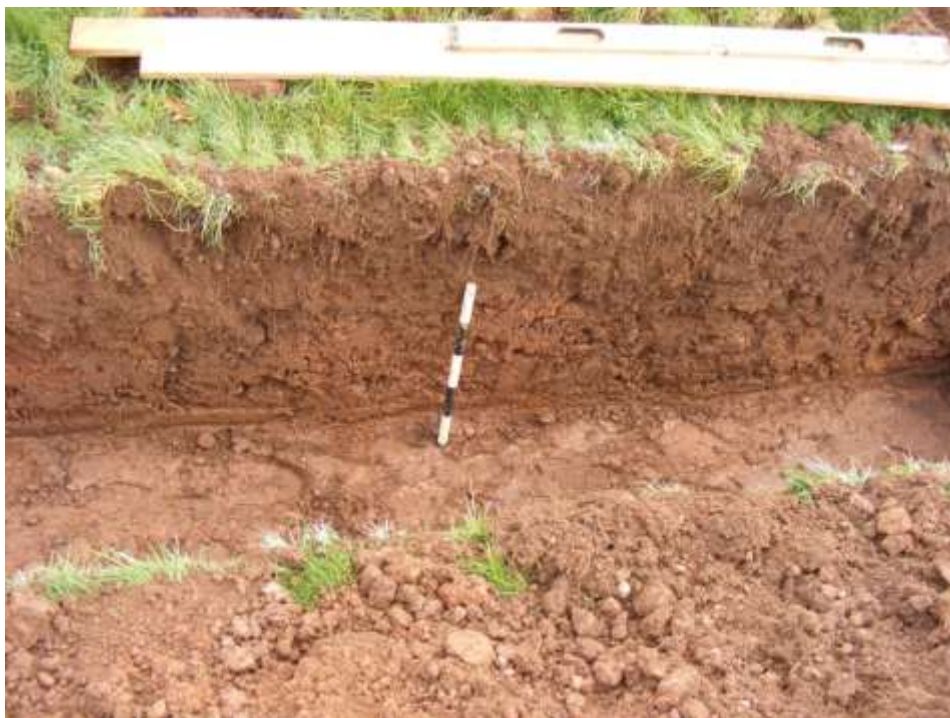
The drainage trench led away from the tower on a north-west alignment and was hand-excavated between the gravestones. The trench arch drain measured 0.85m wide and was approximately 12m long. It was excavated to a depth of 0.9m at the south-east end, becoming shallower towards the north-west end, where it was 0.65m deep. Topsoil, as previously described, overlay a fairly loosely compacted subsoil, consisting of reddish brown clayey

sand, with frequent rounded pebbles and occasional fragments of modern brick and tile. The topsoil was approximately 0.35m thick in this area, however the boundary between the topsoil and subsoil was quite diffuse in this area. No archaeological deposits were observed.

Figure 5: The section for the trench arch drain, looking south-west
