**An Archaeological Watching Brief and
Historic Building Record of Building 2,
22 High Street, Kibworth Beauchamp,
Leicestershire.**

ULAS Report No. 2014-098
©2014

**An Archaeological Watching Brief and
Historic Building Recording (Building 2) at
22 High Street, Kibworth Beauchamp,
Leicestershire**

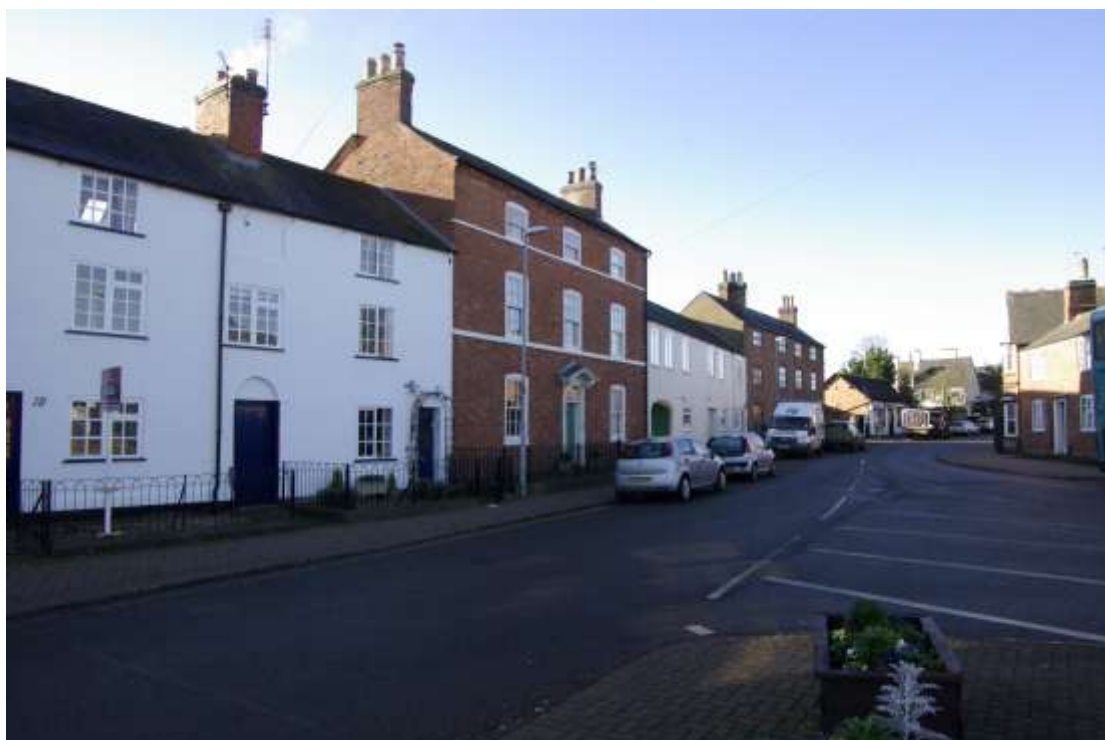
Figure 3 22 High Street
Looking south west. Site entrance is under the archway between the two cars

To the rear (south) of Numbers 22 and 24 is a small yard area which leads to a pair of large two storey outbuildings which are identified as Building 1 and 2. Access to the yard is presently from High Street through a covered entrance created when Number 24 was extended to join the west wall of Number 22 (Fig. 3). The buildings, which until recently belonged to Number 22, were formerly used as stables, stores and haylofts which, although not individually listed, form part of the curtilage of the property (Fig. 4). This report presents the results of work on Building 2 which runs north to south along the eastern boundary of the site. Building 1 lies to the west of Building 2 and is on an east to west alignment parallel to the rear of Number 24. To the south of both buildings is a large south-facing garden which has now been partially truncated by a new housing development covering a number of former rear gardens.

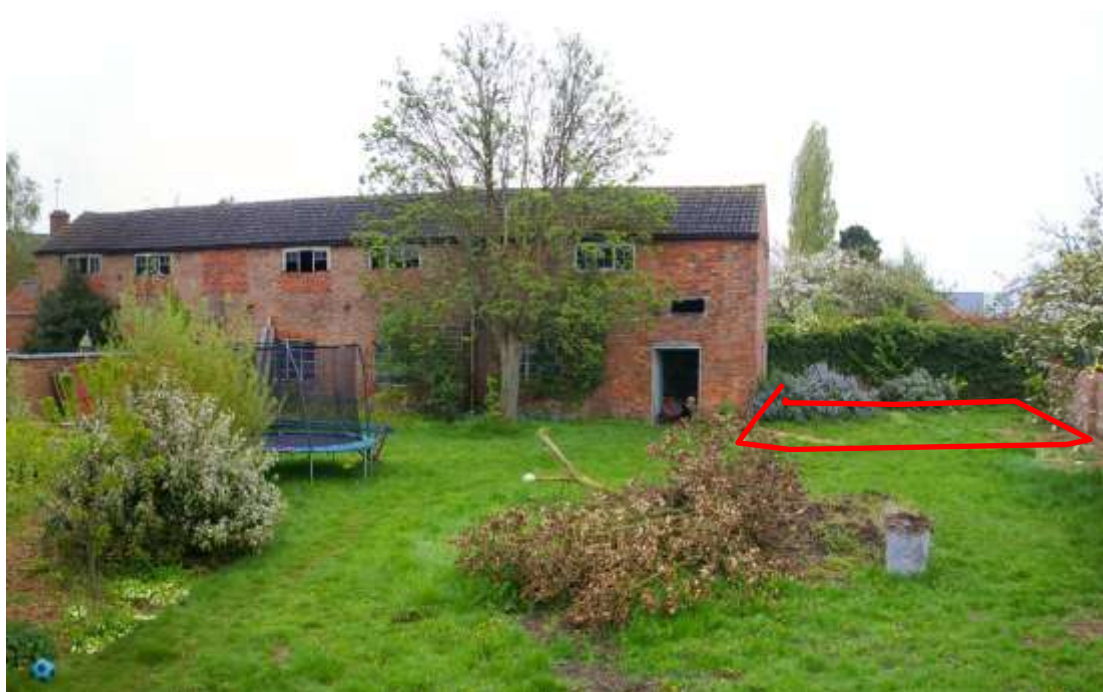
Figure 7 Watching brief location
Looking east. Watching brief area outlined behind gable end of Building 2

site was partially enclosed by the southern elevation of Building 2 and the site boundary wall to the east (Fig. 7). The southern part of the stripped area was bordered by a newly constructed wall running along the entire southern edge of the site. The western side of the stripped area facing the garden was open.

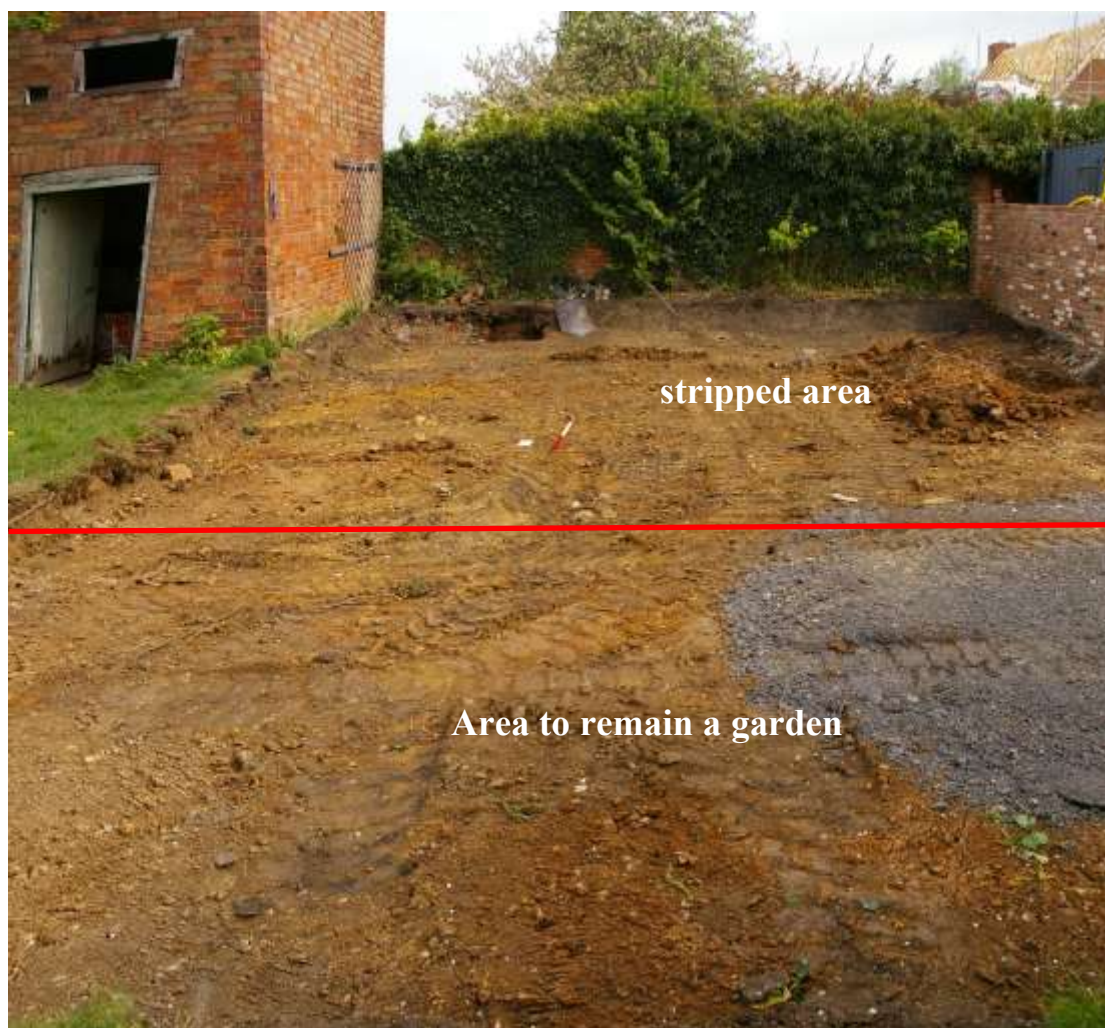
Figure 8 Stripped area
Looking east. 1m scale

The turf and soil was removed by the machine in level spits down to a depth of around 0.3m. The depth of the soil was very variable but tended to be much deeper on the eastern side of the site against the boundary wall. At this point the topsoil lay over silty clay subsoil which had a depth of 0.3m. On the western side of the stripped area 0.17m of topsoil lay over 0.13m of subsoil which lay over the sub-stratum which consisted of a mid yellowish brown sand and gravel with some clay content (Fig. 8).

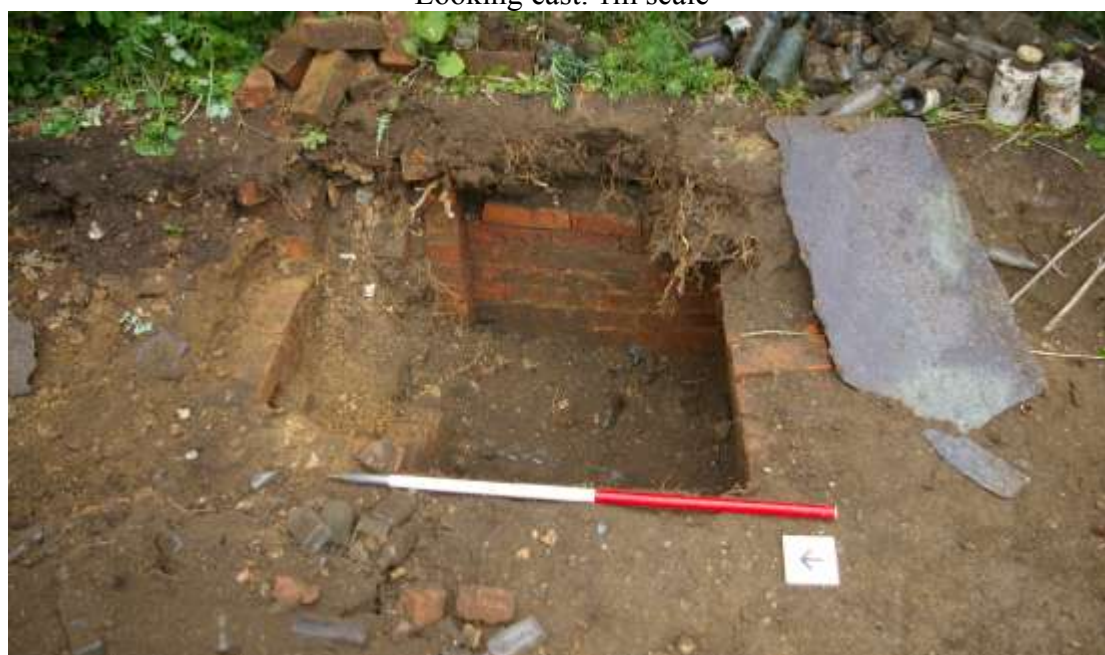
Figure 9 Brick feature
1m scale

A new sewer pipe leading from a cabin on the neighbouring building site was encountered at the south-eastern edge of the site during excavation. Close to the north-eastern corner of the site a small brick rectangular feature, measuring 0.9m by 0.6m and partially covered by a large single slate slab, was revealed. The interior of the feature was filled with soil and a large number of wine, medicine and whisky bottles. Judging by the labels visible on the bottles, these were broadly dated to between 1950 and the 1960s.

The brick feature was excavated to a depth of around 0.7m and bottles and soil were still being removed. Eight or nine courses of brick were revealed. The brick sizes suggested a late 19th or early 20th century construction date.

Overall, the watching brief was negative with the exception of the brick feature. This seems likely to be a disused cess pit or drainage feature.

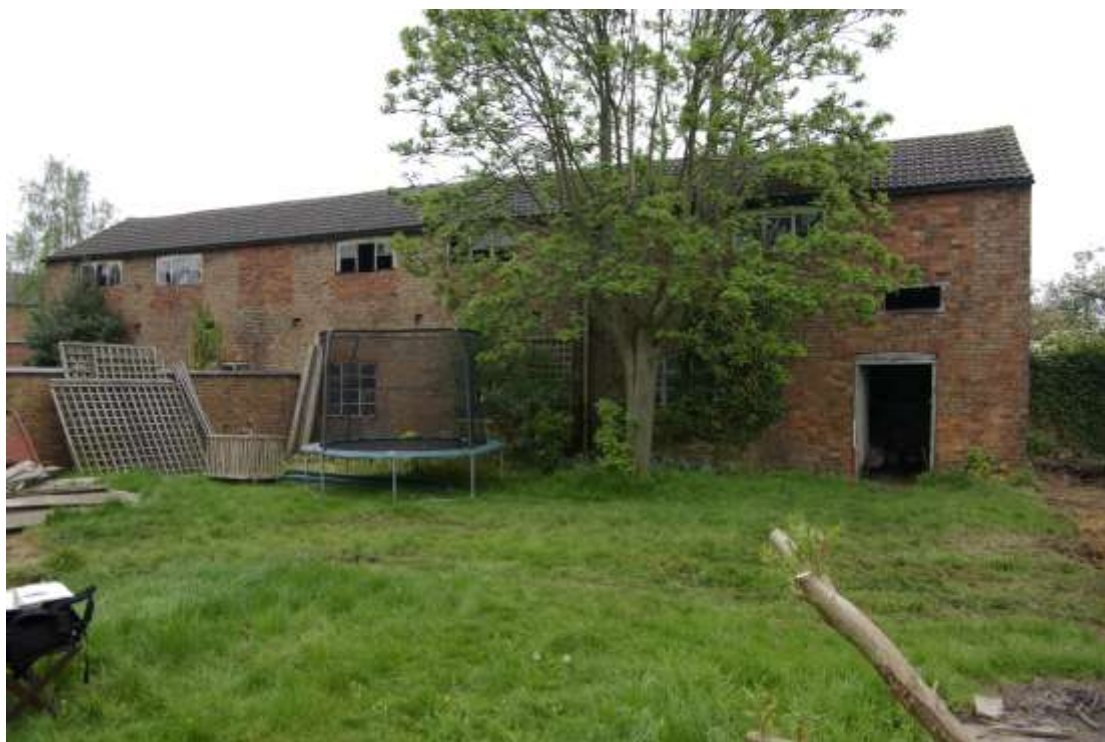
Figure 10 Building 2 West facing elevation
Looking east

Building 2 forms a two-storey structure built on a north to south alignment to the rear of the buildings fronting onto High Street. It is set to the east of Building 1 which follows an east to west orientation. The building is constructed using red bricks measuring 240mm long by 76mm high by 114mm wide for the northern two thirds of the building and 240mm long by 70mm high by 114mm wide for the southern third. The bricks are laid in courses of three stretchers and one header as seen in Building 1. Window openings have lintels made of flat-topped soldier courses with curved lower edges. The roof covering is of mid to late 20th-century concrete tiles and is clearly a later replacement. Despite the new roof covering and two sizes of brick the style of building and choice of materials suggest it to be of a mid to late 19th century origin (Figs. 10 and 11). This is a similar date to Building 1 but, as the materials are slightly different, the build dates are likely to be slightly different.

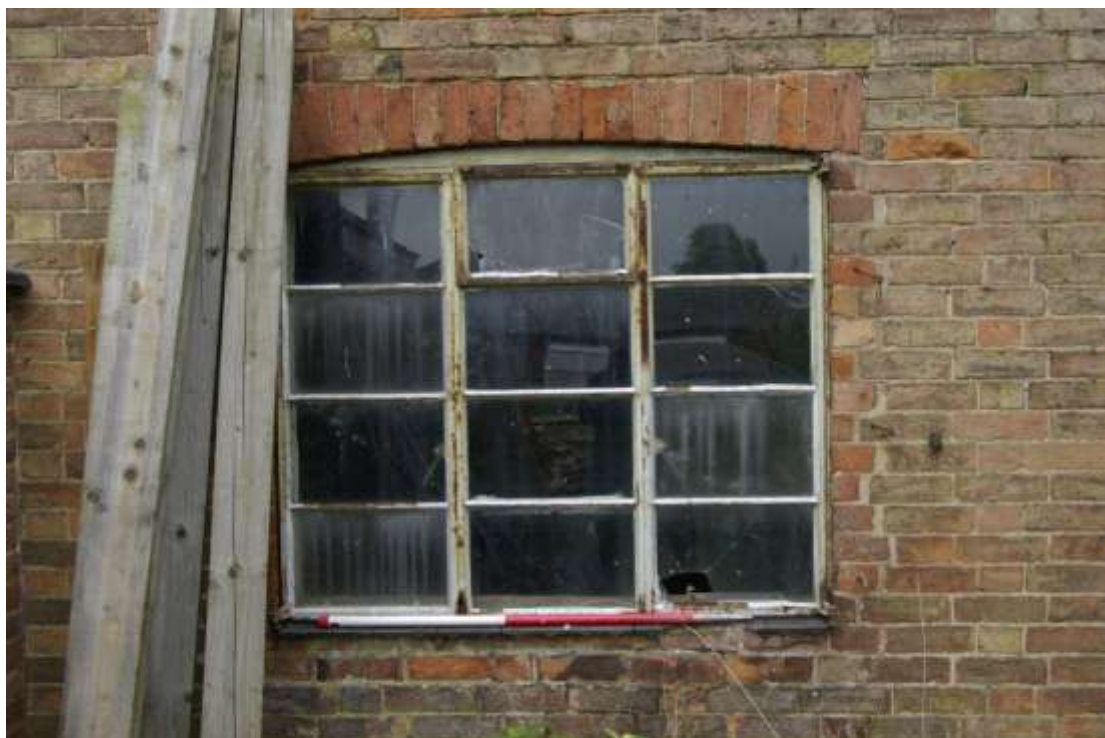
Figure 12 Ground floor window, west facing elevation
Looking east. 1m scale

The ground floor has three metal-framed windows of four by three panes (Fig. 12). These appear to be of possible mid-20th century date. The ground-floor windows in the portion retained by No 22 are similar. The original doorway to the building is at the northern end of the elevation. The sills are made from flat roof tiles. The doorway on the ground floor at the south end has been modified from a partially blocked window (Fig. 13). The wooden door and fittings appear to be of early 20th century date and may be re-used from elsewhere. The brickwork up the southern corner appears to have been partially rebuilt or repaired which might correspond to the shortening seen on the 1929 Ordnance Survey map. The first floor windows have been partially blocked with brickwork filling their lower halves leaving the crudely sawn off wooden frames on top (Fig. 14). Two first-floor windows have been completely blocked up. The same partial and full blocking can be seen on the northern end of the building which does not form part of this survey (see Fig. 6)

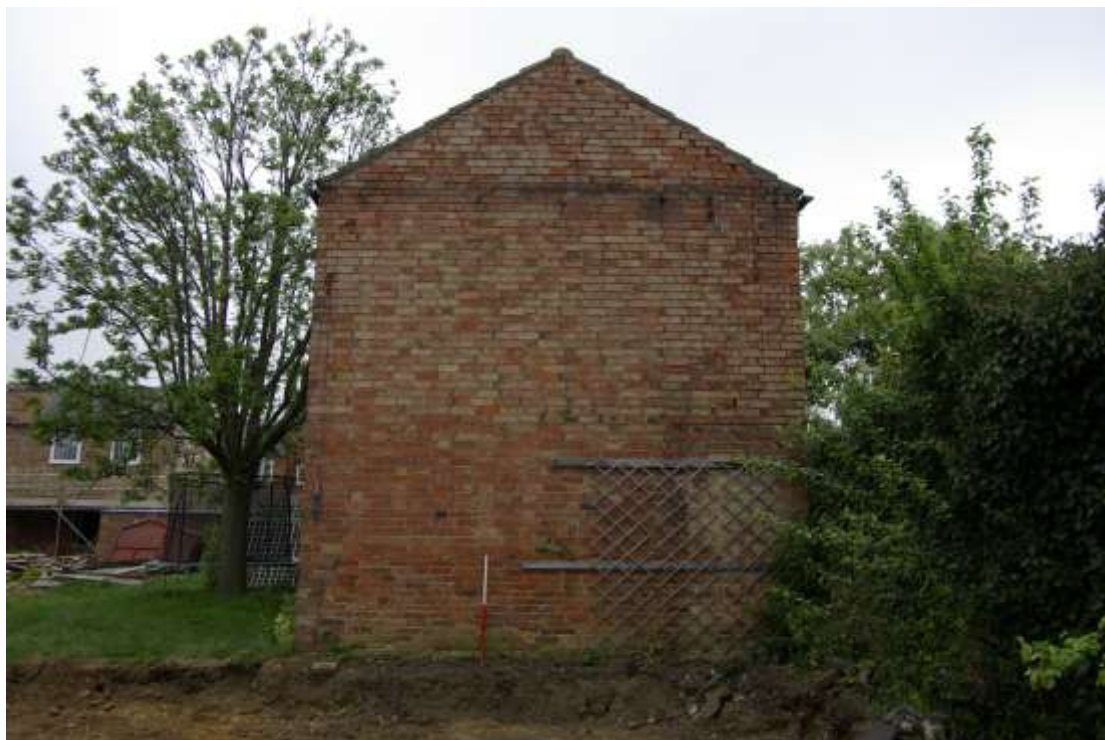
Figure 15 South facing gable end
Looking north. 1m scale

The south facing elevation is a plain brick-built gable end wall. There is evidence of some rebuilding or repair in the south west corner and thinner (60mm high) bricks have been used at the base. This would suggest that re-used bricks have been used to patch a repair or as part of the rebuilt gable (Fig. 15). Apart from the patching there is no clear evidence of the apparent shortening seen on the 1929 map.

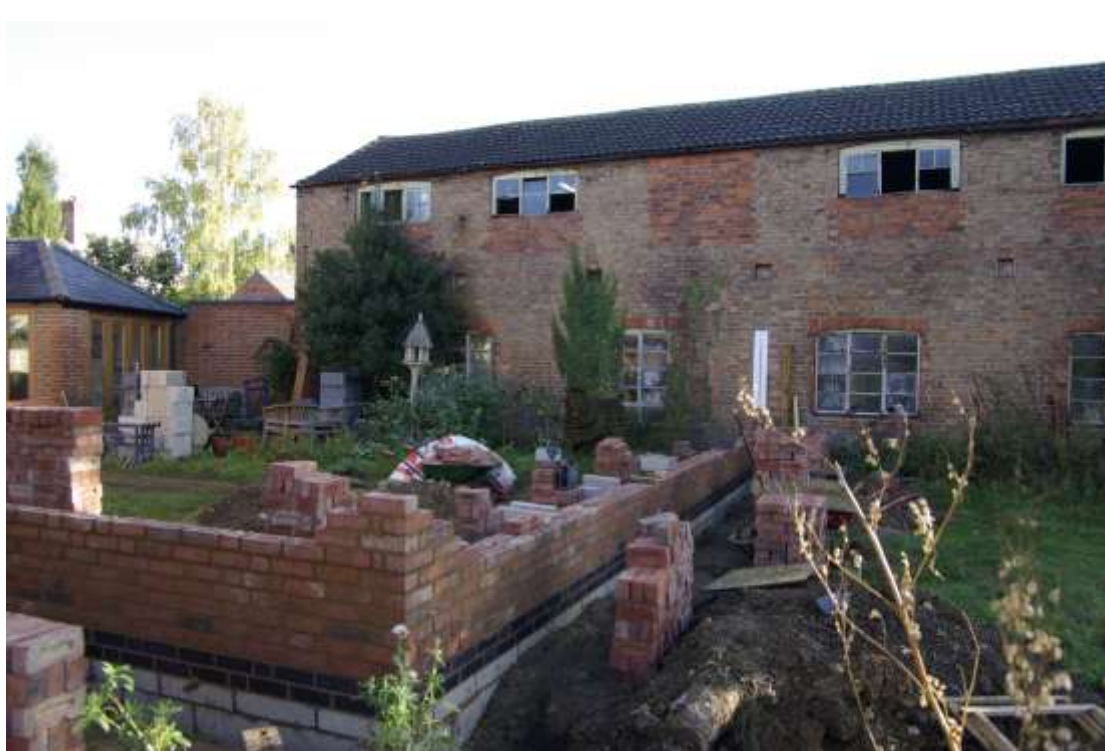
Figure 16 Northern end of Building 2 belonging to 22 High Street
Photo taken in October 2013 during construction of new boundary wall

The north facing elevation forms part of the building which is being retained by the owner of 22 High Street and so is not part of this survey (Fig. 16). The building has been divided internally by the insertion of a modern breeze-block wall.

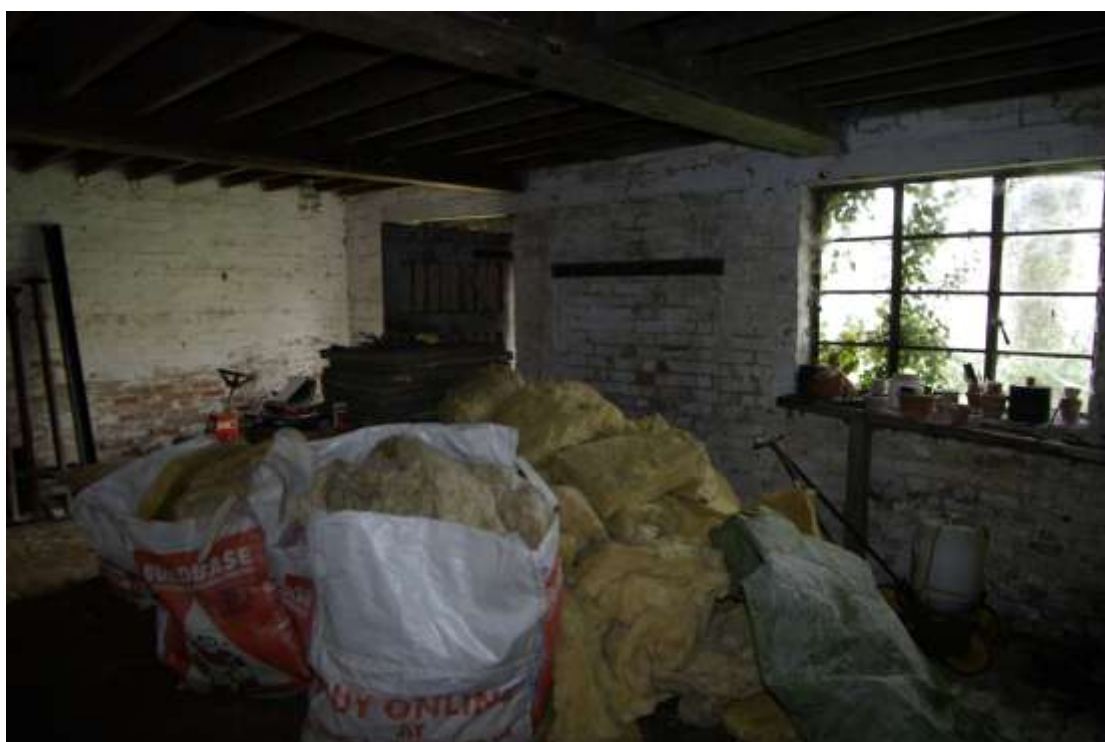
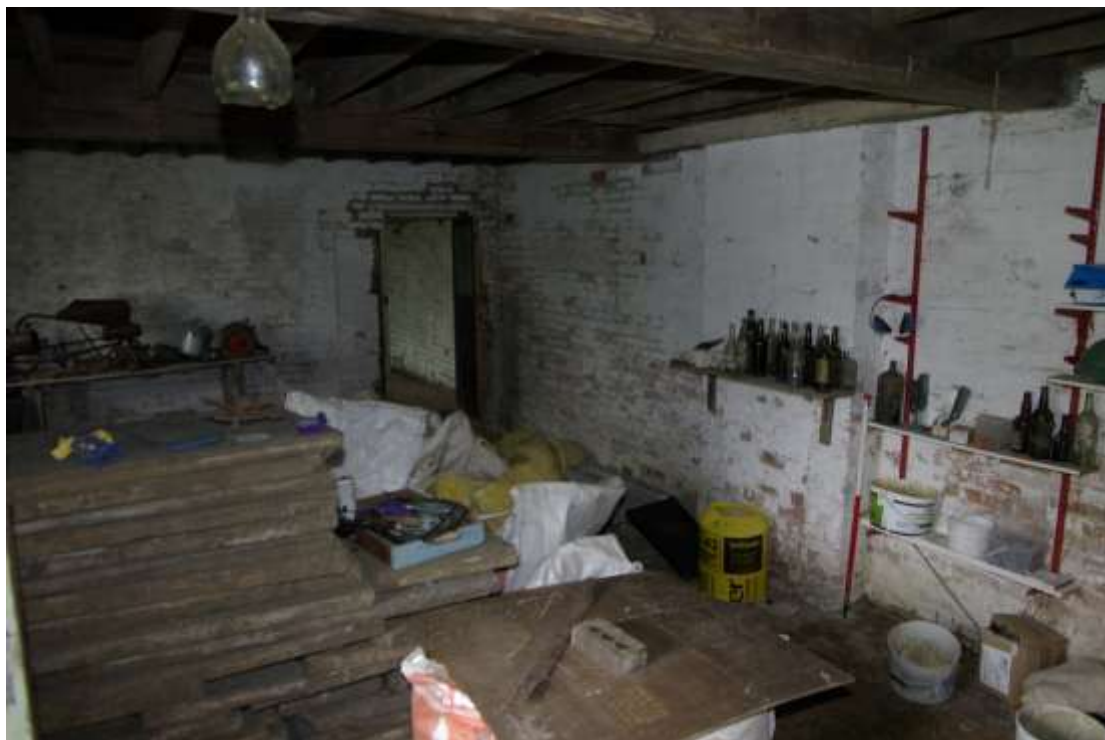
Access to the ground floor is through the modified doorway seen on the west facing elevation. The room is open and has a brick floor and a blocked fireplace and chimney breast on the east wall (Figs. 17 and 18). The first floor is supported by east to west chamfered beams, one of which has a two-ring spectacle mark facing the doorway (Fig. 19). This may be an apotropaic mark but seems quite late in date for such a building especially as the timbers appear to match the 19th-century date of the building.

Figure 17 Ground floor, south room
Looking south west

Figure 18 Ground floor, south room
Looking north east. 1m scale

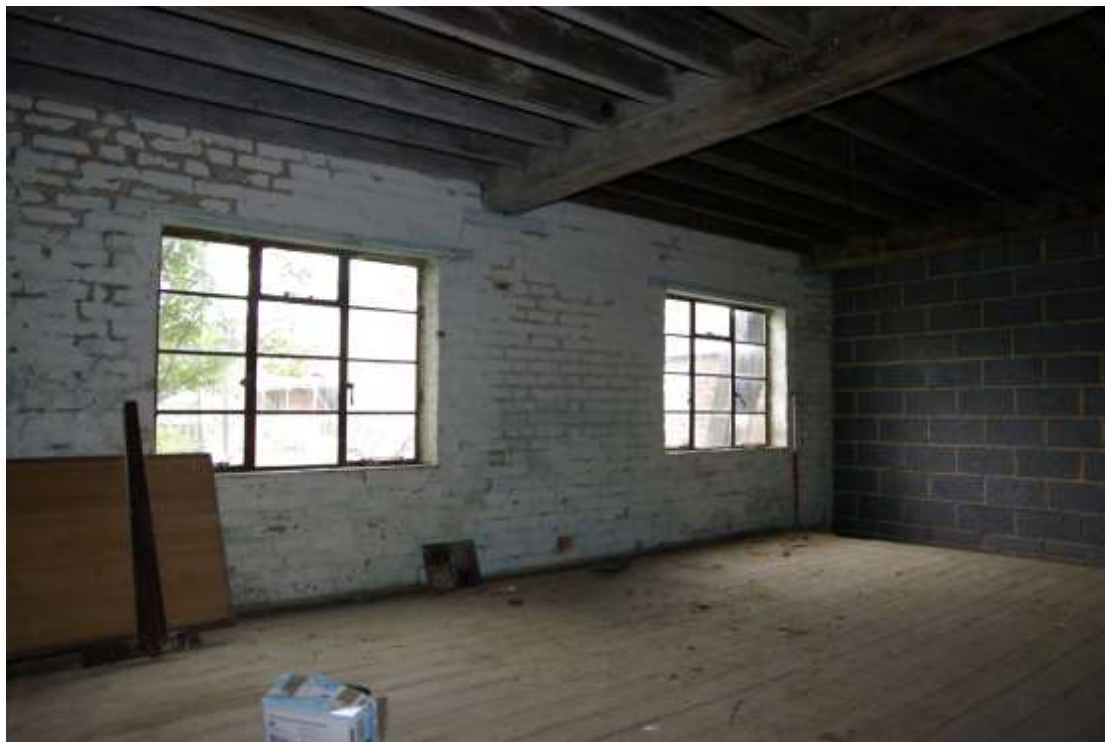
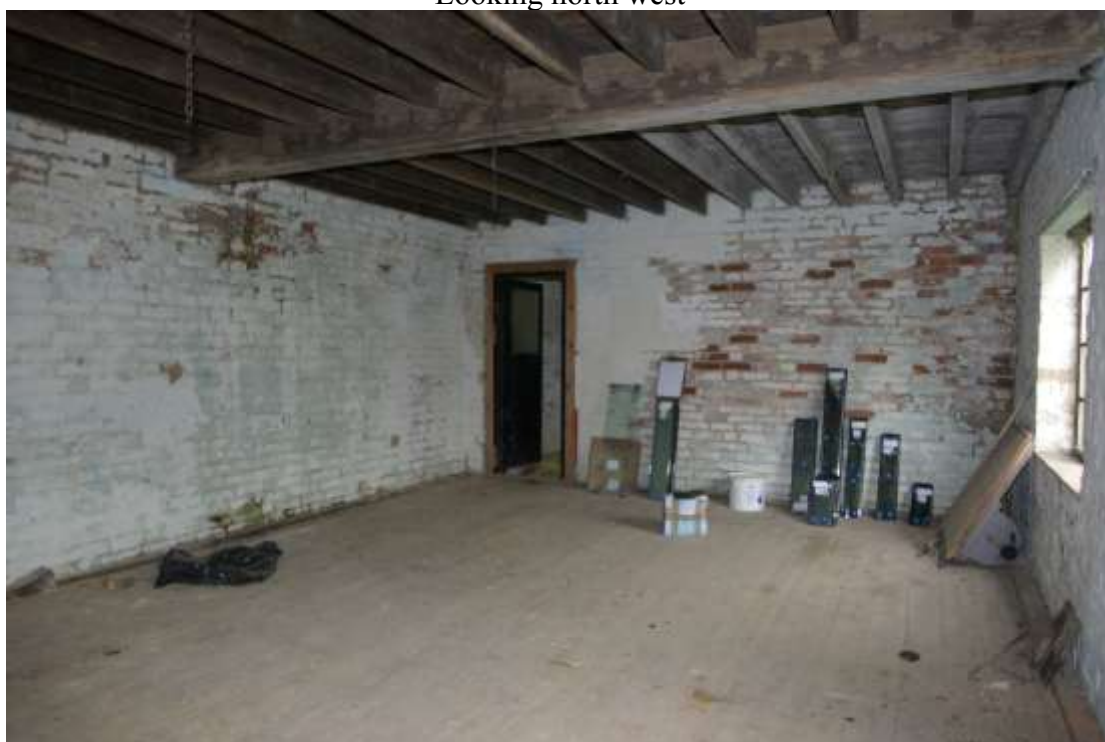
The northernmost room of this survey is actually the central room for the whole building. It has a raised wooden floor which appears to be original, or at least of early 20th-century date (Figs. 20 and 21). Both the floor and the ceiling have been cut to allow the new dividing wall to be inserted. The chamfered beams match those in the south room and have evidence of shipping marks on them suggesting a Baltic origin.

Figure 20 Ground floor, central room
Looking north west

Figure 21 Ground floor, central room
Looking south east

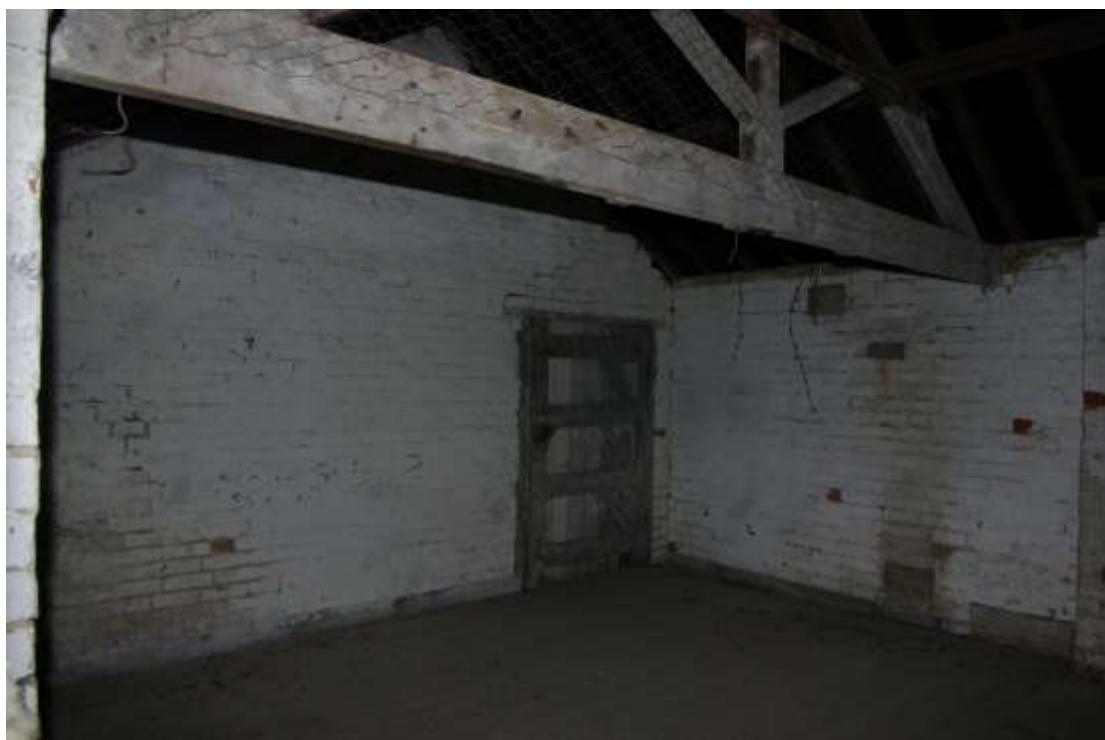
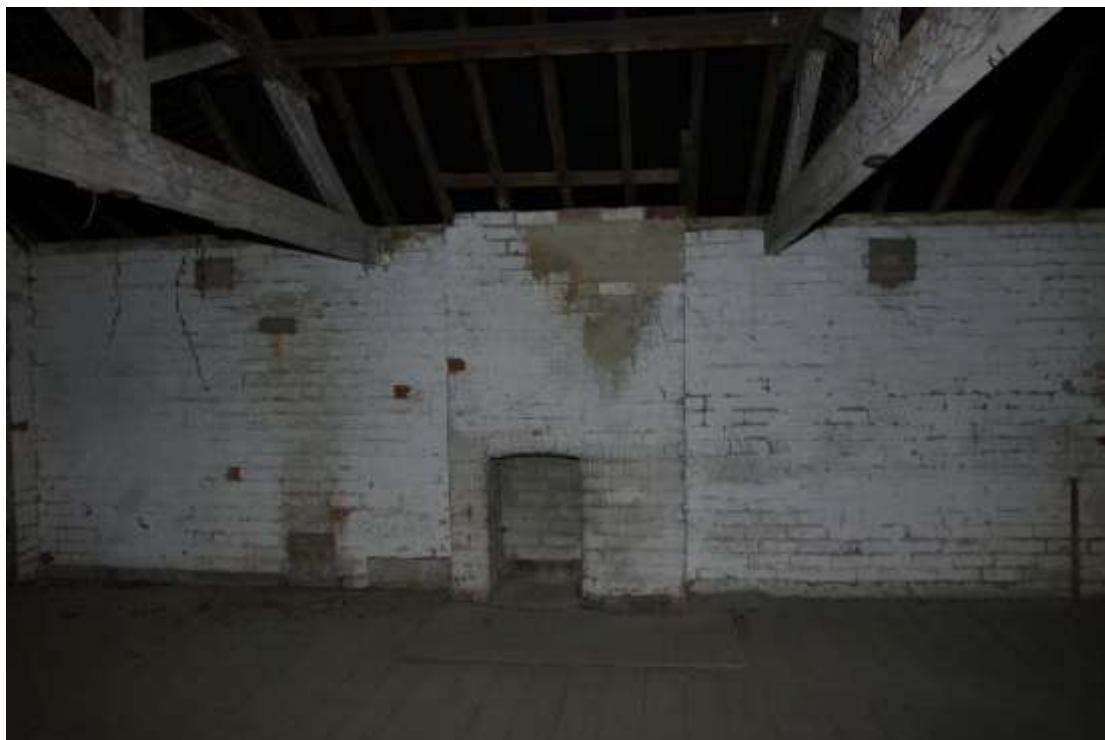
The south room has a wooden floor and bare brick walls with a small fireplace on the east wall (Figs. 22 and 23). A full-height brick wall with a single doorway leads into the adjacent room.

Figure 22 First floor, south room
Looking north west

Figure 23 First floor, south room looking east

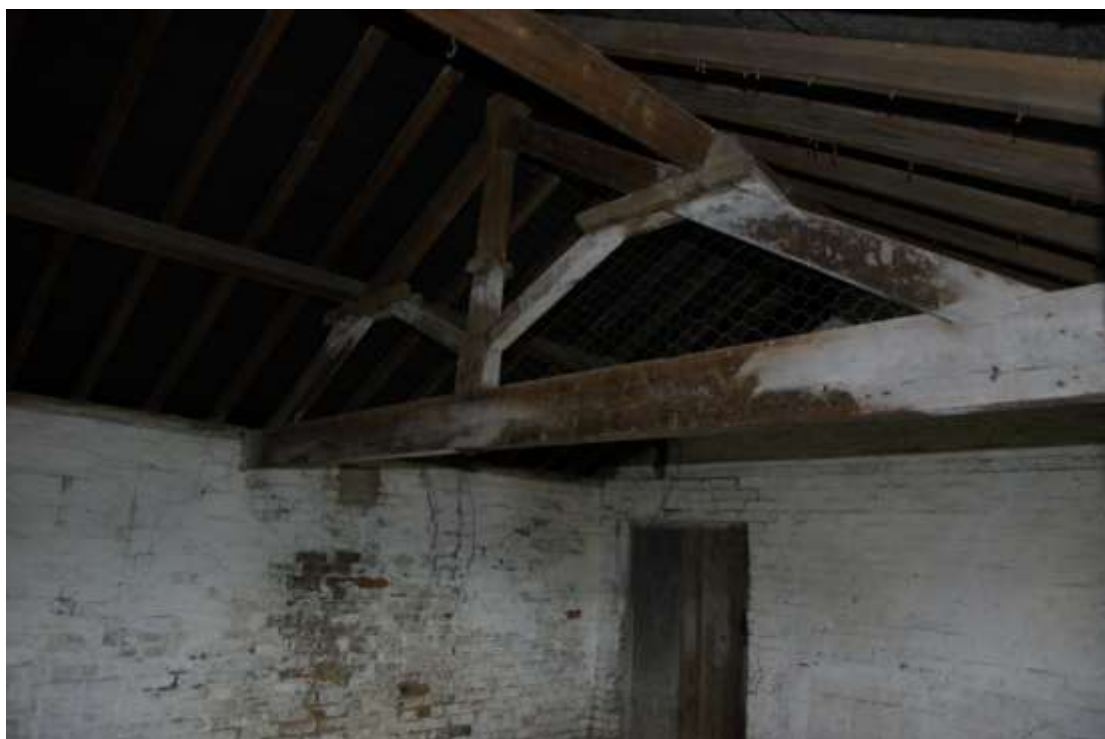
Figure 24 First floor roof detail
Central room, looking south east

As with the ground floor room, this room has been created by the insertion of the modern breeze-block wall. The roof structure for this and the south room are typical of mid to late 19th-century agricultural buildings (Fig. 24). The trusses consist of a king post with raking struts and cleated purlins supported on the backs of the principal rafters. The socketed king post is supported by the horizontal truss spanning the room.
