**An Archaeological Evaluation at
Park House Farm,
Leicester Lane,
Desford, Leicestershire.**

NGR: SK 4976 0358

ULAS Report No. 2014-038
©2014

For: Hilyer and Son Ltd

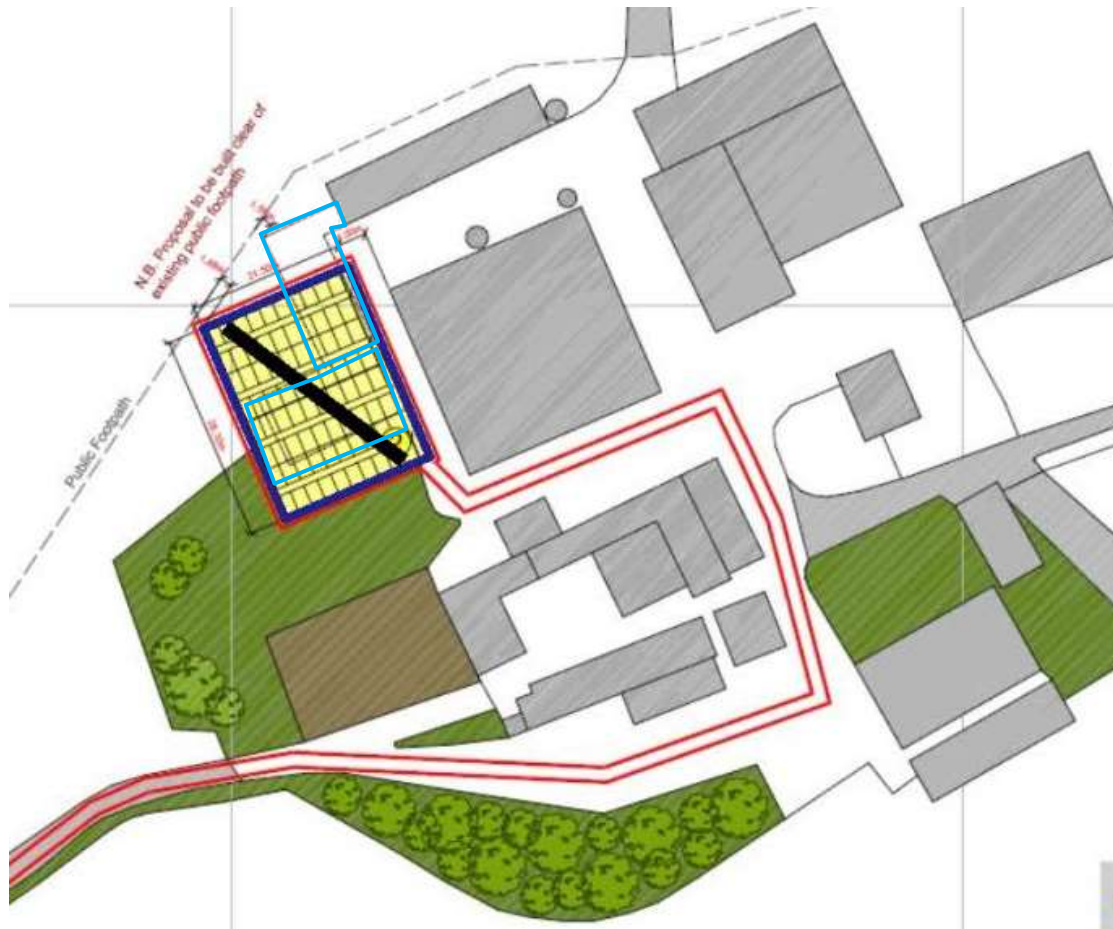
Figure 3 Proposed Development

From a plan supplied by client.

Evaluation trench shown in black. The earlier buildings are highlighted in light blue

It is proposed to build a single agricultural building in the north western corner of the farm complex which will partially cover the footprint of two later 20th century farm buildings (Fig. 3). The buildings had been used as farrowing sheds and, according to the client, were relatively lightweight structures with minimal foundations. At the time of the evaluation these buildings had been demolished leaving a large area of disturbed topsoil and building debris and only a small area of undisturbed field (Fig. 4).

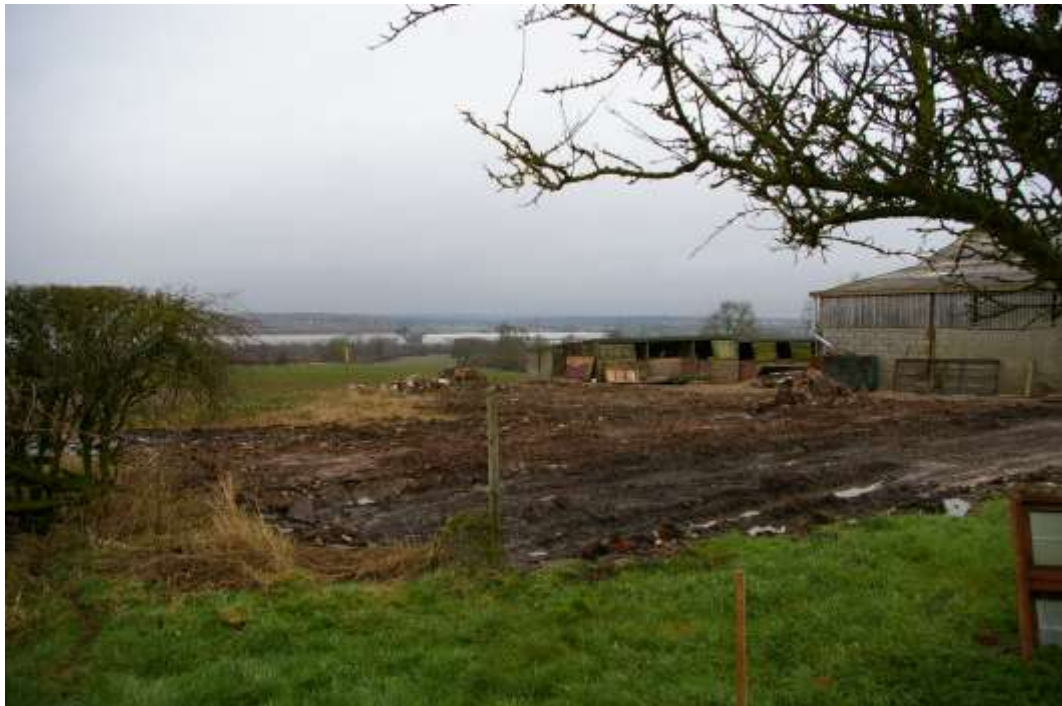
Figure 4 Evaluation area

Looking north

The demolition of the earlier buildings had caused a great deal of ground disturbance leaving a spread of mixed topsoil, building rubble and debris (Figs. 4 and 5). Despite this there was still an area of field which remained undisturbed. This undisturbed area will be under the north western corner of the proposed new building and so offered the highest potential for archaeological remains.

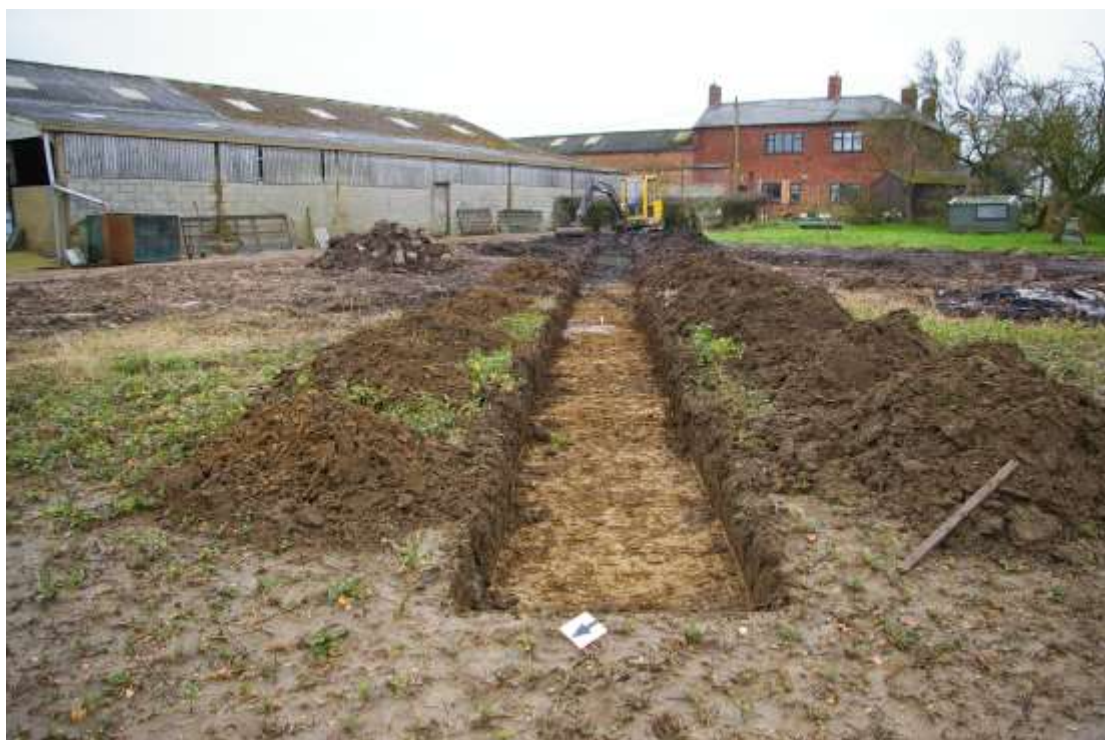
Figure 6 Post excavation photograph of trench
Looking south east. 1m scale

The evaluation trench was laid out on a diagonal, north west to south east, orientation across the new building footprint. The evaluation trench was dug from the north west (the undisturbed end) to south east. The topsoil was found to consist of a dark grey clay silt with an average depth of 0.21m. Removal of the topsoil revealed a mid yellowish grey clay silt subsoil of a thickness varying between 0.05m and 0.18m. The subsoil was removed to expose a pale yellow clay silt substratum which had occasional brighter orange sandy silt patches with some sub rounded stones (Fig. 6).

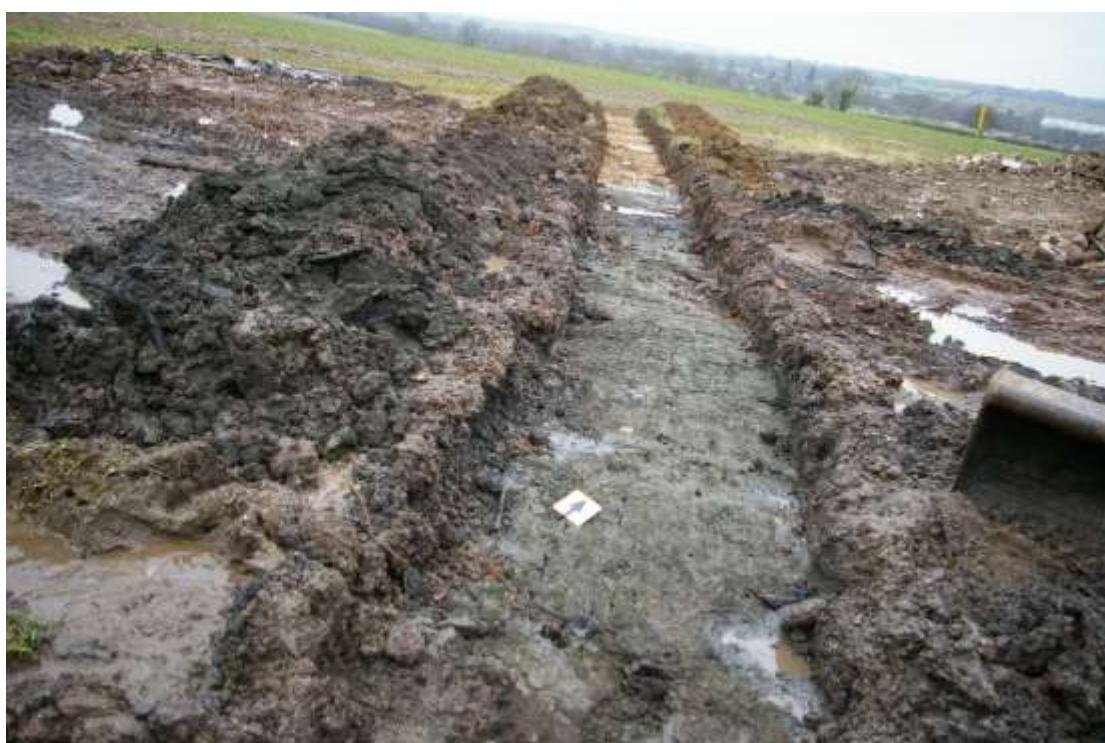
Figure 7 Post excavation photograph of trench
Looking north west. 1m scale

The substratum in the evaluation trench was clean and undisturbed for the first 11m from the north west end. At this point a modern land drain running from north to south along the trench was exposed. The backfill for the drain was clearly quite fresh and the machine operator remembered digging the drain a few years before. At approximately 17m along the trench an area of roots and root disturbance was seen which corresponds to the east to west hedgeline seen on the earlier OS maps and which was removed to make space for the recently demolished buildings. Beyond the line of the hedge the topsoil and subsoil became a waterlogged mix of dark grey clay silt, sludge and debris. Removal of this exposed a slightly truncated natural clay silt substratum which had been stained to a mid greenish blue by slurry and modern

activity associated with the activity within the building (Fig. 7). Despite the staining it could be seen that no archaeological features cut into the natural substratum, however it would appear that at least 0.1m of natural had been shaved off to construct the earlier buildings.

No archaeological features or deposits were observed within the trench.
