**An Archaeological Watching Brief
for M1 J18 Wind Turbines, Northamptonshire.**

SP 57500 72100

ULAS Report No 2014-132
©2014

**An Archaeological Watching Brief during works
associated with the Installation of Wind Turbines
at M1 J18, Northamptonshire (SP 57500 72100).**

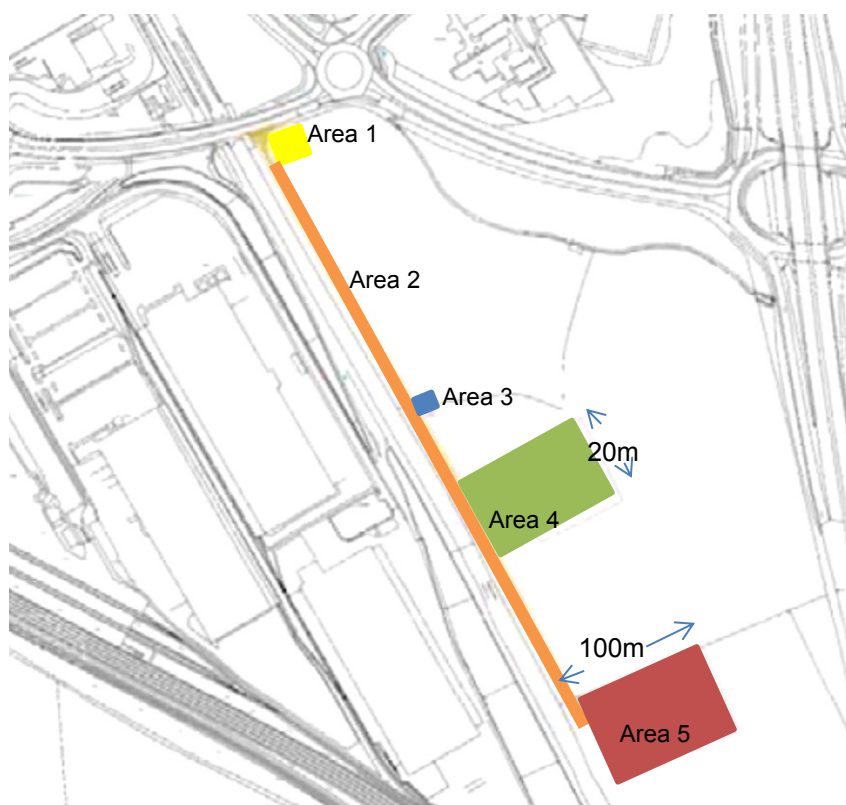
Figure 5. Site plan with areas of study.

For the purpose of clarity the study area has been divided in five different sections (Fig. 5):

- Area 1: Site compound located in the northern area of the site
- Area 2: Access road running north to south on the western part of the site
- Area 3: Substation located c.300m south of compound
- Area 4: Access and foundations for Turbine 1, c.500m south of compound
- Area 5: Access and foundations for Turbine 2, c.600m south of compound

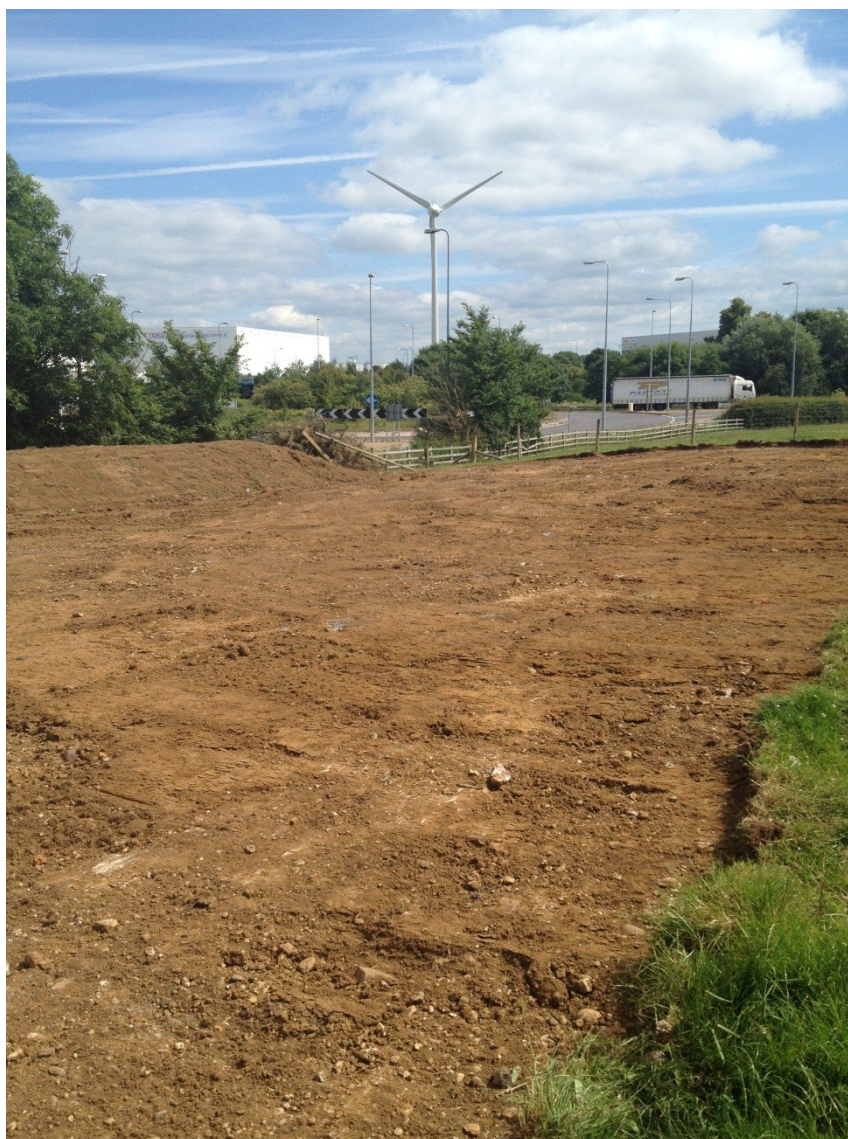
Figure 6. Area 1, Disturbed made-ground.

The compound area was located north of the study area. This area has been disturbed by the works associated with the construction of the road and roundabout (Fig. 6).

Fill/made ground: disturbed soils, 0.20m made up ground.
No archaeological deposits were observed.

The topsoil and made up ground was stripped to approximately 0.20 – 0.3m. It consisted of disturbed orange-brown sandy clay soil with frequent brick and tile fragments and tarmac.

Modern tipped deposits mixed with subsoil.

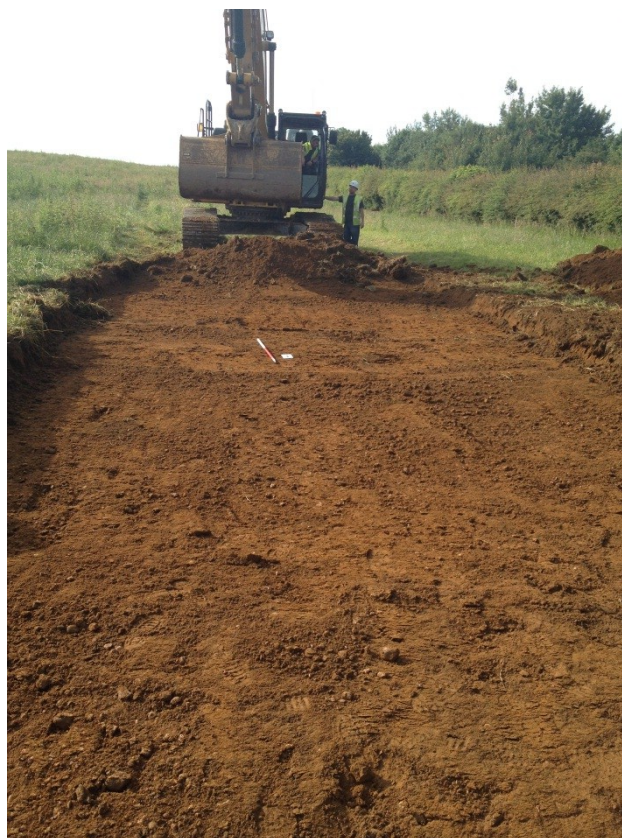
Figure 7. Area 2, Topsoil stripped onto natural subsoil.

The access road ran north-south along the western boundary of the site. It was c.720m long and c.5m wide. The majority of the road uncovered orange-brown sandy clay beneath the topsoil (Fig. 7). However, an area of metalling was uncovered near the top of the slope that could be related to the nearby roman road, Watling Street.

Fill/made ground: topsoil, 0.25m deep, onto orange-brown sandy-clay and gravel natural soil.

The topsoil was between 0.25m and 0.30m deep and consisted of two layers. Beneath was a dark brown slightly gravelly sandy clay with occasional rootlets. The gravel was subangular to rounded (topsoil).

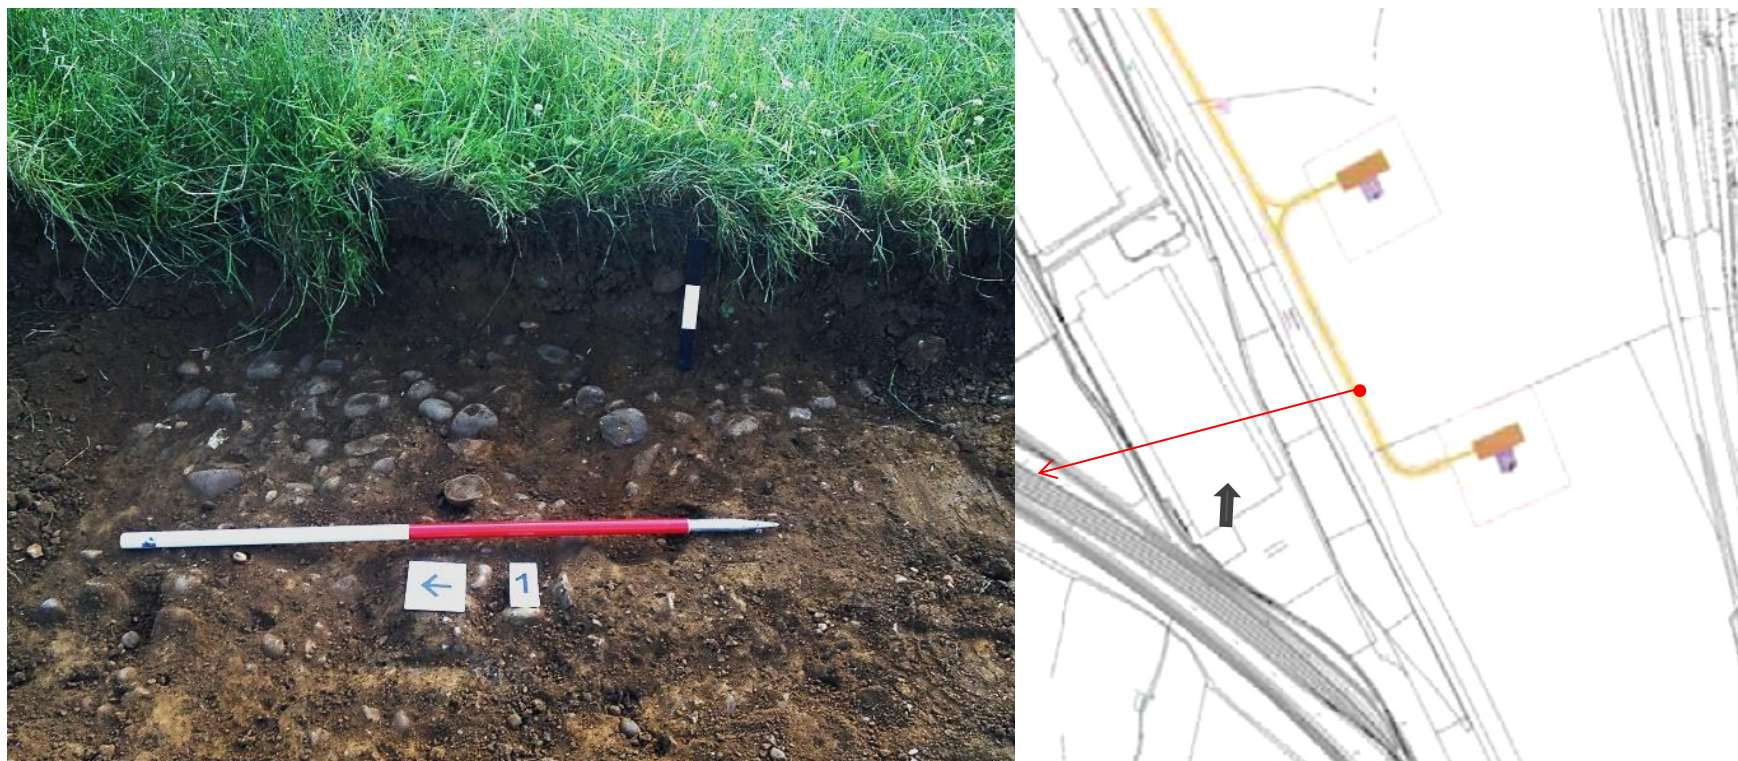
Figure 8. Location of metallised surface (context 1) in area 2.

Approximately 45m north of the field boundary, there was a metalled surface of small to medium rounded pebbles (1) set in a matrix of very compact orange clay (2). The surface is very disturbed and is approximately 5m wide. The metalling ran east-west along the top of the hill. The best preserved section survives on the east side (Fig. 8). No associated ditches were observed and no dating evidence was recovered.

Topsoil over possible natural soils. The metalled surface although undated is possibly Roman and associated with the nearby Watling Street.

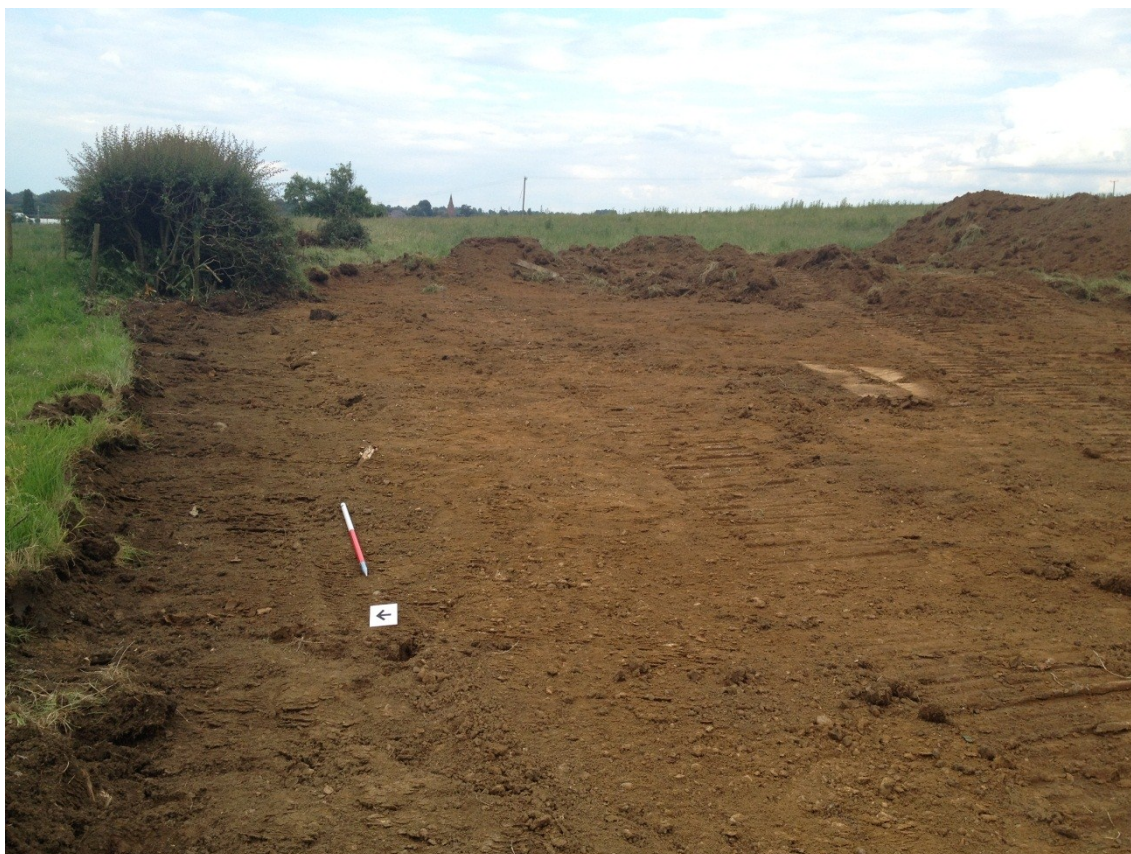
Figure 9. Area 3, Stripped area of the substation.

Area 3 relates to the ground excavation for the substation, approximately 300m south of Area 1 (Fig. 9).

Fill/made ground: 0.25m of topsoil onto orange brown sandy clay and gravel natural soil.

No archaeological deposits were observed.

The topsoil was 0.25m deep. A firm brown slightly sandy gravelly clay (3) with angular to rounded cobbles and gravels.

Topsoil over natural soils.

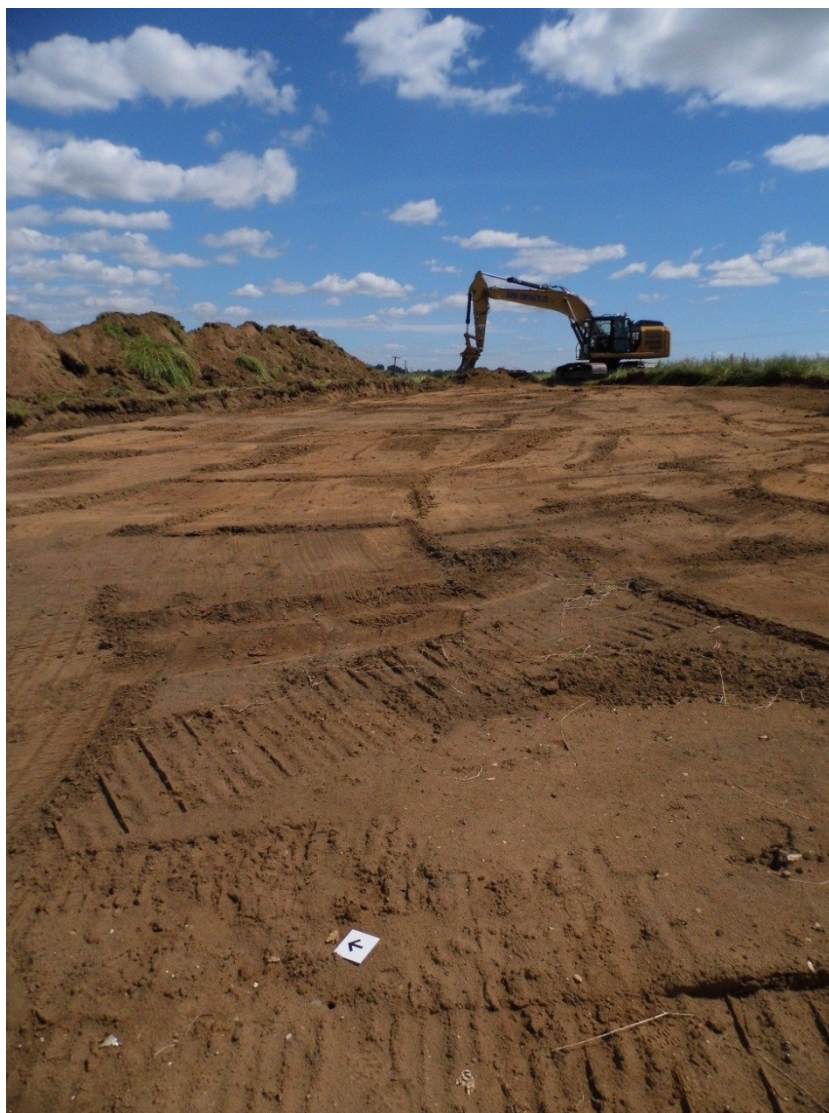
Figure 10. Area 4, Stripped area of Turbine 1.

This area is associated the excavation in preparation for the installation of Turbine 1. Area 4 is approximately c.100m long running west-east from the access road (Area 2) and a minimum width of c.5m and a maximum of c.20m (Fig. 10).

Fill/made ground: 0.25m to 0.30m of topsoil onto orange brown sandy clay and gravel natural soil.
No archaeological deposits were observed.

The topsoil was 0.30m maximum depth and consisted of a layer of reddish brown and brown slightly sandy clay with occasional sub-rounded cobbles.

Topsoil over natural soils.

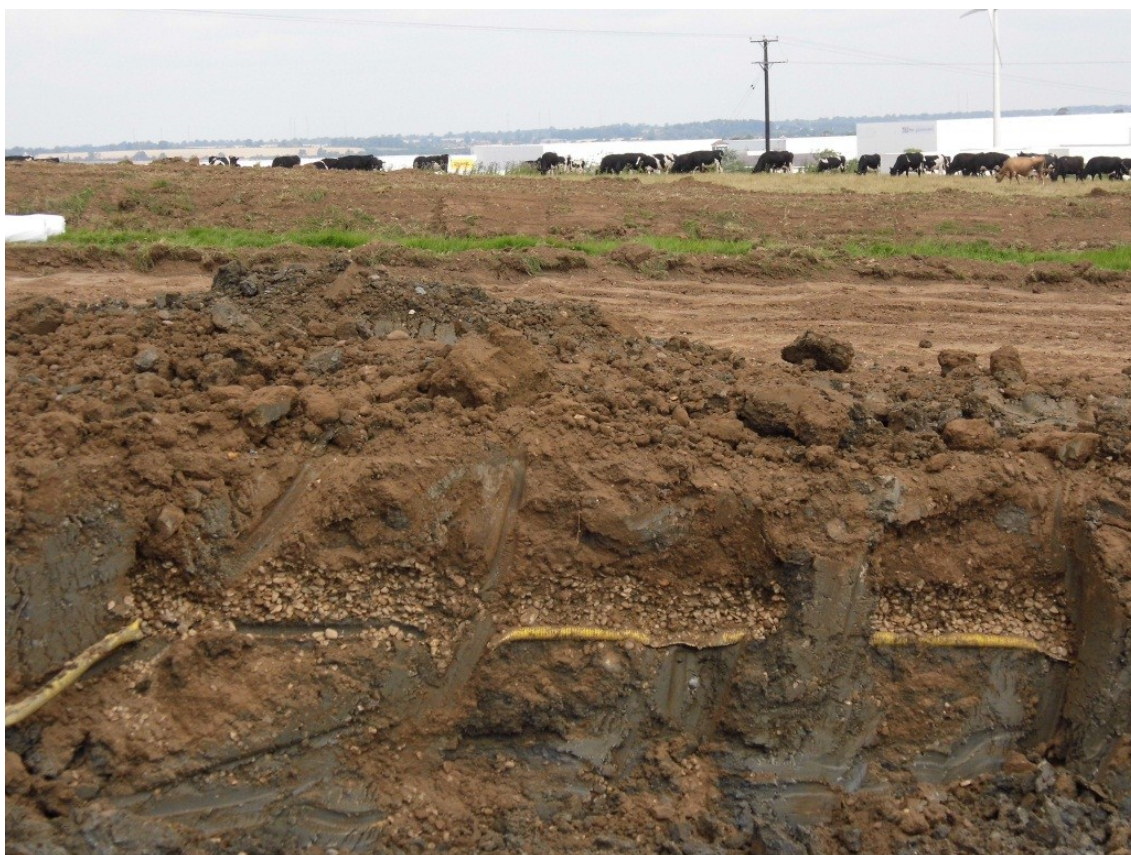
Figure 10. Trench in Area 5 showing made up ground.

This area is located at the highest point of the site. Area 5 related to the groundworks associated with the installation of Turbine 2. The stripped area was c.100m in length (on a west-east alignment), turning east off at the top of Area 2. The access to this area is 5m wide and is slightly curved. The maximum width of this area is c. 20m.

Fill/made ground: 0.10m to 0.30m of grey brown sandy clay topsoil onto orange brown sandy clay and gravels redeposited natural soils.

This area lies on a slight slope towards the east and therefore the topsoil of the western side has not been completely removed. Consequently, although unlikely, the grey brown sandy clay could be masking archaeological features. The maximum depth of excavation was 0.30m towards the north side of this area. Here, the topsoil overlays slightly disturbed orange brown sandy clay and gravels. The deeper slot in the eastern side of the area has exposed previous work (Figure 10) and indicates that this area consists of made up ground with mixed soils, including grey clay.

Made ground - topsoil overlying redeposited natural soils.

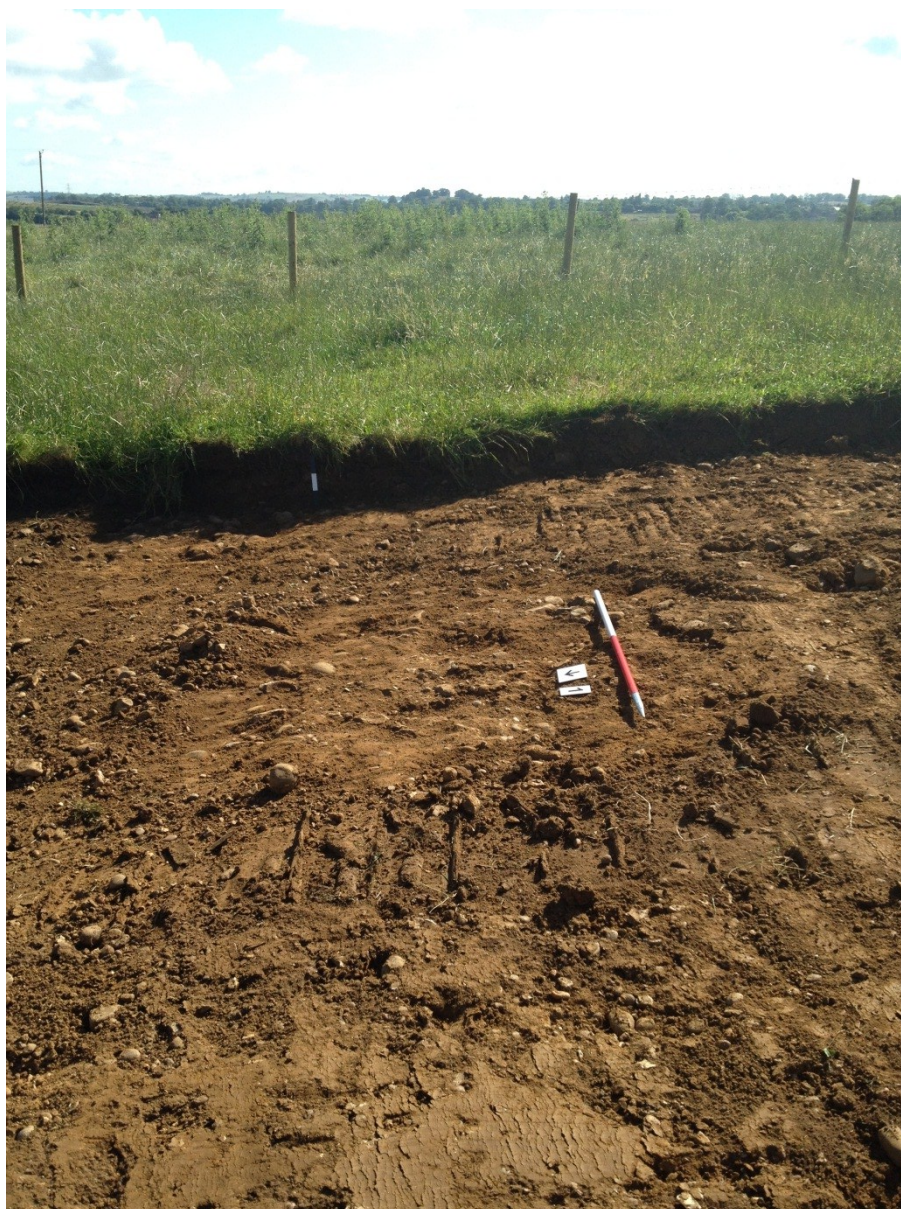
Figure 11. Traces of metalling with slight earthwork running eastwards beyond the access track marked by nettles.

The archaeological watching brief was undertaken between June - August 2014 during groundworks for the construction of two wind turbines on land adjacent to Junction 18 of the M1 Motorway found only one area containing archaeological deposits. An area of metalled surface, probably a road or trackway, was revealed in Area 2 and possibly relates to the nearby Roman Road of Watling Street although no datable evidence was discovered to support this. Investigation of the area shows a slight earthwork and a line of nettles and weeds possibly marking the route of the road running east-west perpendicular to Watling Street (Fig. 10).
