Archaeological Monitoring of
Groundworks, Cathedral Square
Leicester,
NGR: SK 583 044 centre

ULAS Report No 2014-236
©2014

For: The Casey Group

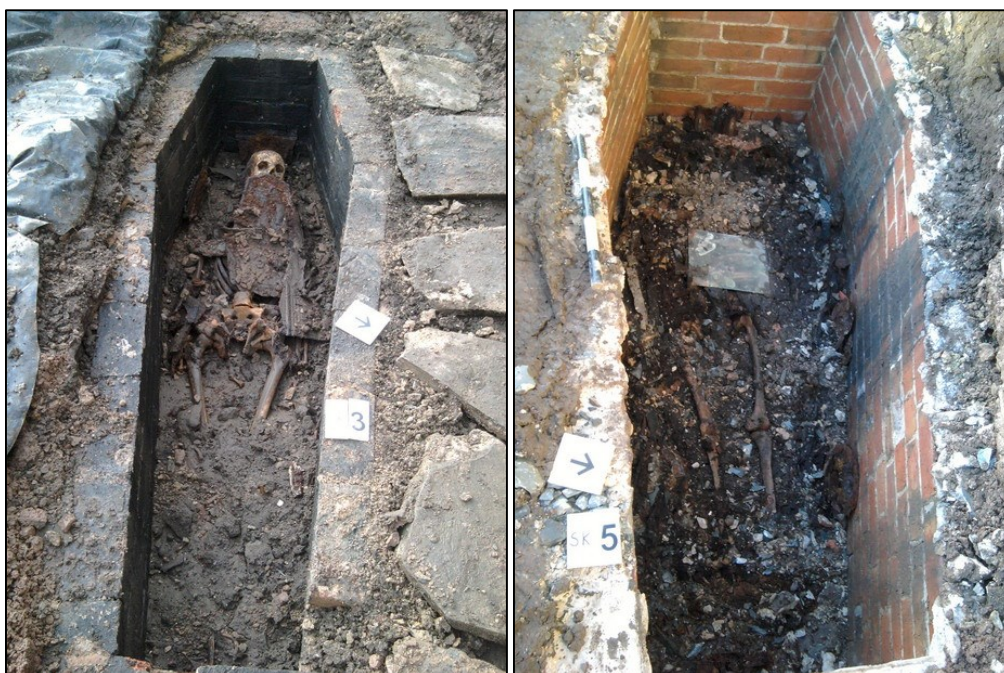
Plate 1 Brick-lined grave 3 containing inhumation SK3
Plate 2 Brick-lined grave 5 containing inhumation SK5 Elizabeth Farmer

The next phase of work comprised the removal of all pavement areas and further general reduction of all ground levels across the whole site within the old Cathedral Gardens area. The removal of pavements on the east side of the south porch revealed three more single coffin-shaped brick-lined graves. Each contained a single inhumation buried in what were now decayed coffins with associated coffin furniture (BLG3 SK3 (Plate 1), BLG4 SK4 and BLG 5 SK5) Figure 4). All three appeared to be constructed as single chambers and were capped with slate slabs, although they may have been partly dismantled and any upper chambers and burials removed during the last grave yard clearance. All three burials were found to be at a level above the proposed formation for the new water feature located on the east side of the south porch. Hence, all three burials were recorded and removed, and stored with the other remains that were awaiting reinterment. Only one of the three burials contained a legible coffin plate BLG5 SK5 (Plate 2) which read 'Elizabeth Farmer Died 26th October 1817 Age 23'.

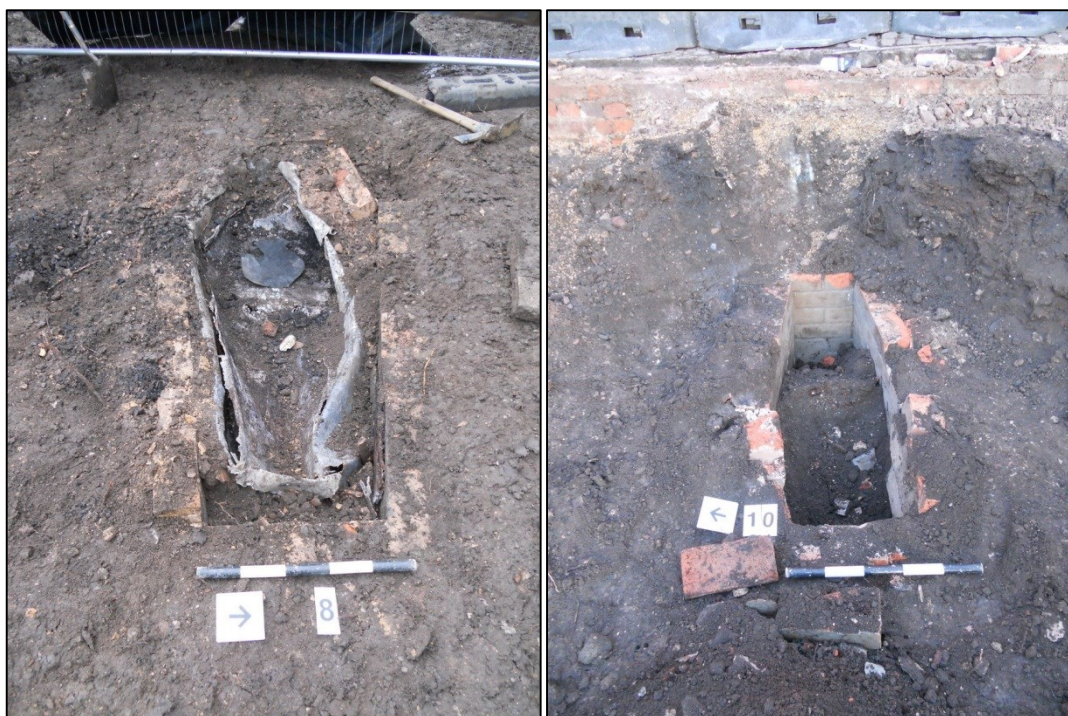
The removal of pavements in the north-east corner of the Cathedral garden close to the Cathedral's Old Song School and Administrative Chapter revealed two more single coffin-shaped brick-lined graves (BLG6 and BLG7) (Figure 4). Further work at the northern end of the west lawn revealed three more brick-lined graves (BLG8, BLG9 and BLG12) (Figure 4). Brick-lined grave 8 was located close to the south porch and had no slate capping (Plate 8). The upper chamber contained a collection of charnel bone placed on top of a lead coffin. The charnel and disarticulated bone were collected and stored with the other disarticulated remains. These burials were located below any new formation level so were resealed with a deposit of pea grit gravel.

Plate 3 Brick-lined grave 8 with reinterred lead coffin

Plate 4 Brick-lined grave 10 Infant burial size

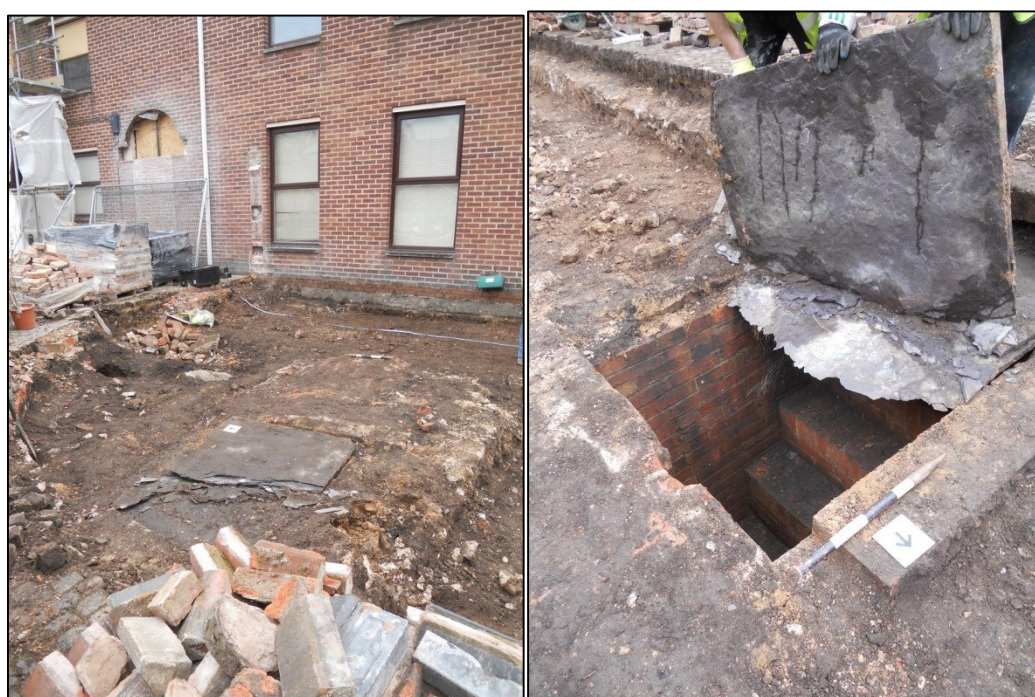
The much larger subterranean burial chamber (BLG 17) could be classified as a vault as it could house a minimum of two coffins side by side and included access steps (Plates 5, 6 7 and 8). The vault's internal dimensions were 2.00m long, 1.30m wide and 2.60m deep. The chamber at the base of the vault appears to be the only one that was used to house burials. They comprised three inhumations buried in what were now decayed coffins. Two of the coffins were adult size while the third which was located in the middle was a child. This was a lead-lined coffin complete with a brass inscription plate which was legible and so enabled identification. The coffin plate inscription read 'William the Son of William and Hannah Ingle was born Feb 8th 1783 died Nov 10th 1787'.

Plate 5 Brick-lined grave or vault BLG17
Plate 6 BLG17 slate cap removed and revealing brick access steps

All three burials were found to be at level 1.80m below the formation level for the new tree pit but the top the vault was above this level. This required that all three burials were covered by a sheet of terran and sealed under layer of pea gravel 0.50m thick. The top of the vault was then carefully demolished down to new formation level and was then sealed with layer of stone and rubble.

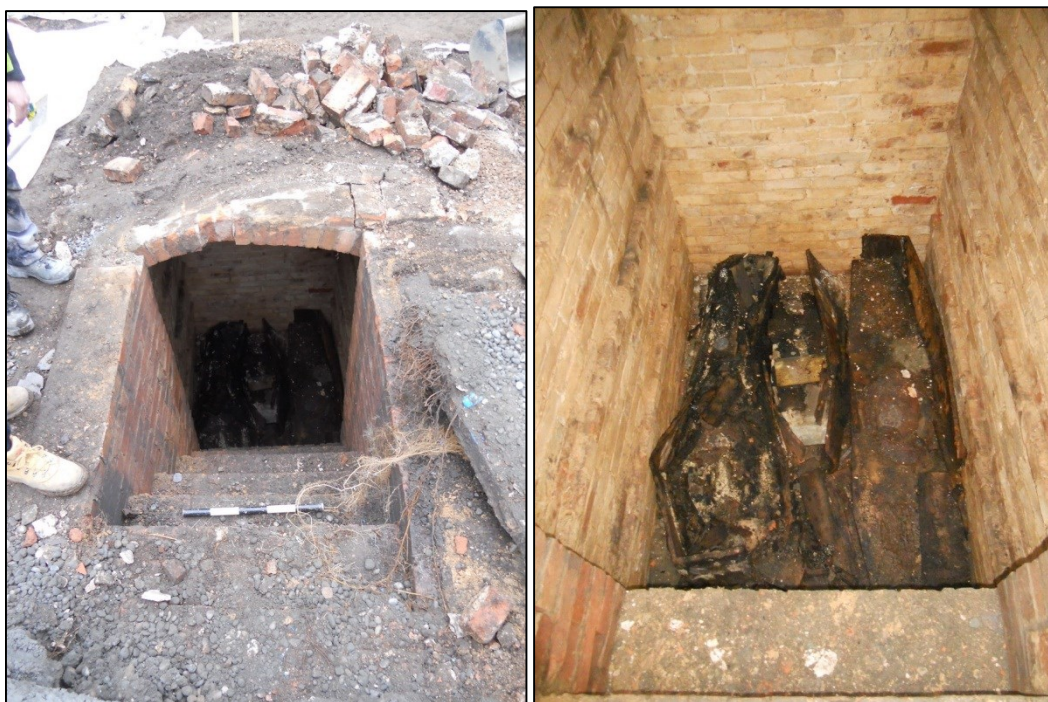
Plate 7 BLG17 slate cap removed with brick access steps and burials visible
Plate 8 BLG17 burials found at the base of the vault

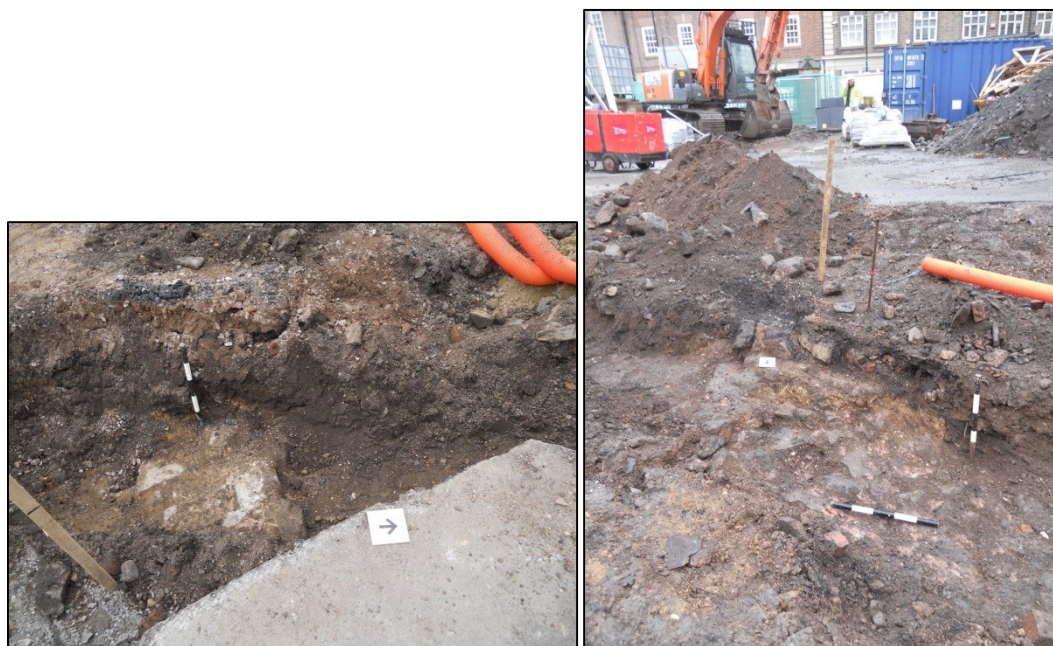
The initial excavations were located in the north-east corner of the former schoolyard and comprised stripping tarmac surfaces and underlying stone gravels for the new pavements. There was also various service trenches excavated within this area and they all measured approximately 0.60m wide and had variable depths of between 0.30m and 0.70m. A north-south service trench had revealed stone wall foundation **(05)** which was found at a depth of 0.70m below the current ground surface, and had a minimum width of 1.50m (Plate 9 and Figure 6). This foundation consisting of roughly hewn granite stones laid in random pattern and bonded with dark yellow lime mortar. The foundation was thought to be part of the north wall of Wyggeston's Hospital west wing. Within the same service trench a possible brick pavement **(06)** was observed at a depth of 0.75m below the current ground surface. The pavement appeared to be running west to east across the trench and located on the north side of the west wing. All the bricks measured 0.23m x 0.12m x 0.10m and were laid flat in

stretcher pattern but were not bonded. Further excavations within this area exposed another segment of the west wing's north wall which was again located at a depth of 0.70m.

Plate 9 Hospital West Wing Foundations north wall (05)

Plate 10 Hospital west wall foundations (11)

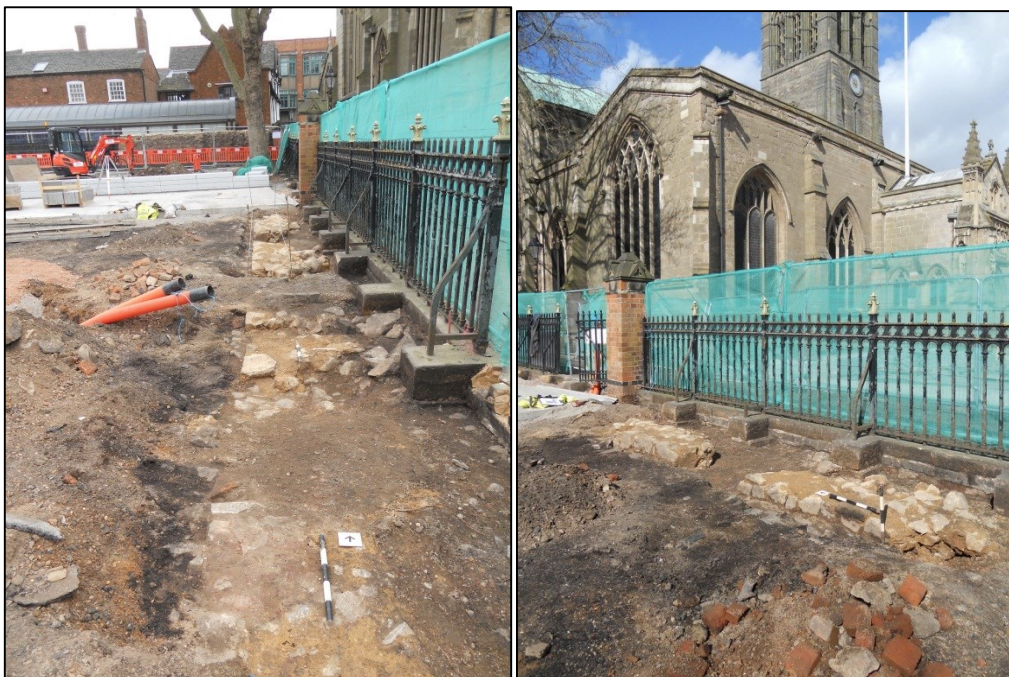
Plate 11 Wyggeston's Hospital east wall foundation
Plate 12 Wyggeston's Hospital east wall foundation

Excavations on the east side of the former school yard for lawn area and path which leads to the visitor centre within St Martins have uncovered the remains of Wyggeston's hospital east wall **(18)** in various locations (Figures 6, and 7). The top of the wall and foundations were found only at a depth of between 0.15m and 0.20m below former ground level. The exposed remnants of wall comprised supporting foundation consisting of roughly hewn granite stone bonded with red clay. The stone coursing or bonding pattern was random and measured 1.10m wide and had minimum depth of 1.00m. On top the remnants of a wall had survived as two courses of random coursed roughly hewn granite stone, bonded with a lime mortar (Plates 11 and 12). The wall and measured 1.00m wide and 0.25m high. Part of potential internal floor surface **(17)** was exposed on the west side of the wall. The surface comprised small flat stones, slate and occasional tile fragment embedded in greyish brown silty clay.

Both the stone wall foundations were sealed by stone rubble layer **(12)** between 0.10m and 0.30m deep. This area appeared to have been previously levelled, with a stone rubble layer comprising crushed sand stone and granite and was thought to be remnants demolition material from Wyggeston's Hospital. Overlying were layers of stone gravel and clinker **(03)** up to 0.25m thick, which had perhaps been deposited to help raise the ground levels.

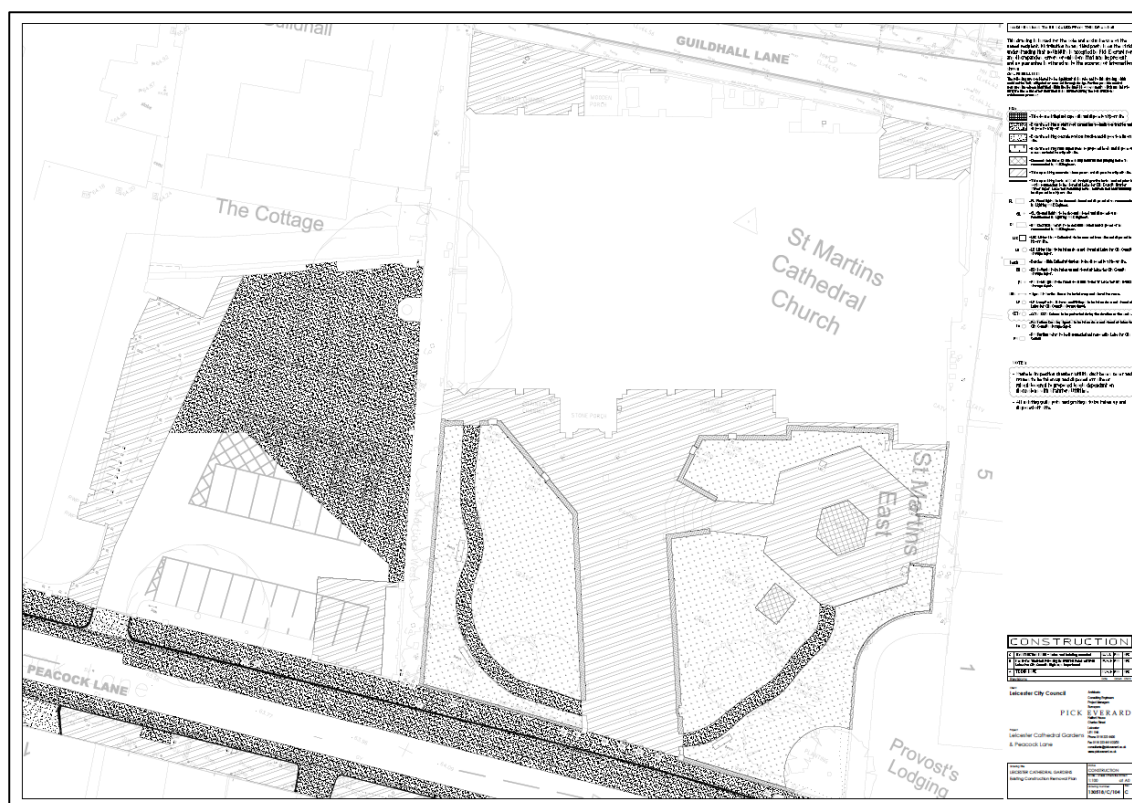
Fig. 1: Site location and archaeological watching brief strategy

4.4 As part of the development of the former school, and its incorporation into the precinct of the cathedral as Cathedral Gardens, it has been decided to lower the level of the Precinct lawns to their pre 1980 level, and to form raised beds and other garden features, including a water feature, across the whole area.

- 4.5 The project will involve attendance to monitor any groundworks which have the potential to damage buried archaeological remains.
- 4.6 Cuttings, area clearance and removal of tarmac will be the responsibility of the landscape contractor. Groundworks below this point will be under the supervision of the archaeologists, who will have full access to the site at points and times agreed with the landscape contractors, in order to excavate, reveal and if necessary lift any archaeological features discovered by the necessary works.
