**A Retrospective Level 2 Historic
Building Recording and Trial Trench
Evaluation at Butchers Yard,
2 High Street, Earls Barton,
Northamptonshire.**

ULAS Report No. 2014-216
©2014

For: Life Space Developments Ltd

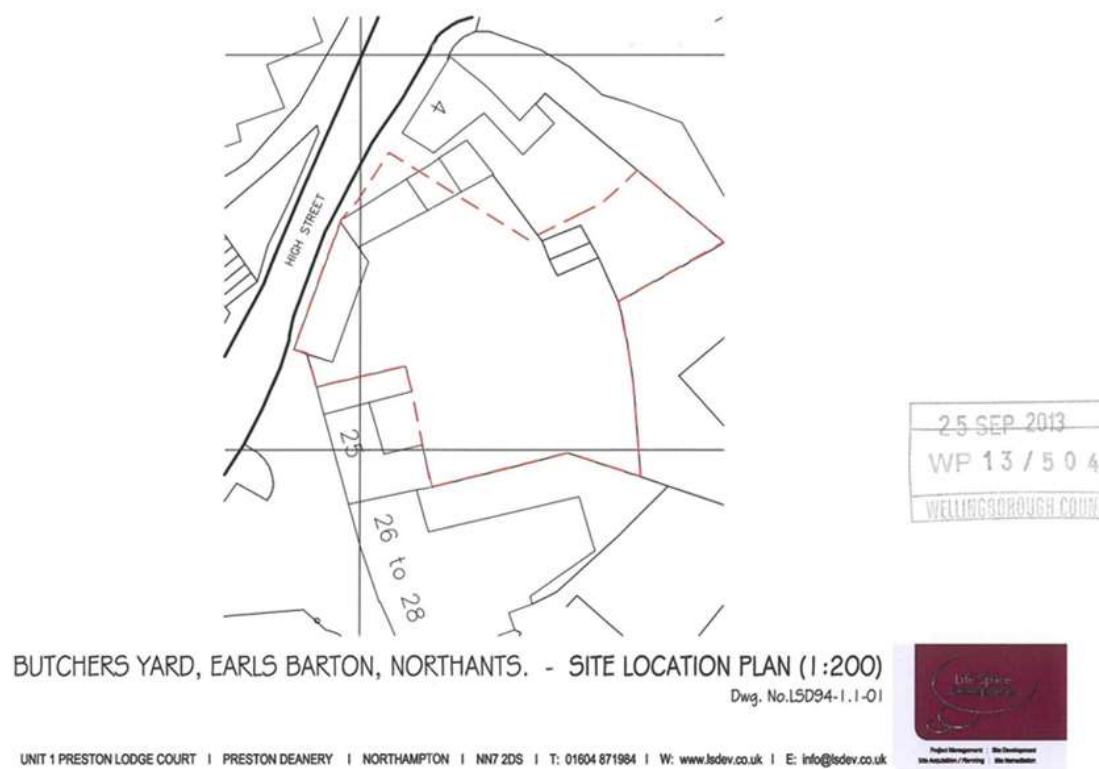
Figure 2: Site before redevelopment
Plan supplied by client. Red line indicates site boundary

overgrown yard to the rear (Figs 2 and 3). The buildings were most recently used as a dance studio. A row of shops, built from stone and brick, form the south west boundary of the site (Fig. 4).

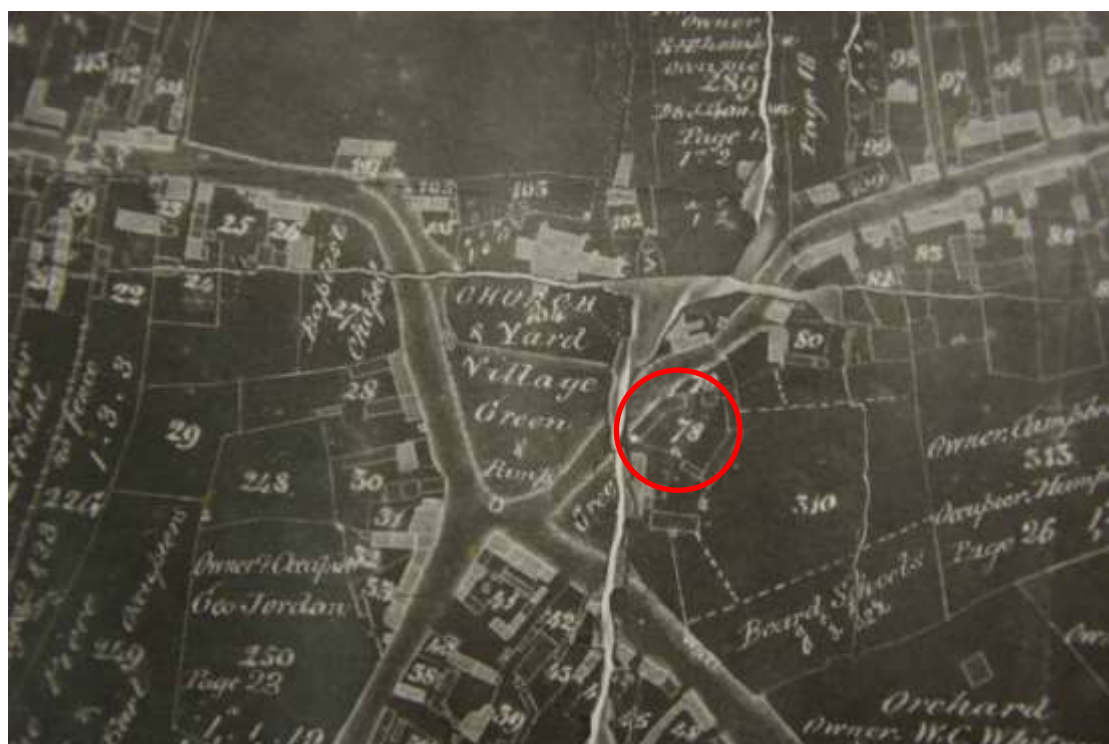
The earliest available map is the 1772 enclosure map which shows the footprint of the buildings much as they survived until demolition (Fig. 5). The map shows a narrow building running along the edge of the street. There is a distinct kink in the building as the road curves around towards the north-east so it is not clear if the building is formed of two components or of a single long building. A two-storey stable building, discussed below, is not present on this map. There appears to be a large yard to the rear of the buildings with a corresponding row of similarly sized buildings along the south eastern site boundary. The row of buildings, currently in use as small shops, is also present although it is possible that this map may show older buildings which have been replaced by the present buildings having a similar footprint. Alternatively the brick-built shops may have been rebuilt or re-skinned with brick.

Figure 5: 1772 enclosure map
Site highlighted

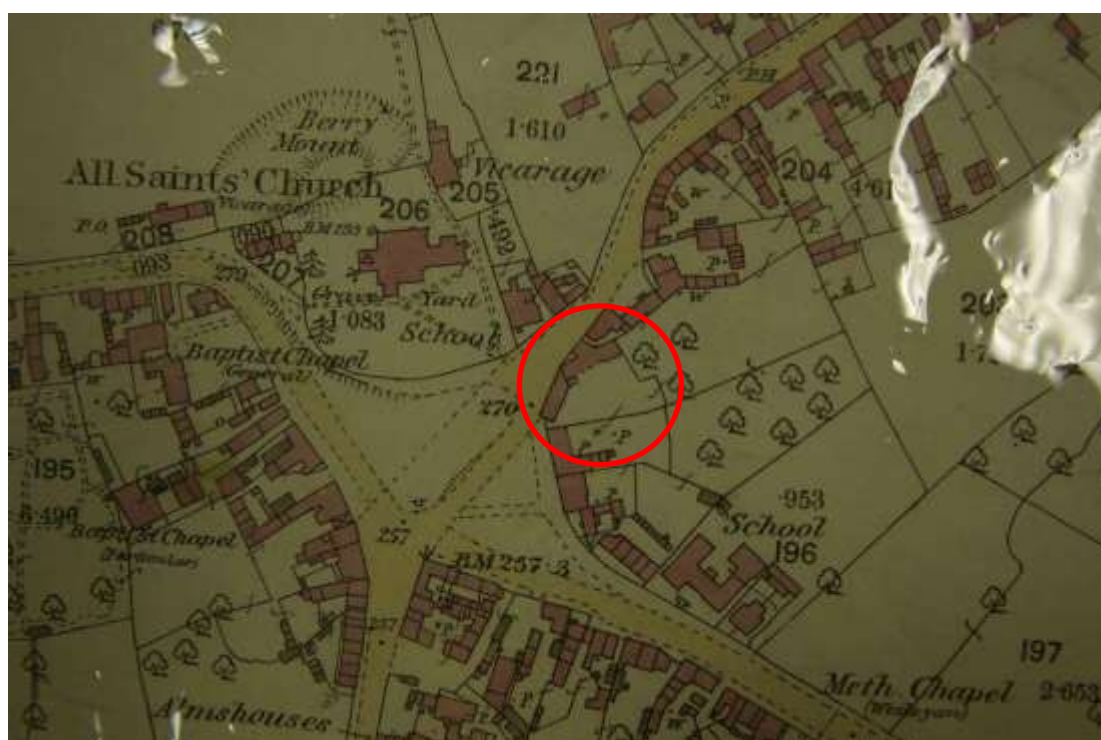
The First Edition County Series Ordnance Survey map published in 1885 shows a significantly different layout to the 1772 enclosure map (Fig. 6). The large yard to the rear of the streetside buildings has been subdivided into smaller plots and the buildings along the south eastern boundary have been removed. The long kinked building along High Street is clearly shown as two buildings on this map with the northernmost building appearing to have an open side facing into the smaller yard. The angles at which the buildings join suggests that the open sided building may be the earliest structure. An additional building has been added to the northern end of the open sided building. A small building now projects out onto High Street. The row of shops appears to have virtually the same footprint as it does now.

Figure 6: Ordnance Survey County Series map. First Edition 1885

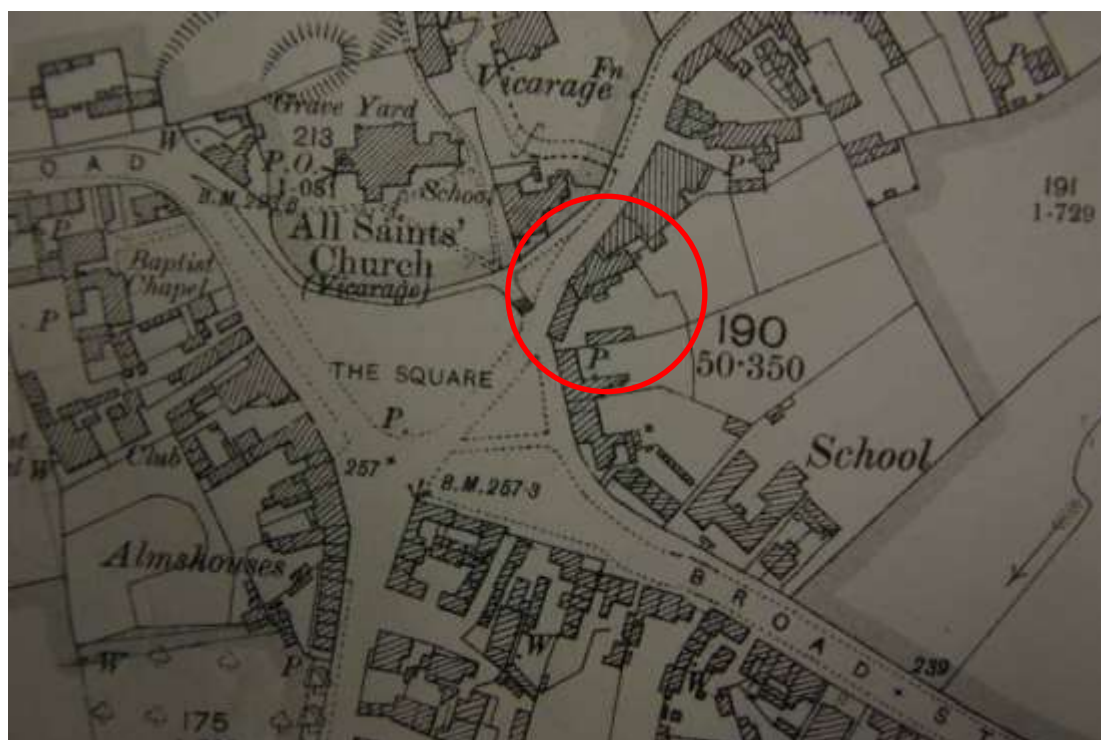
The 1900 edition of the Ordnance Survey is the next available edition. This map shows that a new structure has been added along the southern boundary of the site and the open fronted building has had an additional structure built across its front (Fig. 7). It is not clear what the function of any of these buildings was. Subsequent editions of the Ordnance Survey show very little change until the 1976 edition which shows that the structure added to the front of the open fronted building has now been removed (Fig. 8). The open fronted building also appears to have been divided into three sections by this date.

Figure 7: Ordnance Survey County Series, 1900 edition

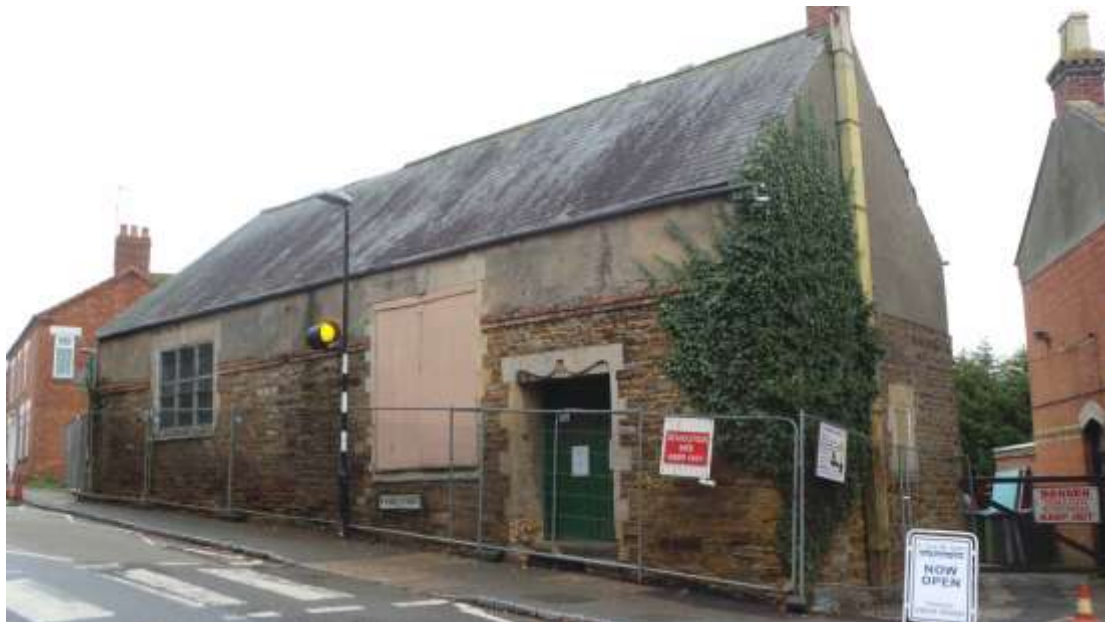
Figure 9: Taller, steeply pitched roof building seen from High Street
Looking east. Photo taken by client

The north-west facing frontage along High Street formed a prominent feature when seen from the open square to the south west (Figs. 9 and 10). The frontage consisted of two components: a tall structure with a steeply pitched roof on the southern side and a much lower structure to the north. Both buildings appeared to have been built from locally sourced ironstone similar to that seen on other nearby buildings. Both appear to be single storey structures.

The taller building was again built from coursed ironstone rubble but at some point in time had the wall height increased by a further metre, or slightly more. The height extension was made using red brick which was covered in render. It was not possible to see what brick bond had been used. Even before the height extension the ironstone part of the wall was higher than the adjacent building to the north which again suggests a different construction date for the two buildings. A row of red bricks showed the original eaves height before the steeply pitched roof was raised. This may be an indication that the building was thatched when first built, or perhaps that extra ceiling height was required at a later date. A set of double doors with limestone detailing and a carved lintel was set towards the southern end of the elevation. A wide window and what could have been a loading bay had similar limestone detailing and lintels. These openings extended above the original eaves height showing that these were later modifications which may have been added when the roof was raised. The well-maintained roof was covered in Welsh slate.

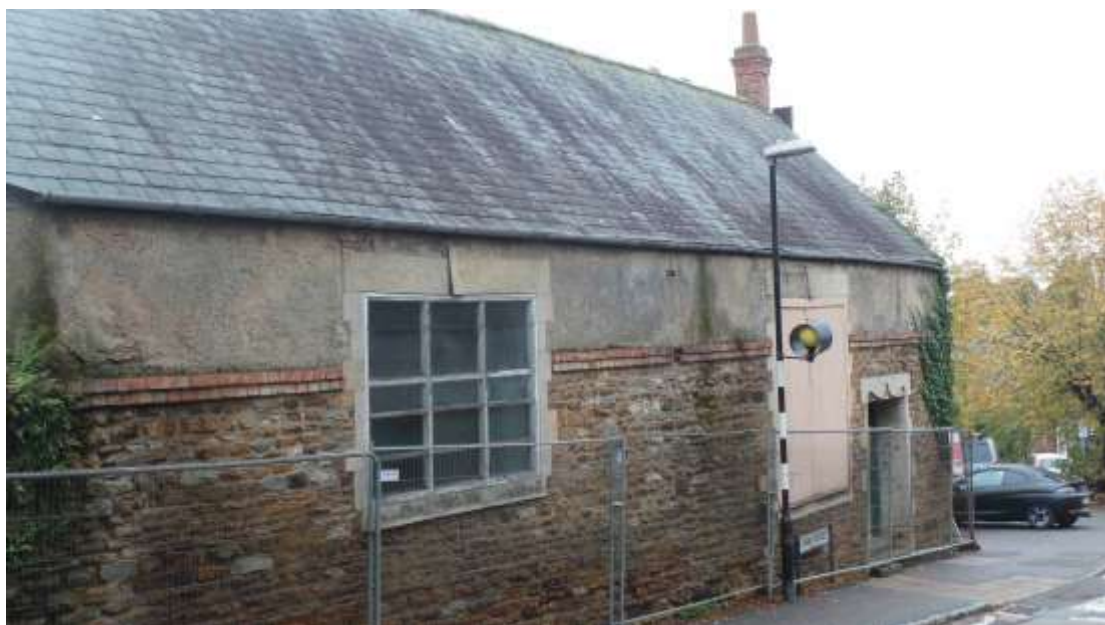
Figure 10: Taller, steeply pitched roof building seen from High Street
Looking south east. Photo taken by client

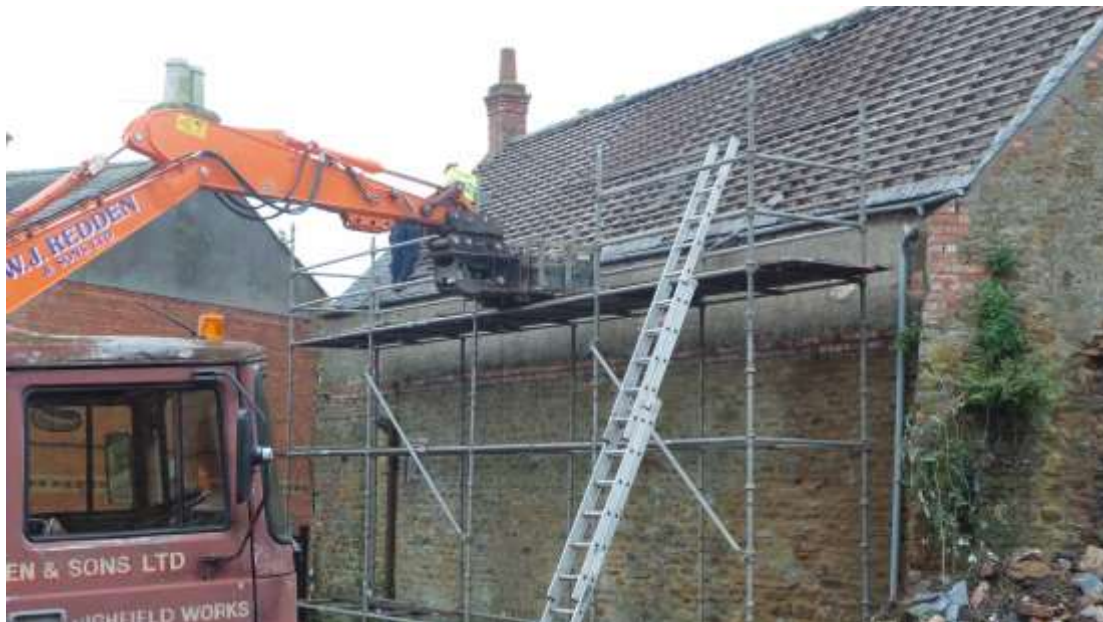
Figure 11: Rear of steeply pitched roof building
Looking west. Photo taken by client

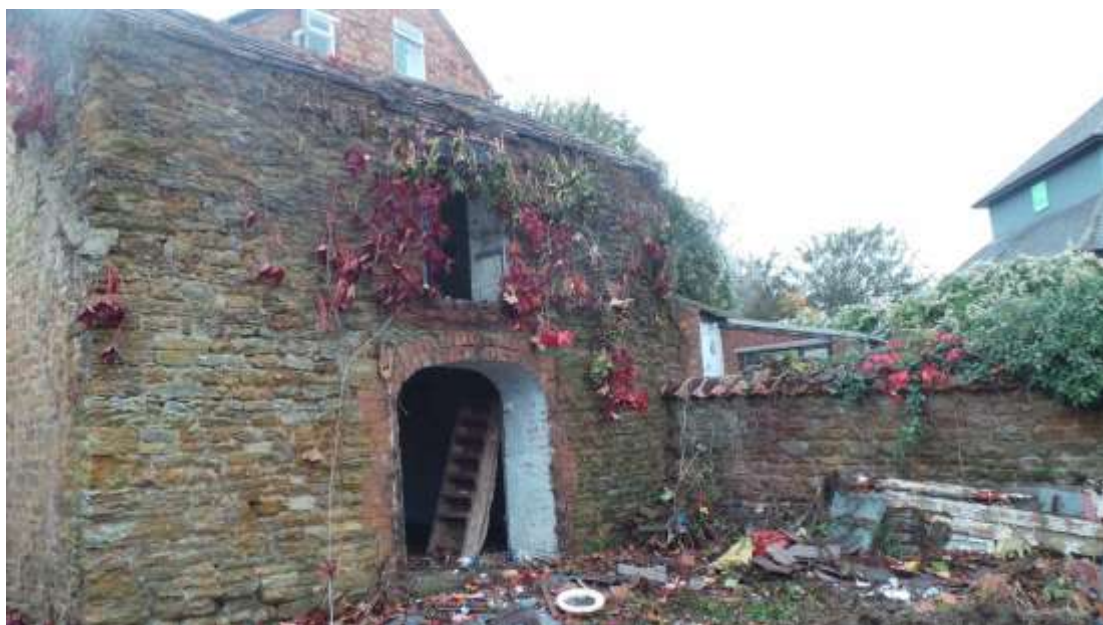
Figure 12: Stable building
Looking north. Photo taken by client

To the north-east of the lowest building was a two-storey rectangular building which could not be seen from the road as it was obscured by a brick-built house which still stands. This building appears to have been a small stable and was built entirely of coursed ironstone rubble (Fig. 12). The building is not shown on the 1772 enclosure map but is clearly present on the 1885 Ordnance Survey map. The building had a wide ground floor doorway with brick detailing and a hayloft type door at first floor level. Parts of this structure were still standing at the time of the evaluation and the ground floor appeared to be laid with modern concrete (Fig. 13). The walls had been whitewashed and the north and east walls had been skinned internally with red bricks. It could be seen that this two-storey stable butted against the lower open-fronted building and can clearly be seen as a later addition between the 1772 and 1885 maps.

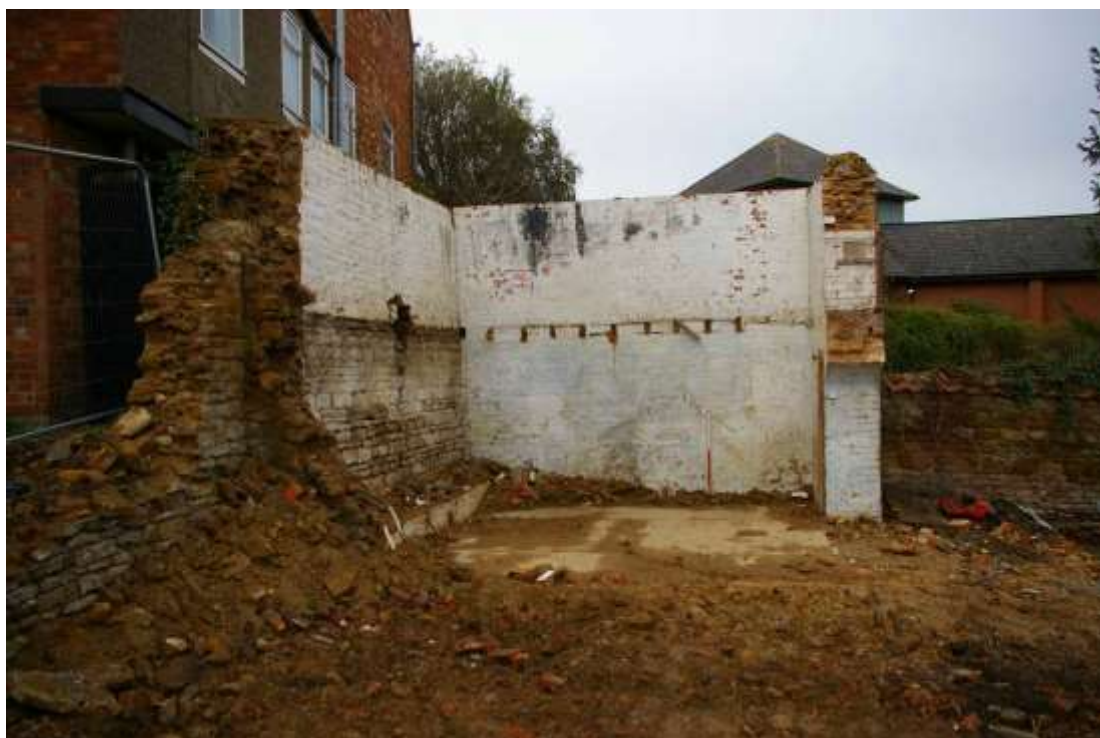
Figure 13: Partially demolished stable building
Looking north-east. 1m scale

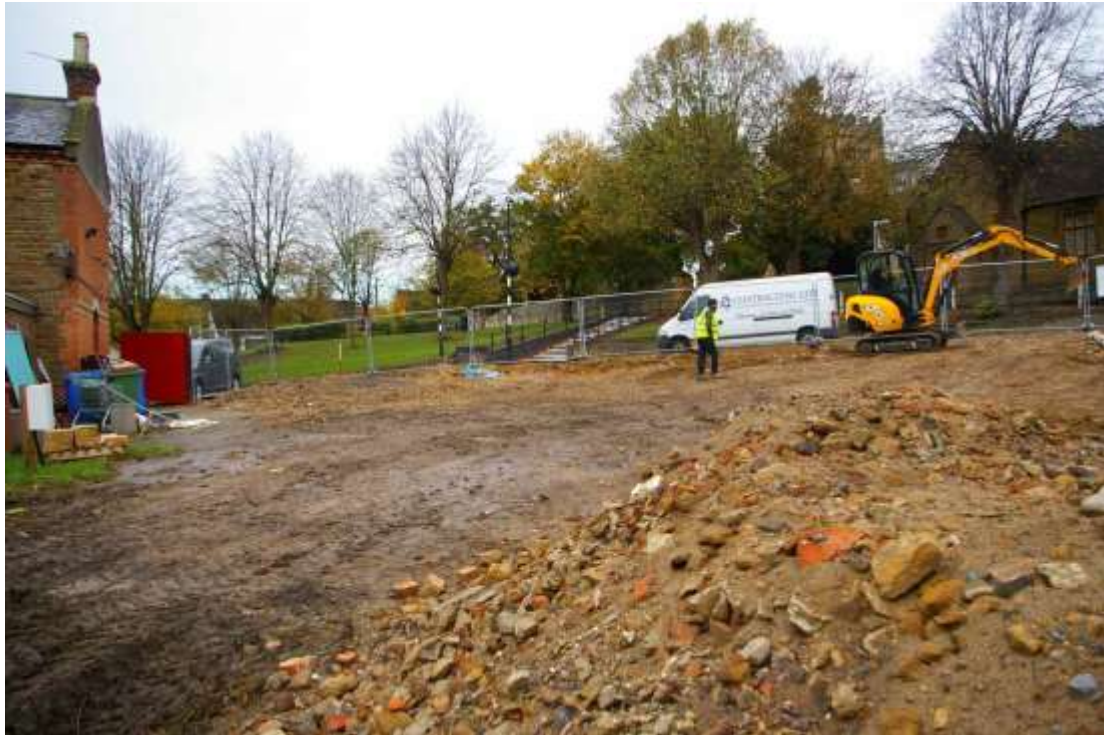
Figure 14: Site prior to trial trenching
Looking northwest

At the time of the evaluation the site was open to the road after the demolition of the buildings (Figs. 14 and 15). Part of the yard was covered with tarmac with the south eastern portion having a mix of turf and small trees and shrubs. The boundary along the south eastern edge was extremely overgrown. There was no physical demarcation between the rear of the properties belonging to the shops and Number 2 High Street land. A number of rubble spoil heaps remained on site. Because of a number of physical constraints, discussed below, three trenches were excavated instead of the two specified trenches (Fig. 16).

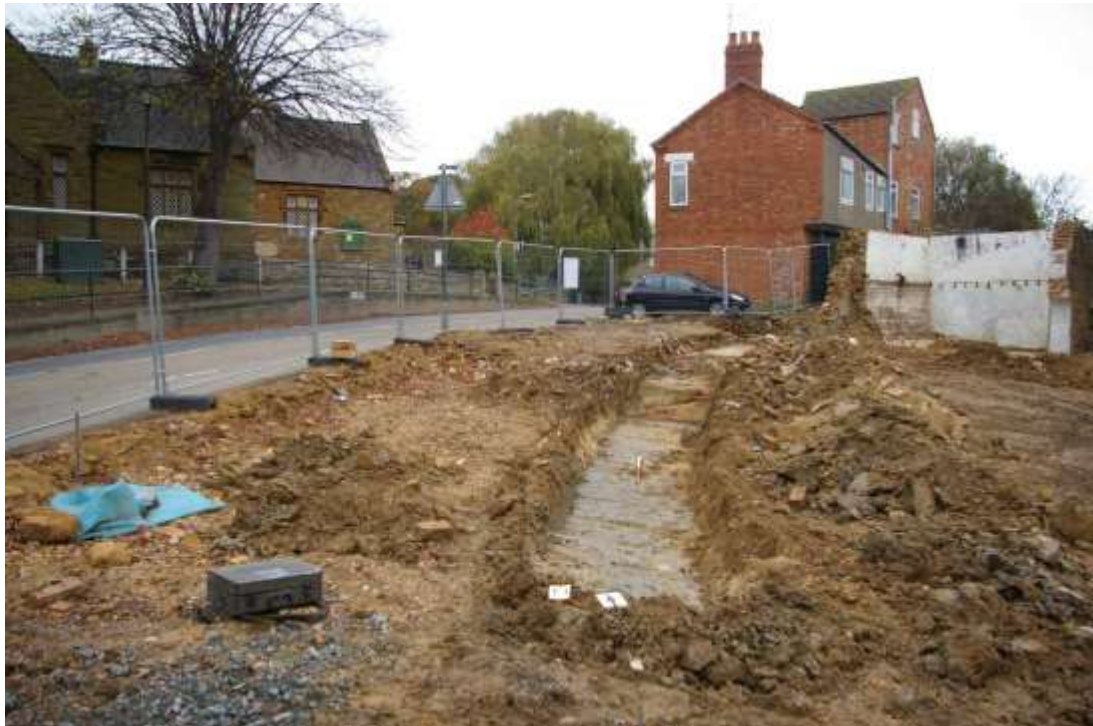
Trench 1 was located along the High Street frontage targeting the footprint of the proposed new housing. Once the remnants of loose demolition rubble had been cleared a mid yellow brown sandy clay with lots of broken brick, slate and ironstone layer was exposed. This layer had a thickness between 0.1 and 0.28m below which was the natural substratum which consisted of a mid grey hard clay with pockets of sand and ironstone. A single line of red bricks marked the alignment of a shallow drain. At the north-eastern end of the trench a large area of closely packed blue bricks marked the former floor surface of the lower open-fronted building. The bricks had been laid over a thick layer of concrete which could not be removed by the machine but sample excavation along one edge indicated that it extended at least 0.15m below the top of the natural. Other areas of modern disturbance could be seen along the length of the trench (Figs 17, 18 and 20). Further towards the north-east the ground had been dug away through and below the level of the natural substratum so it was decided to leave the length of Trench 1 at 17m.

No archaeological finds, features or deposits were observed in this trench.

Figure 17: Trench 1
Looking north-east. 1m scale

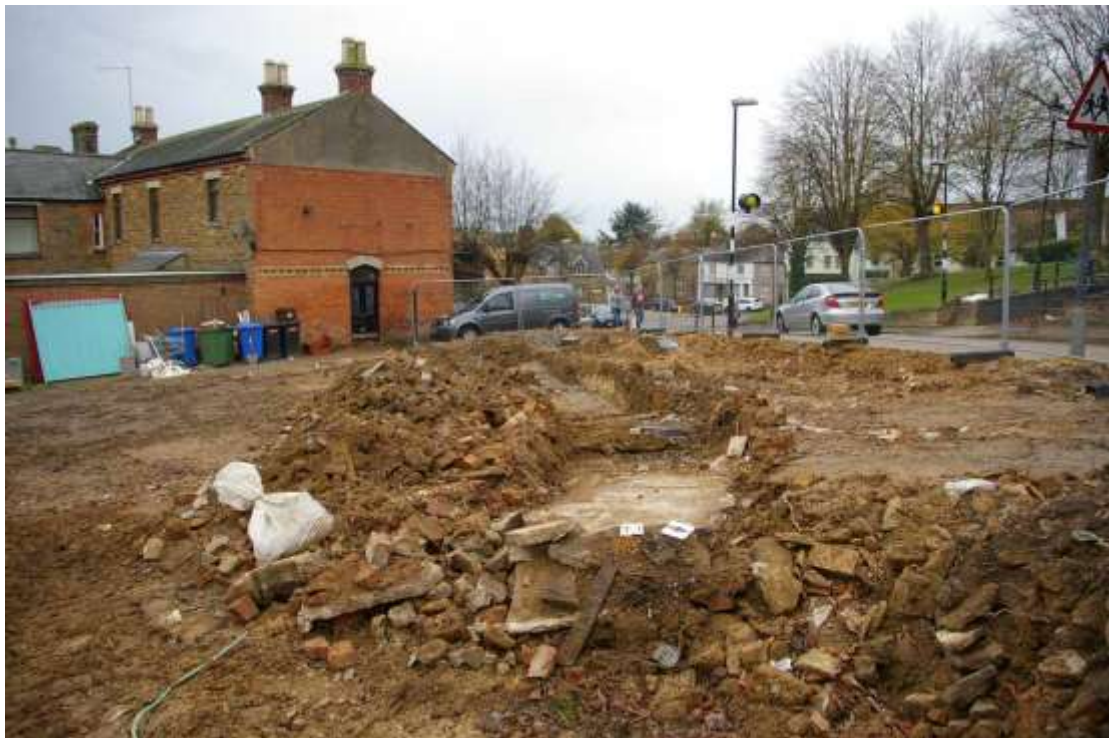
Figure 18: Trench 1
Looking south west. 1m scale

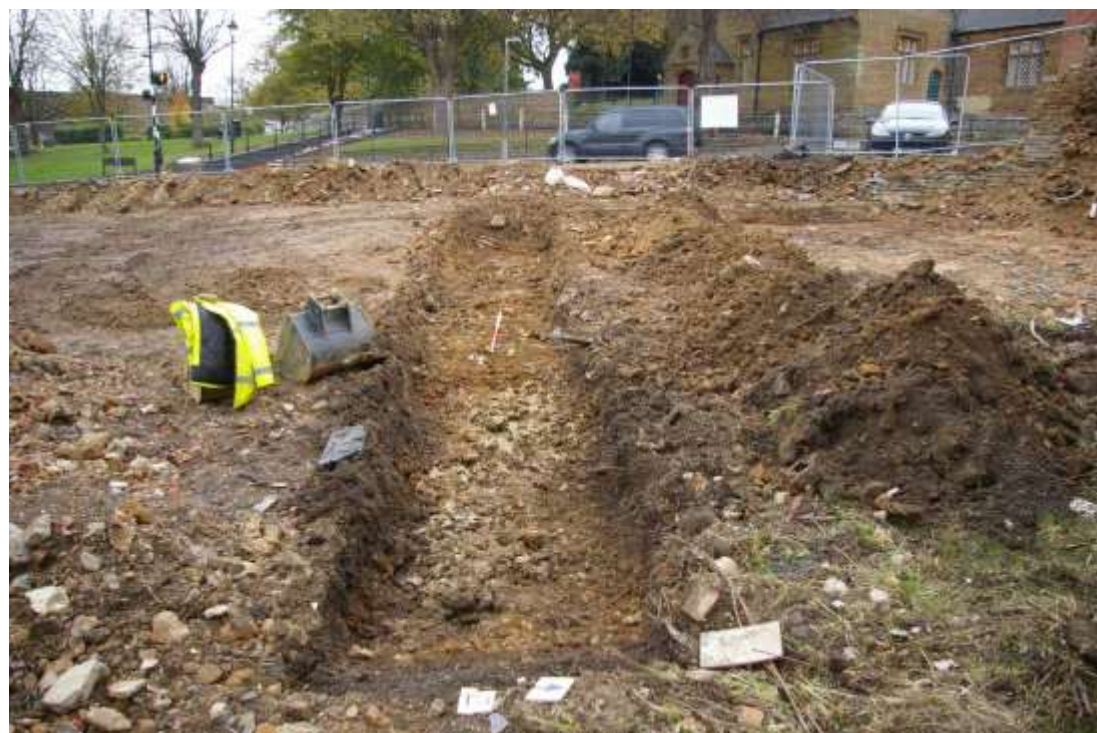
Trench 3 was placed in an open space between Trenches 1 and 2 over the site of a proposed parking area. It was hoped that this may identify any plot boundaries or backyard features which may have survived behind the more recent buildings. As with Trench 1 no topsoil or subsoil was present. Between 0.17 and 0.37m of mid yellow brown sandy clay and demolition material was removed to exposed the undisturbed natural substrata consisting of ironstone brash at the north-west end and mid grey clay with ironstone patches in the sound east (Fig. 21).

No archaeological finds, features or deposits were observed in this trench.

Figure 21: Trench 3
Looking west. 1m scale
