An archaeological field evaluation at  
**'The Breaches', Melton Road,  
Barrow upon Soar,  
Leicestershire  
(SK 58374 17285)**

ULAS Report No 2013-200  
©2013

Planning Authority: Charnwood Borough Council  
Planning Application Number: P/10/1518/2

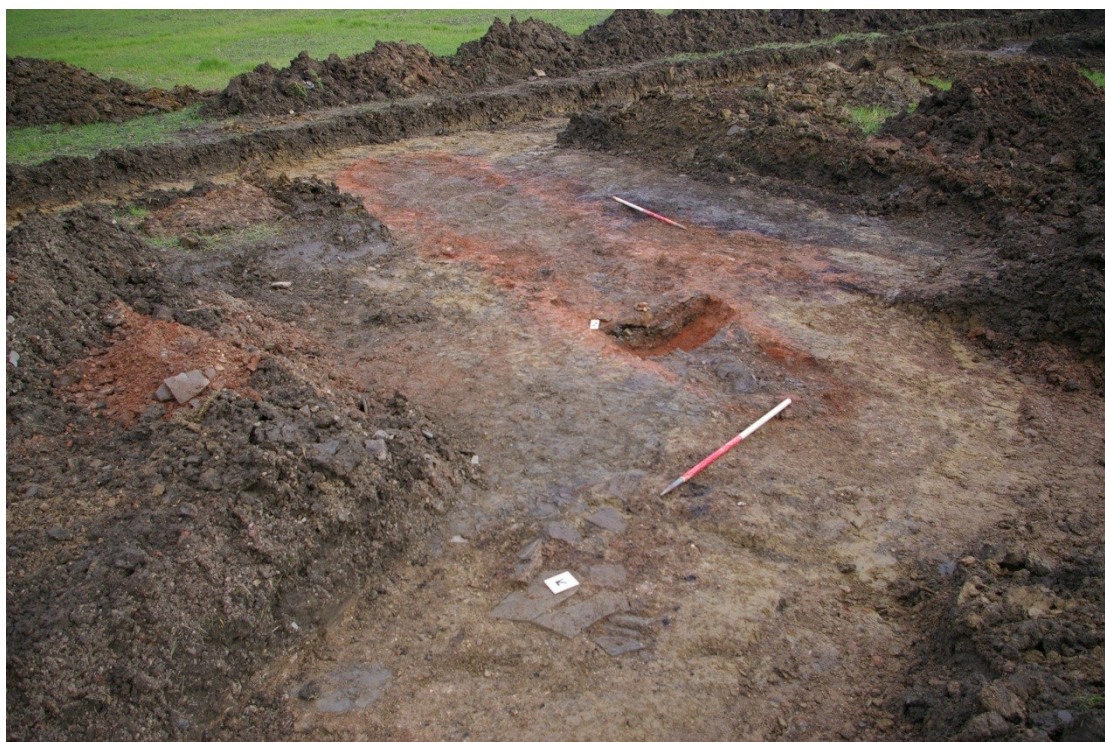
Plate 1: Post excavation shot of kiln [2] in Trench 01, looking north-east

The western feature was orientated north-east to south-west and this feature was partially excavated (Plate 1 and Figure 4).

A narrow pit [2] measuring 8m by 2m had been excavated. This cut was surrounded by an area of burnt red clay, which appeared to be heat affected natural clay, although it is possible that this represented a lining to the structure of the feature. On the eastern side of the feature the burnt clay was laminated with layers of charcoal, which may have represented trampling.

The main fill of the pit (1) consisted of variable creamy grey clay and lime remnants with frequent laminar grey mudstone and areas of red clay.

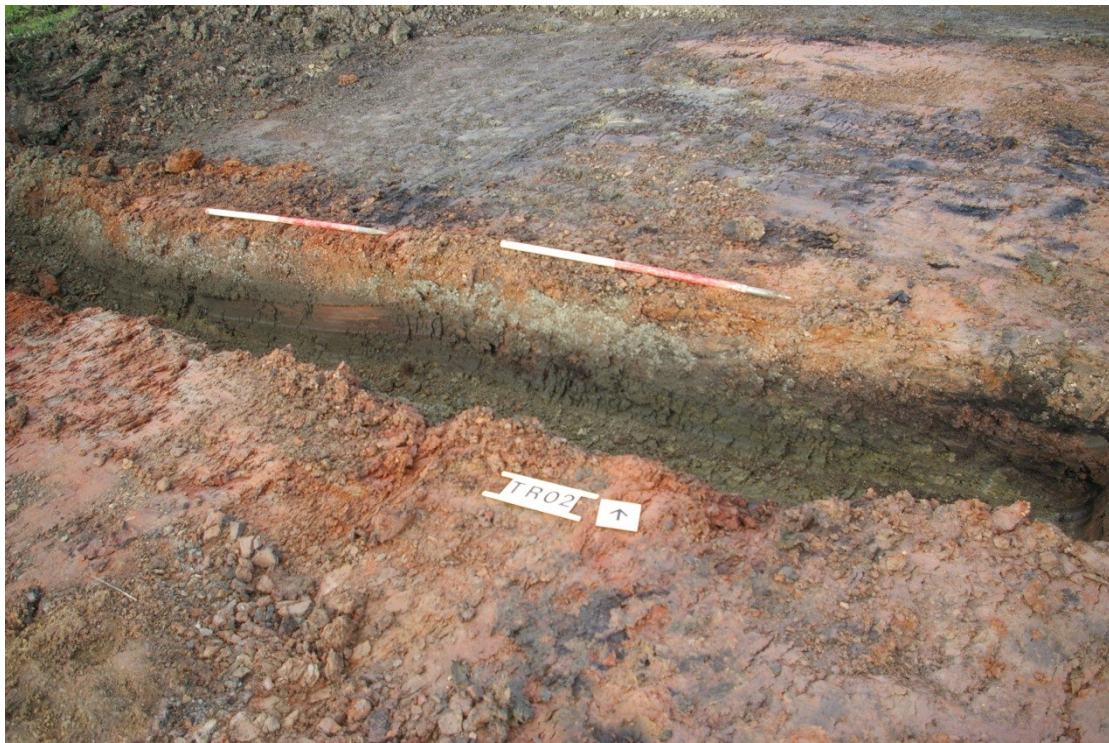
Plate 2: Trench excavated across spread in Trench 02, looking north

Trench 02 contained two features. Part of a linear feature, most likely part of a kiln, could be identified towards the south-western end of the trench, apparently orientated east to west. At the north-eastern end the trench was extended to reveal an amorphous area of burnt clay, charcoal and soil (measuring approximately 7m x 8m). A machine bucket slot, measuring 0.6m wide, was excavated across the feature and it appeared that the feature was a large spread of burnt clay and kiln material around 0.2m – 0.3m deep (Plate 2).

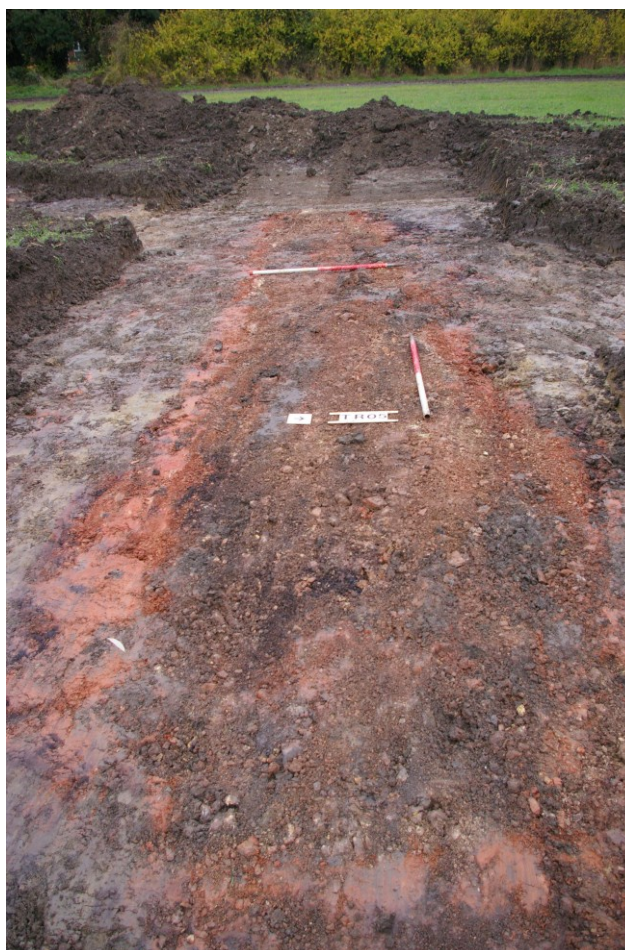
Plate 3: Kiln in Trench 05, looking west

The other, which had been further exposed by widening the trench, was 7.6m long and between 1m and 2m across. The form seemed very similar to the kiln [2] in Trench 01, although the pit at the end of the kiln had been damaged, possibly by the plough, and so the kiln was not excavated (Plate 3).

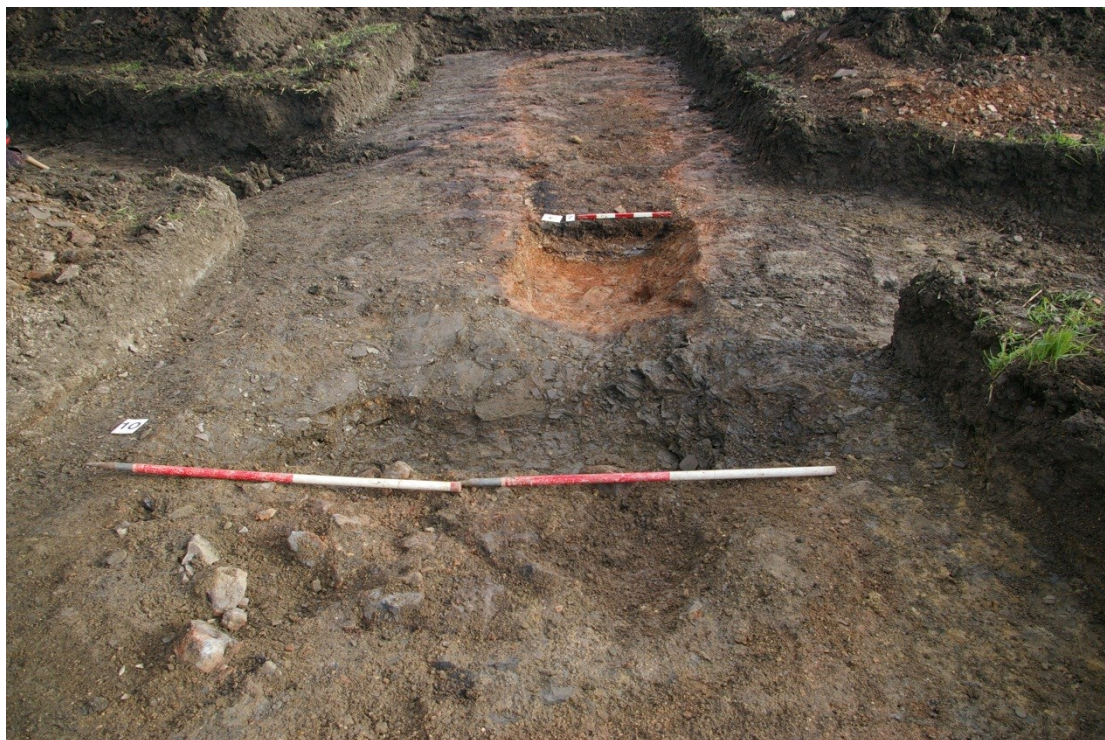
Plate 5: Kiln [7] and pit [10], post excavation, looking north-east

This trench contained a very well preserved kiln feature (originally numbered (4)), which consisted of an elongated pit [7], lying north-east to south-west and measuring 7.35m long and between 0.65m and 0.80m wide and 0.21m deep (Plate 5 & Figure 7). The pit was 0.21m deep and contained a fill (8) of black, dark grey and dark-brown clayey silt with very small pieces of limestone. The fill was loose and under a thin upper deposit of subsoil.

Joined onto the south-western end of the kiln was a large sub-circular pit [10], measuring 2.4m by 2.3m, which had been cut into the mudstone to a depth of 0.3m, with fairly shallow sides and an uneven base. The pit contained a fill (11) consisting of an upper fill of mainly mid to light brown silt and stones, some of which had been burnt and a lower fill consisting of layers of silty clay plus reddish patches of burnt clay, limestone fragments and quite a large amount of charcoal and ash.

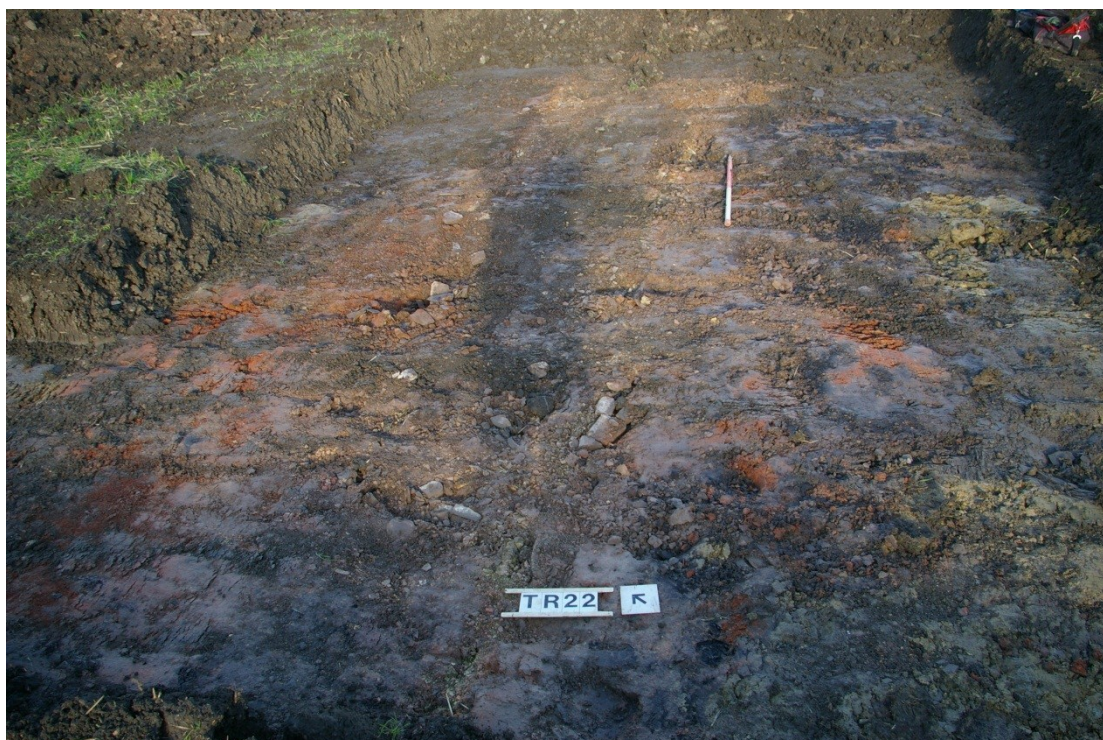
Plate 7: Kiln feature in Trench 22, looking north-east

The trench contained three features. At the south-eastern end of the trench was a patchy area of burnt clay that may have been part of a kiln feature, or a dump of kiln material. Around the centre of the trench was part of a kiln feature that appeared to be orientated north-east to south-west.

Close to the north-western end of the trench was a large, fairly well preserved kiln. The kiln measured 6m by 1.4m and was unusual in that it appeared more uniform than that in Trenches 01, 12 and 15 and was not burnt at the north-eastern end. The south-western end, however, was very disturbed and burnt, with red clay spread out in a wide halo at this end.

Although not all the kiln features were excavated, their observed general form would suggest that all the kilns seen within the evaluation trenches were of this same 'clamp' or 'linear' type form. The un-excavated kiln in Trench 22 was slightly more uniform in shape and did not exhibit the burnt clay halo around the main clamp. This may be simply that the kiln failed to fire (or fired badly) and so did not stain the clay surrounding the kiln. However, there were signs of burning clay around the southern end of the kiln, and so maybe the kiln partially fired and was abandoned.

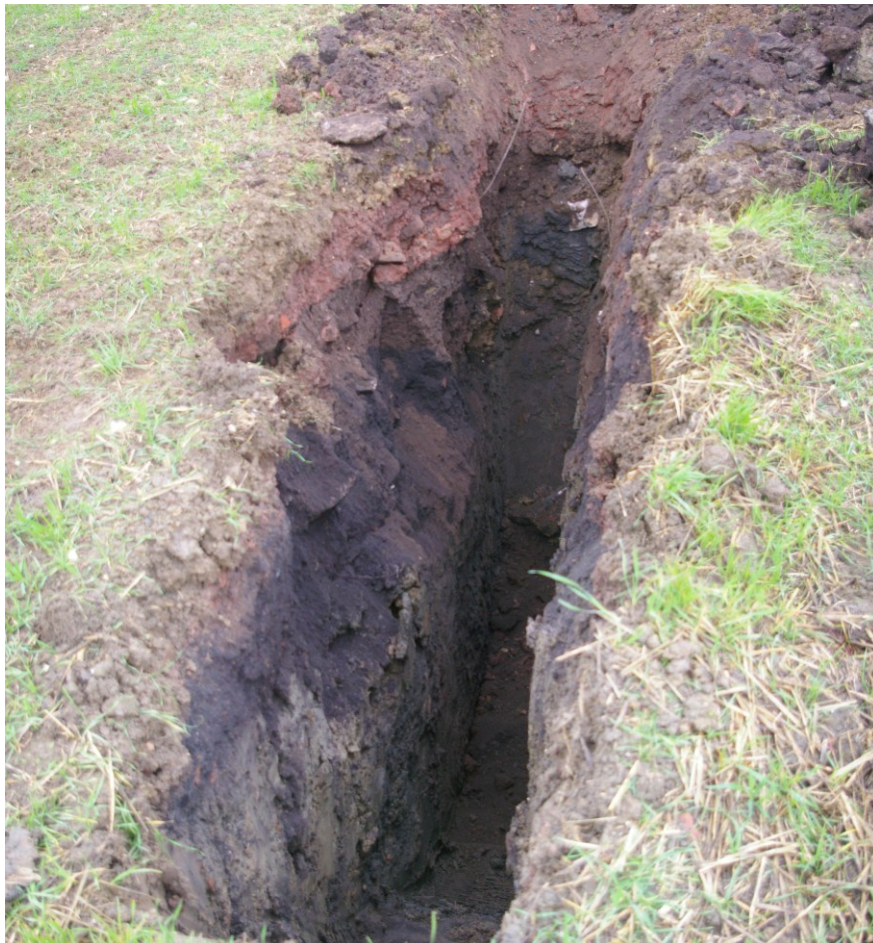
Plate 8: Geo-technical pit excavated in northern part of field, showing deep quarry backfill, looking west

The trenches revealed a large amount of made ground throughout the field, which would be in keeping with the historical and cartographic evidence for the town, which shows a large amount of limestone extraction throughout the Barrow upon Soar area. The evaluation would suggest that the eastern edge of the site (observed within Trenches 09-11 and 25) was relatively undisturbed by quarrying as, for the most part, a natural sub-stratum of yellowish-brown clay was observed throughout the eastern side of the trenches, along with plough furrows, suggesting the remains of a medieval field system.
