An Archaeological Evaluation Land at Shilton Lane, Coventry

An Archaeological Trial Trench Evaluation

at Shilton Lane, Coventry

ULAS Report Number Report No. 2014-203 ©2014

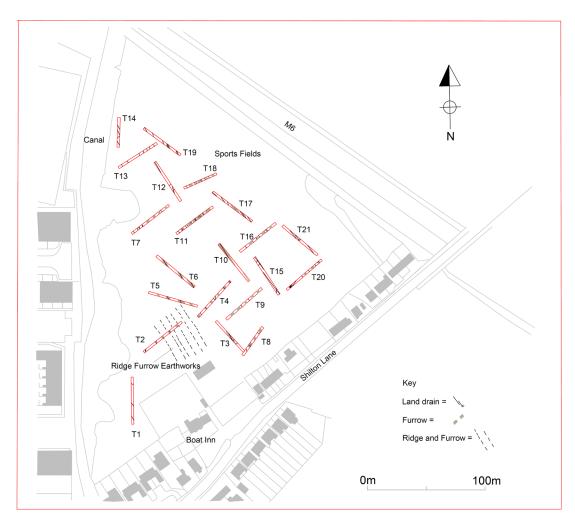
Figure 2 Trench location plan

Trenches 3-4; 6-11; 15-21

Most of the trenches (16) were located within former sports fields in the eastern half of the development area. These trenches were located within an area which had been modified with the ground levels levelled and reduced during construction of the sports fields. Most trenches contained the truncated remnants of furrows and all appeared to be running north-west to south-east orientation away from the Shilton Lane. No dating evidence was recovered although these are likely to be medieval or early post-medieval in origin. Within these trenches were several field drains which were varied in their orientation and are likely to have been inserted when the playing fields were constructed. The natural clay substratum was reached after around 0.20m - 0.50m of topsoil and subsoil had been removed.

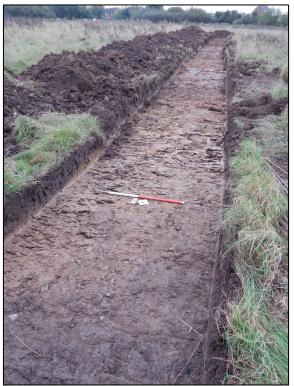
Plate 2 Trench 5 looking north-east

Trenches 2 and 5

This area was located towards the south-west corner of the development area and contained two trenches, numbered 2 and 5. These trenches cut across ridge and furrow which had survived as shallow visible earthworks. Both trenches contained the truncated remnants of ridges, furrows and modern land drains. Again all appeared to be running in a north-west to south-east direction away from the Shilton Lane. In contrast to These trenches appeared to be in an area that had not been heavily modified and reduced during construction of the sports fields. Natural clay was reached after around 0.24m - 0.39m of topsoil and subsoil had been removed.

Trench 5		Orientation SE - NW	Length 42m	Notes: R furrow Va drains.	idge and rious land				
Interval	0m NE	5m	10m	15m	20m	25m	30m	35m	42m SW
Topsoil Depth	0.20m	0.26m	0.20m	0.30m	0.20m	0.20m	0.23m	0.17m	0.20m
Subsoil Depth	0.10m	0.07m	0.07m	0.07	0.14m	0.19m	0.16m	0.18m	0.10m
Top of Natural	0.30m	0.33m	0.27m	0.37m	0.24m	0.39m	0.39m	0.35m	0.30m
Base of Trench	0.38m	0.43m	0.39m	0.37m	0.44m	0.39m	0.41m	0.42m	0.36m

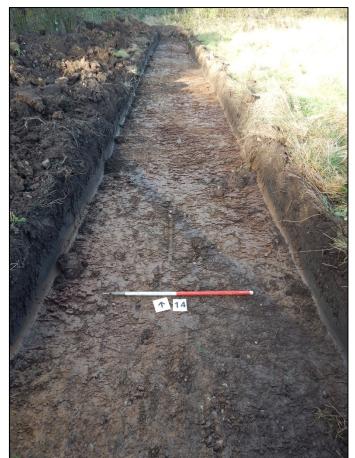
Plate 3 Trench 14 looking north

Trenches 12-14 inclusive were located in north-western end of the development area close to the canal and contained layers of made ground. These layers contained modern pottery, glass and layers of demolition, which suggests that they were perhaps deposited when the canal was closed and backfilled in the late 20th century.

All the trenches featured modern land drains, cutting the natural clay and orientated north to south and south-west to north-east. A thick layer of made ground and topsoil directly overlay the firm grey-orange natural clay substratum, with subsoil being absent from both trenches. No other archaeological finds or deposits were located.

Trench 14		Orientation NE - SW	Length 24m	Notes: Va drains.	otes: Various land Minimum depth to archaeology or nat rains. substratum 0.30m			r natural	
Interval	0m SSW	5m	10m	15m	20m	24m	NNE		
Topsoil Depth	0.26m	0.30m	0.20m	0.29m	0.30m	0.26m			
Subsoil Depth	0.10m	0.16m	0.10m	0.12m	0.12m	0.13m			
Top of Natural	0.36m	0.46m	0.30m	0.41m	0.42m	0.39m			
Base of Trench	0.39m	0.46m	0.30m	0.45m	0.42m	0.39m
