**Historic Building Record:
25-27 Bede Street, Leicester SK 5794 0400**

A programme of historic building recording and survey of a late 19th century factory and warehouse, located at 25-27 Bede Street, Braunstone Gate, Leicester (SK 5794 0400) was carried out by ULAS on behalf of Architects LE1 and Kingsbury Special Ventures, on the 2nd and 3rd of October 2006. The survey has indicated that the buildings were designed by local architectural firm, Redfern and Sawday and constructed circa 1889 on behalf of Orson Wright, a local businessman and entrepreneur. The building survey archive will be deposited with the Leicester City Museum Service under the Accession Number A30.2006.

This document presents the results of a programme of historic building recording and survey of a 19th century factory and warehouse complex, located at 25-27 Bede Street, off Braunstone Gate, Leicester, National Grid Reference SK 5794 0400. Planning permission (2005/0321) has been granted for the residential conversion of the former industrial building, which is included on Leicester City Council's list of buildings of local interest (Ref. L/041). In mitigation of alterations proposed throughout the complex,

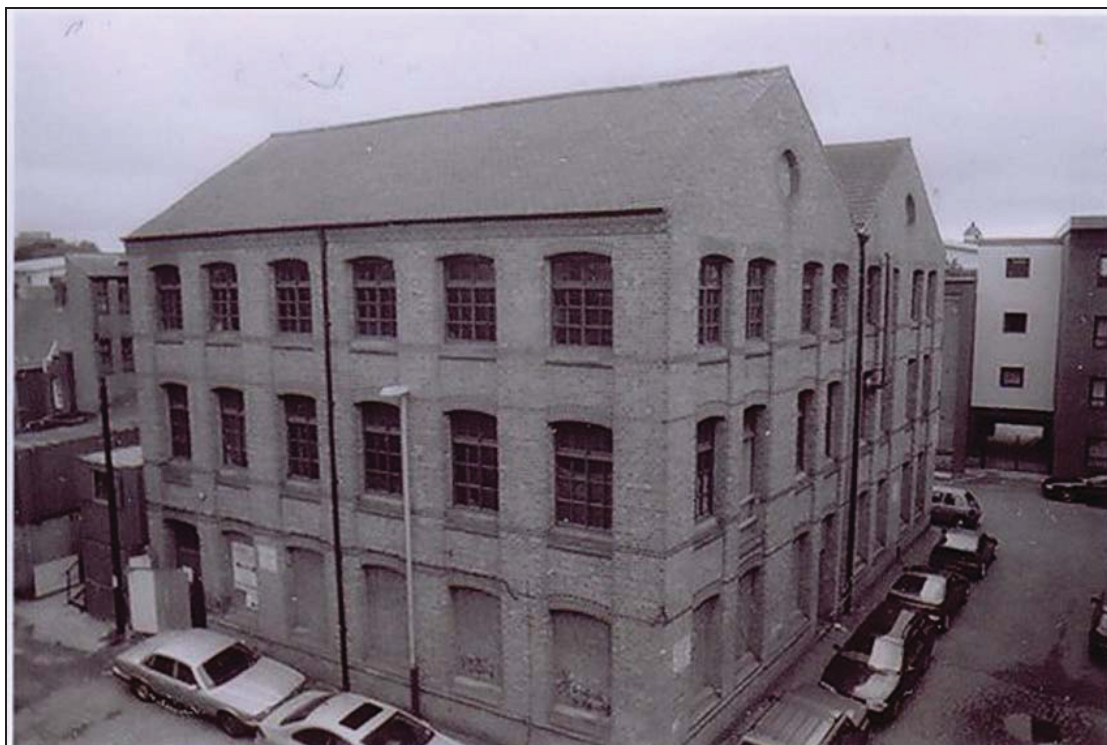
Plate 1. 27 Bede Street. Looking east (taken from fire-escape of adjacent building)

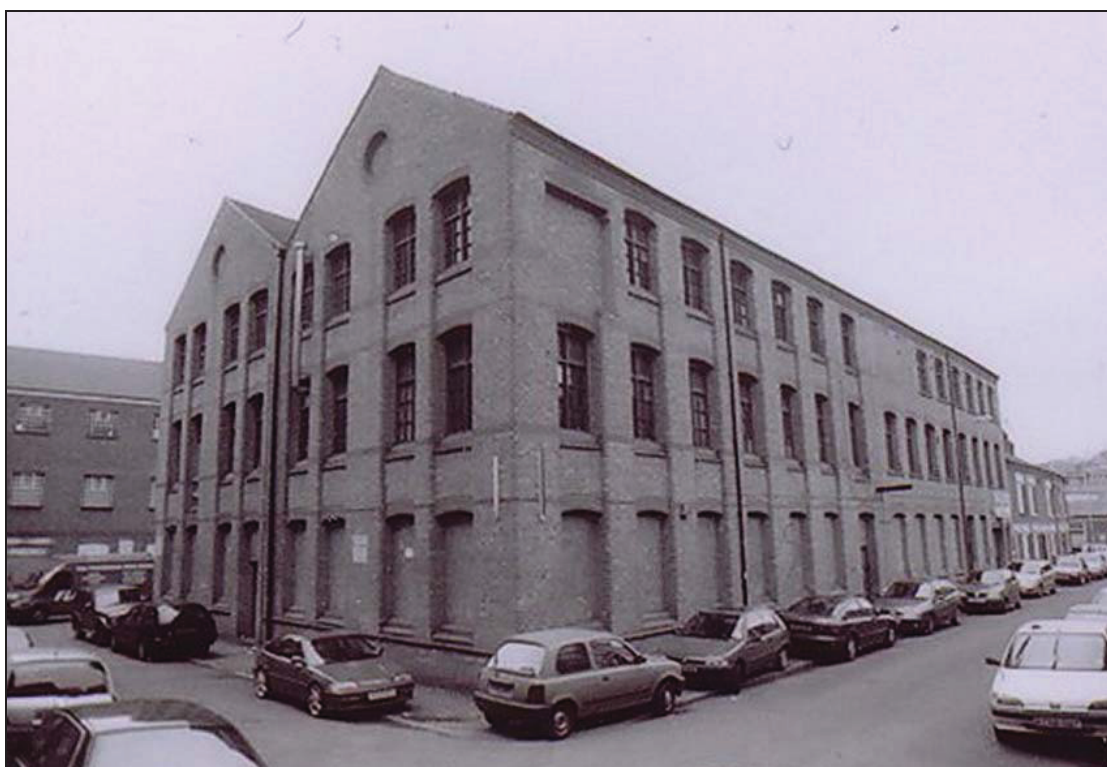
The factory complex at 25-27 Bede Street is a three-storey, red-brick building, ostensibly L-shaped in plan form, but actually composed of two distinct elements, hereafter referred to as the factory block (Number 27) and the warehouse block (Number 25; A and B above, Plates 1-3). The factory block is located at the south-eastern end of the complex and is a double-pile structure, with the principal façade, overlooking the southwest/northeast stretch of Bede Street, measuring some 18.80m in length and composed of seven recessed window bays. The principal entrance is located in the seventh bay, at the right-hand end of the building. This consists of a

wide opening, with multi-pane overlight, and houses a timber, 9-panel door. The southwest facing, gable elevation is M-shaped and composed of eight recessed window bays, with a circular window within the apex of each gable. The doorway located at ground floor level, within the fourth window bay from the left hand side, is a late insertion. A loading door at first floor level, within the second bay from the left hand side is apparently original. The northwest facing rear elevation, measuring 15.3m in length, is composed of six recessed window bays, with an original entrance located on the ground floor, within the first window bay from the left-hand side. Fenestration on ground and first floors consists of timber-frame, multi-pane windows, set within tall, recessed openings with segmental arch-heads. Window openings on the second floor are squatter, although the framing arrangement is similar. Sills consist of a double tier of chamfered sandstone, projecting from the face of the building at first and second floor levels, but flush with the wall face on the ground floor.

Plate 2. 25-27 Bede Street. Looking north

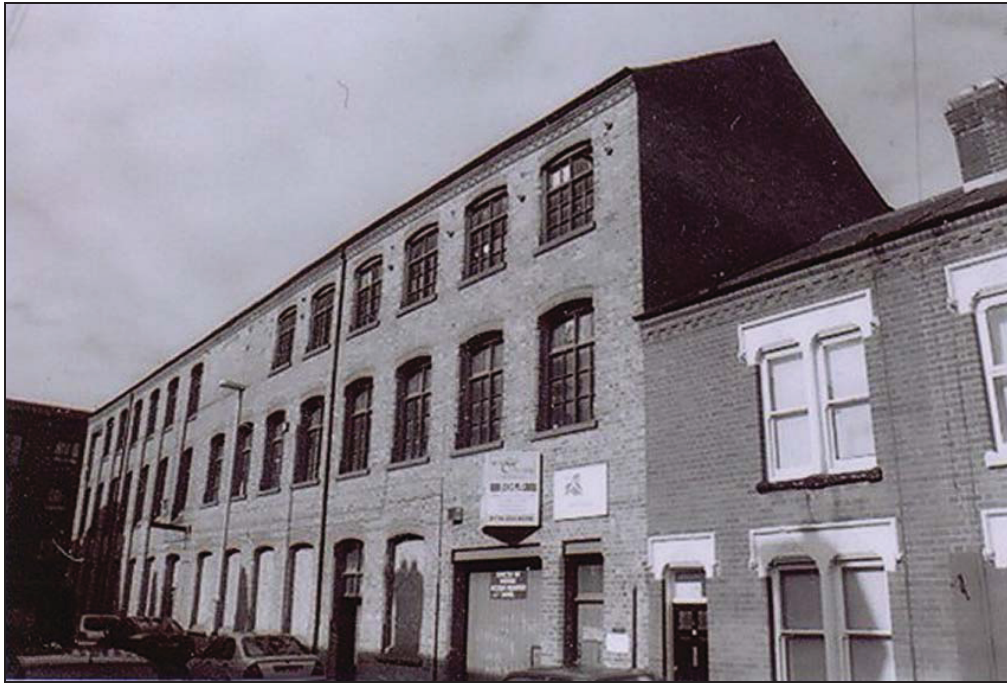
Plate 3. 25 Bede Street. Looking west

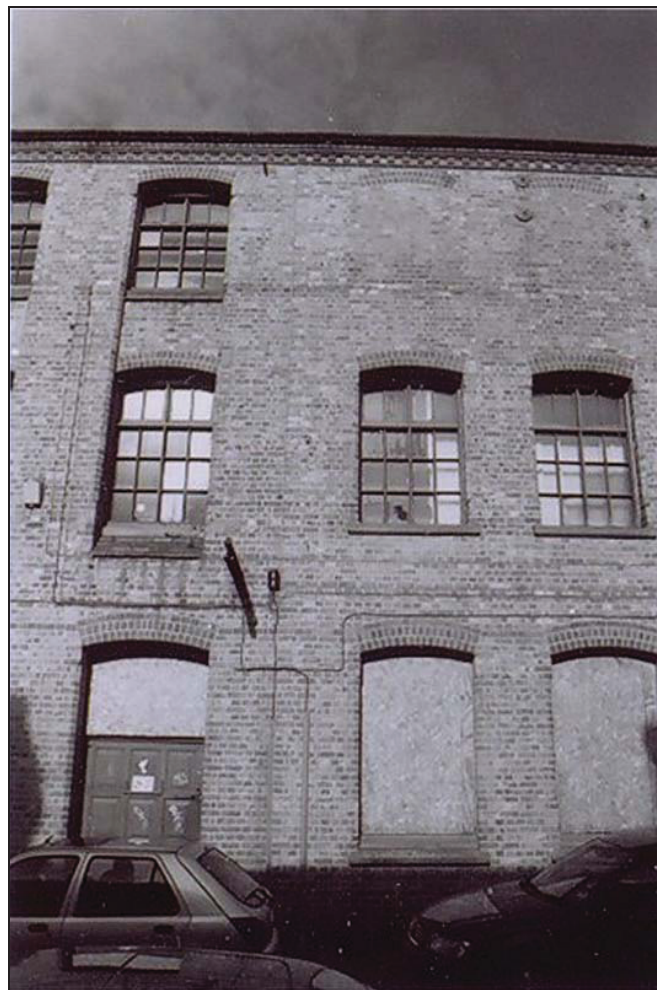
On the principal façade, to the right hand side of the main entrance, a vertical joint rising the full height of the brickwork indicates the division between the factory and the warehouse block (Plate 4). The principal façade of the warehouse block measures 19.9m in length and comprises 8 window bays: unlike the factory block, the bays are not recessed, the window openings being flush with the face of the wall (Plate 5). There are three entrances at ground floor level. At the right hand end of the factory block, in the seventh window bay, is a narrow, inserted doorway, with glazed overlight. A segmental arch-head visible above, presumably relates to an earlier opening, now blocked. To the left hand side of this is a wide loading entrance, also inserted. Again, a segmental arch-head visible above, appears to correspond with the position of an earlier opening. Fenestration matches the arrangement seen in the factory and decorative treatment is similar, with matching chamfered corners to the window and doorway reveals. Blue brick string courses at the levels of the ground and first floor window heads and beneath the level of the second floor window sills are similar to those on the factory elevations. A dentilated eaves course has blue brick detailing. At second floor level, windows within the first and second bays from the left hand side are blocked with brick. The northeastern gable end elevation is blind, with neighbouring terraces built up against the warehouse to first floor level. At the time of the survey, the rear, northwest facing elevation was not available for inspection due to redevelopment of adjacent properties, but is composed of seven window bays, with a narrow toilet block projecting at right angles from the end bay, rising the full height of the building.

Plate 4. Interface between no.s 25 and 27 Bede Street (27 is on the left hand side). Looking northwest

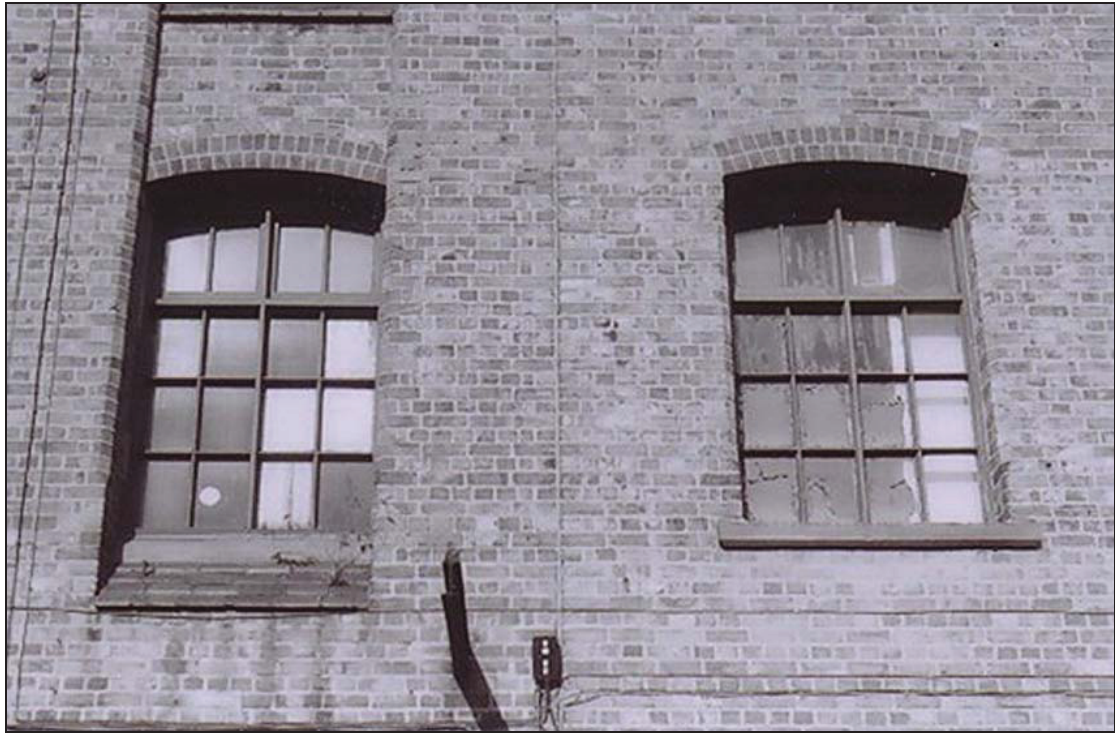
The factory block has a number of decorative features which are carried around each elevation of the building. Window and door openings have chamfered corners: in the recessed window bays the chamfers rise the full height of the building, stopped just above the sill of the ground floor window and just below the second floor window head. String courses at the level of first and second floor window sills comprise a double band of blue bricks; at ground and first floor window level, single, continuous bands of blue brick are taken around the building, following the curve of the arched window heads. There is a dentilated eaves course to the front and rear elevations. Roofing material to the frontage range of the factory block consists of ceramic tile: on the back range, the roof is capped with welsh slate.

Plate 5. 1st floor window details (27 is on left hand side). Looking northwest.

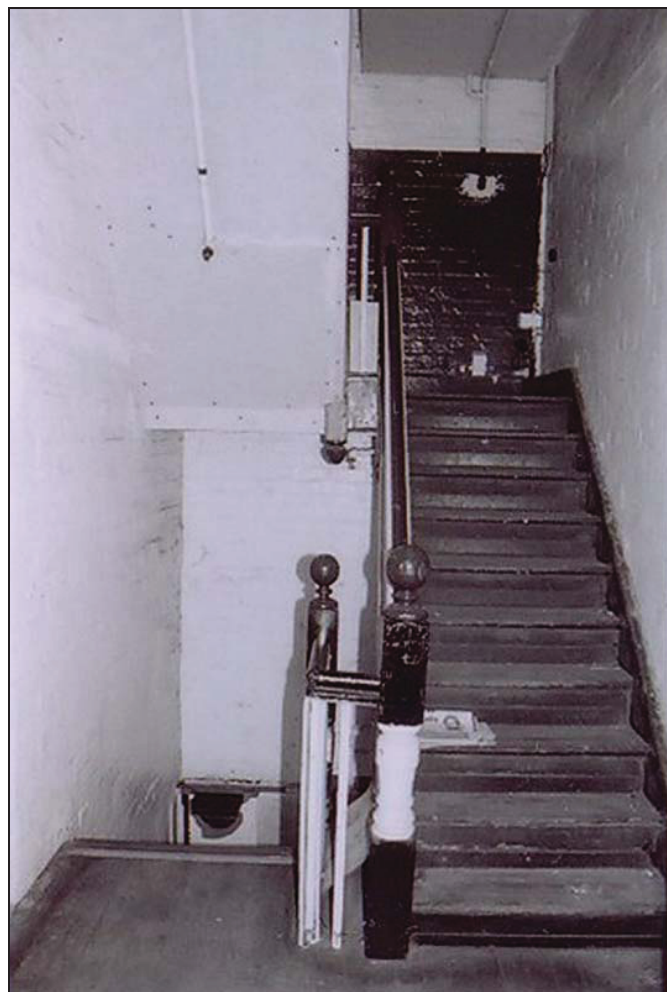
The principal entrance opens onto a plain vestibule of painted brick. Directly opposite the front door is an open-well staircase (Plate 6), with turned newels and pendants (although these are boxed in at ground floor level and at the level of the half landing between ground and first floors). Balusters are of plain stick type. Much of the staircase and stairwell is clad in fire-proof asbestos sheeting. On the right hand side of the entrance is the lift-shaft, which has cast-iron, fire-proof doors. A segmental arch-headed doorway on the left-hand side of the entrance leads to the ground floor of the factory block. A door to the rear of the staircase was blocked at the time of the survey, but presumably provided access through to the adjacent warehouse block. First and second floor landing areas have a similar arrangement, with opposing segmental arch-headed doorways located in front of the stairs, providing access to the upper floors of the warehouse block in addition to those of the factory. There are cast-iron lift-shaft doors on each floor.

Plate 6. 27 Bede Street. Staircase from 1st to 2nd floor. Looking northwest.

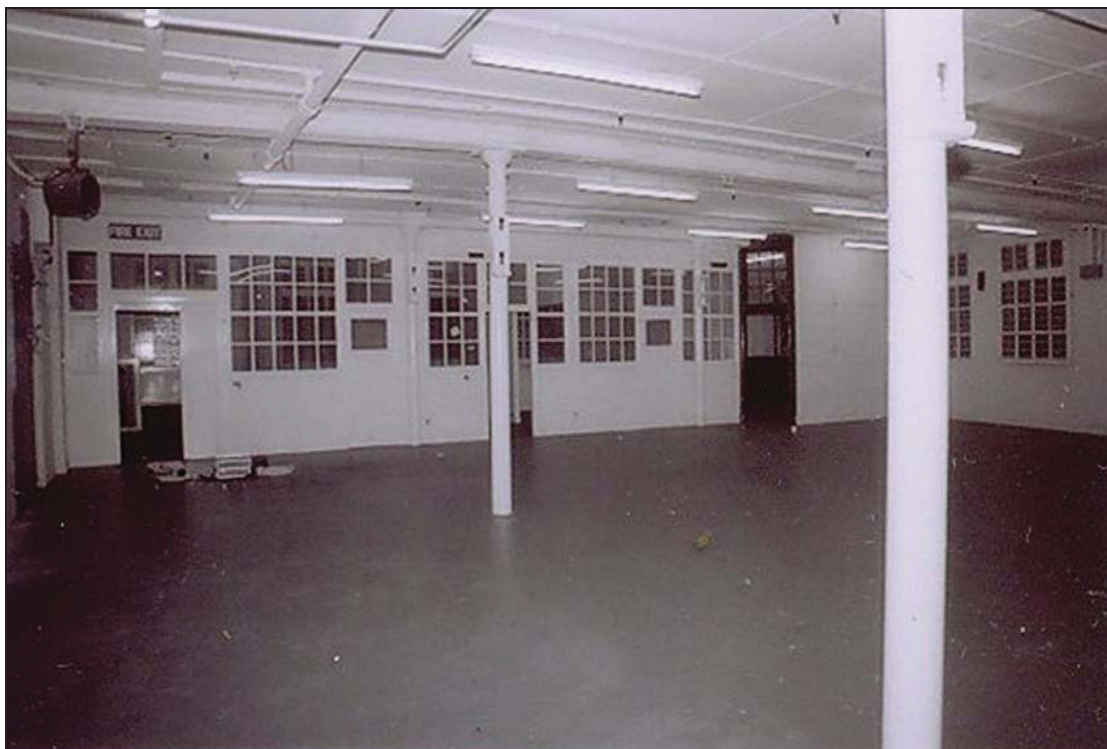
Entrance to the ground floor of the factory is via a doorway leading from the entrance vestibule to the first of four offices that are located along the frontage of the ground floor area (Plate 7). The offices are constructed from timber and are part-glazed, probably dating to c1930s/40s. The main office is located in the southern corner of the building and has mahogany wainscoting to all four walls. An early electric fireplace is located in the centre of the partition wall, dividing this from the adjacent office (Plates 8 & 9).

Plate 7. 27 Bede Street, ground floor. Looking south, towards offices.

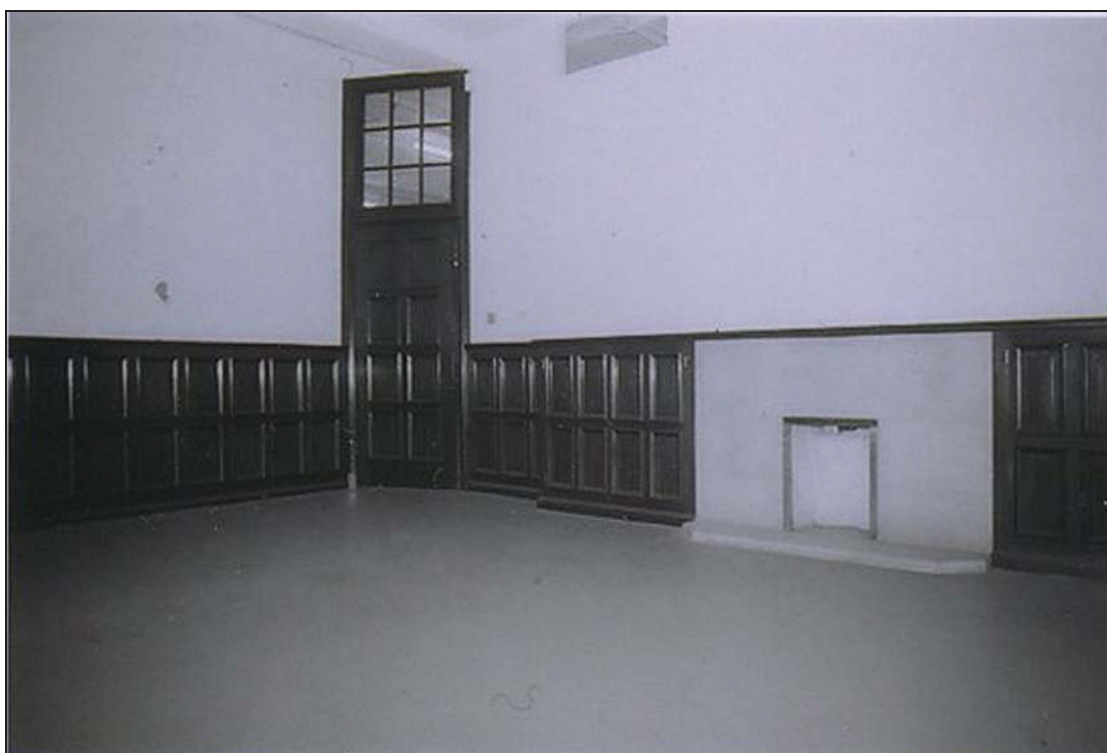
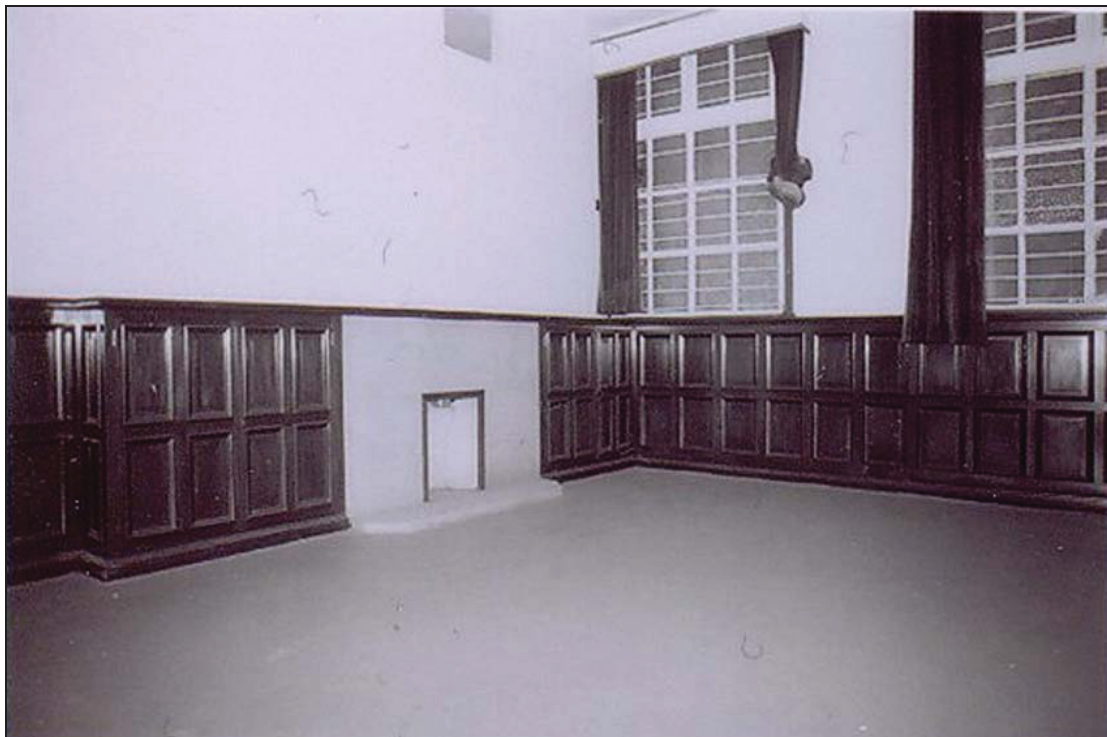
Plate 8. 27 Bede Street. Ground floor, main office. Looking north.

Plate 9. 27 Bede Street. Ground floor, main office. Looking east.

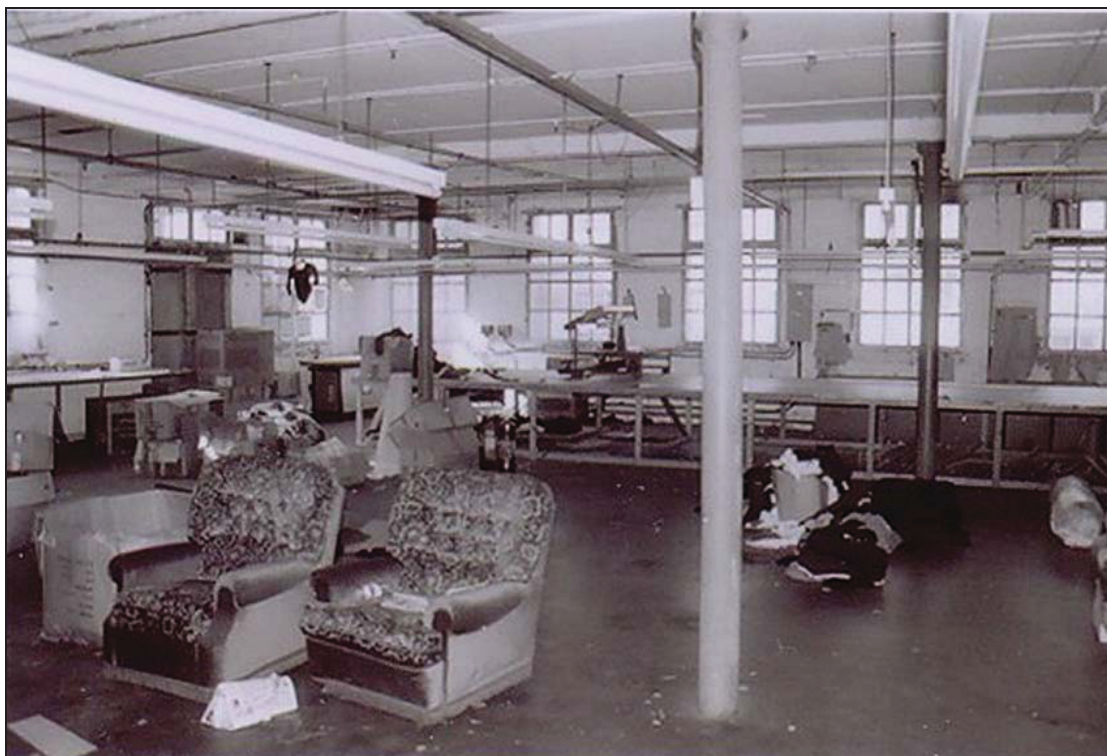
The first floor arrangement mirrors that of the ground floor, being generally of open plan form with a range of smaller offices along the frontage wall. The arrangement of the offices appears early, with surviving elements of matchboard panelling, part-glazed partitions and a timber 6-panel door indicating a late 19th-early 20th century date. Three pairs of cast iron columns match the arrangement of those on the ground floor. Against the northeastern wall, a toilet block projects into the room and the inserted rear staircase, boxed in, with modern, fire-proof door for access, rises up against an internal chimney stack. The stack appears to be part of the original build and there is evidence of a fire-place, now blocked, presumably at the time that the staircase was inserted.

Plate 10. 27 Bede Street. 1st floor office. Looking southwest.

Plate 11. 27 Bede Street, 1st floor. Looking west.

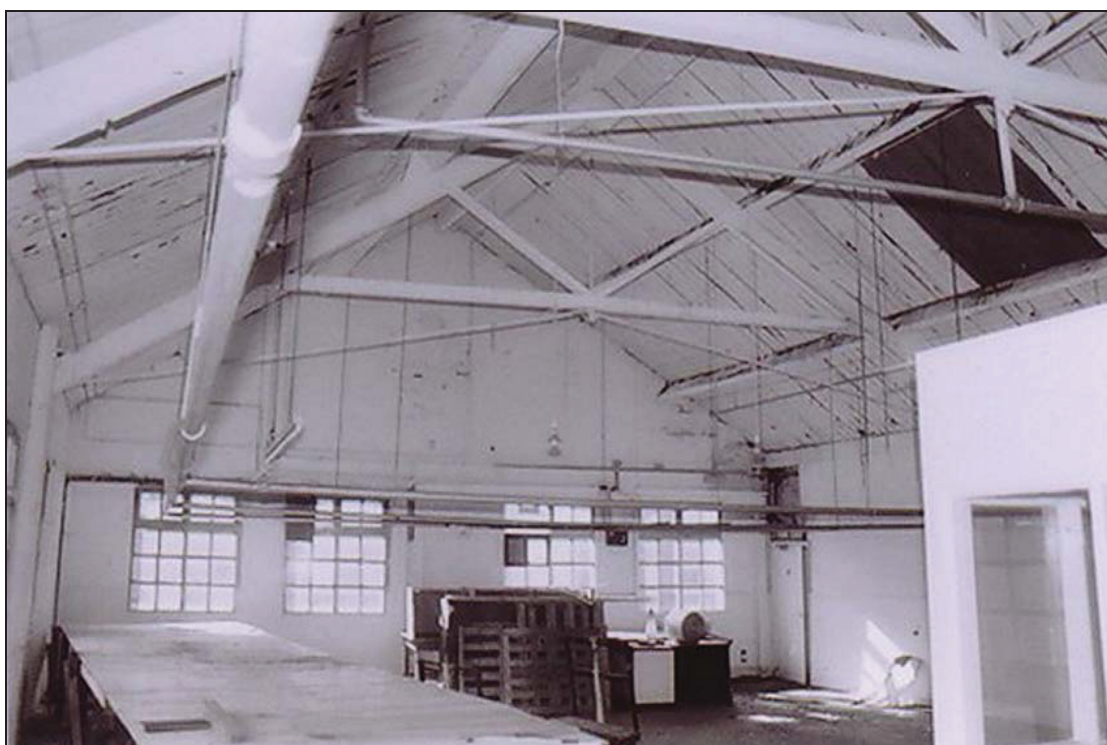
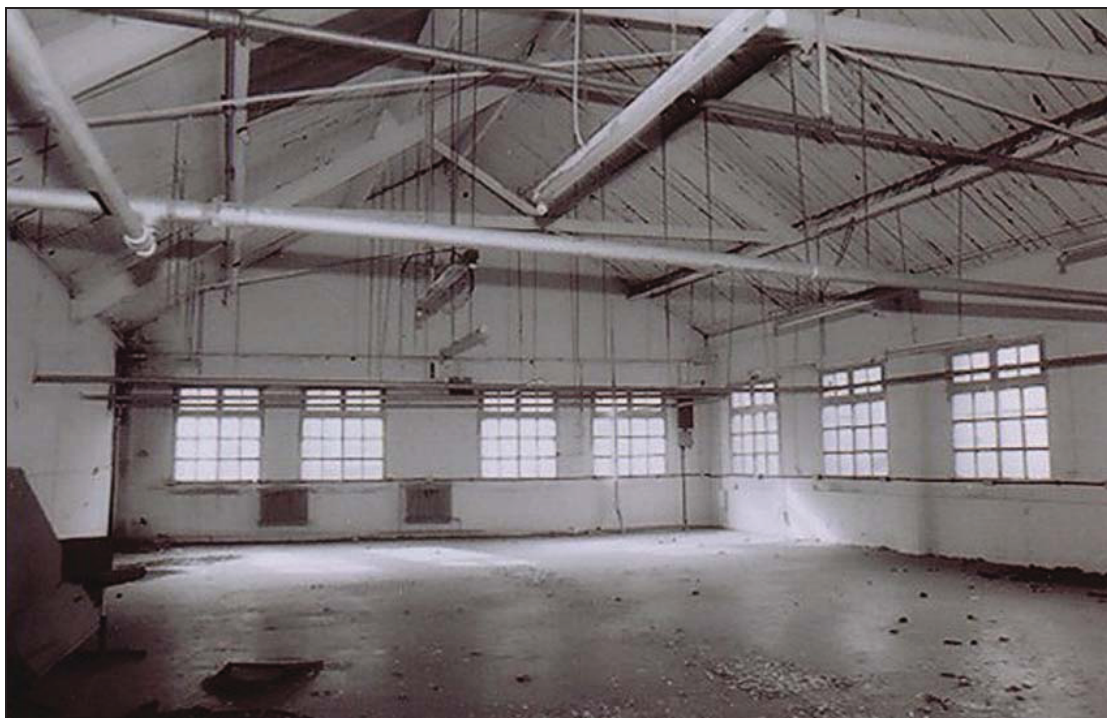
The second floor is presently divided into two large rooms, the dividing wall corresponding with the valley of the double-pile roof. Within the southeastern room modern partition walling material has been used to create office, kitchenette and 'powder room' compartments which communicate with the toilet block along the northeastern wall. Within the northwestern room, the boxed-in rear staircase is located against the internal chimney stack.

The trussed rafter roofs are of collar-rafter type, with raking braces and an iron tie-bar in the king post position. At the apex, the principals are housed in a cast-iron yoke through which the tie bar passes. Iron ties rising from the wall-plates to the centre of the collar prevent the side walls from spreading under the load of the roof, in lieu of a tie-beam. Two orders of purlins are carried on cleats over the backs of the principals. The ridge plate sits on top of the cast-iron yoke. Similar cast-iron fittings occur in the roof structure of Bradgate Stables, Groby, built in 1857 and also at Launde Abbey, probably dating to 1844 (TRP 2006,ULAS Report No. 2006-055; Finn 2005, ULAS report no. 2005-096).

Plate 12. 27 Bede Street, 2nd floor. Looking southwest.

Plate 13. 27 Bede Street, 2nd floor. Looking west.

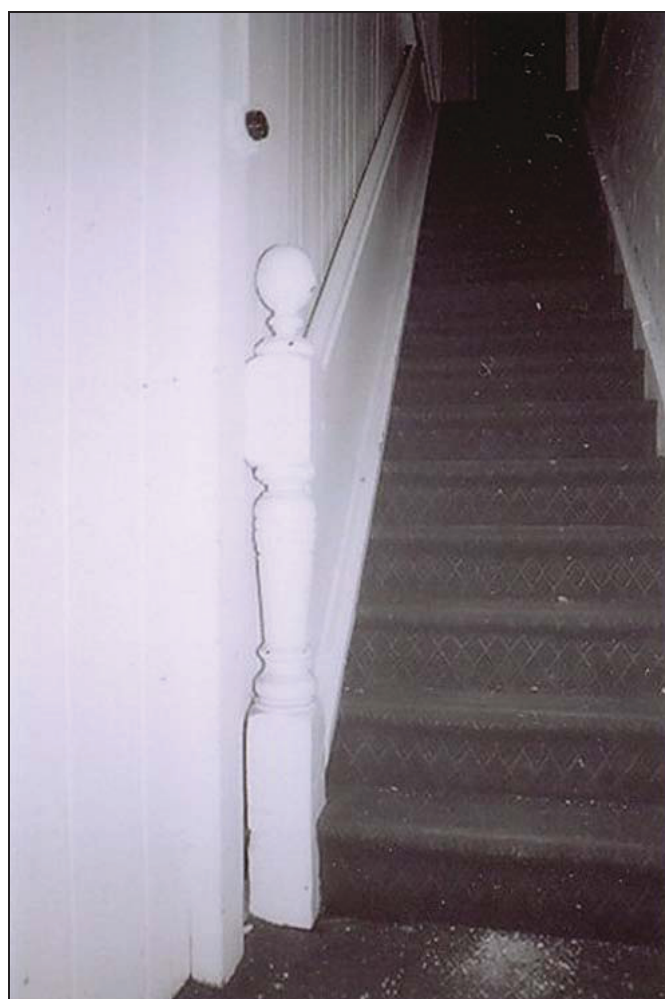
The main entrance to the warehouse block is located within the eighth window bay of the principal façade. Although the present opening is late, there is evidence of an earlier doorway in a similar position. The present entrance opens onto a small vestibule which leads directly to a single flight of stairs up to the first floor. Modern partition walling encloses the vestibule and there is no access to the ground floor of the warehouse via the main entrance. The staircase, serving all floors, is early and constructed of timber (Plate 14), with turned newels and stick balusters in the same style as those of the principal staircase within the factory block. Matchboard

partitions, which were originally used to enclose the staircase, survive beneath modern asbestos fire-proof cladding.

Plate 14. 25 Bede Street. Staircase to 1st floor. Looking northwest.

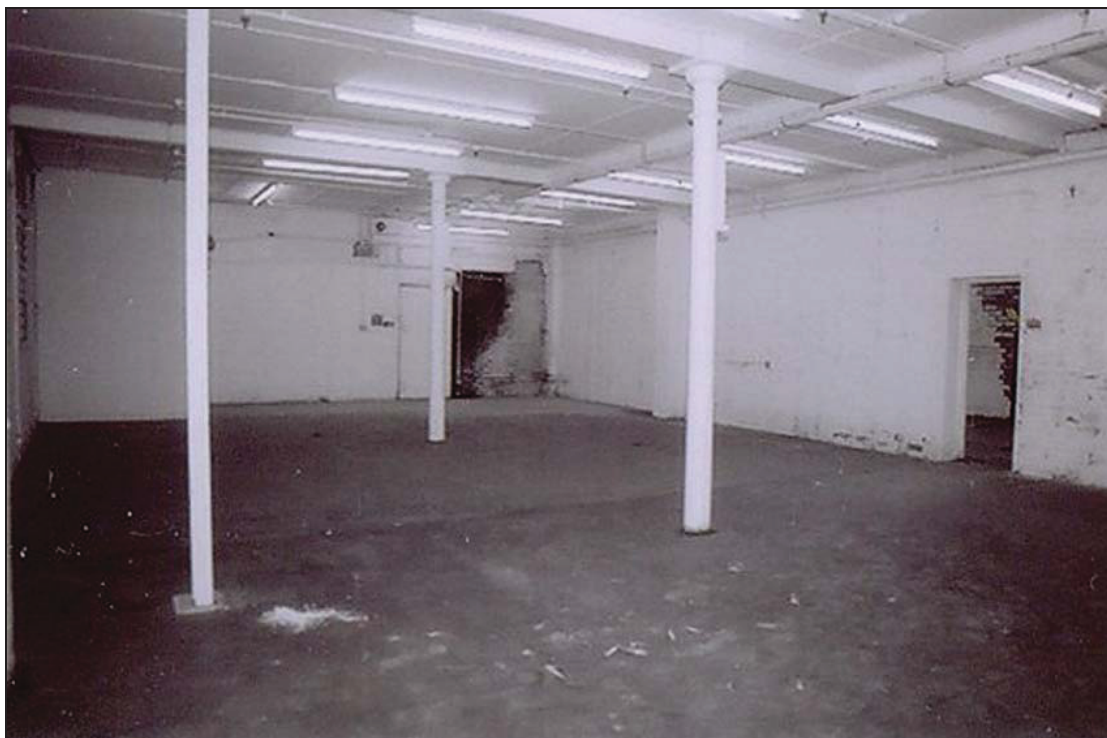
The ground floor of the warehouse block is open plan, with transverse timber ceiling beams supported on a row of cast-iron columns, aligned southwest/northeast across the room (Plate 15). The columns have brackets to support line shaft bearings and there were presumably three columns in place originally, with the column to the northeast now replaced by a modern brick wall.

Plate 15 25 Bede Street, ground floor. Looking southwest

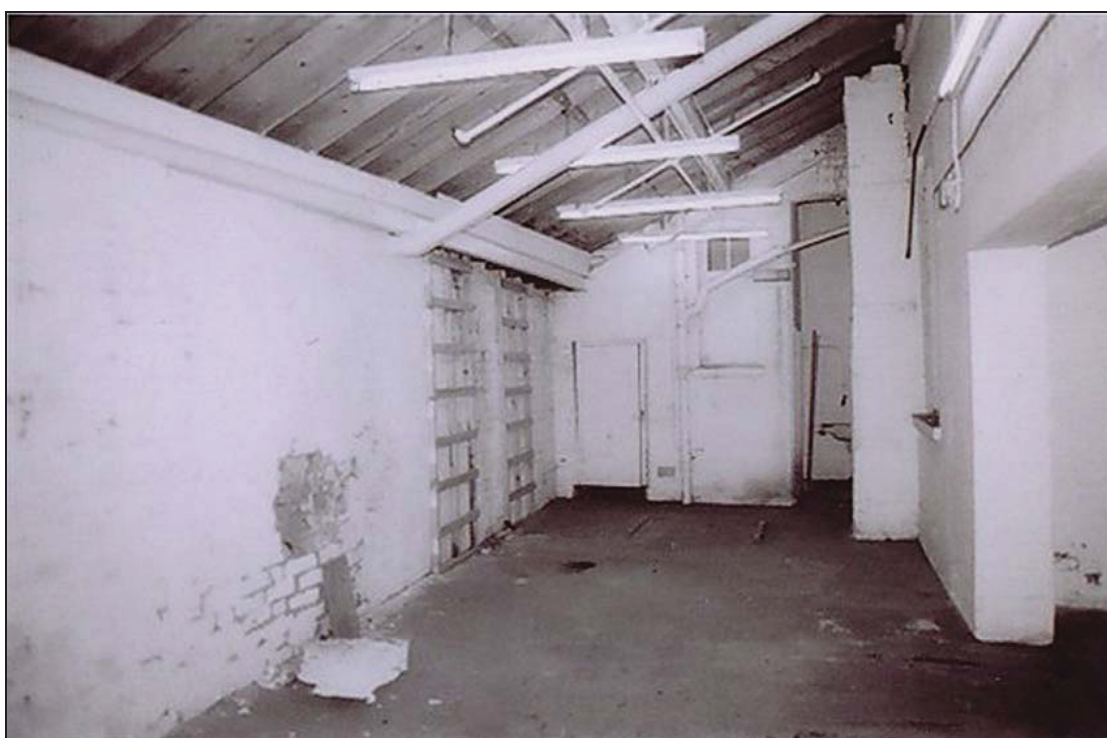
Within the rear courtyard area, an external chimney stack to the rear of the warehouse block, does not appear to be tied in to the fabric of the building (Plate 16). Within the warehouse a flue pipe descending from the ceiling corresponds with the position of the external stack, indicating the former presence of a boiler.

Plate 16. 25 Bede Street, former yard area. Looking northeast

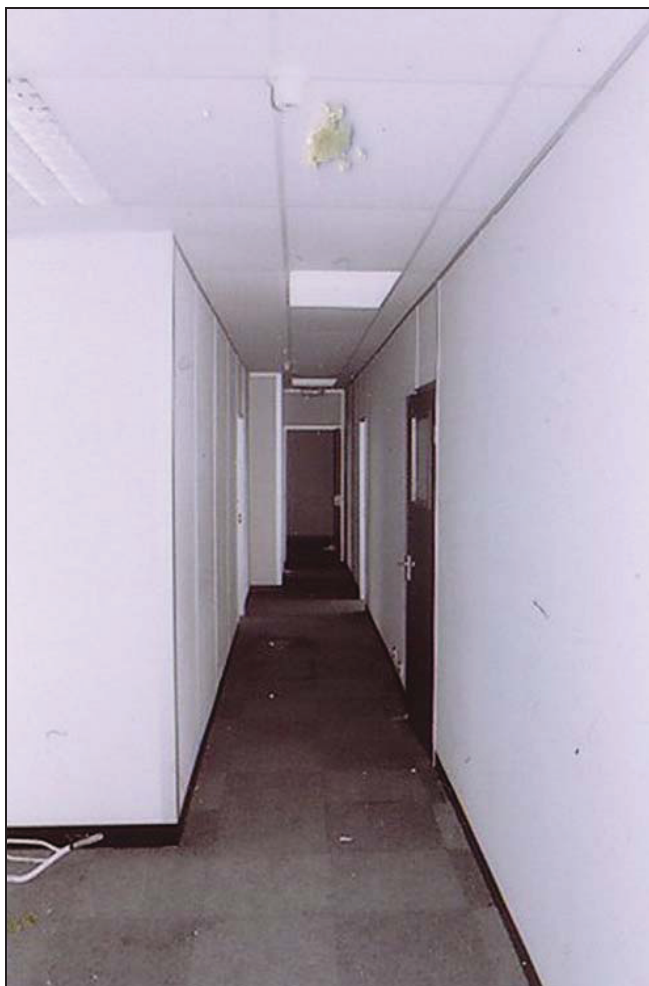
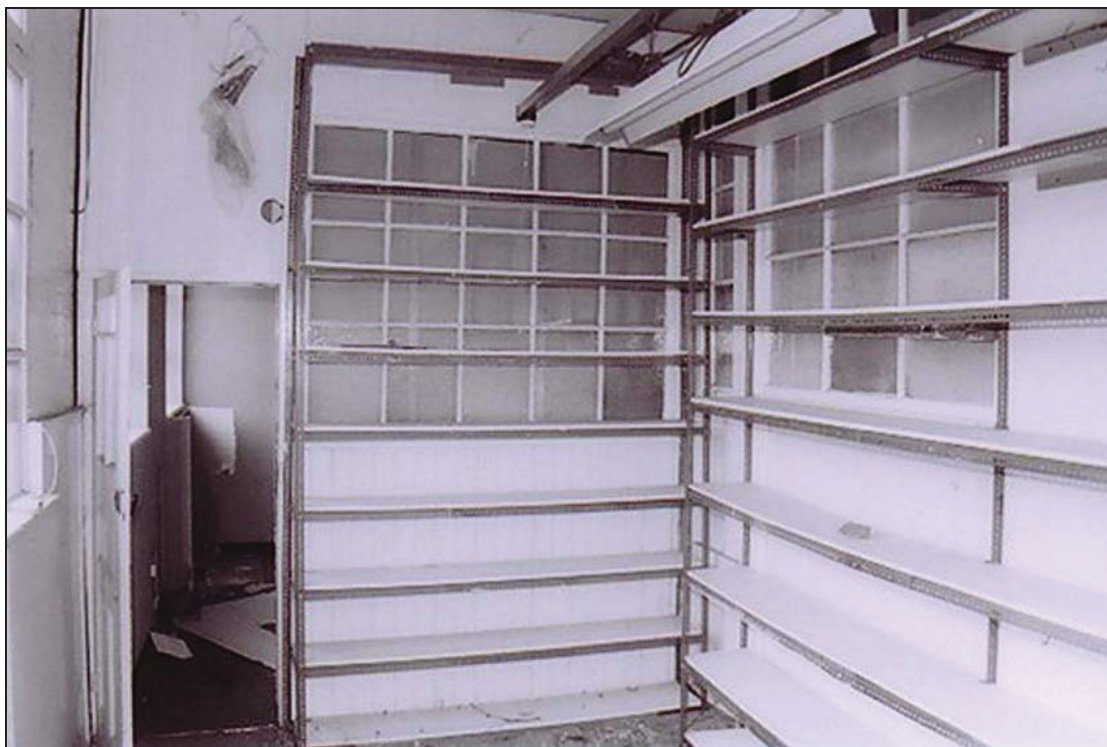
The first floor of the warehouse block is divided up by modern partition walling into a number of offices, with a central corridor running along the length of the floor (Plate 17). The eastern corner office however, is early, formed of matchboard panelling, with partial glazing and an early 2-panel door (Plate 18). Three cast-iron column supports are *in situ*, boxed in but visible through holes in the present suspended ceiling. Access through to the principal stairwell of the factory block is provided by an apparently original doorway, with segmental arch head.

Plate 17. 25 Bede Street, 1st floor corridor. Looking northeast.

Plate 18. 25 Bede Street, 1st floor office. Looking southwest.

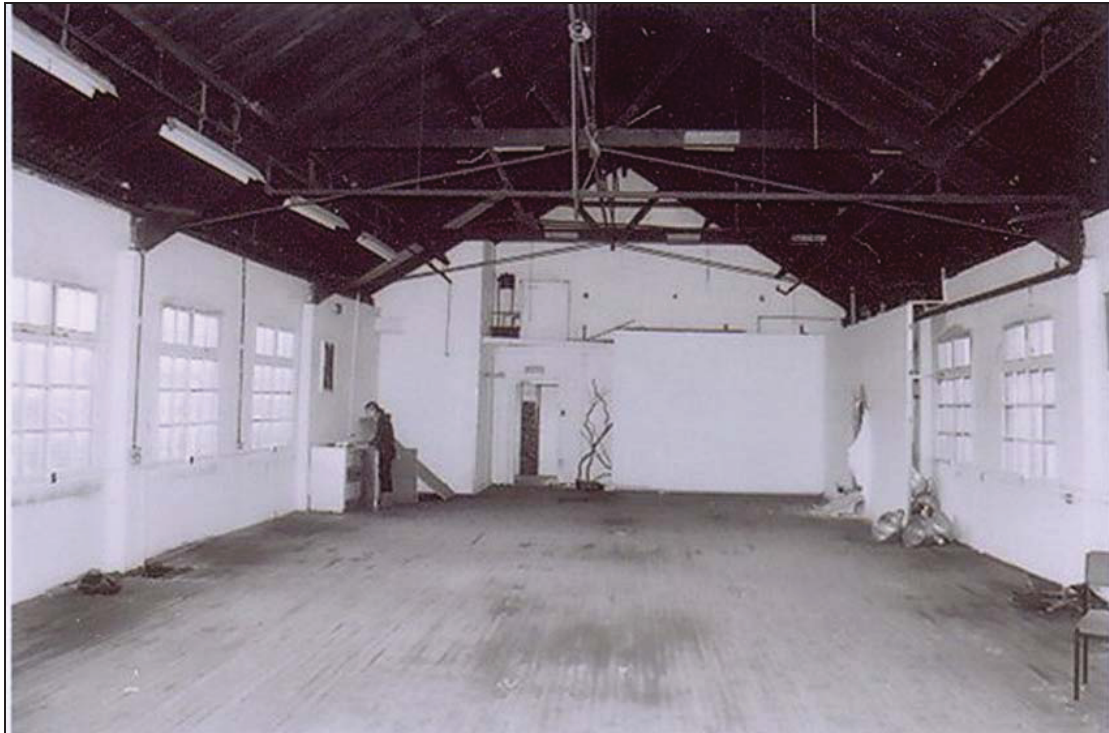
The second floor is of open plan arrangement, with a segmental arch-headed doorway providing access through to the principal stairwell of the factory block. On the rear wall in the northern corner, the chimney stack projects into the room and there is evidence of a blocked fireplace and pipework presumably connecting with the boiler flue recorded on the ground floor.

The roof is supported by three collar-rafter trusses, of similar arrangement to those recorded in the factory block.

Plate 19. 25 Bede Street, 2nd floor. Looking southwest.
