An Archaeological Watching Brief  
And Strip, Plan and Sample at  
Haymarket Bus Station, Leicester  
NGR: SK 58890 04780

**An Archaeological Watching Brief and  
Strip, Plan and Sample at  
Haymarket Bus Station, Leicester**

ULAS Report No. 2015-013

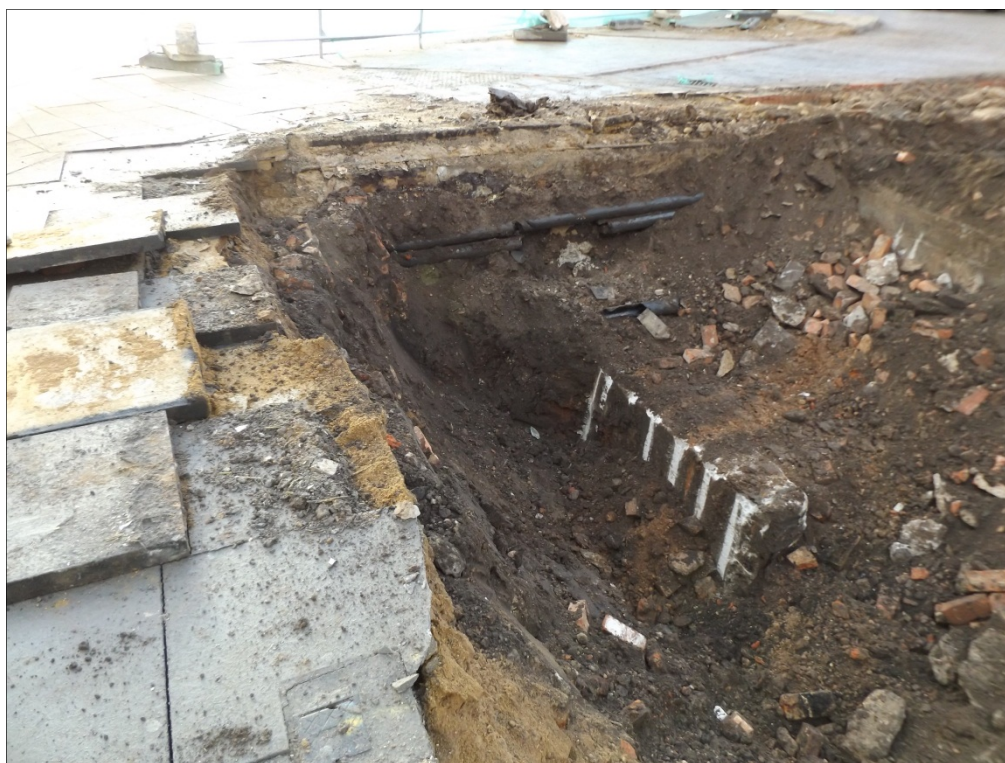
Figure 3: Watching brief area facing East.

The archaeological watching brief took place between the 15th and 19th of December 2014 following the demolition of buildings occupying plots 37,47 and 49 Belgrave Gate, Leicester and 1-5 Charles Street, Leicester (Fig. 2). The removal of large concrete slabs were observed. Beneath these slabs was a build-up of demolition material from the previous buildings that had occupied the site (Figs 3-4). Due to the depth of the excavation and the poor stability of the ground, accurate measurements were not possible. However a construction worker was able to safely enter the excavated area and measured a depth of 3.50m. No natural substratum was observed at this depth.

The removal of further concrete slabs, concrete footings and a concrete staircase were observed and in the north-eastern corner of the site a brick wall, probably a Victorian cellar; this had been truncated by the more recent concrete wall footings.

No archaeological deposits were identified during the groundworks.

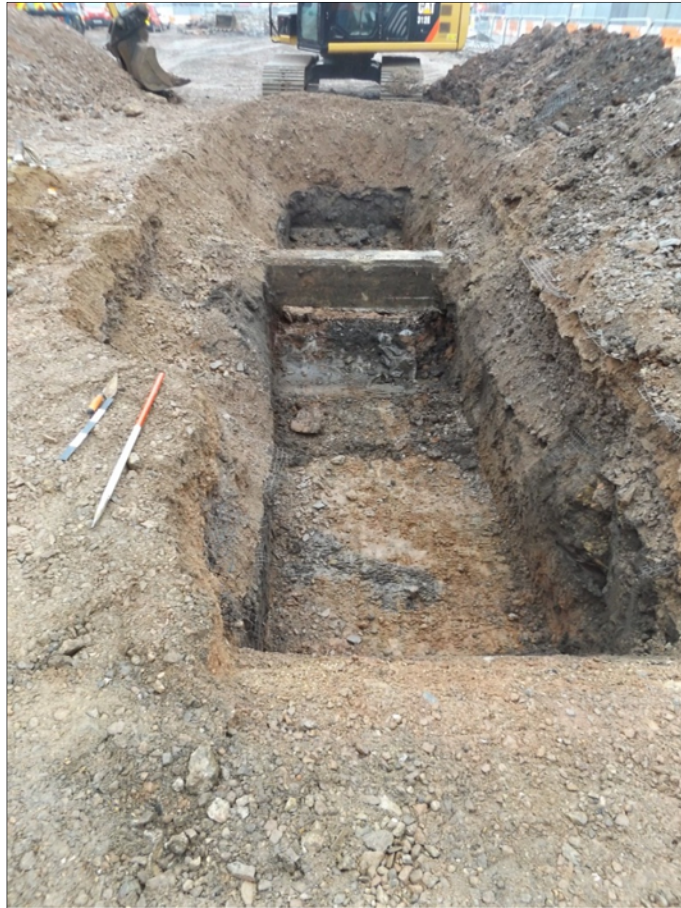
Figure 5: Strip, Plan and Sample area facing North

The archaeological strip, plan and sample took place on the 16<sup>th</sup> and 17<sup>th</sup> February 2015 on the area of the Haymarket Bus Station (Fig. 2). An attempt to excavate a continuous area was hampered by the large amount of disturbance in the area. Large concrete footings and walls were common throughout the area to be stripped; however it was possible to excavate some areas down to the natural sub stratum (Fig. 5). In these areas depths were measured for each of the fills.

From these observations it is clear that that the area had previously been truncated and that no archaeological deposits were disturbed by the groundworks.

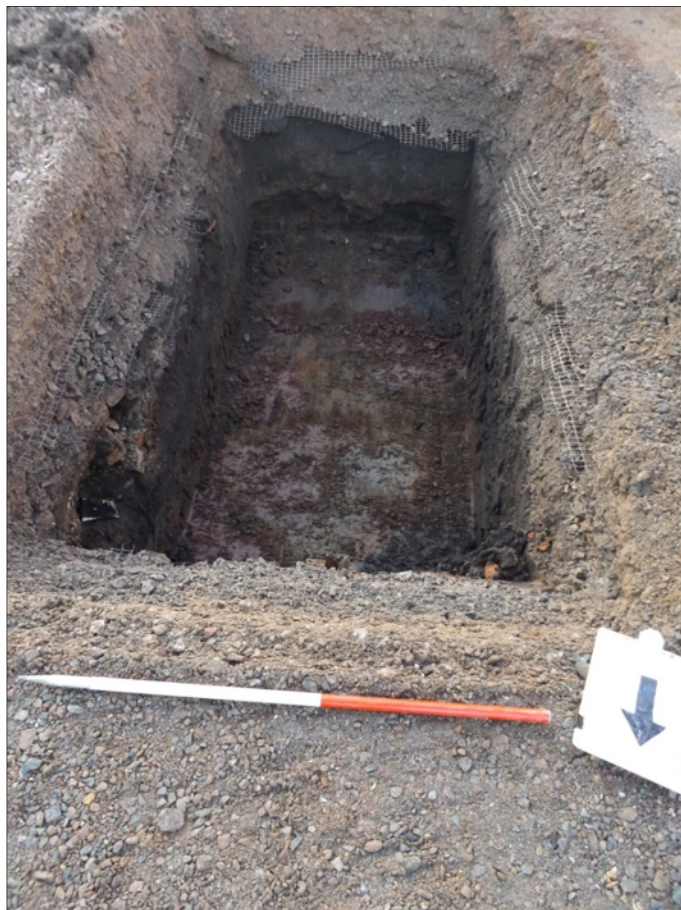
Figure 6: Strip, Plan and Sample area facing South

The upper most fill across the area was Type 1 hardcore varying in depth from 0.85m to 1.15m. Below this was a layer of demolition rubble that measured between 0.45m to 0.60m in depth across the site. Below the rubble a band of re-deposited pinkish-brown redeposited clay was observed measuring between 0.15m and 0.25m in depth across the site. Beneath this clay lay a very dark buried topsoil mixed with modern brick and plastic sheeting measuring between 0.55m and 0.70m. This lay directly on top of the undisturbed natural substratum which was observed at depths of between 2.15m and 2.80m across the site (Fig. 6).
