**An Archaeological Field Evaluation on
Land at Church Street/Bowleys Lane,
Appleby Magna,
Leicestershire.**

NGR: SK 3137 0977 (centre)

ULAS Report No. 2014-176
©2014

For: Jupiter Strategic Land Limited

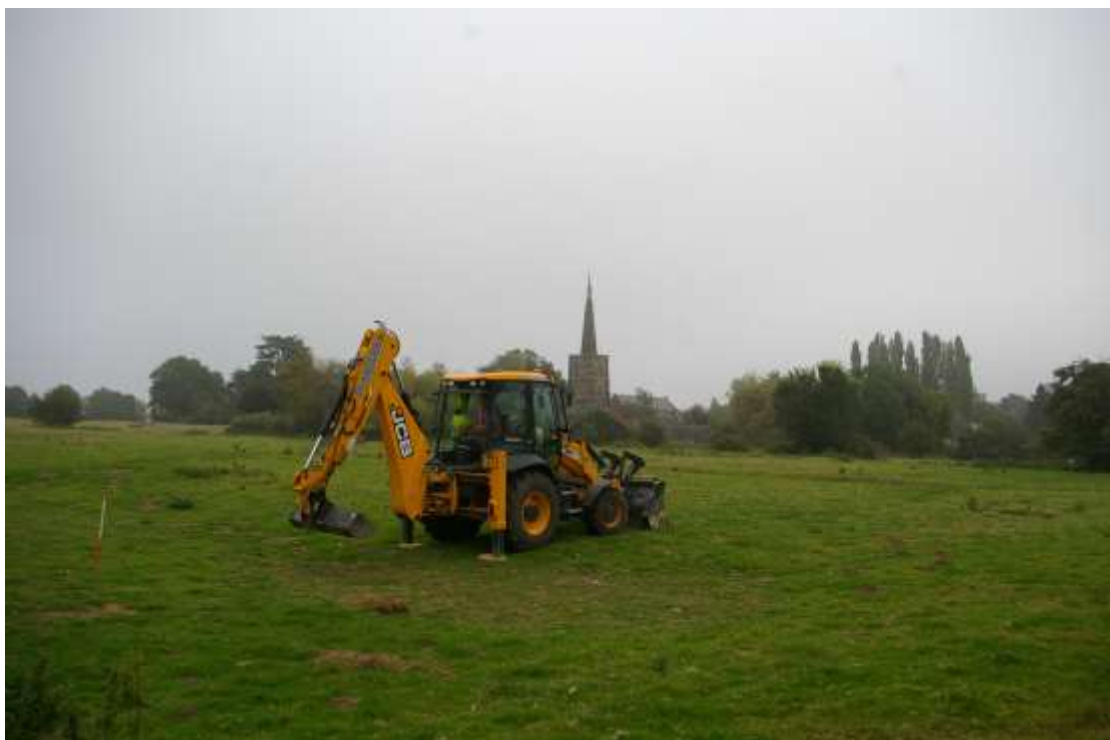
Figure 8 Trench 1 before excavation
Trench 1 to be dug between ranging poles. JCB is on top of low earthwork

Trench 1 was located towards the south side of the site near to the field entrance onto Bowleys Lane. This area of the site was relatively level with shallow depressions running up the slope to the north either side of a low mound across the centre of the proposed line of the trench (Fig. 8).

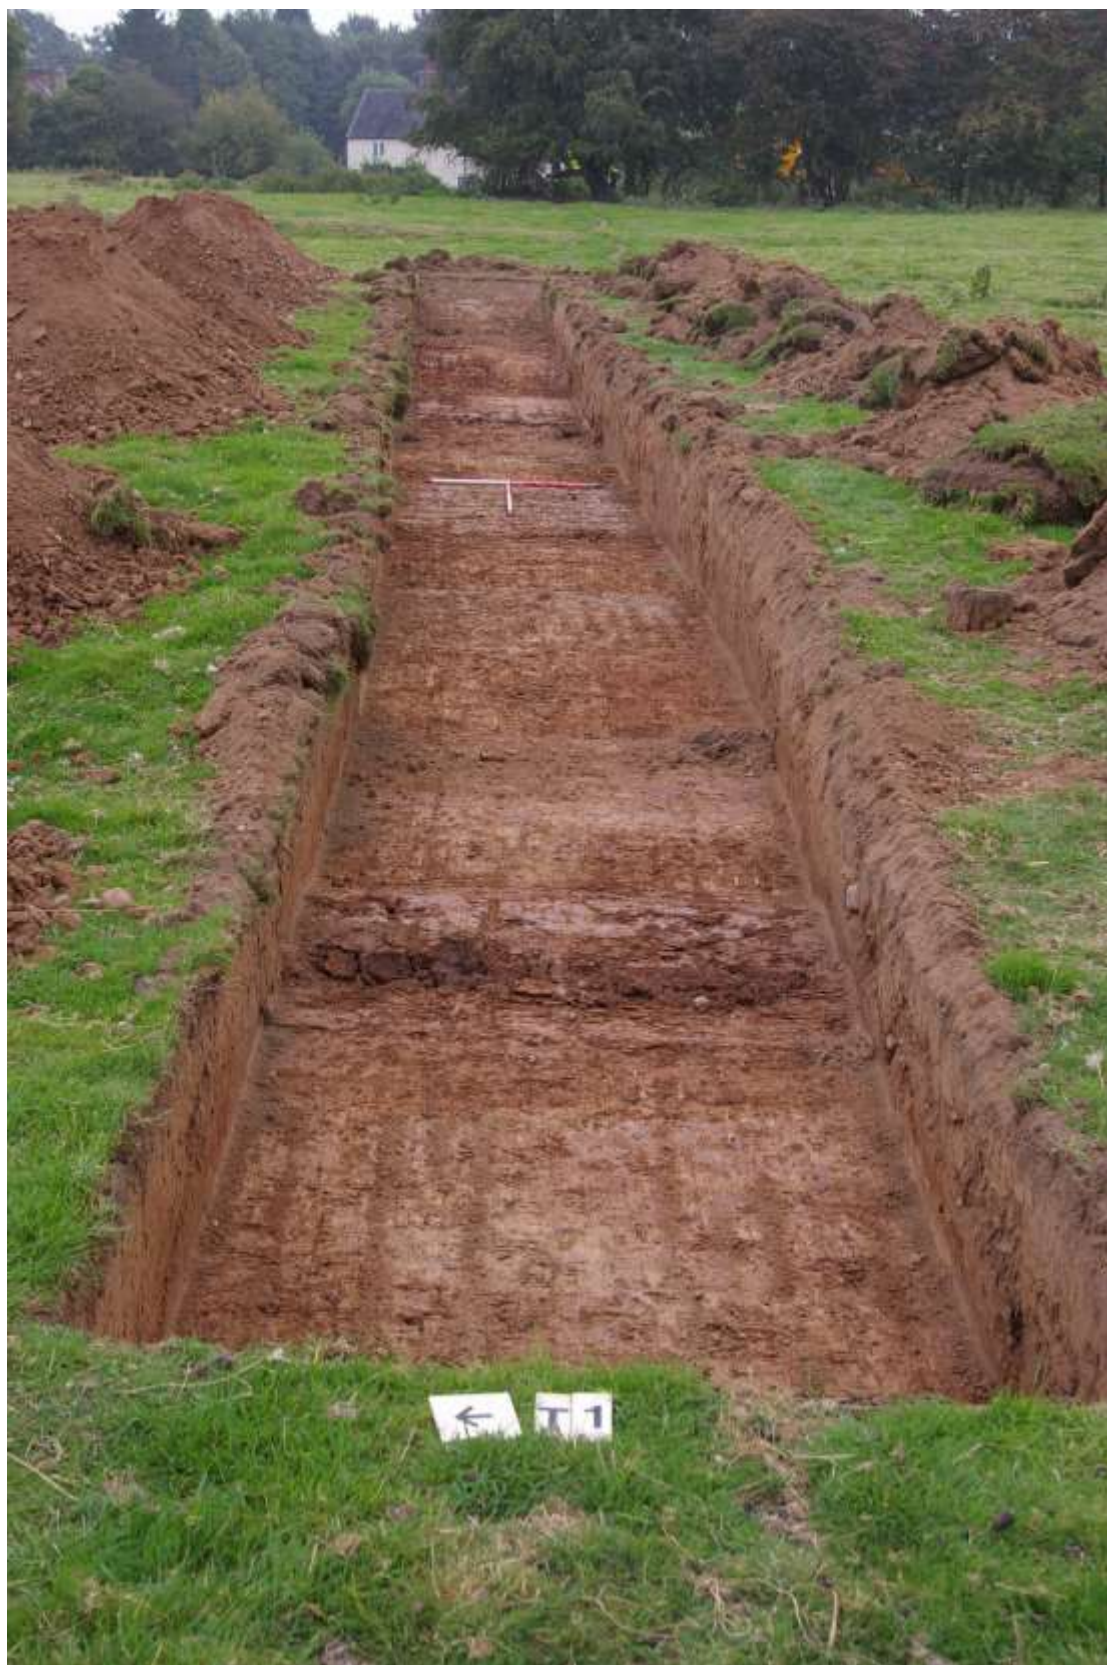
Figure 9 Trench 1 after excavation
Looking east. 1m scales

Between 0.15 and 0.2m of light grey brown slightly clayish sandy-silt topsoil was removed to reveal the subsoil consisting of a light reddish brown silty sandy-clay. Below the subsoil was the natural substrata of light reddish brown sandy-clay with patches and bands of sandy gravel (Fig. 9). Running from north to south in the centre of the trench was a single narrow ditch or gully [4] measuring 1.48m wide and 0.24m at its deepest point. The feature did not appear to relate to any of the earthworks seen prior to excavation although it did follow the same alignment as the shallow depressions running up the slope. When excavated the fill (3) was found to be a mid-red brown clay-silt with no finds being recovered from it (Figs. 10 and 11). The shelving shape suggested a recut feature which may indicate its use as a drainage gully or plot boundary.

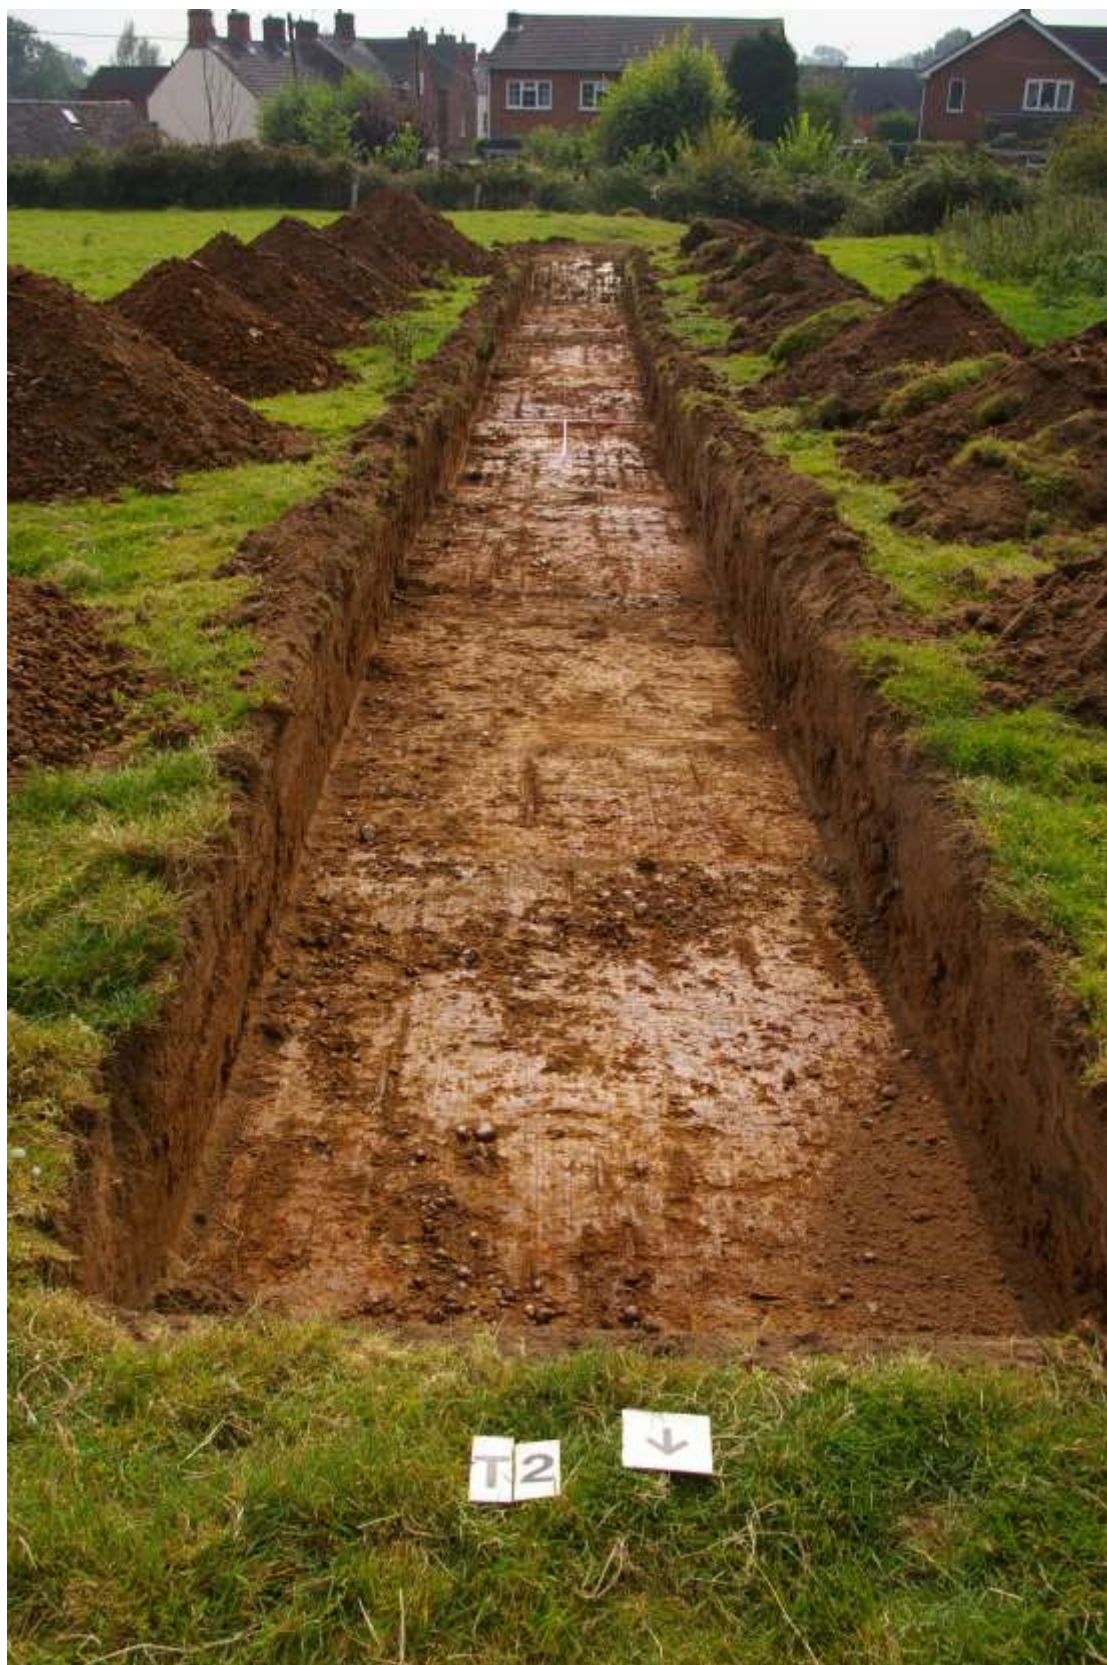
Figure 12 Trench 2 after excavation
Looking south. 1m scales

and 0.2m of topsoil and 0.24 and 0.42m of subsoil of the same description as in Trench 1 were removed to reveal the natural substrata, also as seen in Trench 1 (Fig. 12). Two features were observed in this trench: east to west gully/ditch [11] and north east to south west linear [13] (Figs. 13 and 14). Ditch [11] was approximately 0.6m wide and only 0.2m deep and contained a mid-reddish grey sandy silty-clay with occasional sub-rounded stones and rare flecks of charcoal. Seven early medieval Oxidised/Reduced Sandy ware pottery sherds were recovered from the fill as was a single sherd of 13th century Chilvers Coton A ware. The feature ran parallel to Bowleys Lane and towards Church Street suggesting the line of a possible plot boundary.

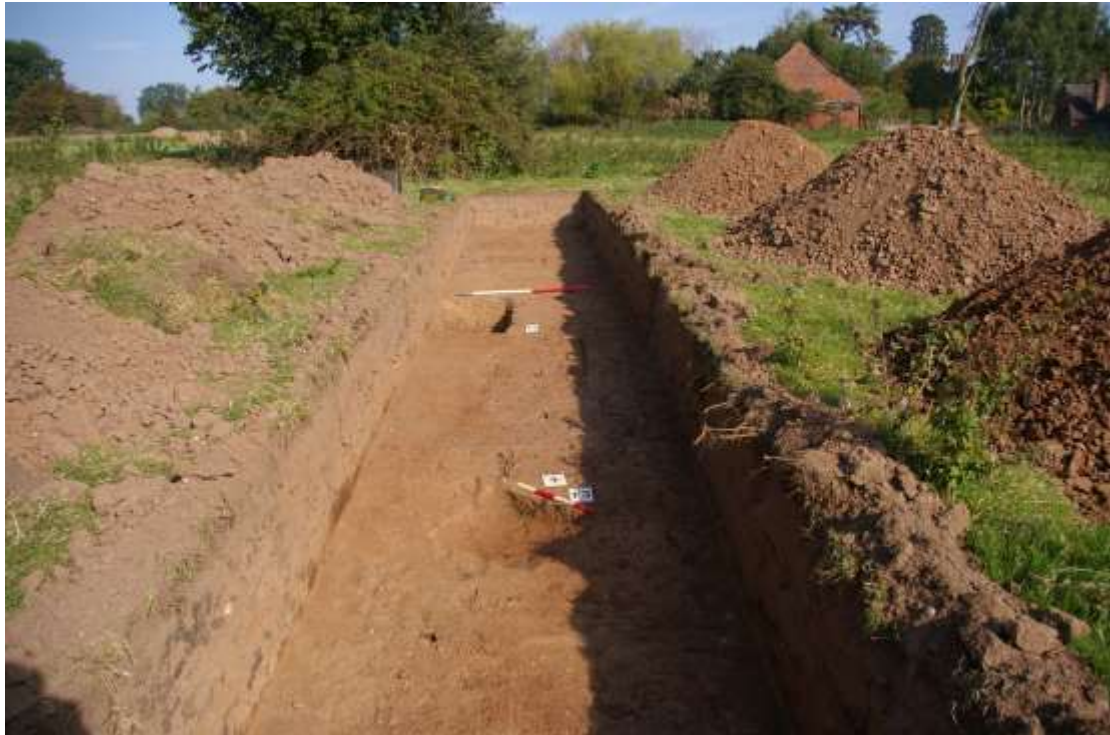
Figure 13 Trench 2, features [11] and [13]
Looking north. 1m and 0.4m scales

Linear feature [13] was a slightly more ephemeral and wavy edged feature than [11] and had less well-defined edges. At its widest the gully measured 0.52m and was only 0.11m deep. The mid-brown-grey silty-clay fill (12) did not contain any datable finds.

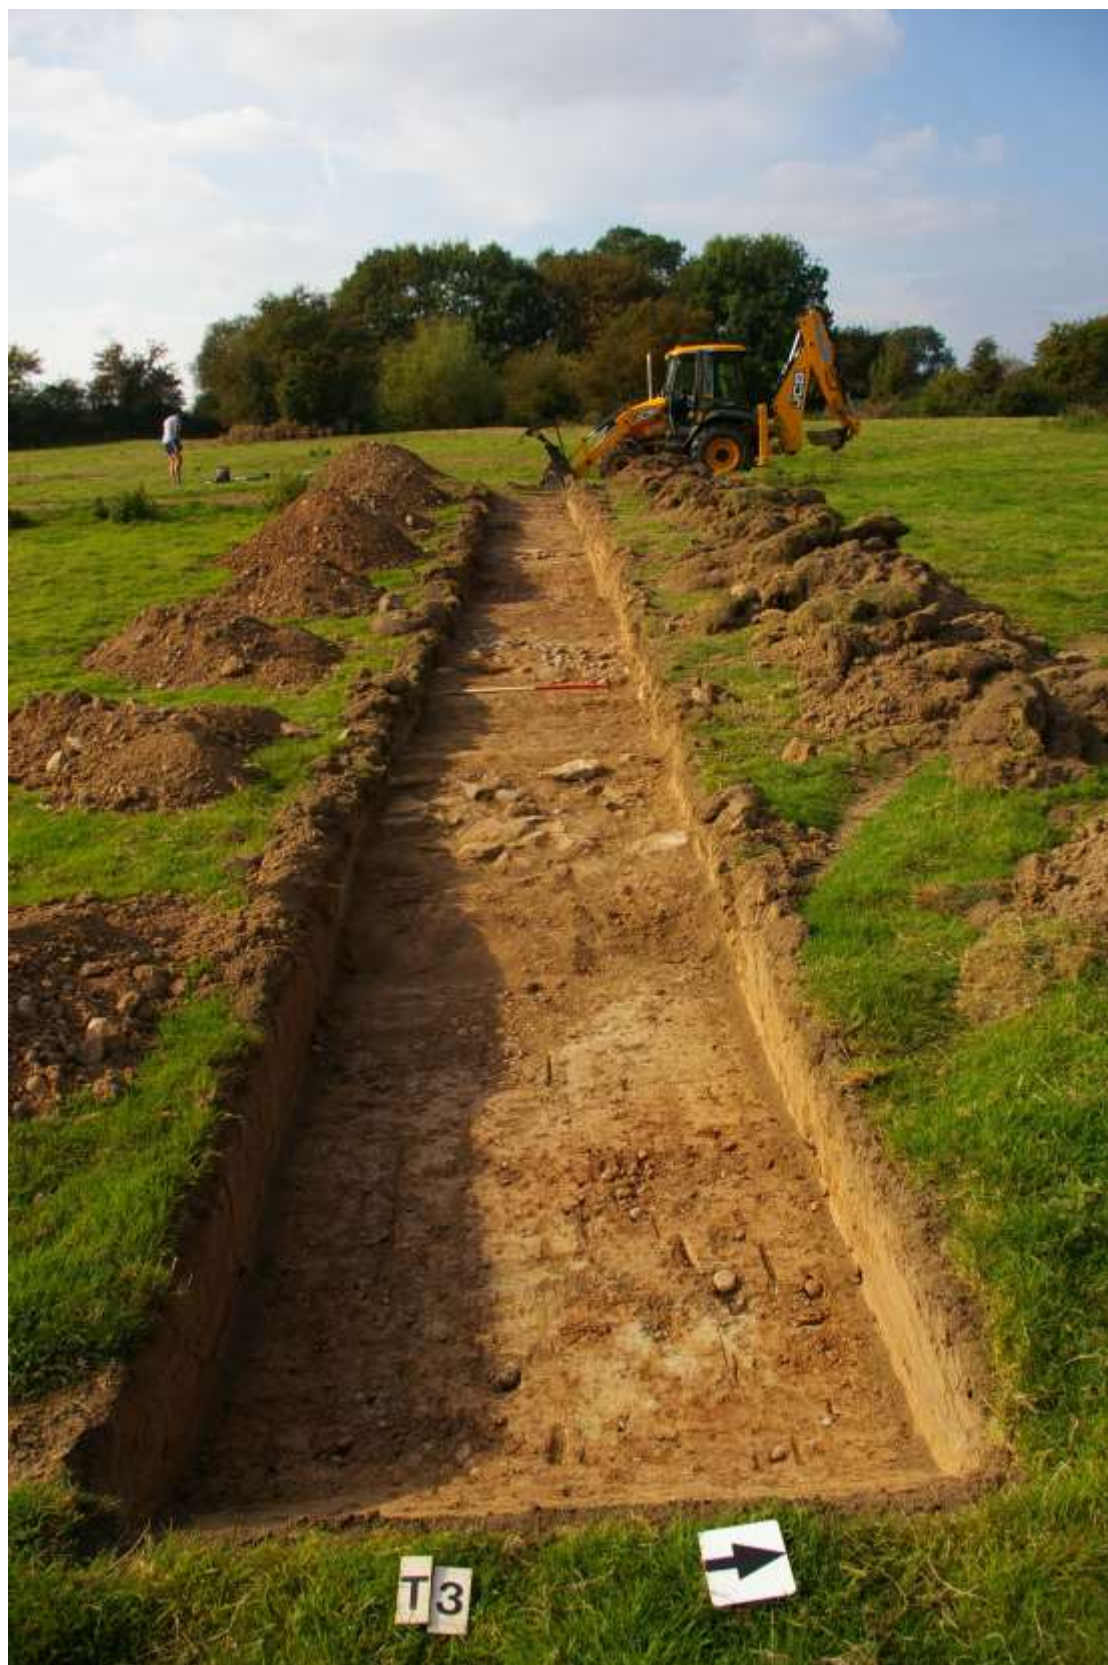
Figure 15 Trench 3 after excavation
Looking west. 1m scale

Trench 3 was located to the east of centre of the site. It was placed to the north of a semi-circular earthwork depression which may be from possible clay extraction or a drainage feature. The north-western end of the trench ran through a small gap in a long north to south earthwork bank. As in the previous trenches the same subsoil and topsoil was seen although only 0.12 to 0.2m of topsoil survived and between 0.07 and 0.25m of subsoil was seen. In places, i.e over stone features, the subsoil appeared to be virtually non-existent. Slightly lighter pinkish red sandy clay with stony gravel patches could be seen in this trench. During machining a 14th to 15th century Medieval Sandy ware strap handle was recovered from the subsoil. Four features were observed within this trench: Pit feature [15], stone drain (18), possible cobbled surface (19) and possible stone surface (20) (Fig. 15).

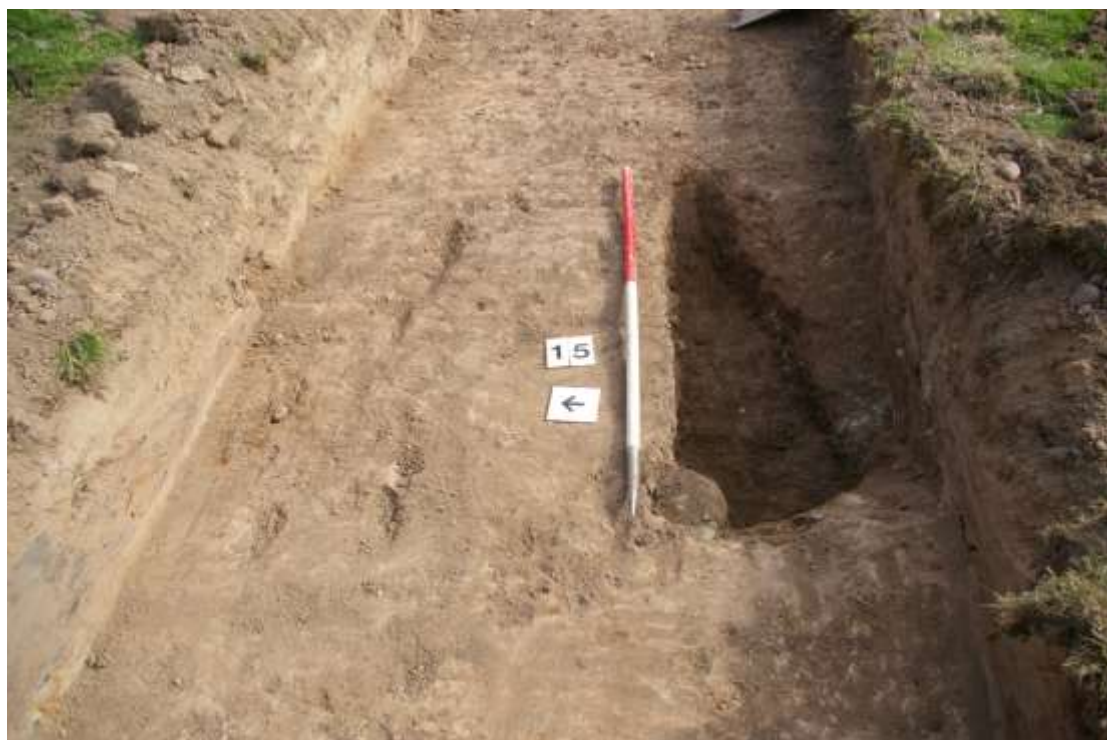
Figure 16 Trench 3, Pit [15]
1m scale

The pit-like feature [15] first appeared to be a wavy-edged linear feature but upon excavation showed itself to be an irregularly shaped circular feature with its edges beyond the limits of the evaluation trench (Fig.16). A single sherd of abraded 13th century Medieval Sandy ware pottery was recovered from the feature which contained pale greyish brown clay-silt fill (14) with frequent sub-rounded stones.

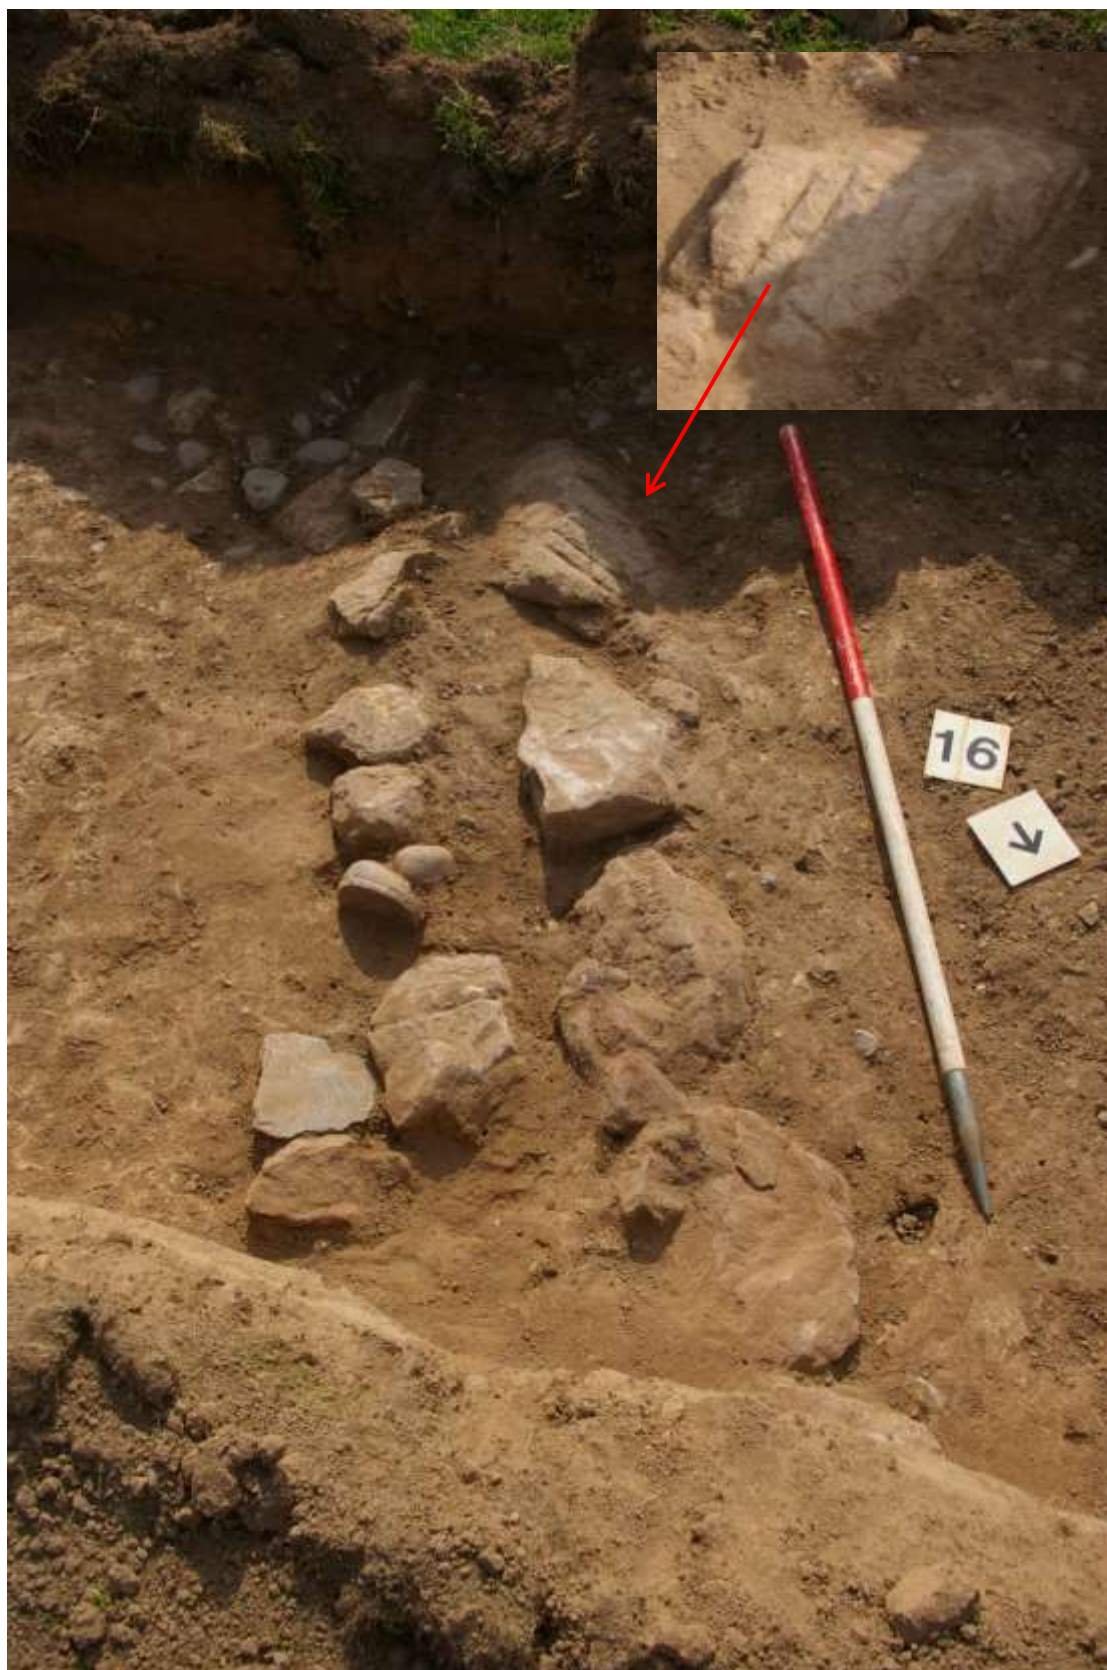
Figure 17 Trench 3, possible drain (18)
Inset: toolmarks on stone

Two metres to the east of pit [15] was a possible stone drain feature built on a north to south alignment. The feature was made from unworked blocks of limestone with the exception of a single piece of stone which showed signs of parallel tool marks suggesting re-used stone (Fig. 17). The stones, set in a possible cut [17], formed two distinct lines with a silt-filled gap approximately 0.2m wide creating a drain-like feature. Projecting the line of the feature southwards for around 10m led to the semi-circular earthwork and which may be associated with each other.

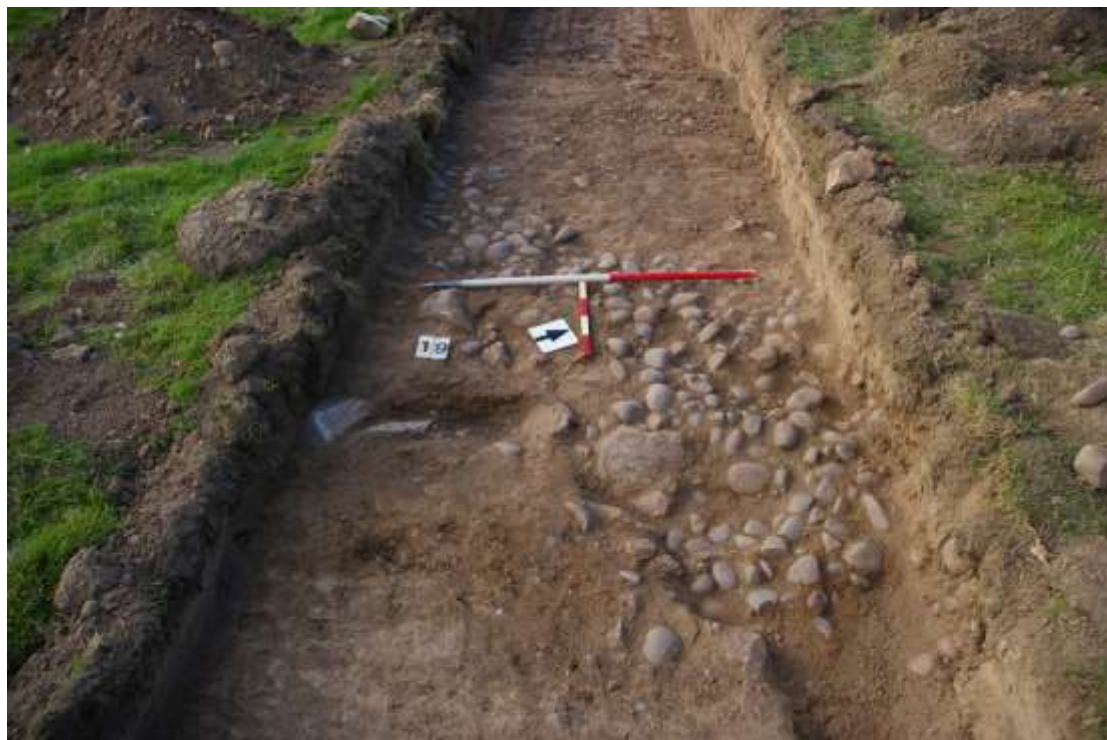
Figure 18 Trench 3, cobbled surface (19)
1m and 0.4m scales

A further 5.5m east of drain were the truncated remains of a probable cobbled surface (19) (Fig.18). The rounded cobbles varied in size from 0.04 to 0.1m in diameter and were closely packed together with two or three layers visible in places. This appeared to follow a north-east to south-west alignment with a partial boundary created on the eastern side by a number of unworked limestone lumps. The west boundary was more abraded and may have extended further west than at present. An iron nail and rim sherd of 13th century Medieval Sandy ware pottery was recovered during cleaning.

former Dormer's Hall. The possible surfaces in Trench 3 may also relate to the same period as similar pottery was recovered from the fill during cleaning. As only the trench width areas of both surfaces and the possible drain were examined more work would be needed to fully understand their form and function. The features seen in Trench 2 may be associated with property boundaries running down towards Church Street. On the basis of the pottery found in the east to west gully, they may still be of a similar date which might suggest that this corner of the site did not belong to the Dormer's Hall complex.

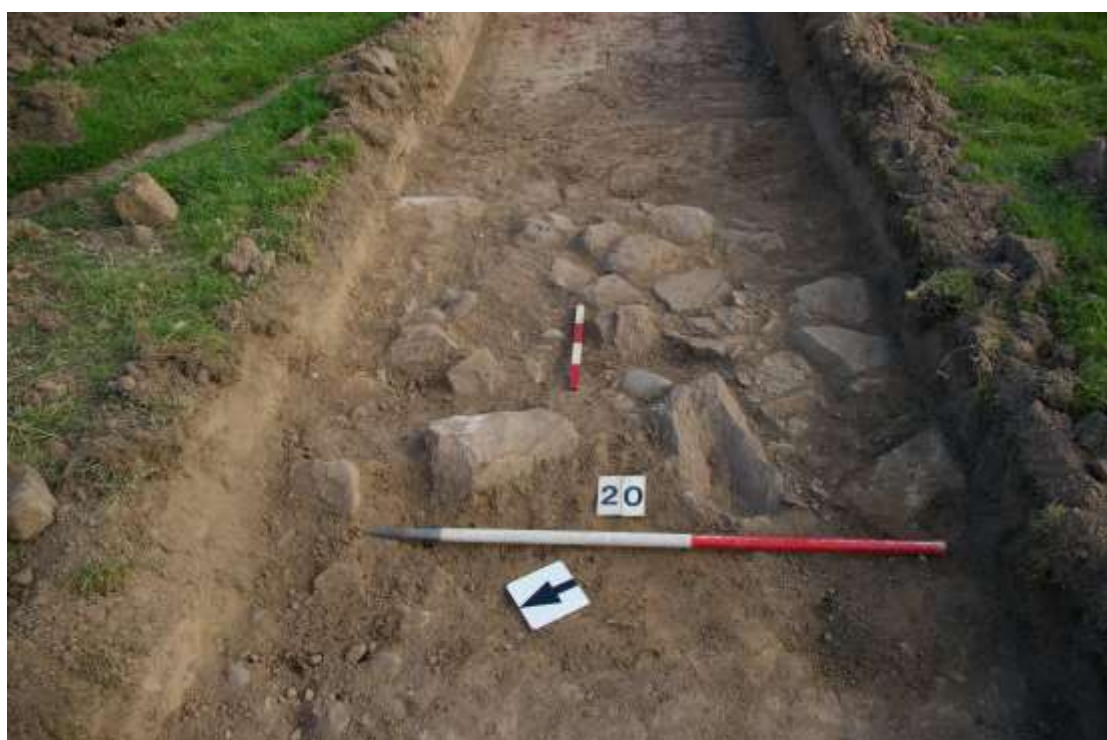
Figure 19 Trench 3, stony surface (20)
1m and 0.4m scales

Another 2.5m east of cobbled surface (19) was a second apparent surface (20) created by a spread of closely packed unworked limestone set in a clay-silt matrix (Fig. 19). This area had the appearance of an attempt at a hardstanding area although, as such a small area was exposed, it could be a deposit of dumped stone. Another single sherd of 13th century Medieval Sandy ware medieval pottery was found within the matrix during cleaning.

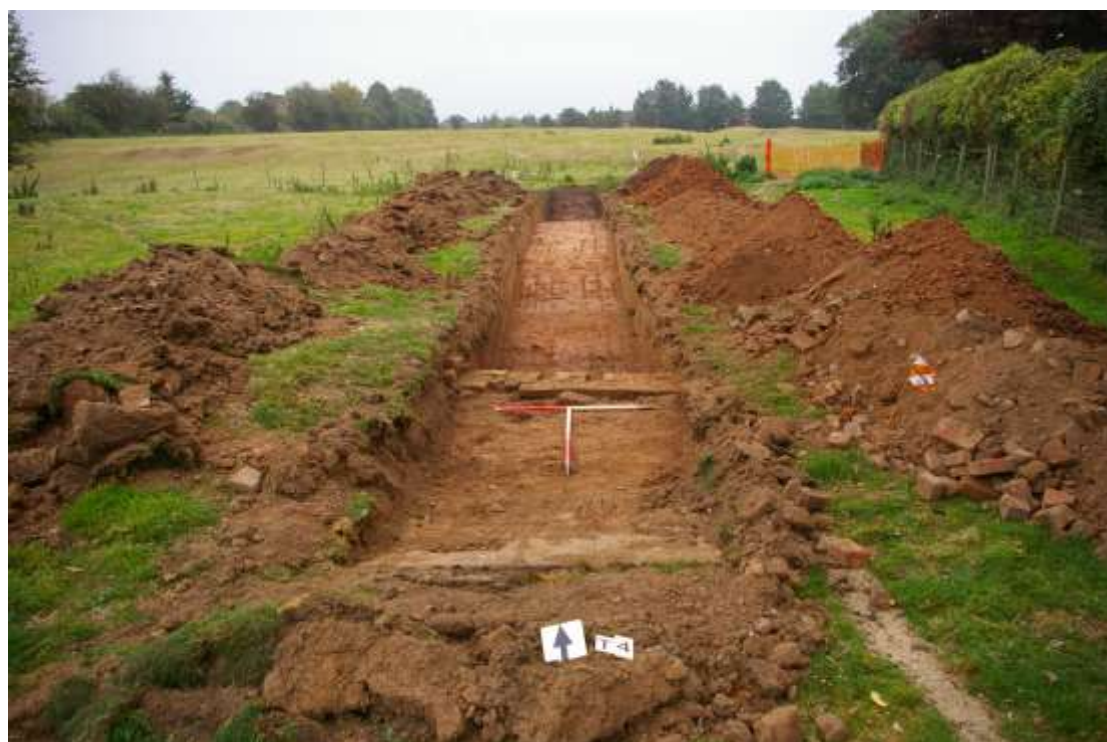
Figure 21 Trench 4 after excavation
Looking north. 1m scales

Trench 4 was located in the north-eastern corner of the site partially overlying a flattish area which extended west towards the sole remaining fishpond (Fig. 21). The flattish area appeared to be a backfilled area which may be from a backfilled fishpond system or from clay extraction and landscaping (Fig. 22). Two features were observed within this trench; the foundations of a brick wall (6) and a large area of backfill and made ground (5).

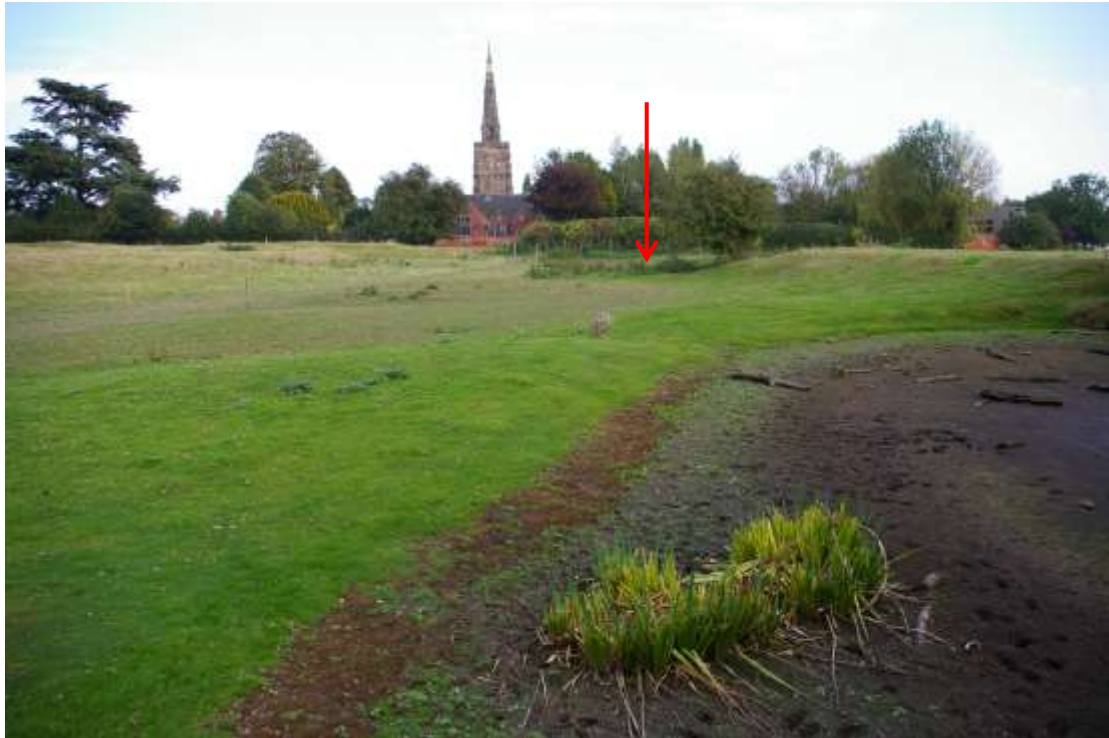
Figure 22 Trench 4 from fishpond
Looking east across backfilled ground towards trench (arrowed)

The backfilled area covered most of the northern part of the trench extending from the northern end as far south as a raised earthwork bank which could be traced westwards to the fishpond in the north-west part of the site. Removal of approximately 0.1m of turf and topsoil exposed the top of a mixed spread of dark grey and black sandy clay with patches of dark brownish orange sandy clay (5). The fill contained frequent numbers of brick fragments, limestone and rounded pebbles as well as a small amount of post medieval pottery ranging from the 15th to the 18th centuries. This was excavated down to 0.95m below current ground level at the north end until a wide cut for a possible drain or service was encountered (Fig. 23). In the centre of the trench the backfill was removed to reveal a thin layer of subsoil-like material on top of the reddish brown sandy clay natural substratum. As noted, the backfill (5) continued as far as a slight east to west earthwork which was where the brick wall (6) was encountered.

The backfilled area examined in Trench 4 may be an attempt to reclaim land previously used as part of a series of fishponds. It is possible that the ponds had gradually silted up and the backfill represents a period of dumping to create a slightly drier and more useable piece of ground. Alternatively, if this is where clay extraction took place then the deposit may be evidence of backfilling the pits. However, the undisturbed nature of the natural substratum below backfill (5) may suggest pond backfill rather than digging for clay. The finds recovered from this material indicate a post-medieval date for this backfilling. The brick wall which appears to form a boundary between the backfill and the rest of the field had been built from reused bricks. The use of clay for the bonding material could point towards a single storey agricultural structure rather than a domestic building. Again this is likely to date to the later post-medieval or early modern periods.

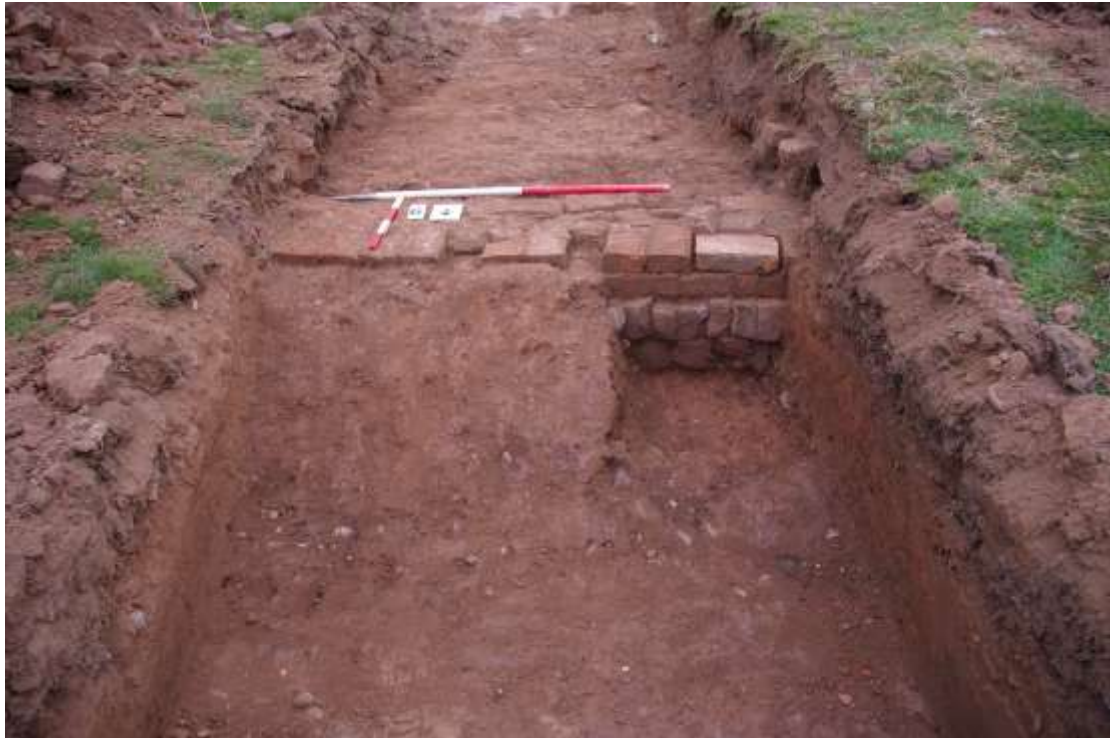
Figure 24 Trench 4, brick wall (6)
1m and 0.4m scales

Wall (6) was built from bricks and bonded with a fine light grey clay. The bricks appeared to be quite badly abraded and were a variety of sizes ranging from 110mm

wide by 55mm thick by 235mm long up to 120mm wide by 60mm thick by 240mm long suggesting that they have been reused from elsewhere. Four full courses survived but the area above and around the wall contained a large number of loose bricks indicating that the wall may have been levelled to create a flat field. Most bricks were red but a row of blue or semi vitrified bricks could be seen on the second course (Fig. 24). The foundation wall appeared to have been built in a narrow cut [7] which partially cut into the natural substratum and the made ground (5).

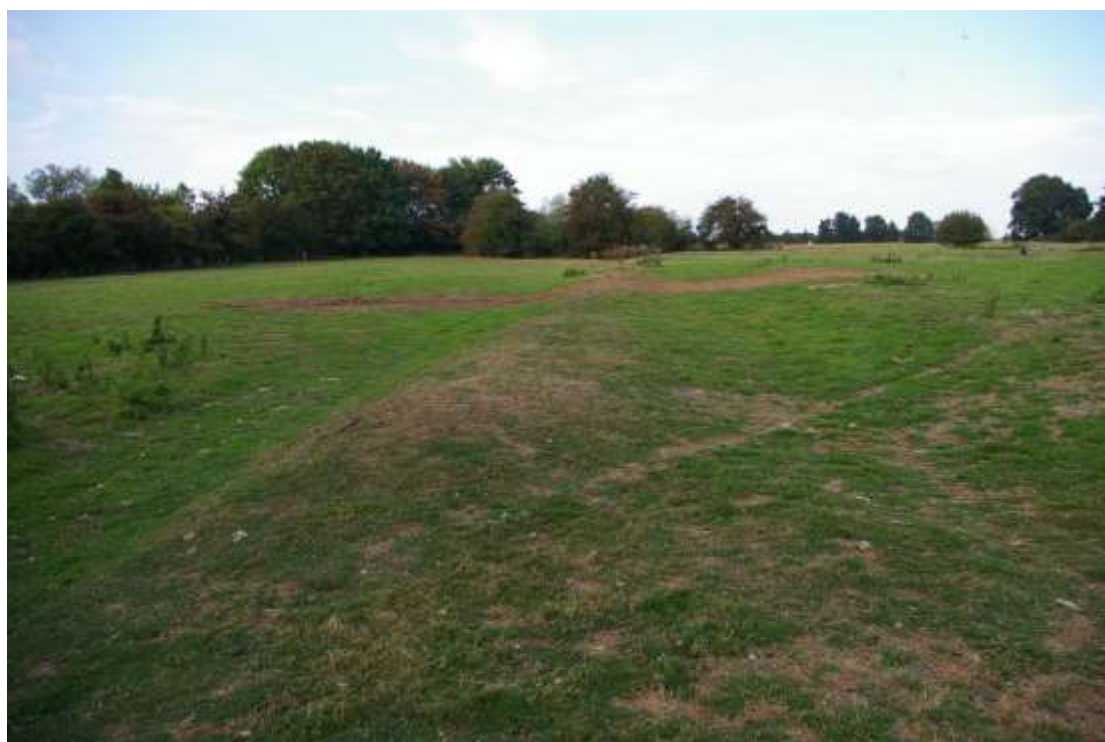
Figure 26 Trench 5 location

Trench 5 was located towards the south-west of the site on an east to west alignment. The trench cut across a north to south double bank running almost from Bowleys Lane towards the pond (Fig. 26). Between 0.15 and 0.3m of topsoil and 0.14 and 0.3m of subsoil of the same description as in Trench 1 were removed to reveal the natural substrata, also as seen in Trench 1 (Fig. 27). A single north to south ditch [9] located on the western side of the double bank was observed.

Looking north. Photograph taken after backfilling to show earthworks

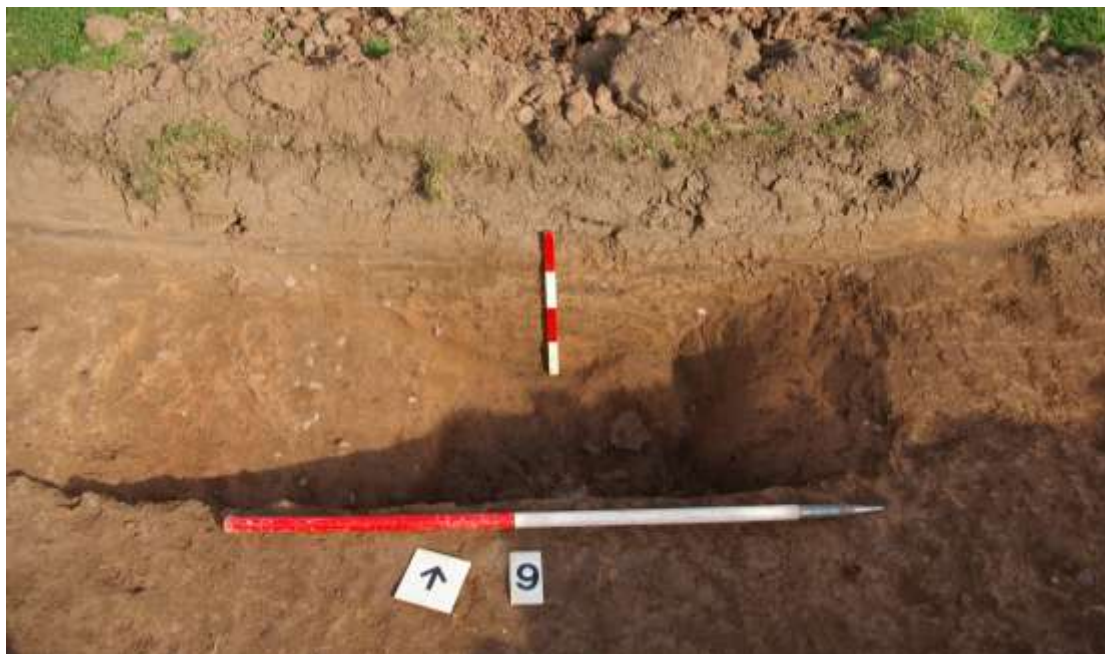
Figure 28 Trench 5, ditch [9]
1m and 0.4m scales

Ditch [9] measured 1.56m wide and 0.37m deep and contained a mid grey brown clay-silt with a number of limestone fragments towards the base of the feature (Fig. 28). Some 14th or 15th century Medieval Sandy ware pottery was recovered from the fill along with a fragment of animal bone.
