**An Archaeological Watching Brief
For The Coach House, Langton Hall,
West Langton, Leicestershire**

NGR: SP71539 93060

ULAS Report Number 2015-164
©2015
X.A. 123 2015

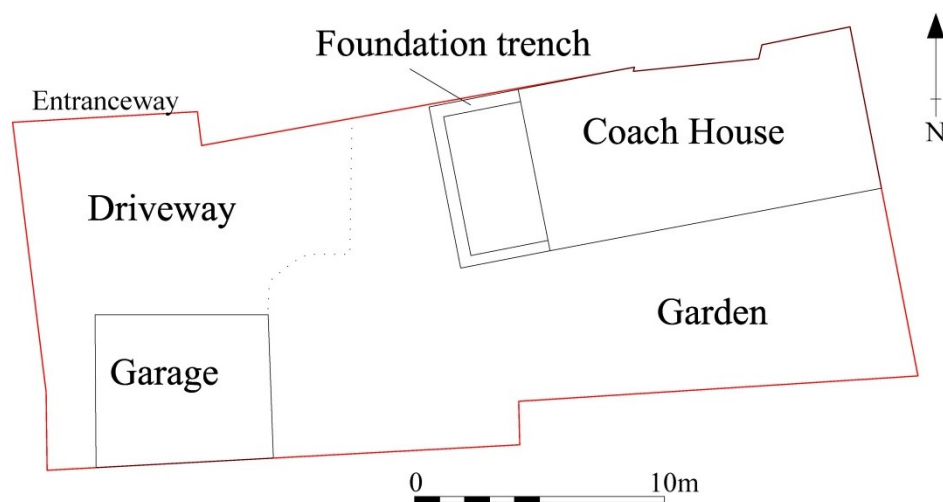
Figure 4: Plan of trench location

Foundation trenches were cut at a consistent width of 0.5m and a depth of 1m on the western side of the house and ran 3.65m in a westerly direction from the north-west corner of the house turning south for 6.65m then east for 3.65m to the south-west corner of the dwelling (Fig. 4). The trench to the north of the plot and along the southern part of the western trench contained a distinct layer of small decorative stones incorporated into the 0.2m to 0.3m deep topsoil comprising part of the gravel pathway and patio (Fig 5). A small number of loose cobble stones, brick fragments and charcoal deposits were also contained within this layer. The subsoil was consistently exposed to a depth of 0.78m to 0.82m and comprised yellowish orange-brown clayey-sand with frequent gravel particularly in the trench to the south of the plot. The subsoil was undisturbed in the north and west trenches with the exception of the north-eastern end abutting the house where a modern drain and fibre optics cable were identified running north-south.

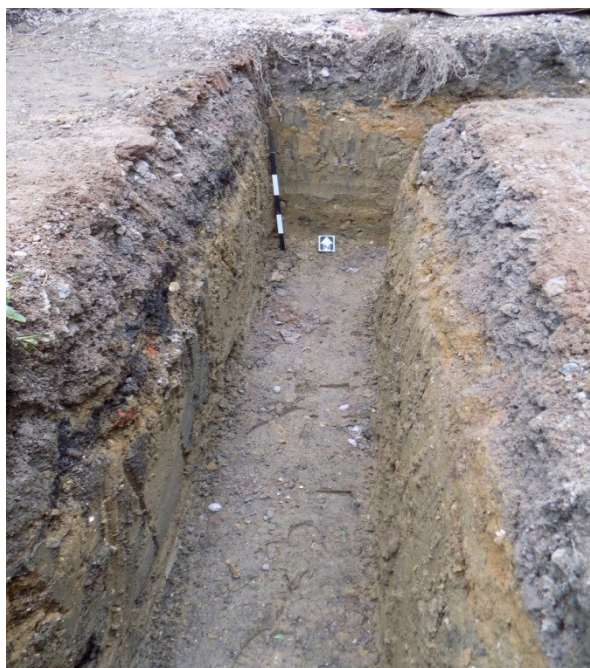
Figure 5 Western trench looking north.

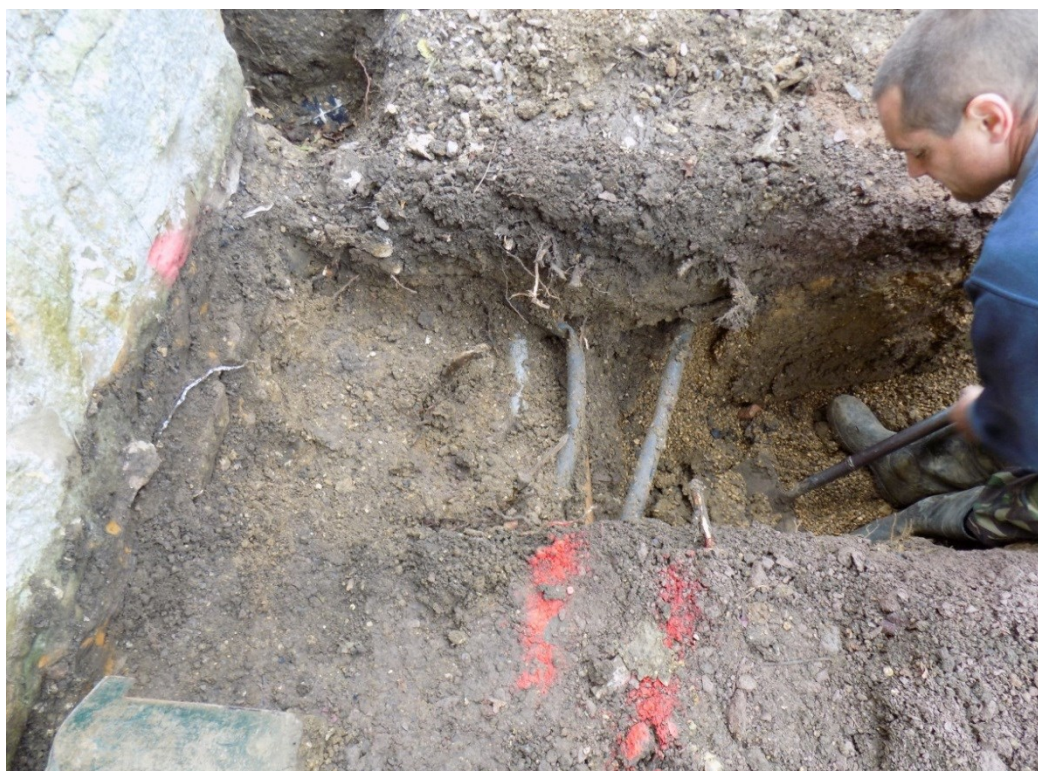
In the southern side of the plot the subsoil was heavily disturbed by various modern drains, ceramic land drain and utilities pipes running north-south and east-west and contained a large amount of pea gravel around these disturbances (Figs 6-7).

Figure 6 Southern trench showing pipes, drain and pea gravel, looking south.

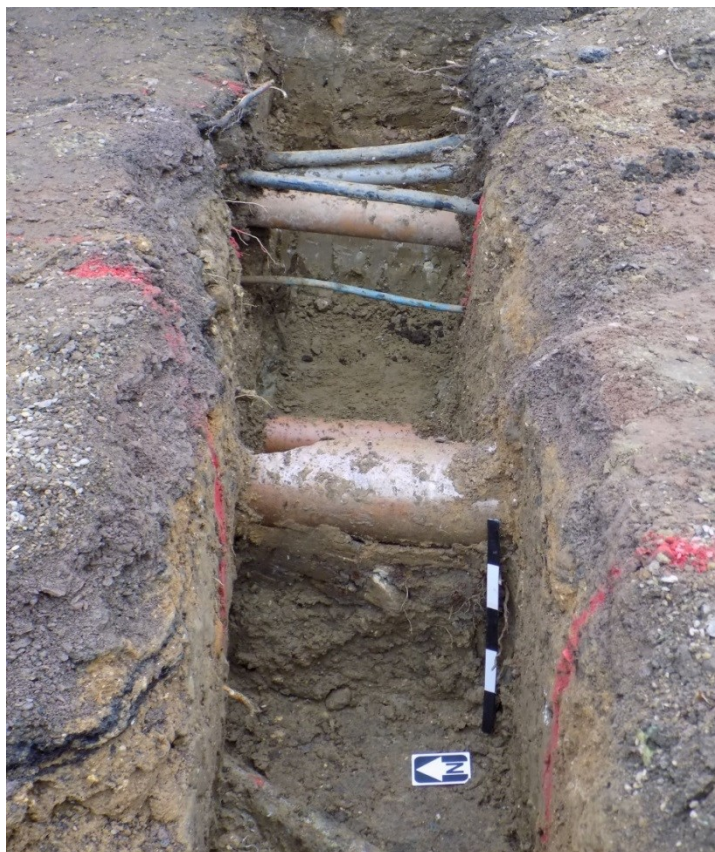
Figure 7 Southern trench showing extent of modern disturbance.

Despite the location of the site in the 18th century stable block, Registered gardens and its close proximity to the Hall, no significant archaeological deposits were identified during the work. All disturbances within the area were modern in nature.
