**An Archaeological Watching Brief For
Installation of Lighting and Cable
Trenches At St. Nicholas Church,
Leicester
(NGR SK 5818 0450)**

ULAS Report No 2015-184
©2015

For: Leicester City Council

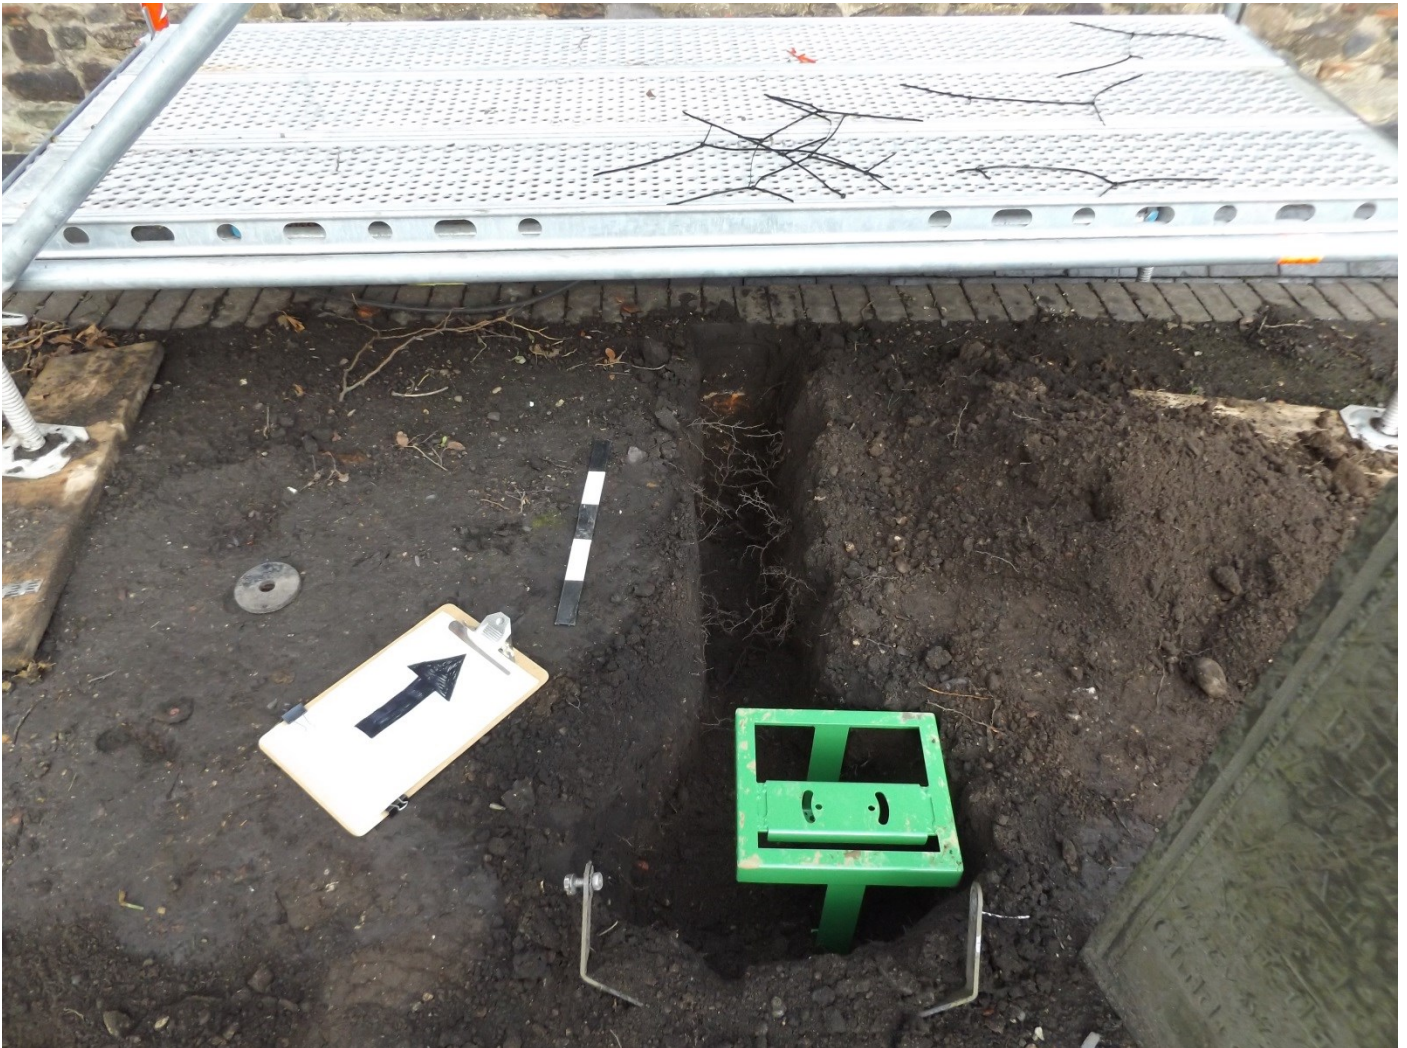
Figure 2: Showing Trench 1 from the southern side of the church.

Trench 1 was located in the south-west side of the church and was 1.6m long and between 0.2-0.5m wide. The topsoil was composed of dark greyish brown, soft, loamy sandy silt and was the only deposit observed. It contained four fragments of Romna ceramic building material (CBM) including part of an imbres roof tile, and fragments of human skeletal remains including phalanges, rib fragments and a femur head.

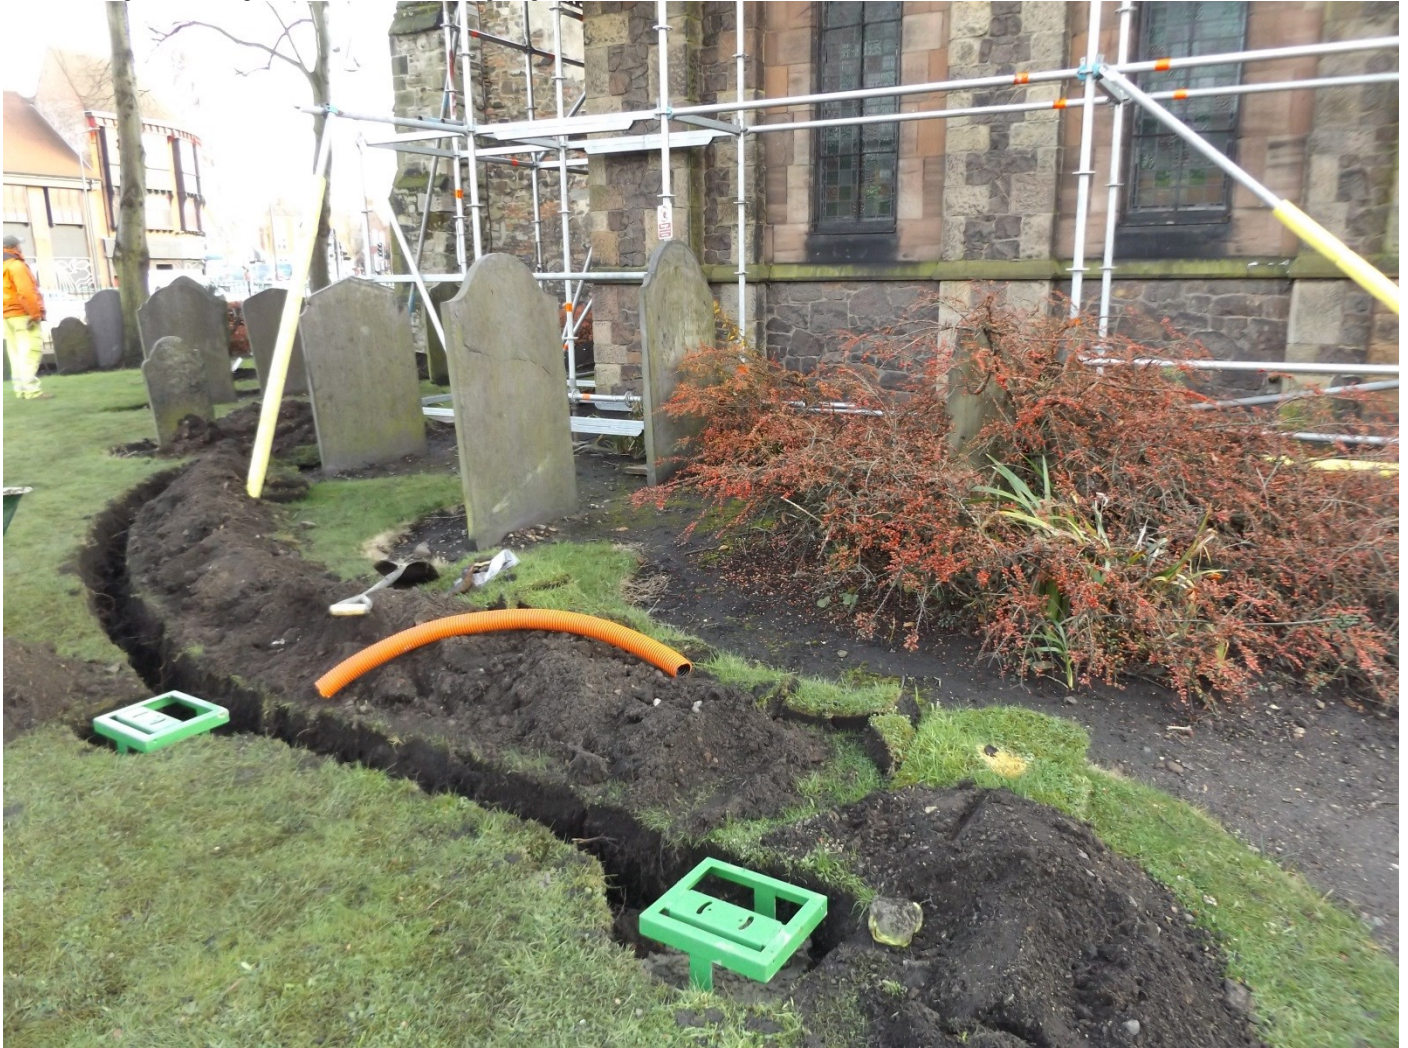
Figure 5: Showing the excavation of Trench 5.

Trench 5 was positioned around the north-east corner of the church and began in the corner of the tower and vestry. The trench headed east towards the north-east corner of the chancel and then continued in an arc along a north-west alignment towards the central path. The trench measured 19.10m long and between 0.2-0.5m wide. Topsoil was the only deposit observed in this trench and it had the same composition as Trench 1. It contained three fragments Roman CBM including a tegula roof tile, and modern pottery and glass. Human skeletal remains were found in two locations within this trench; the first was in the north-western side (close to the path) where 1 fragment of pelvis and 1 fragment of ulna were encountered. The second position was close to the north-east corner of the vestry where 1 fragment of ulna, 1 fragment of rib and 1 fragment of femur was found.

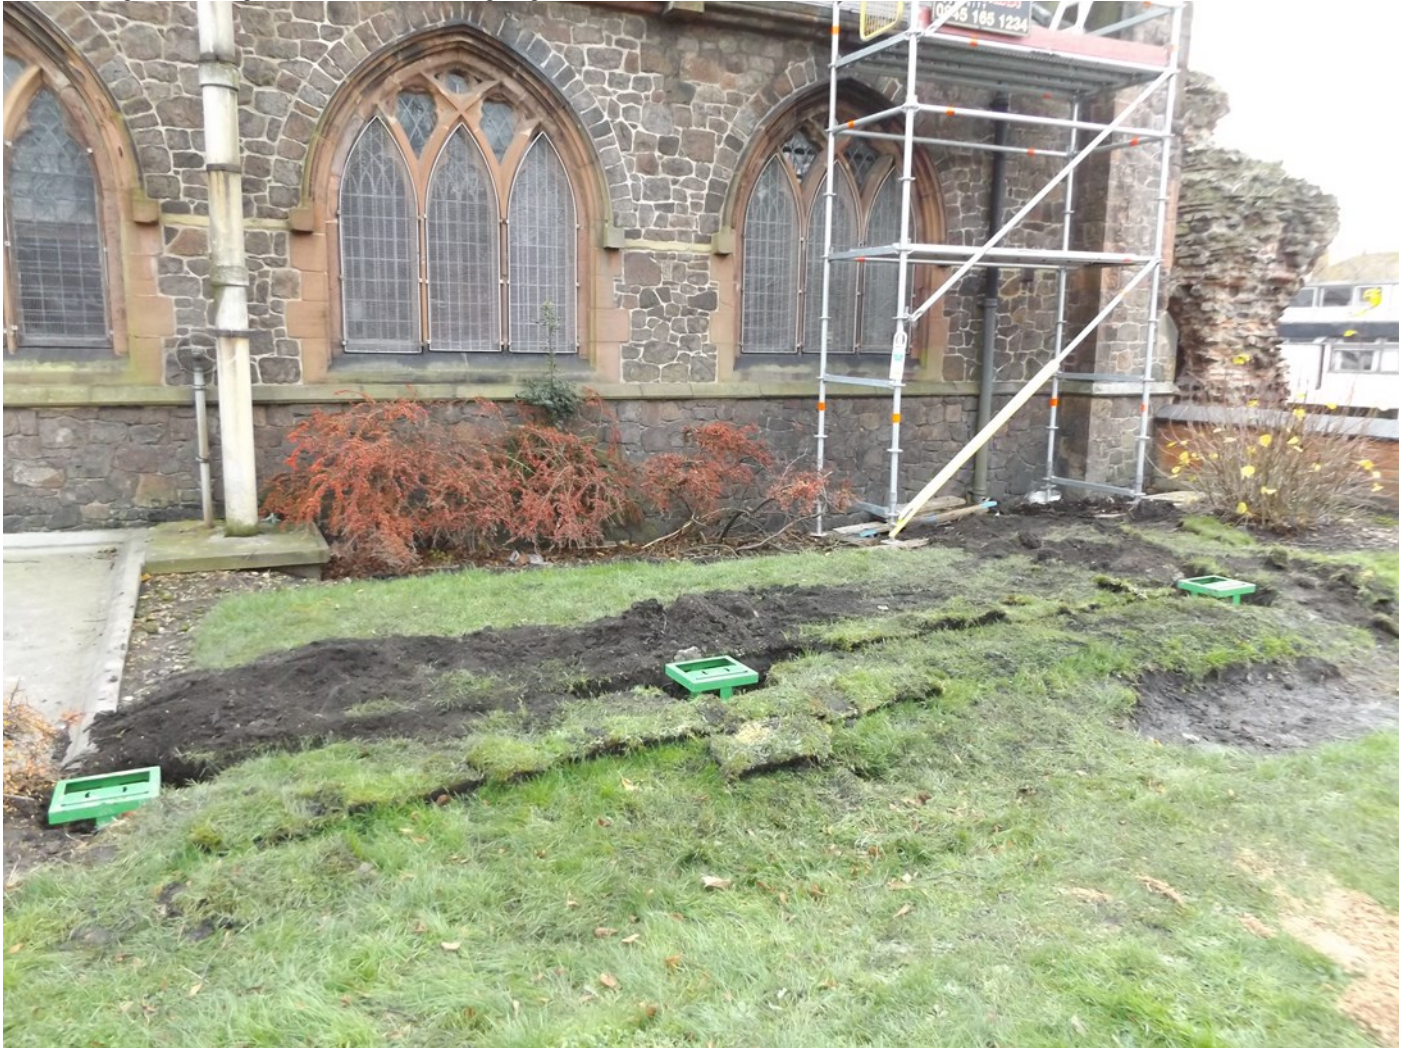
Figure 6: Showing the excavation of Trench 6 and the proximity to Jewry wall.

Trench 6 was located close to the north-western corner of the church and began at the corner of the north aisle. The trench headed to the north and then turned to the east towards the central path in an 'L' shape. The trench measured 10.4m long and 0.2-0.5m wide. Topsoil with the same composition as Trench 1 was found and this contained one small fragment of Roman samian pottery of 2nd-century date, alongside fragments of tegula and imbrex roof tiles, and one flue tile all potentially deriving from the bath building and or *palaestra*. Mortar attaching to these fragments ran over broken surfaces and was clearly due to later re-use of tile rubble. Three fragments of plain floor tile of medieval or later date were also identified. A single small Roman tessera made from reused tile was found from this trench, along with glass, pottery and clay tobacco pipe stems of modern date. A large amount of disarticulated human remains were encountered close to the north-west corner of this trench just 70mm below the current ground level. These included 3 femur fragments, 2 complete femurs (measuring 0.31m and 0.42m), 1 complete skull (possibly a juvenile female), 3 cranium fragments, 2 pelvis fragments, ulna and radius fragments. Occasional patches of light yellowy brown silty sand and gravel was found in the north-west corner of the trench and it is unclear whether this represents disturbed Roman stratum.

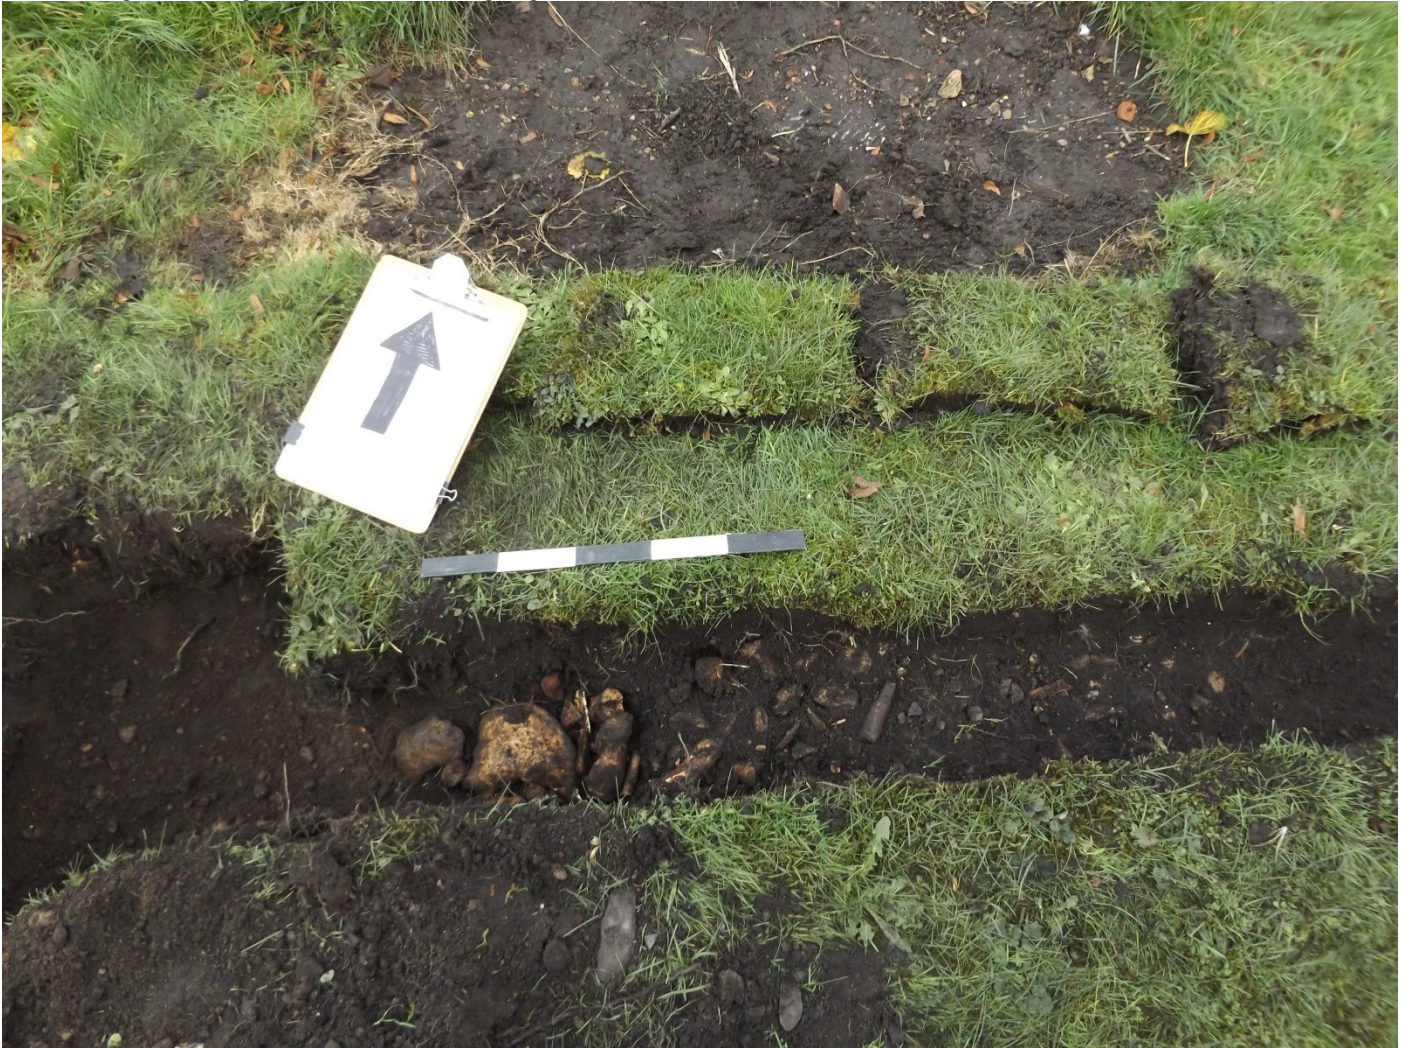
Figure 7: Showing the shallow human remains in Trench 6 and the drain to the north.

The large amount of disarticulated human remains found in Trench 6, none of which was removed from the site, probably results from the installation of a drain, which was previously dug to the north-west. The projected line of the drain crosses the trench at the position of the remains. Since the drain was not found during the excavation it appears likely that the bones were interred within the backfill and the drain was dug deeper than 0.3m.
