An Archaeological Watching Brief
during conservation works to the
medieval fishpond at Grace Dieu
Priory, Belton, Leicestershire NGR: SK
(NGR SK 433 182)

ULAS Report No. 2014-214
©2014

Scheduled Monument 17074

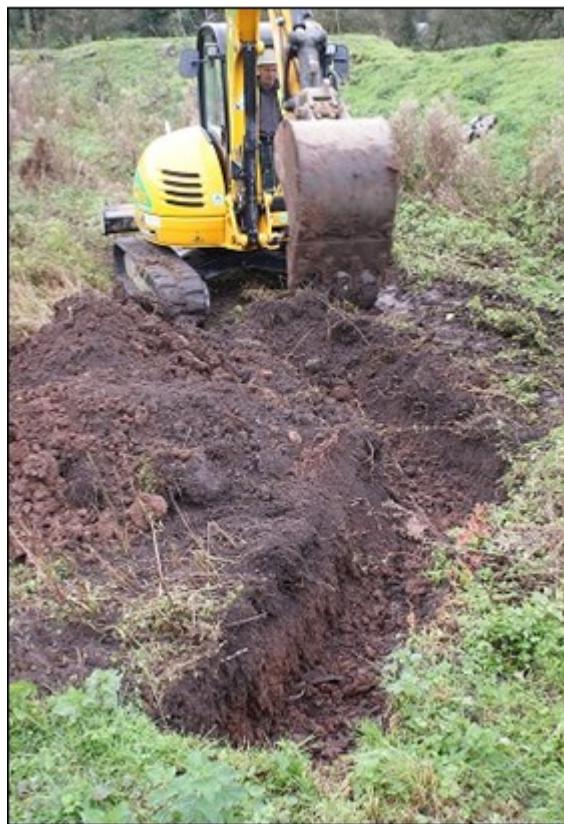
Figure 4. Outset of trenching looking west

Trenching for the seal began at the north-eastern end of the pond, obliquely, initially, approximately 5.00m from the base of the northern embankment. After 2.50m the trench straightened and maintained a rough distance of 3.0m from the embankment along to the end. A profile of deposits was recorded every 5.0m and reproduced in drawing 8.1. The total length of the trench was 82.00m and the average depth reached was 0.5m. The profile revealed, generally, a layer of pond silt (28) lying above a layer of red clay pond lining (29). In the first 20m the pond silt was rich in domestic refuse: pottery, ceramic building material and bone (Table 1). The remainder of the trench, however, produced far fewer finds. Perhaps, being the closest point to the priory buildings, this part of the pond was routinely used for the dumping of domestic refuse. Trench B1 in the trial trenching (Morris 2014) had produced a quantity of shell. The area of seal trench adjacent to this, whilst producing some fragmented shell material, did not produce quantities that would suggest cultivation of shellfish.

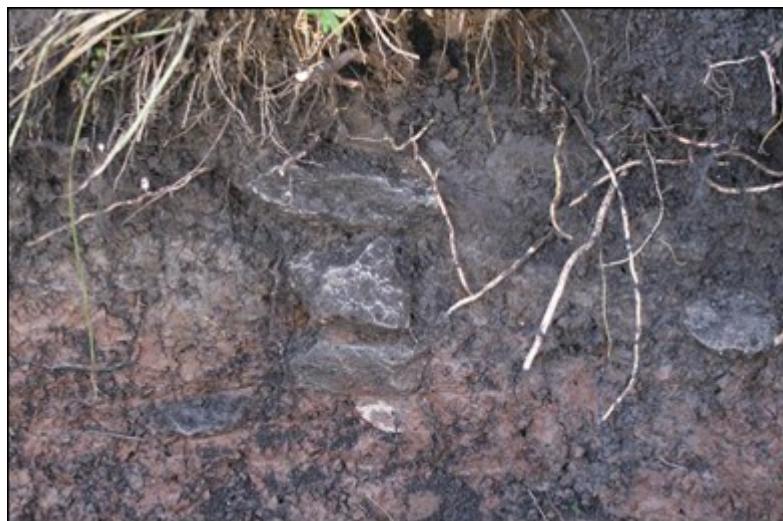
Figure 5. Linear feature in northern trench section, looking north

At two points along the trench, masonry features were recorded. On the northern edge at 2.40m along the trench a small linear feature (30) was revealed in section, clay bonded (Figure 4). No obvious cut could be observed in section, but the matrix (31) was quite distinct from the pond silt and there was possibly some material absent

to the east. The masonry may have been an area of consolidation on the fringes of the pond or the partial remains of a drain running in to the pond itself.

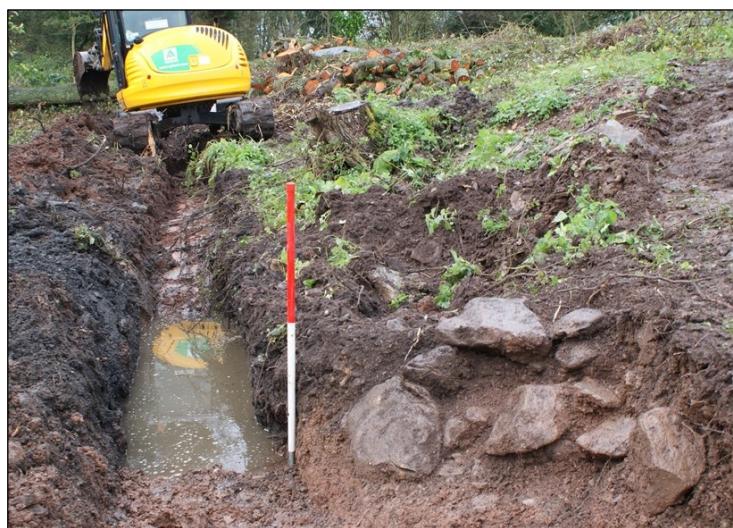
Figure 6. Masonry observed in section at mid-point of trenching looking west.

At 52m the line of the trench was diverted to avoid an area of masonry encountered. A small expanse of rough-hewn granite and limestone blocks was uncovered, bonded by clayey silt bank material. There existed up to three courses in places, but distributed in a way which suggested a spread rather than a wall. The material may best be interpreted as the outermost core to the northern embankment. The spread appeared to occur further south here than elsewhere along the pond fringes. There may have been a collapse of the embankment at this point or alternatively, there may have been additional consolidation. The spread cannot, however, be related to any features identified in the evaluation. The revealed stonework was covered over when the trench was backfilled.

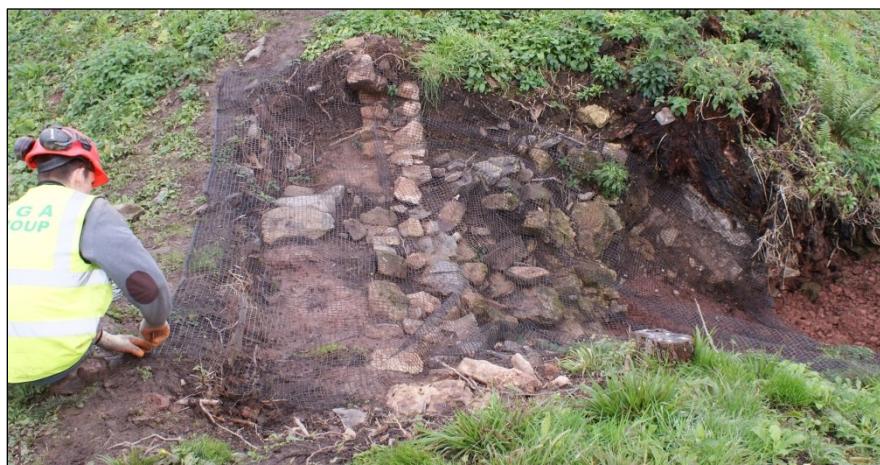
Figure 8. Installation of the GeoGrid membrane and so securing the bank core.

Stabilisation of the bank was straightforwardly completed by installing the GeoGrid membrane to secure the bank core (Figure 8). The membrane was pegged to the ground surface around the exposed masonry. Approximately two thirds of the volume of clay was laid, followed by a second membrane and then the remaining clay. A final layer of GeoCell coconut mesh was laid and seeded.

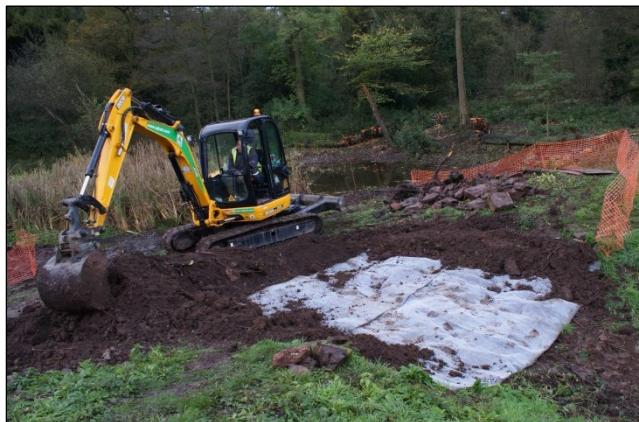
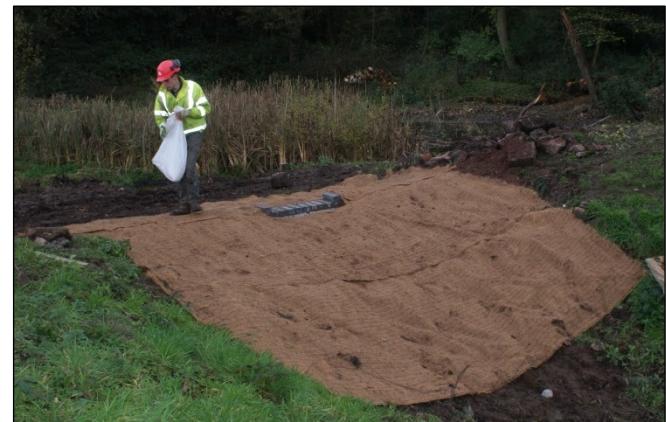
Figure 9. Creation of the spillway looking south west. Covering of gel membrane to the left and laying of coconut mesh around brick spillway to the right.

Preparation for the spillway involved removal by hand, at the outset, of 0.6m of topsoil and some rubble. The material uncovered at this stage, was photographed and recorded and comprised a rough line of granite and limestone. The position and nature of this line did not resemble the wall (5) identified in the trial trenching (Morris 2014), that existed further south and was clearly bonded, whereas the matrix here was of loose bank material. Beneath this line were roughly grouped, roughly hewn, granite and limestone pieces, lumps of pink mortar and an isolated handmade brick. Some of the granite pieces had mortar adhering, but these were clearly not *in-situ*. This arrangement suggests an attempt with some re-used materials to block the breach in the embankment at some point in the more recent past. Some of this material was removed to allow the depth of 0.6m needed for the spillway to be reached. A cement and brick spillway was created and an area approximately 4.0m by 5.0m lined with gel membrane. The embankment was then landscaped with some of the material which had been removed earlier, a layer of coconut mesh and some loose granite from the northern slope (Figure 9).

There is some discussion over the work completed on the spillway and the need to revisit the plans in spring 2015 and amend the design. The work completed during this watching brief involved the removal and replacement of some rubble which was, in effect, earlier loose bank repair. If the changed works involve deeper excavation, it cannot be assumed that this will also be the case and so a further watching brief may be necessary to ensure any archaeology is safeguarded.

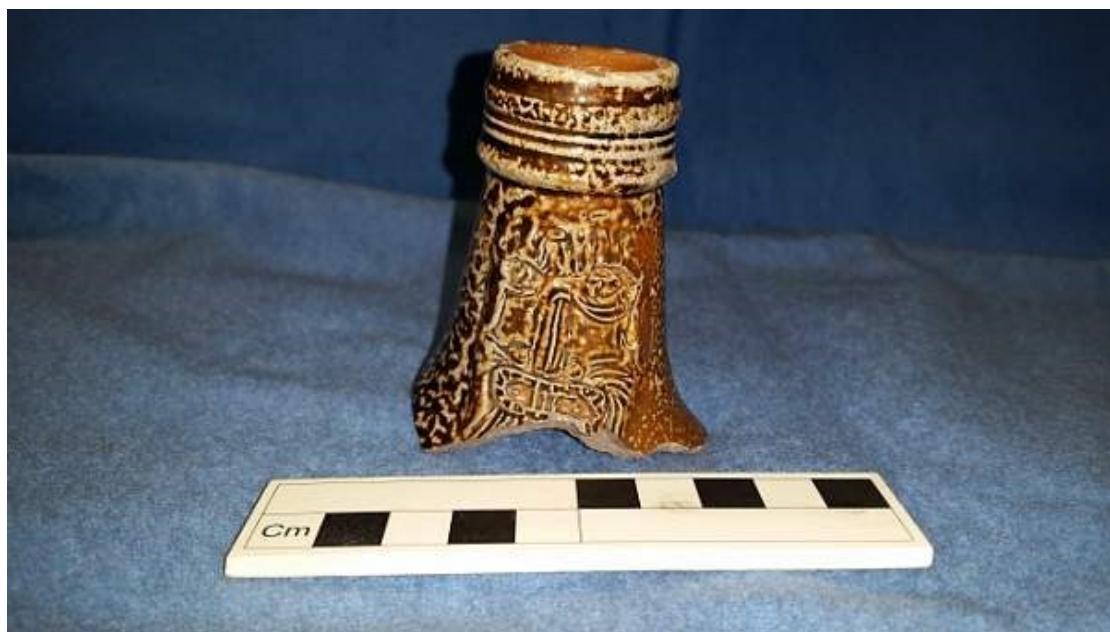
Plate 1: Frechen/Cologne Bellarmine

The two salt glazed stoneware bearded face jugs or bellarmines (Plates 1 and 2) are possibly continental imports from Frechen or Cologne; both fragments have a bead rim and double cordons from which springs the handle. These vessels were copied by English potters working at Fulham and elsewhere from the later 17th century. The face masks on both the Rhenish and English types are known to occur in a wide variety of types, and are not closely datable. The absence also, of a vessel profile and of the heraldic medallions or rosettes which generally occur below the mask (Hurst *et al* 1973), makes a more positive identification difficult. However, one mask (Plate 1)

is very similar to a Frechen example found during excavations at Basing House, Hampshire, (Moorhouse 1970, fig.23.268) dated to the first half of the 17th century, and a general date range of *c.*1625 to *c.*1675 is suggested for the two vessels.

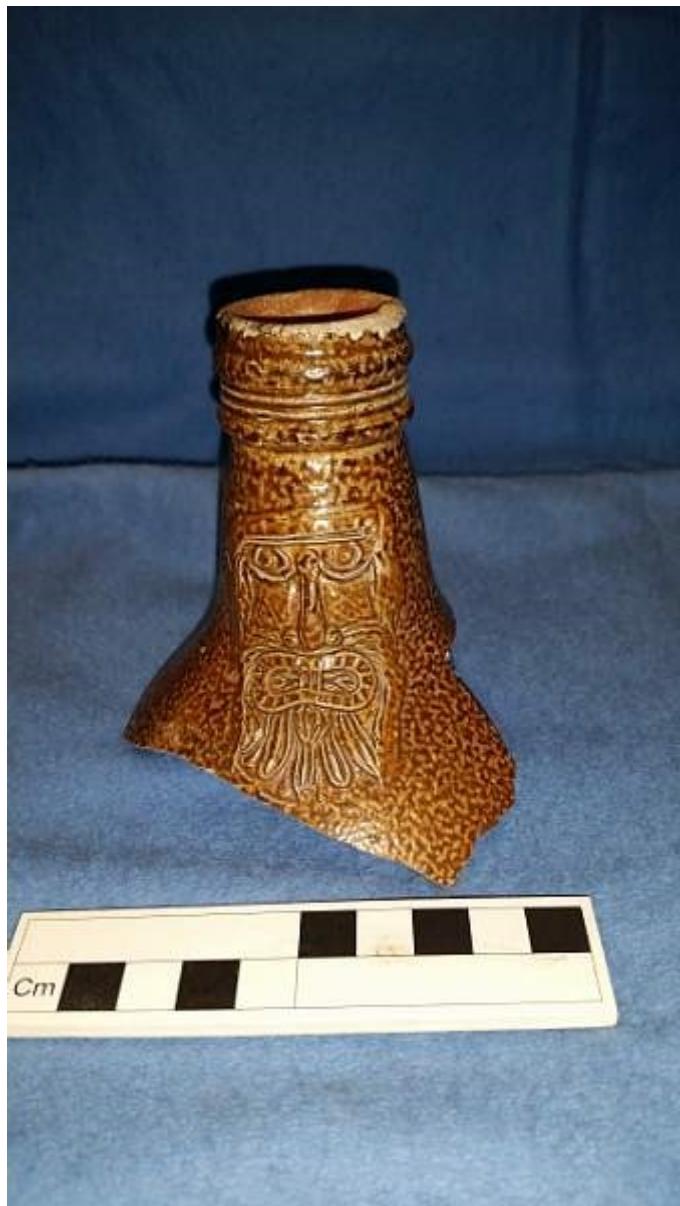
Plate 2: Frechen/Cologne Bellarmine

face-mask has an hour glass mouth. Fine pale grey fabric with quartz inclusions. Rim diameter 38mm, 17th C. Plate 2.
28	FR/CL	1	9	Mottled brown salt glazed body sherd.
28	EA2 – Earthenware 2	11	823	Minimum of two wide mouthed bowls and a jar. Oxidised a light buff with a lead glaze which has fired brown over an iron rich slip, 17th C.
TILE				
28	MS – Medieval Sandy ware	1	256	Monochrome floor tile, black glazed, 14th – 15th C.
28	CC1 – Chilvers Coton A ware	1	137	Ridge tile, very abraded, no glaze survived on upper surface, c.1250-14th C.
